CASE STUDY

A Transformer Repair Facility

**Soil and Groundwater Remediation,
Richmond, BC**

Liliana Jerade, M.Eng., P.Eng.

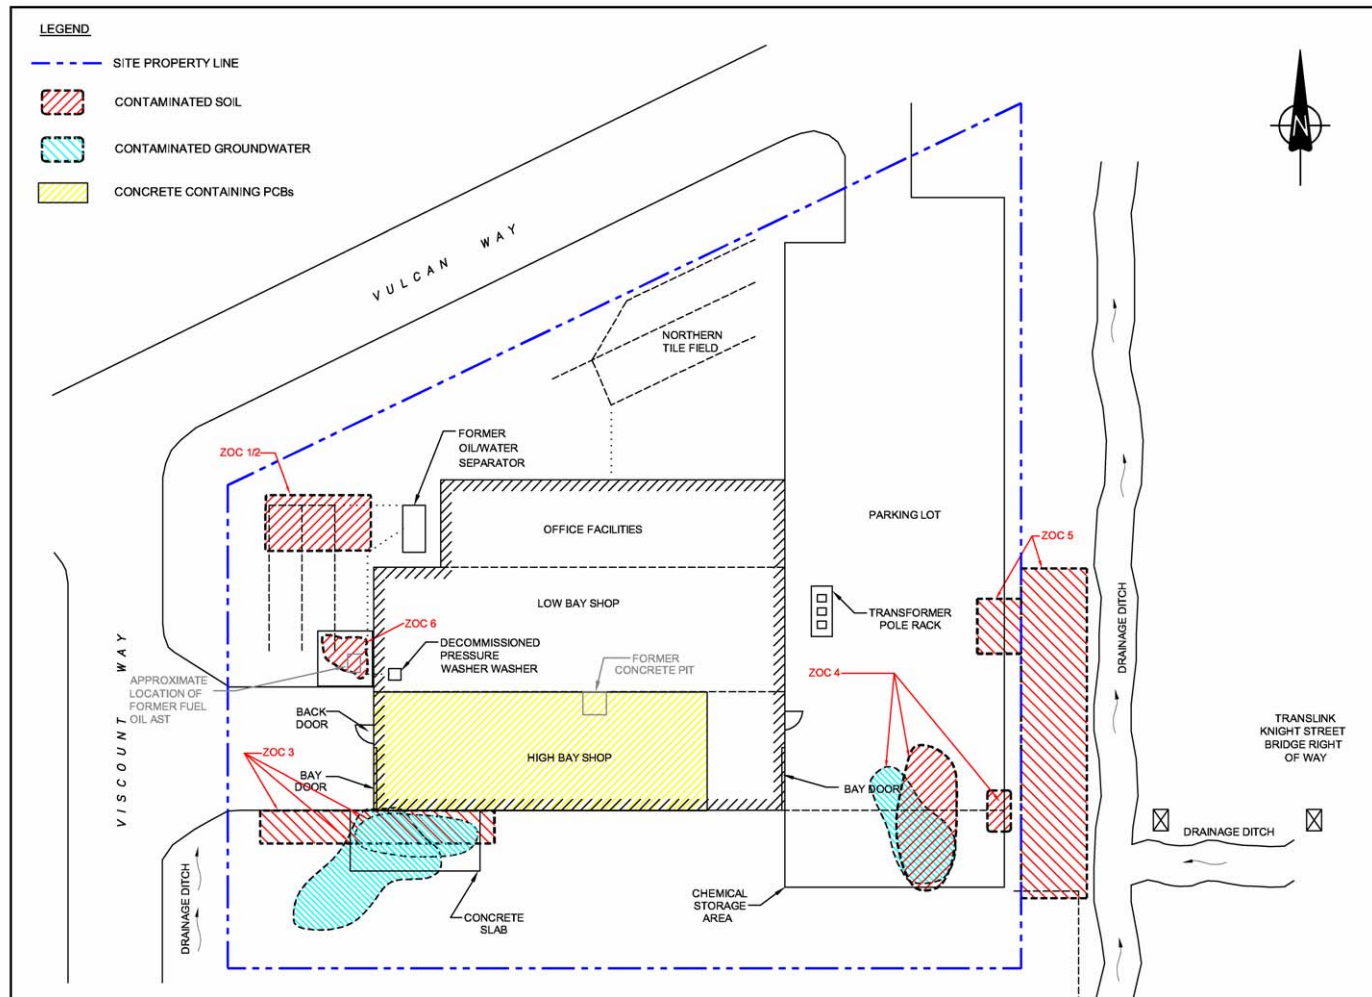
Zones of Contamination

- Six zones of contamination (ZOC) were identified including the Right of Way adjacent to the Site.
- The contaminants identified included:

- Contamination in groundwater was identified in two areas at the Site.
- The contaminants identified included:

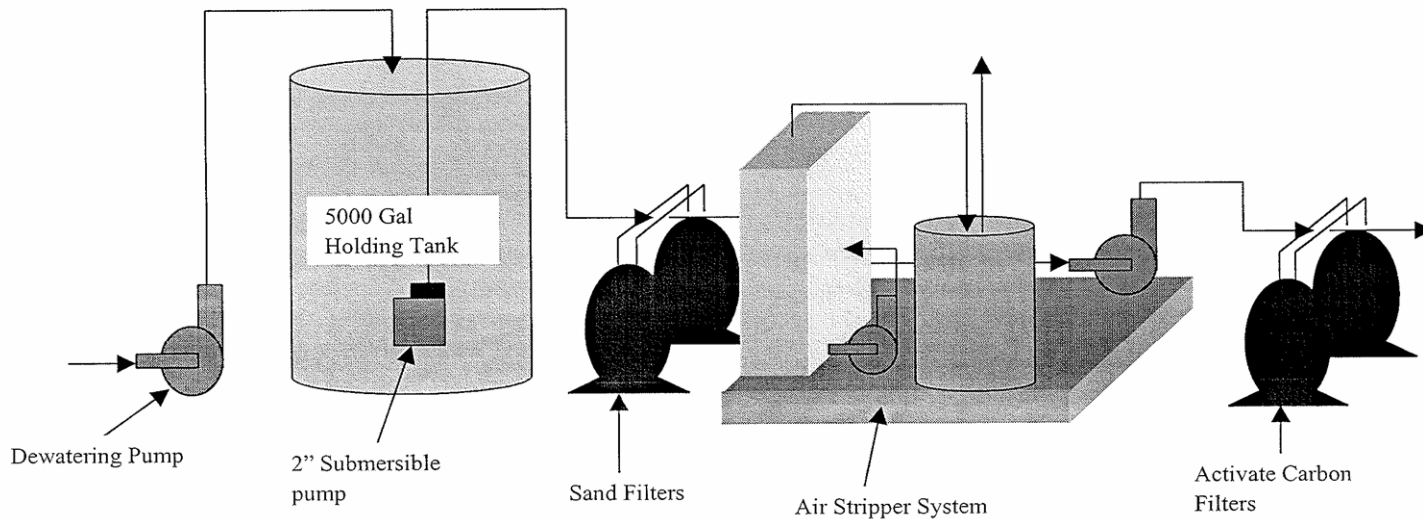
- a Multi-Phase Extraction and Air Stripping system was selected to remediate the groundwater.

Water Treatment System
Capacity 45-60 GPM

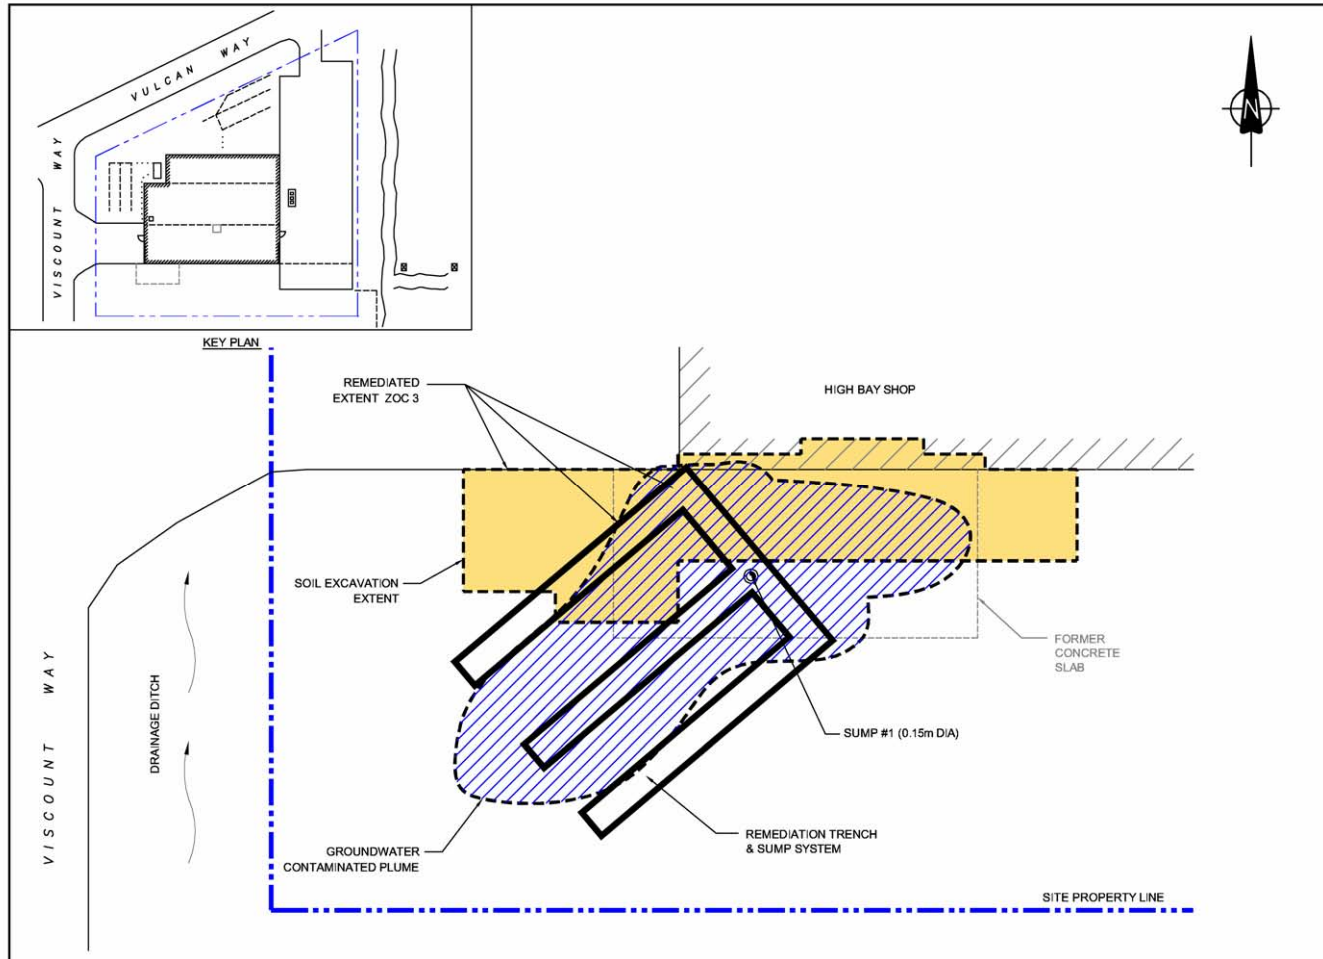
Groundwater Remediation Program

- The design of the remediation system for the 2 impacted plumes consisted of:
 - a main trench approximately 8.5 m long by 1 m wide at a depth of 5 mbg.
 - three additional trenches, 7 m long oriented in the direction of the impacted plumes.
 - installing a sump as the extraction point at the centre of the main trench.
 - backfilling the trenches with gravel to facilitate extraction of groundwater

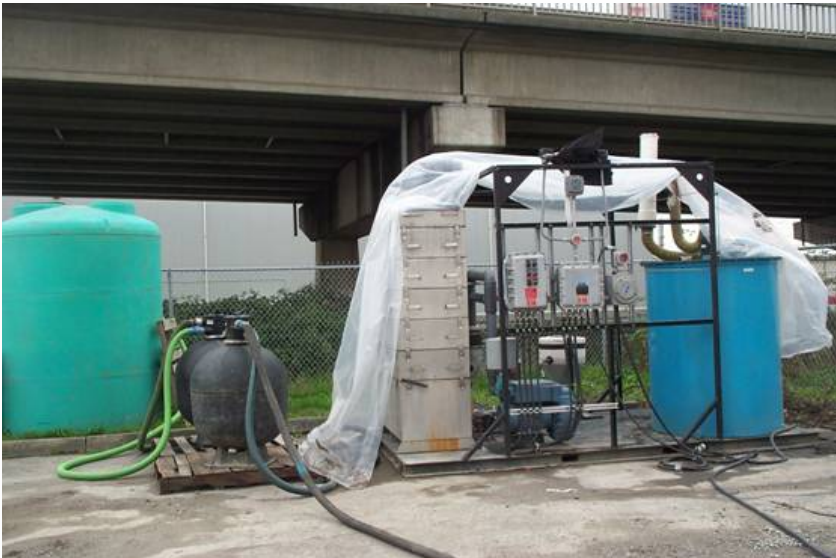
- The system was operated in a batch mode:
 - groundwater pumped from one of the sumps to a holding tank and from there to the treatment system.
 - When groundwater from one holding tank was being treated, groundwater from the second sump was pumped to a second holding tank.
