# In-Situ Remediation of Brine Impacted Soils and Groundwater Using Hydraulic Fracturing, Desalinization and Recharge Wells

Craig Robertson, M.Sc., P.Geol.  
Senior Technical Manager

October 12, 2006

**Wiebe Environmental Services Inc.**

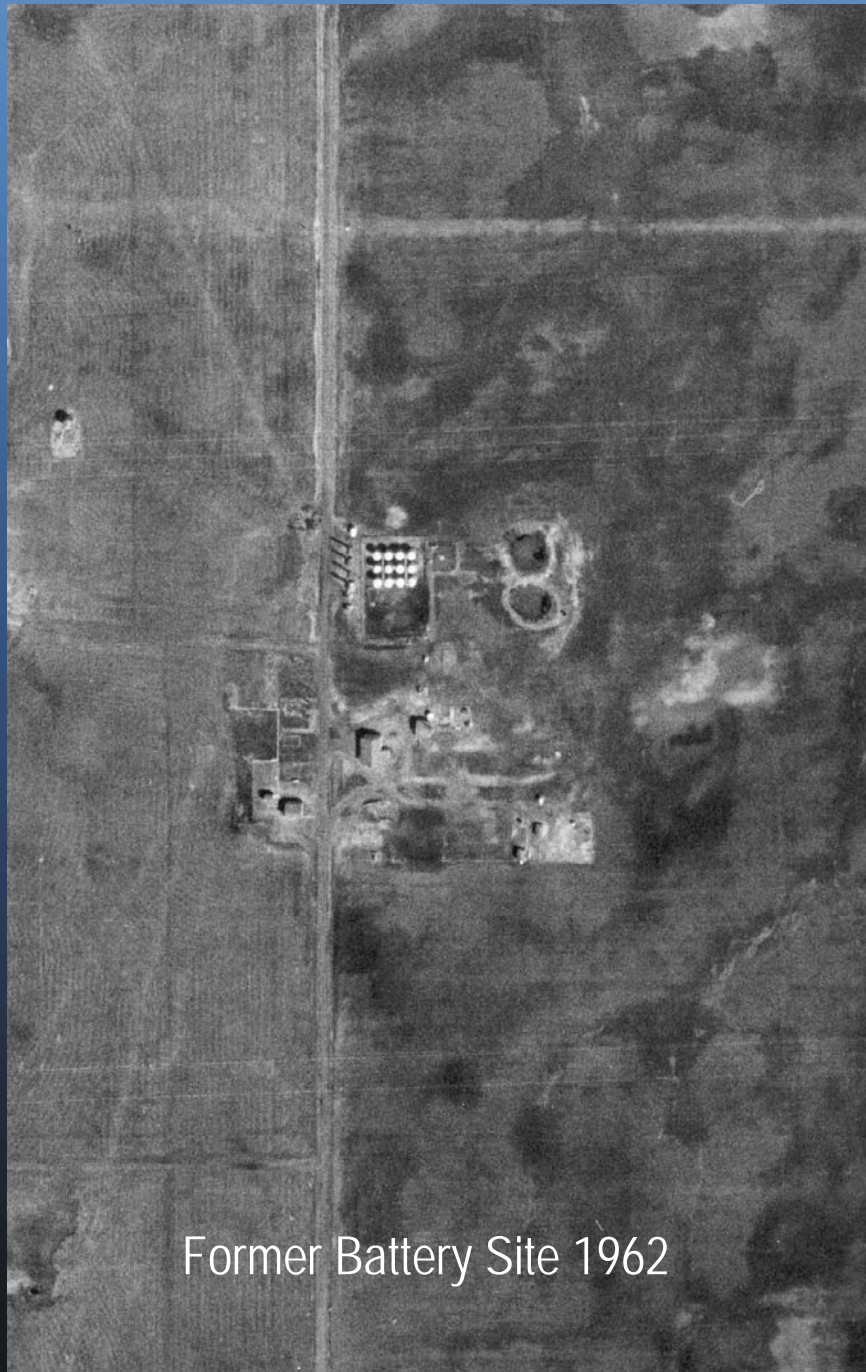
Former Battery Site 1962

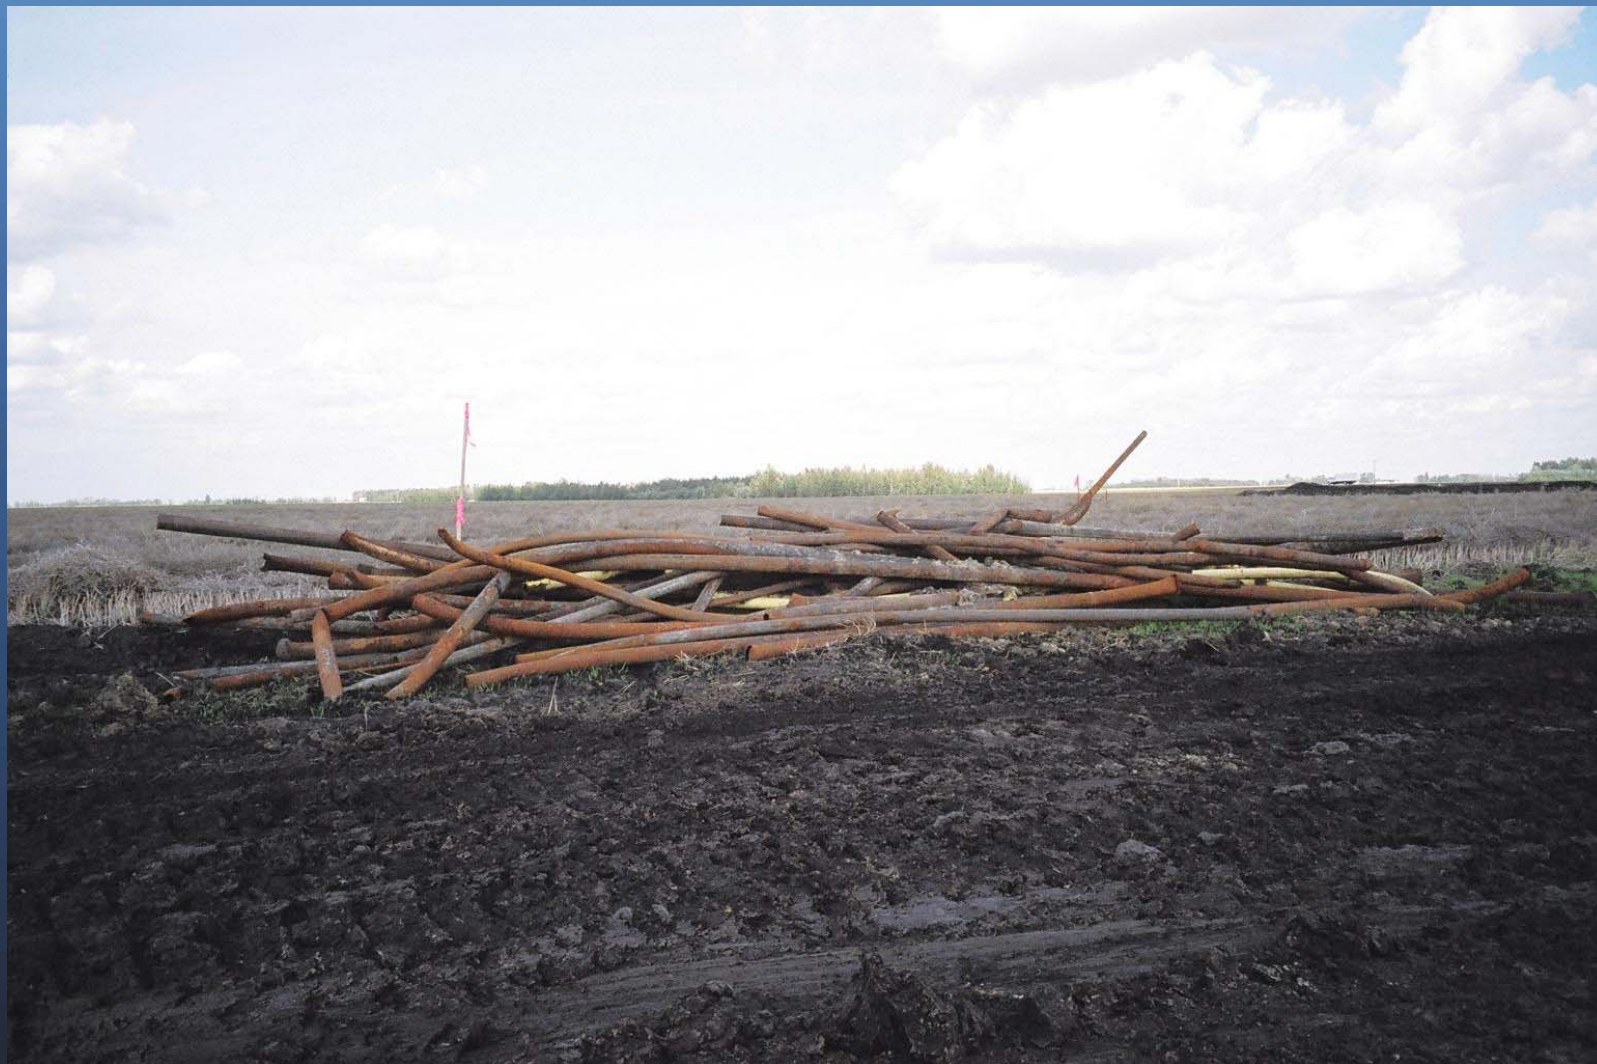
Excavated Pipelines

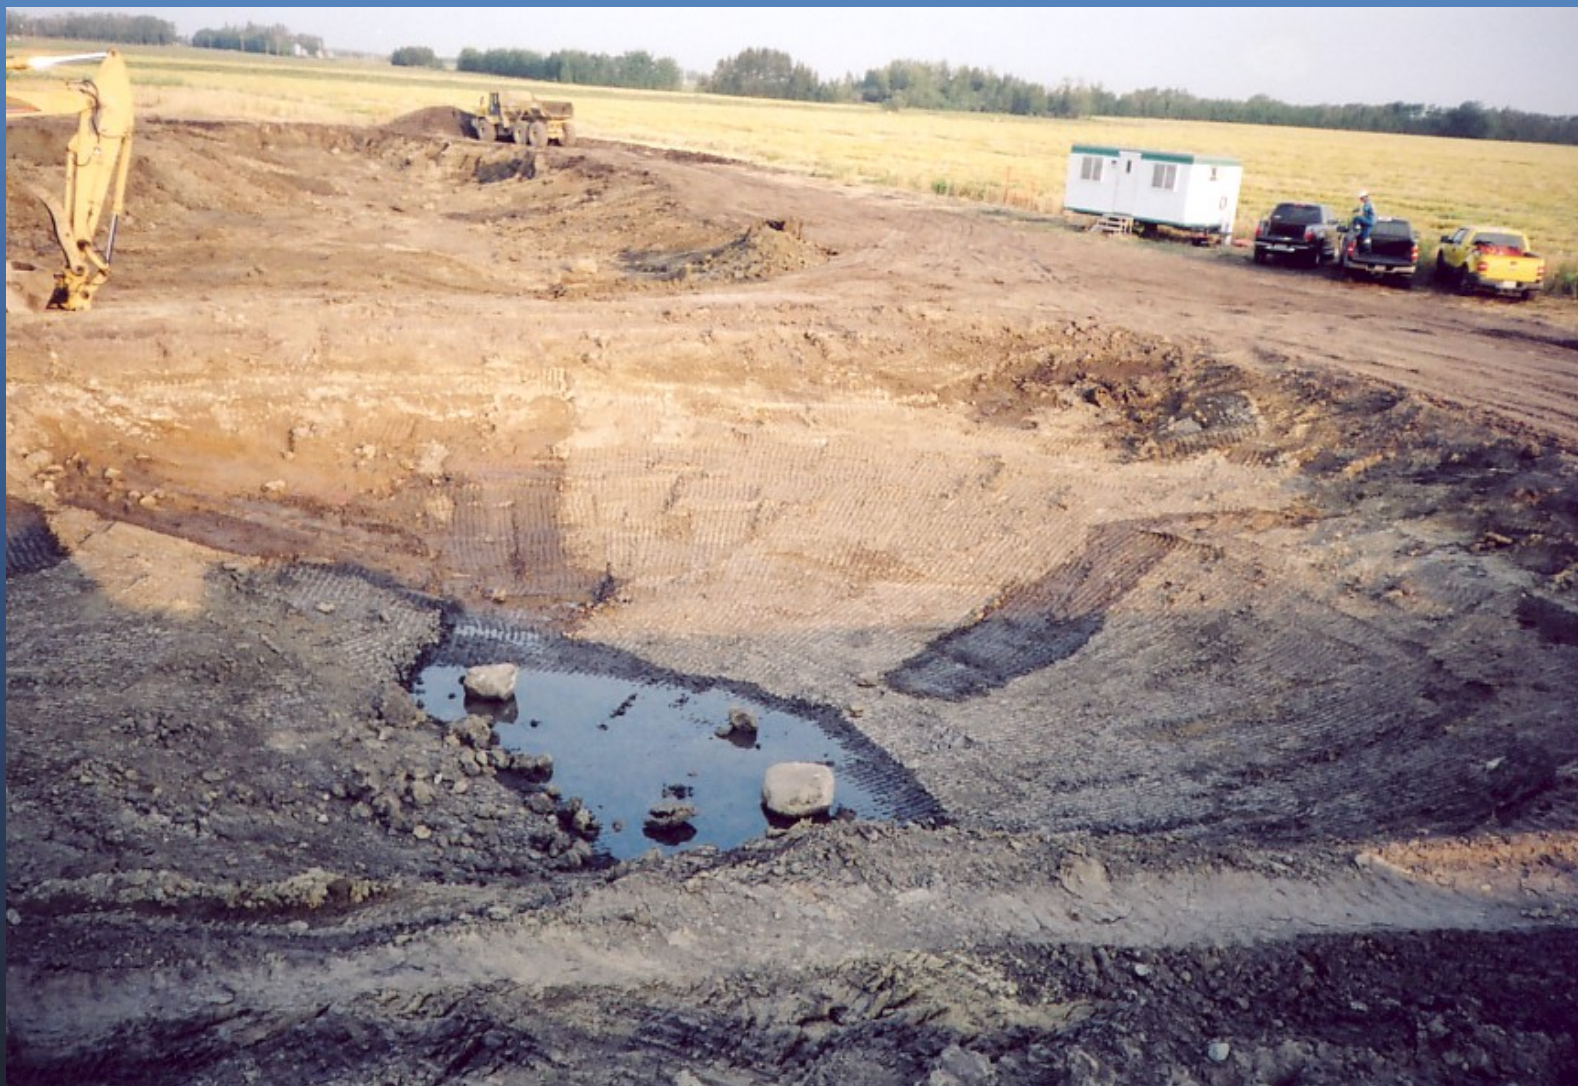
Former Flare Pit Excavation

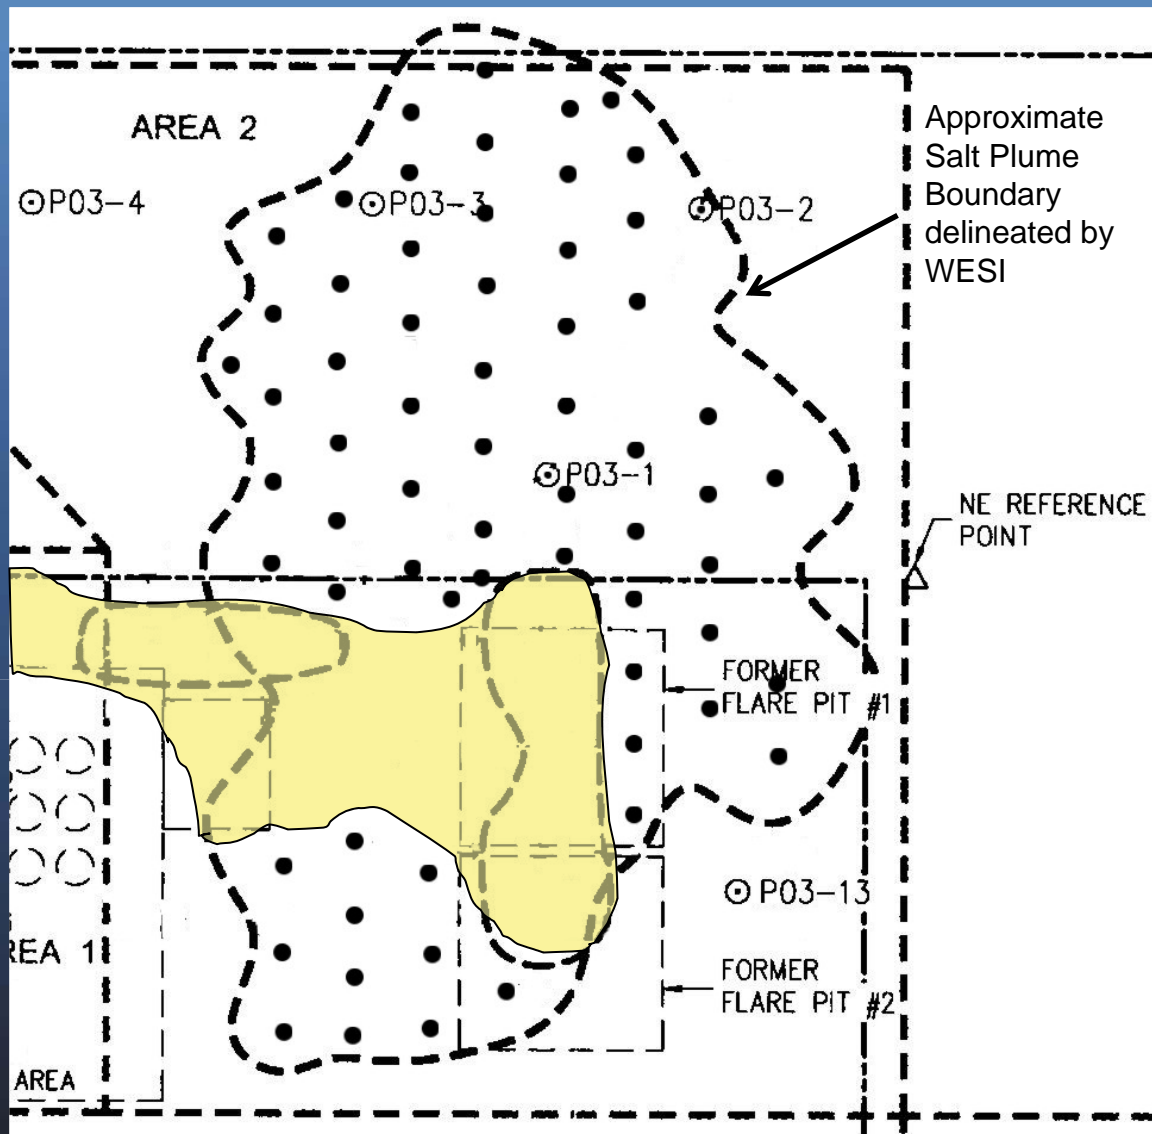
Hydraulic Fracturing Injection Locations

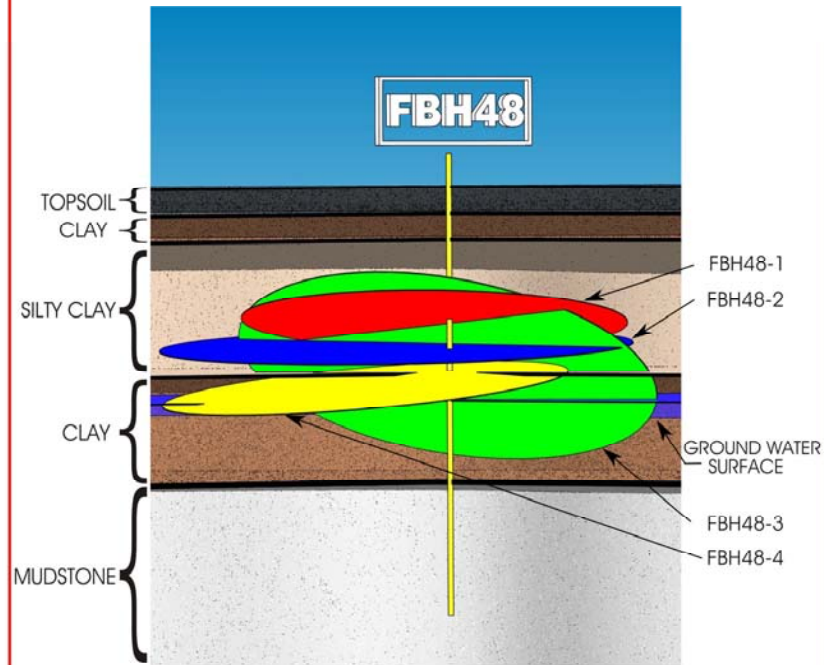
Figure III-9

Three-dimensional representation of sand drainage fractures at Fracture Borehole FBH48

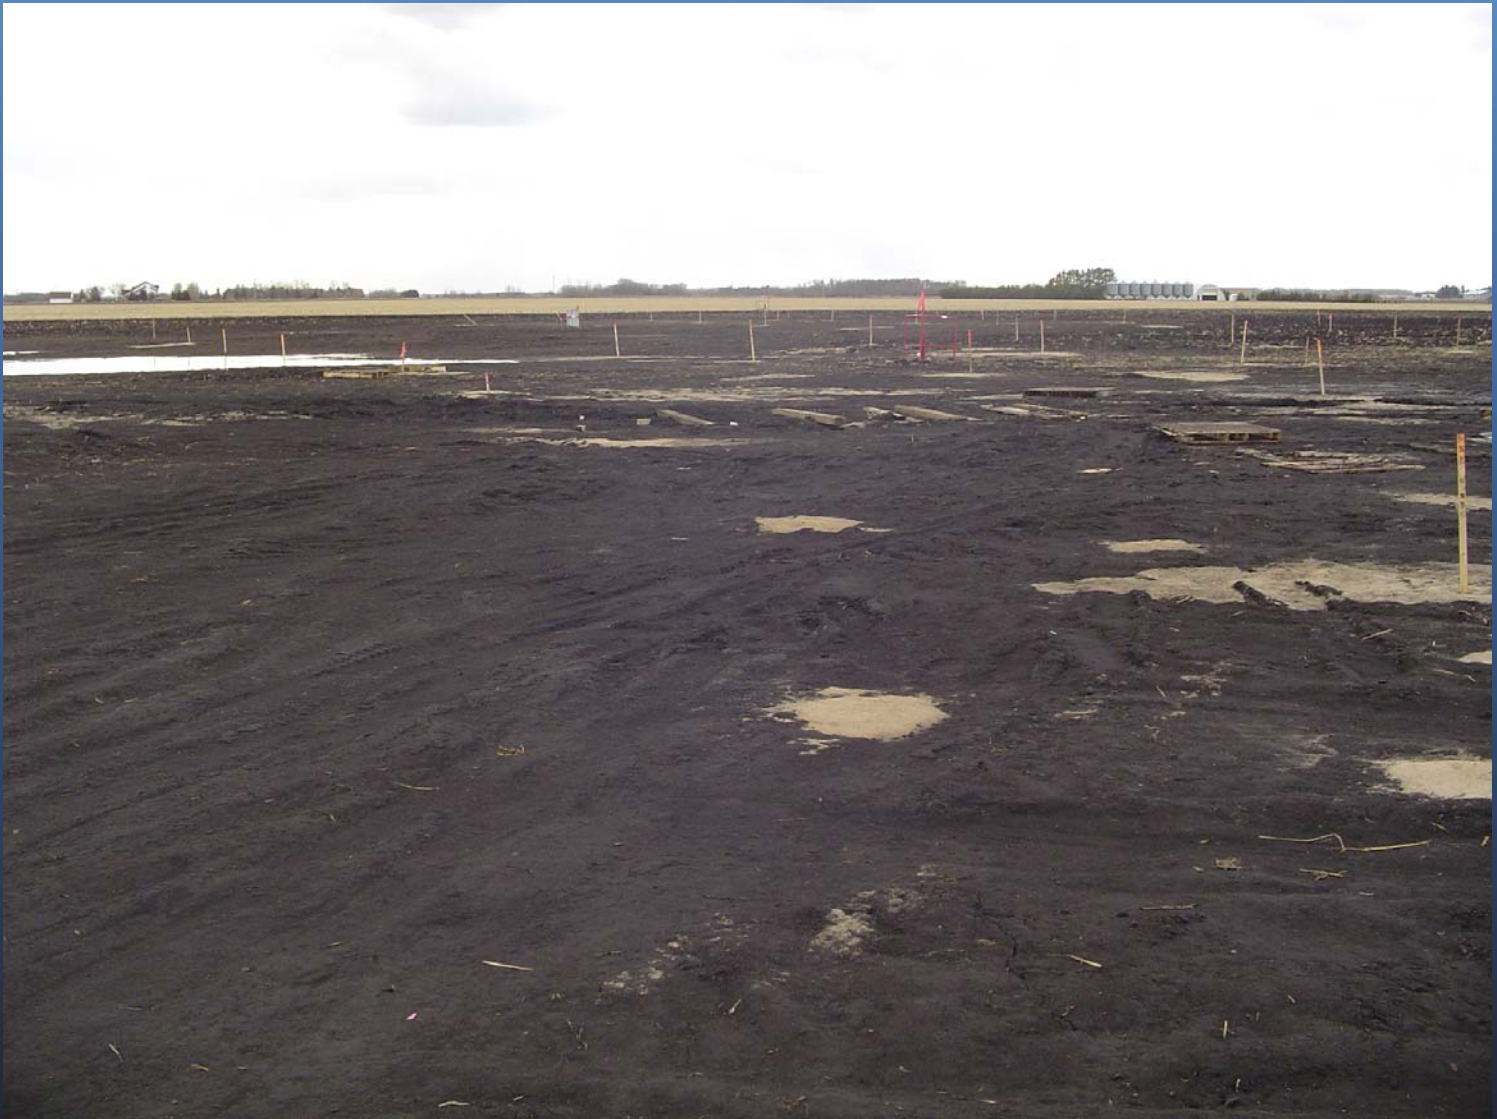
Fracturing Locations
