# 60-Year Old Construction Yard REMEDIATED AND REDEVELOPED

**Vladimir Agatonovic, P. Geol., Focus Environment and Geosciences Group  
Operations Manager/Senior Hydrogeologist**

# 5340 – 1<sup>st</sup> Street SW, Calgary, Alberta

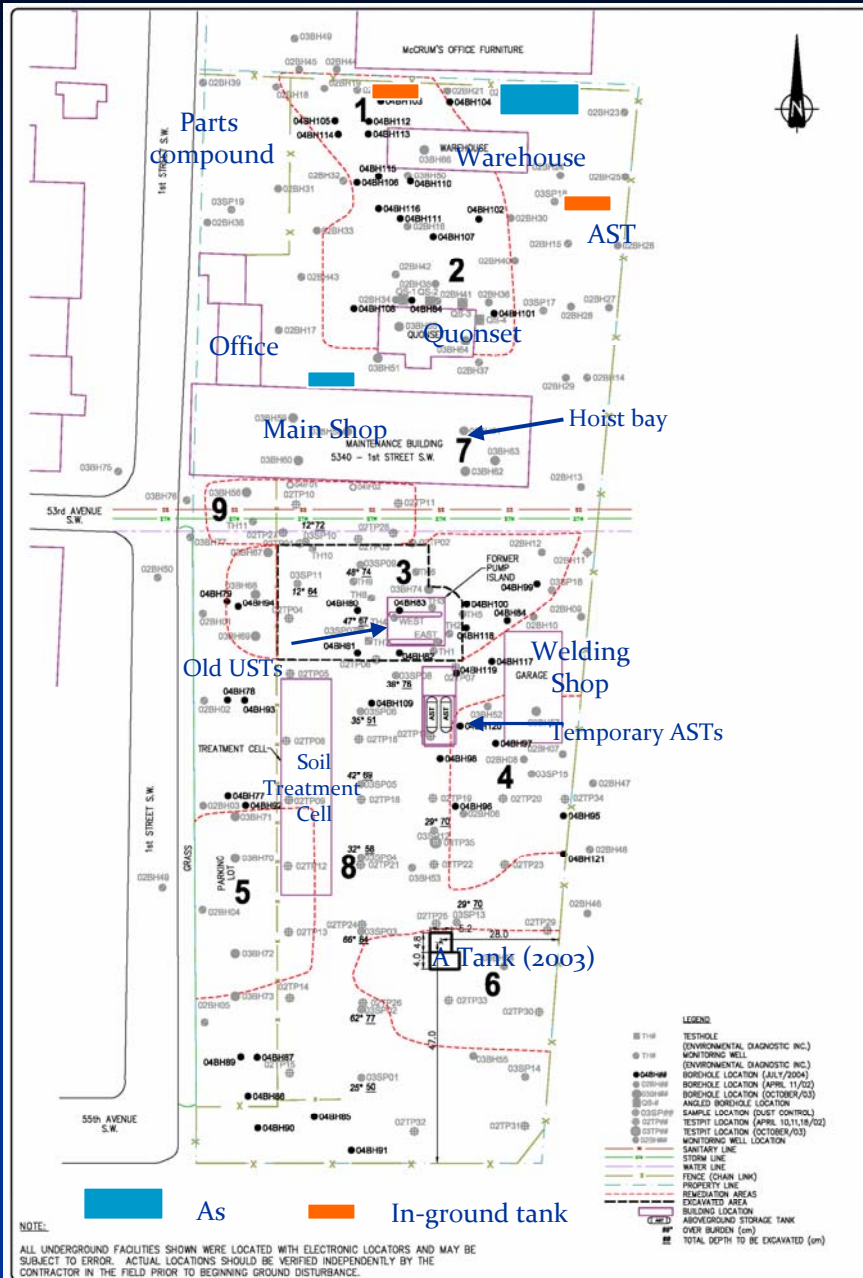
# Site Plan

#	Area	Source	Media Impacted	CoC*
1	Warehouse	In-ground tank	soil and groundwater	PHC and Metals
2	Quonset	former UST	soil and groundwater	PHC
3	Fuel Storage	3 USTs	soil and groundwater	PHC
4	Welding Shop	Hoist Bay	soil	PHC
5	Parking Lot	unknown	soil	PHC and Metals
6	SE Corner	concrete USTs	soil and groundwater	PHC and Metals
7	Main Shop – hoist bay	Hydraulic hoist	soil	PHC
8	South Part	dust suppression	soil	PHC and Metals
9	Utility Corridor	3 USTs	groundwater	PHC

In 2006, Additional areas with metal impacts were detected around Main Shop and Warehouse and remediated.

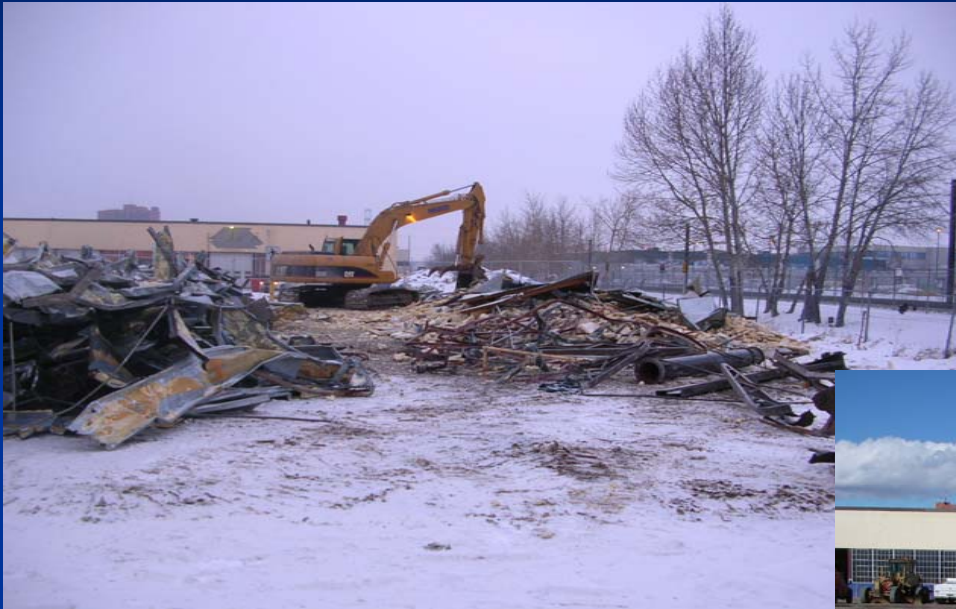
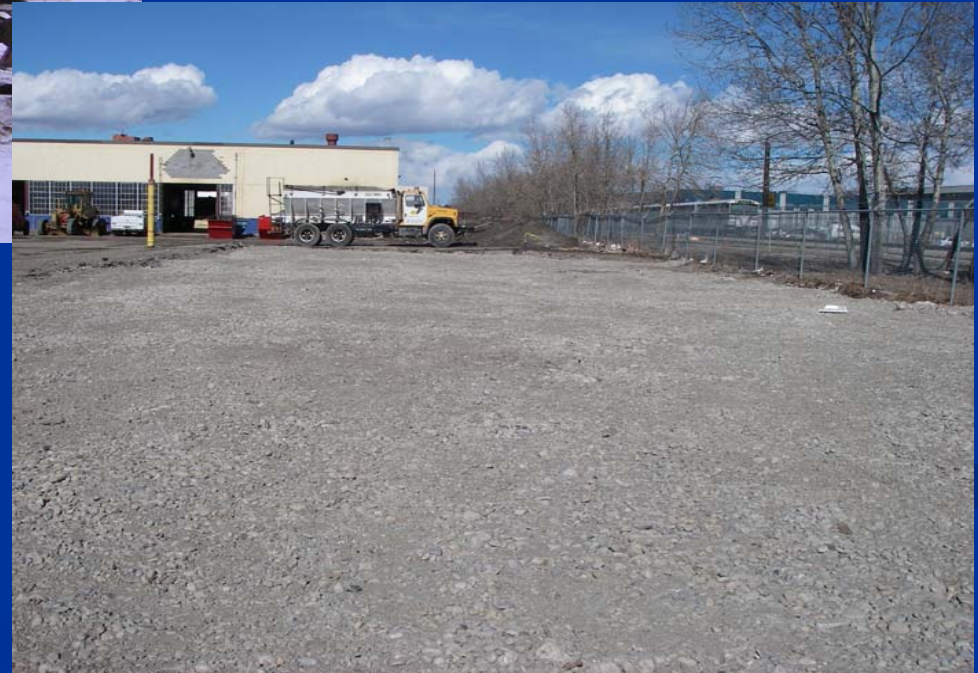
# Welding Shop Demolishment

- In February 2007, Welding Shop was demolished and associated PHC impacted soils excavated and disposed (managed by ARCADIS Canada)

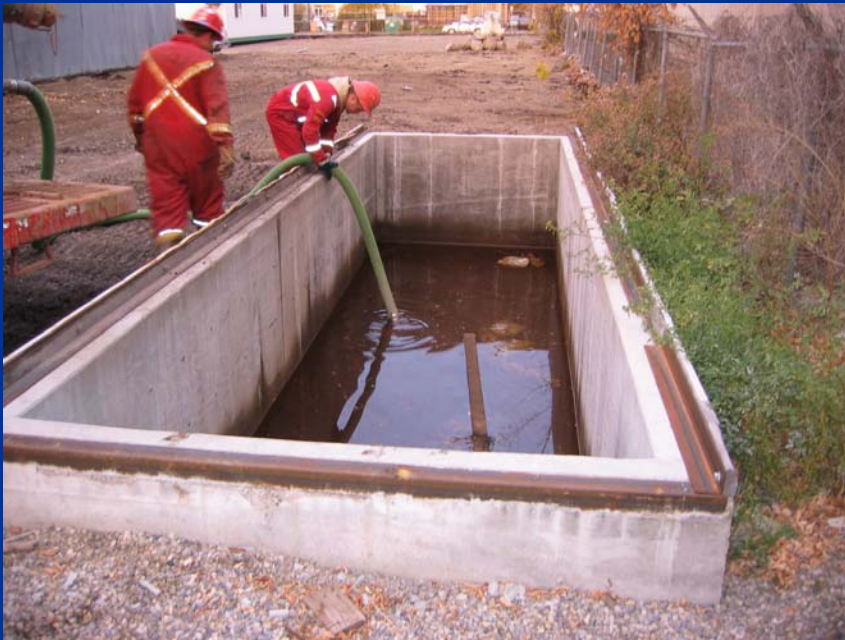
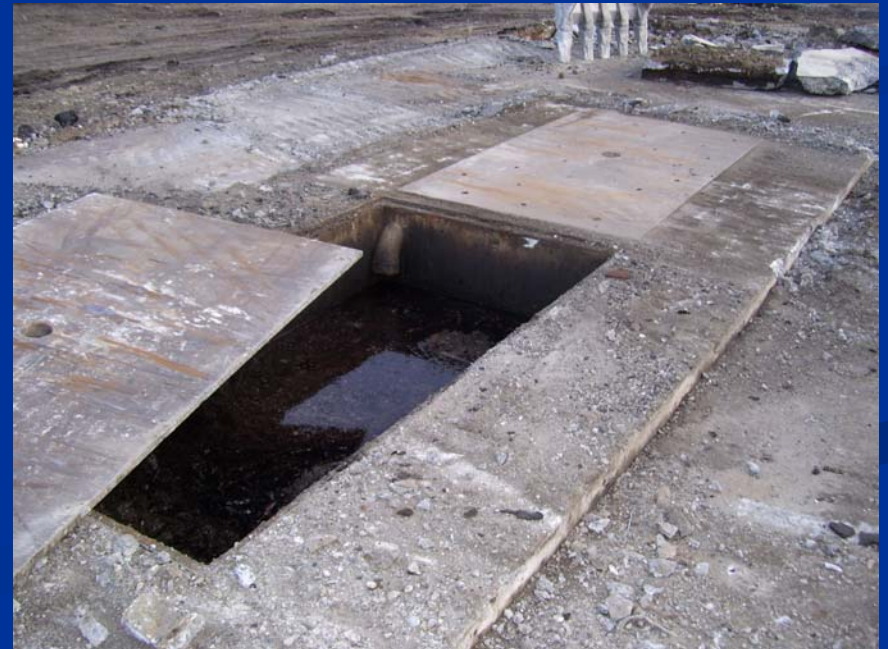
# Liquid Waste Disposal

- 2 in-ground storage tanks

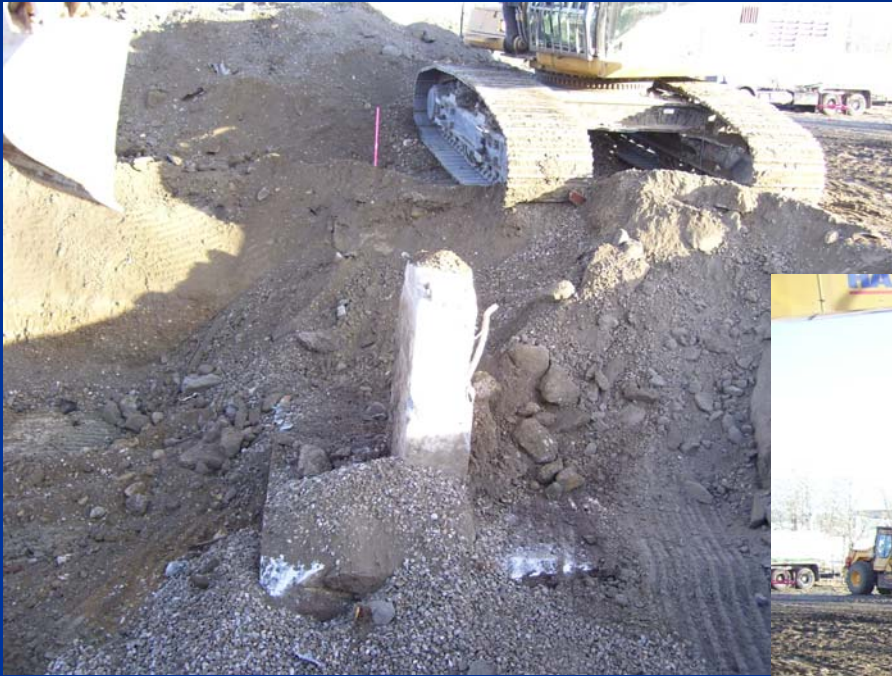
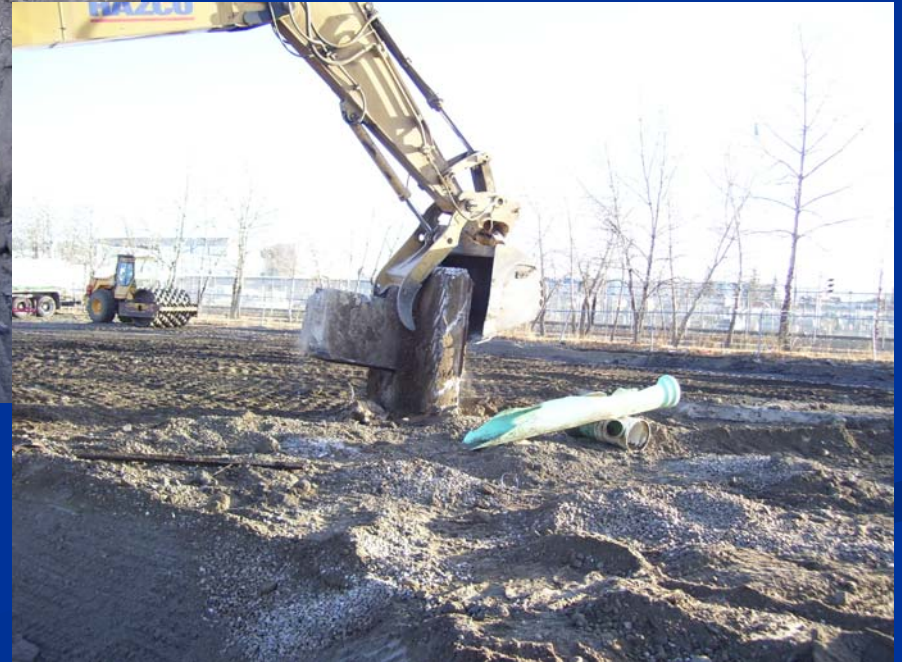
# Hoist Bay Soil Remediation

- In 2006, the remediation was completed in all areas except:
  - Underneath one of the supporting pillars in Hoist Bay area; and
  - Underneath the south end of Welding Shop.
- The RAP was developed by EBA Engineering Consultants in 2004 and remedial activities presented at Remtech 2005.
