8-Mile Channel

Remediation

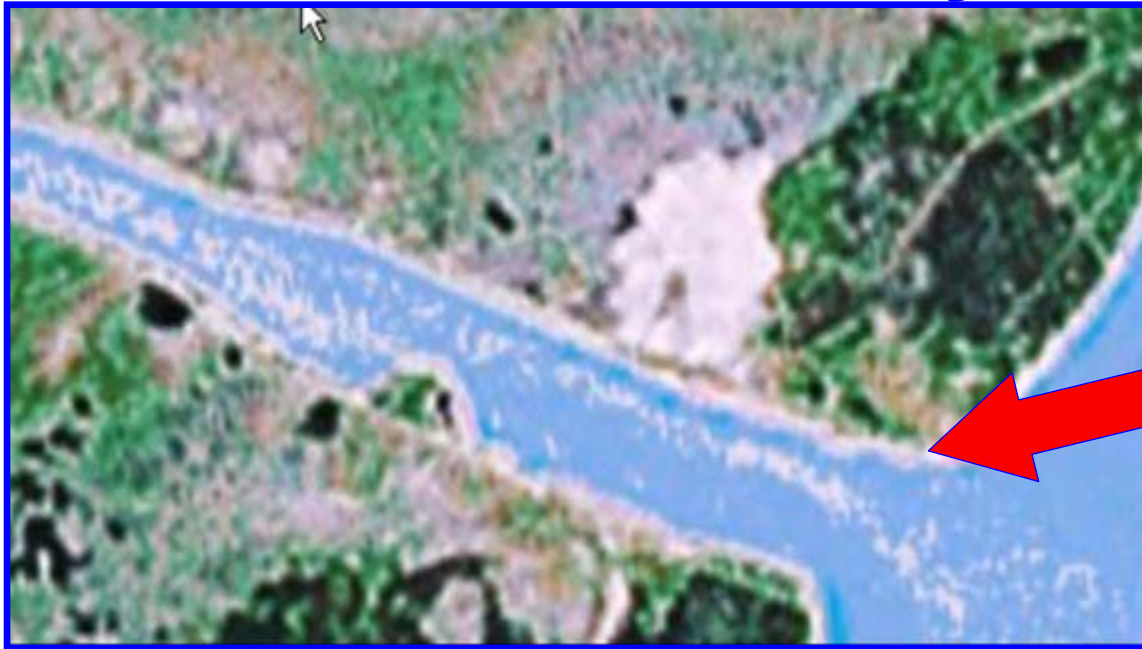
- North side of 8-Mile Channel
- Inlet to channel at Playgreen Lake
- Straddling shoreline

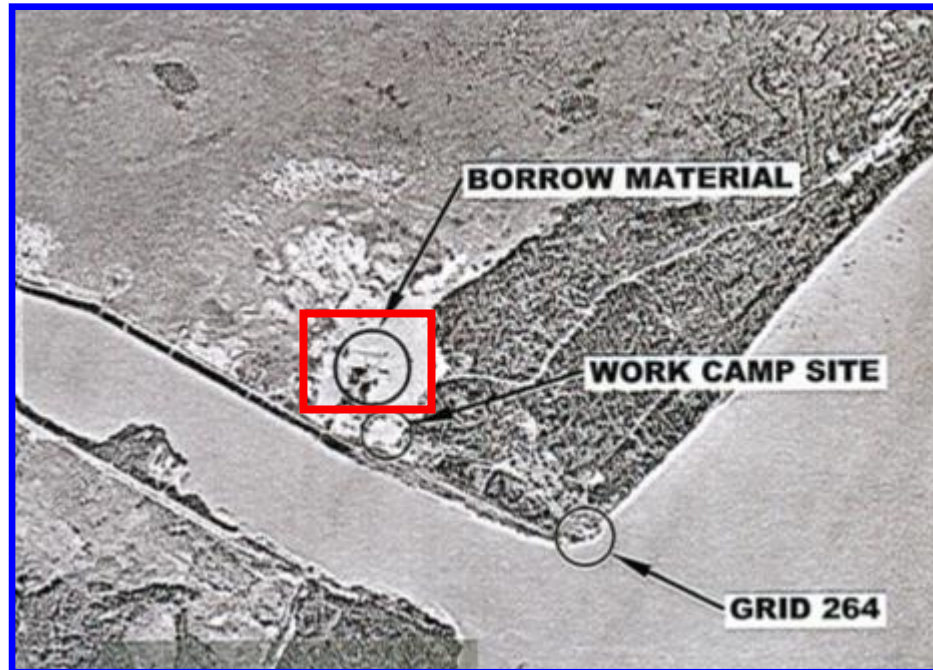
- Texture consistent with channel bottom material
- Initial samples showed no contamination
- Discovered limited debris and evidence of PHC impact during final removal of borrow
