Multi-Faceted Approach to Achieving Remedial Closure at an Active Rail Yard

2013 RemTech Conference
Banff, AB

Presenter: Jason Christensen, P.Eng.
Wednesday October 16, 2013

CN Smithers Rail Yard

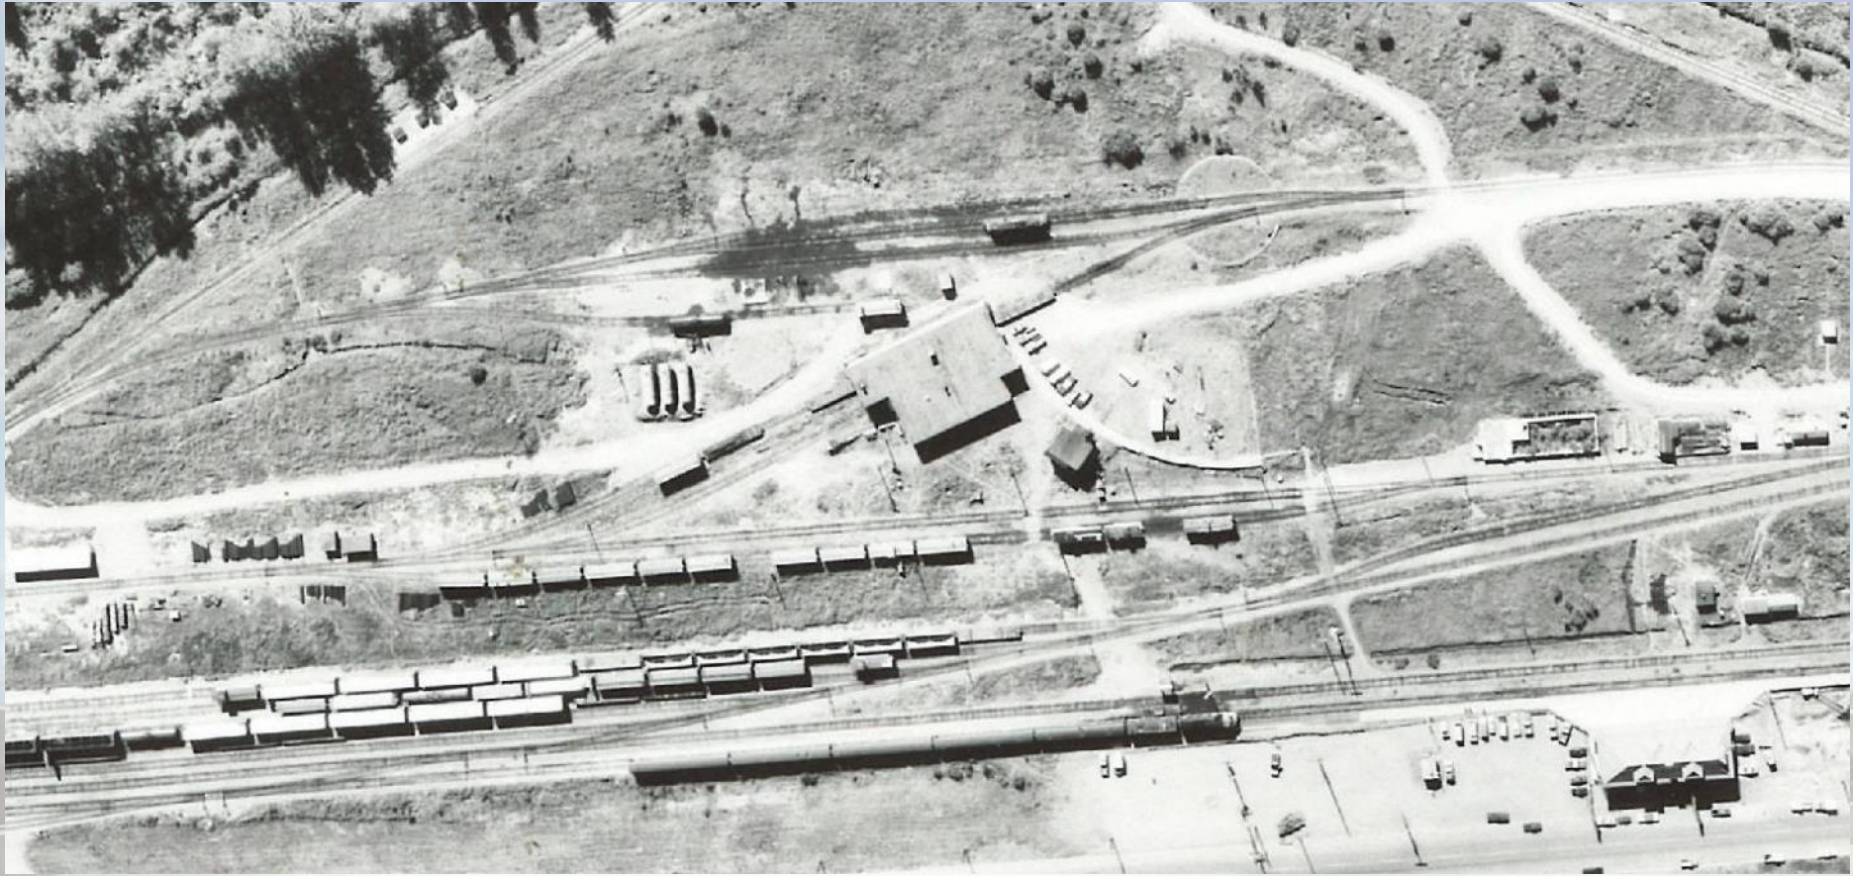
Fuelling Stand (1996)

Diesel Fuelling conducted on Site 1959 to 1997

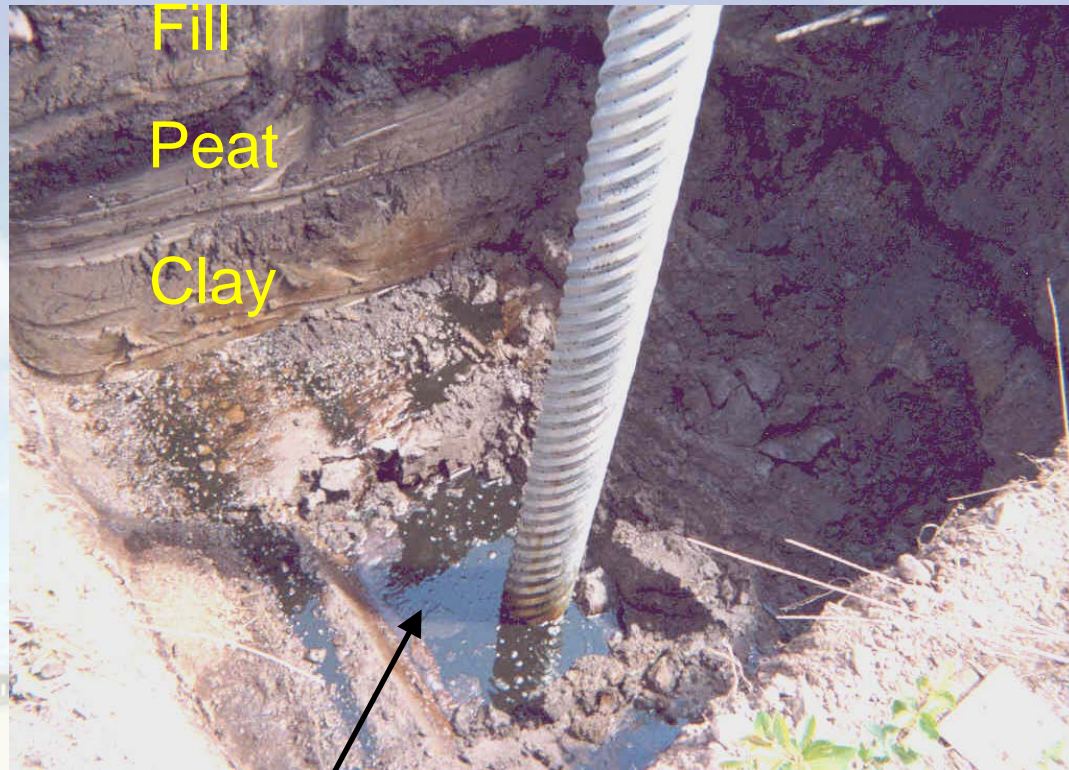
Visible NAPL

Site Geology

Three Distinct layers:

1. Upper sand and gravel fill
2. Middle clay confining layer
 - varies in thickness and elevation
 - undulating clay layer
3. Lower sand unit
 - confined by upper clay layer
 - artesian type aquifer
