The Importance of Considering Combined Surface Water and Groundwater Drainage Issues When Planning Site Remediation

Joe Lenham – Principal Consultant, Environment Tom Dance – Principal Hydrogeologist, Environment Tetra Tech EBA Calgary

Identifying the problem

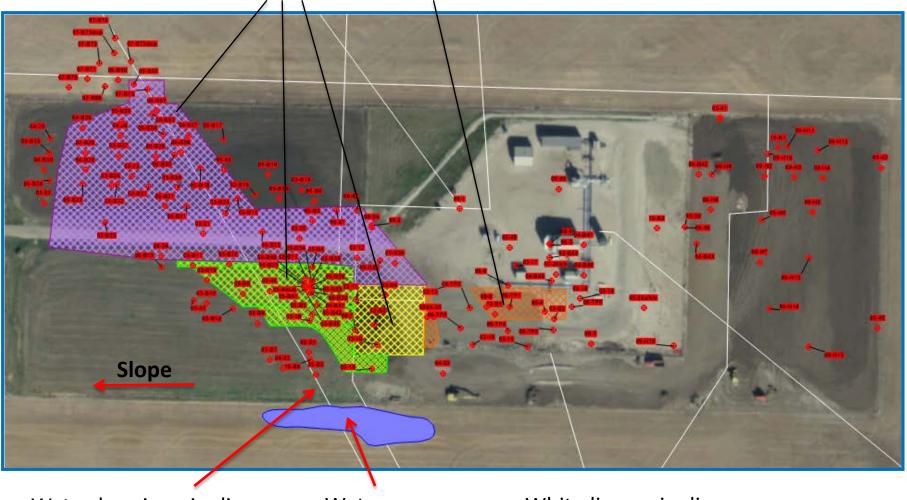
Remediated areas: dig, clean, replace to 4-6 mbgs – over four years (2005-2008).

Water-bearing pipeline

Wet area (off-lease) White lines: pipelines

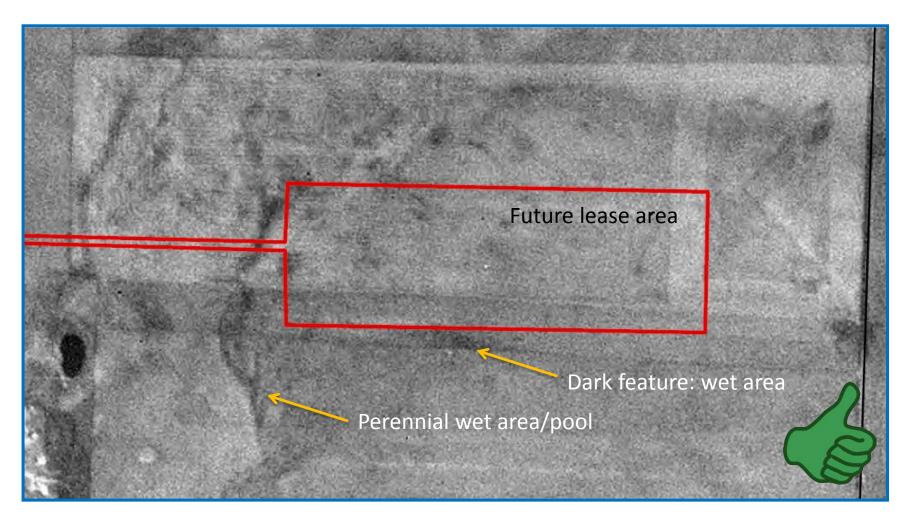
1950 Aerial Image

"It's natural". Job Done! (Is there a prize for the shortest RemTech talk ever?)

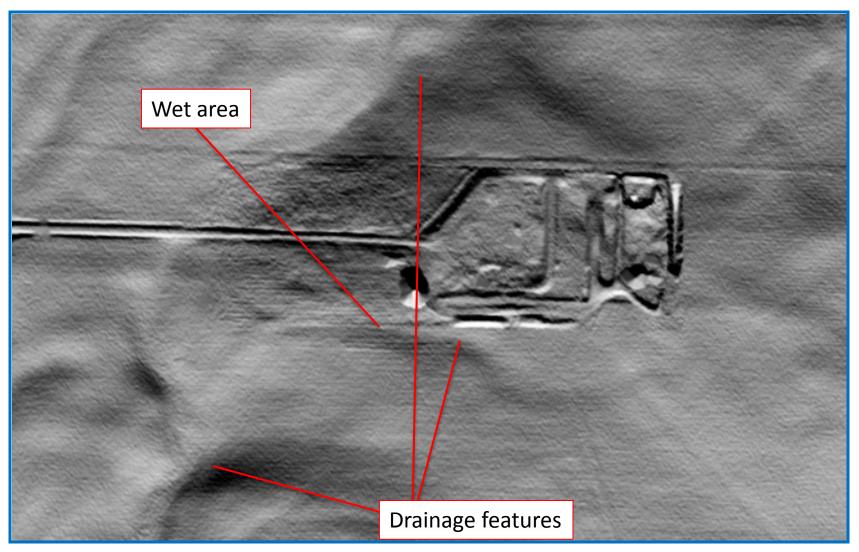
2009 LiDAR

Therefore, our wet area is in a long-standing depression, albeit sloping.

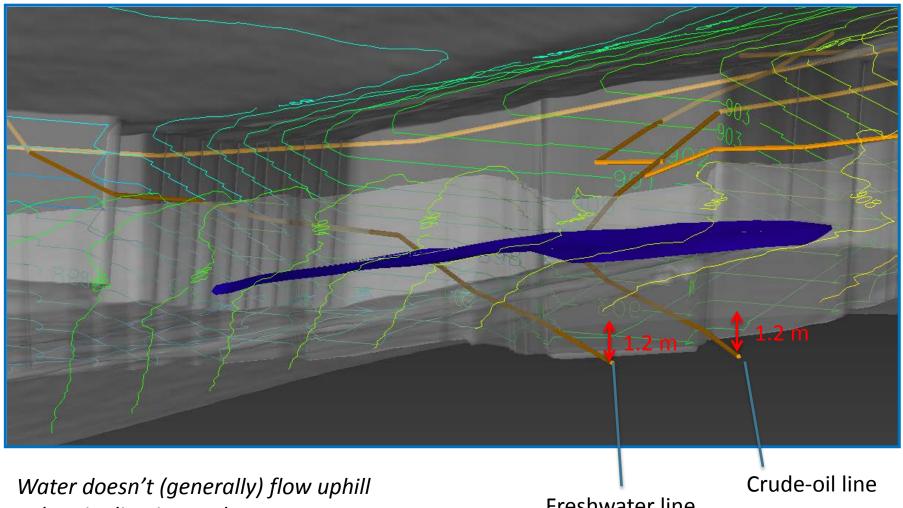
LiDAR side-view

- the pipeline is not the cause.

Freshwater line

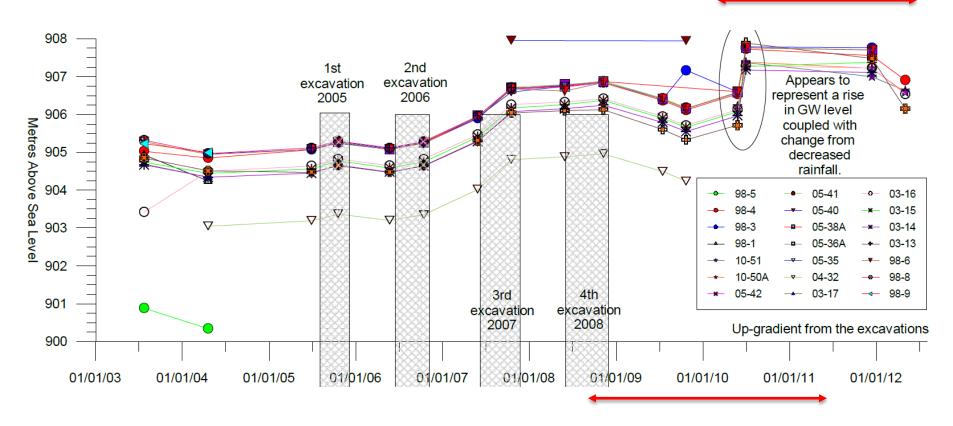
Groundwater Levels Up-Slope From Remediated Zone

Precipitation increases

Wet area appears; worsens

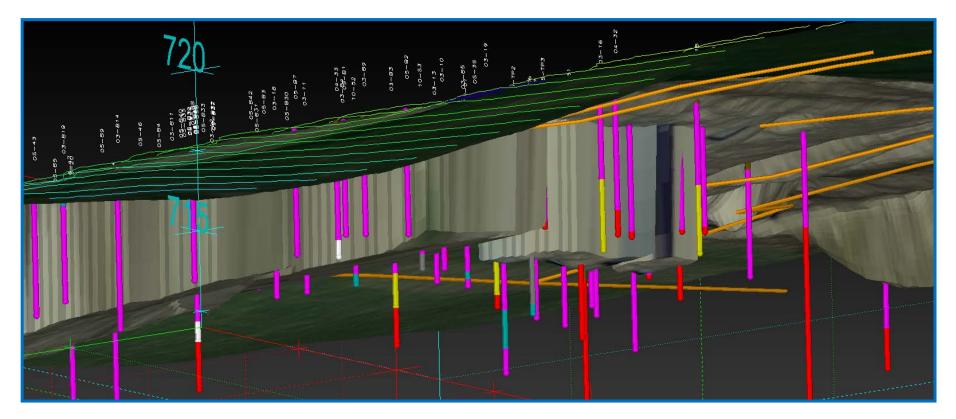
Boreholes: Sand

Till (clay)

Sand

Bedrock (sandstone, shale)

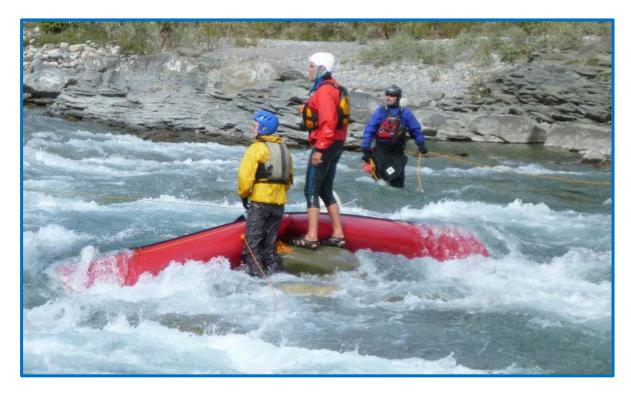
- Thin sand layers dominated shallow GW flow.
- Remediation destroyed the soil structure.

- Homogeneous clean soils were compressed tightly.
- Groundwater "piled up" by ~3.5 m behind the obstruction, like this:

Problem identified!

- Additional temporary wells confirmed GW levels extended to wet area.
- Confirmed that groundwater/surface water interaction was the problem.
- Now our client was empowered to improve the situation.
- Substitute drainage is being installed on the existing leased land.
- We received a compliment \bigcirc .
