Characterization and Remediation of Lac-Mégantic

Remediation Technologies Symposium (RemTech 2014) October 15 - 17, 2014

By Denis Millette, Eng., P. Eng., Agr., Ph.D.
Principal, Senior Hydrogeologist

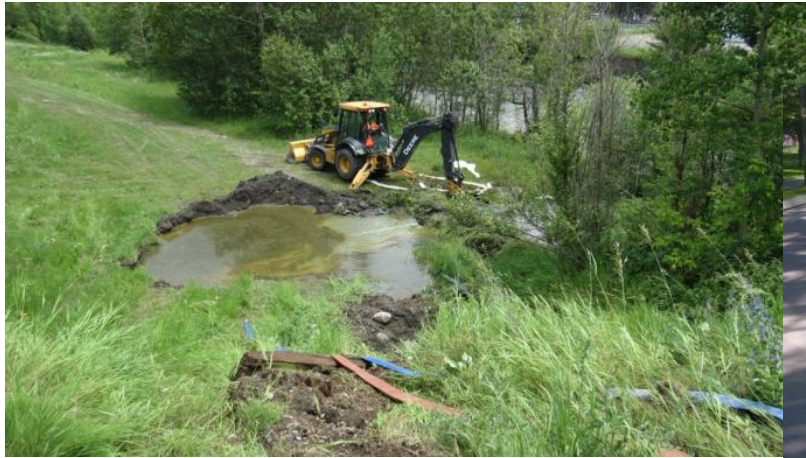
Redundant pond for sewage water
Source: MDDEFP

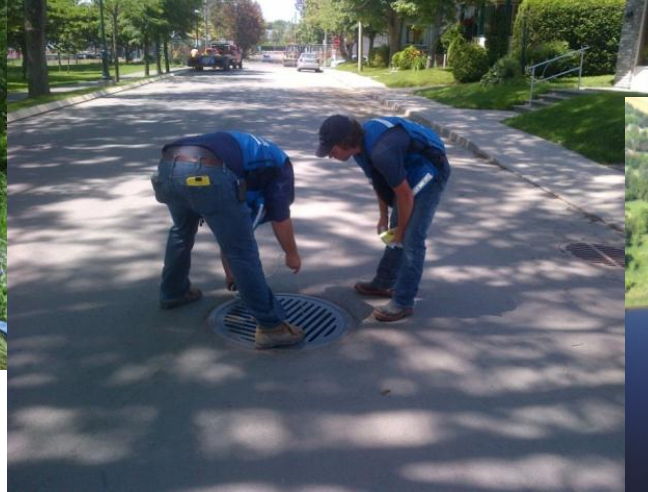
Vapour monitoring of sewer lines
Source: MDDEFP

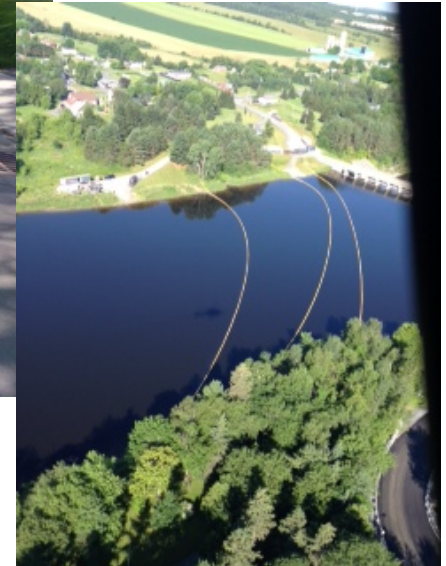
Booms on water bodies
Source: MDDEFP

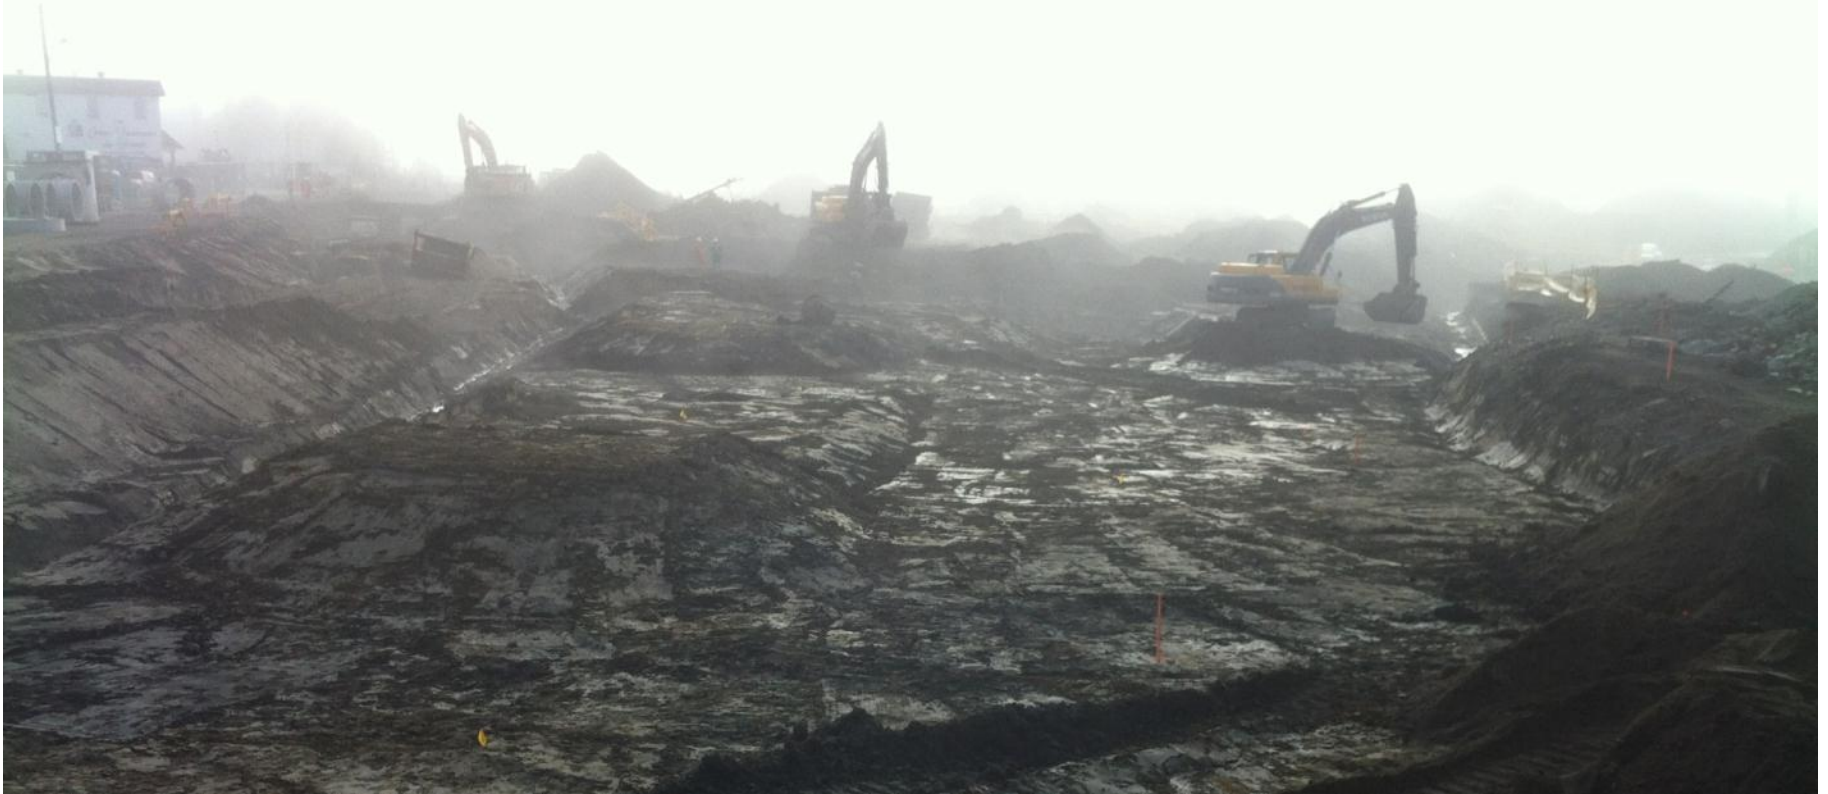
Mass Excavation for Railway Track Reconstruction

- Mass excavation of contaminated soil along railways scheduled to be returned to service in December 2013.
- Most significant volume of contaminated soils excavated.

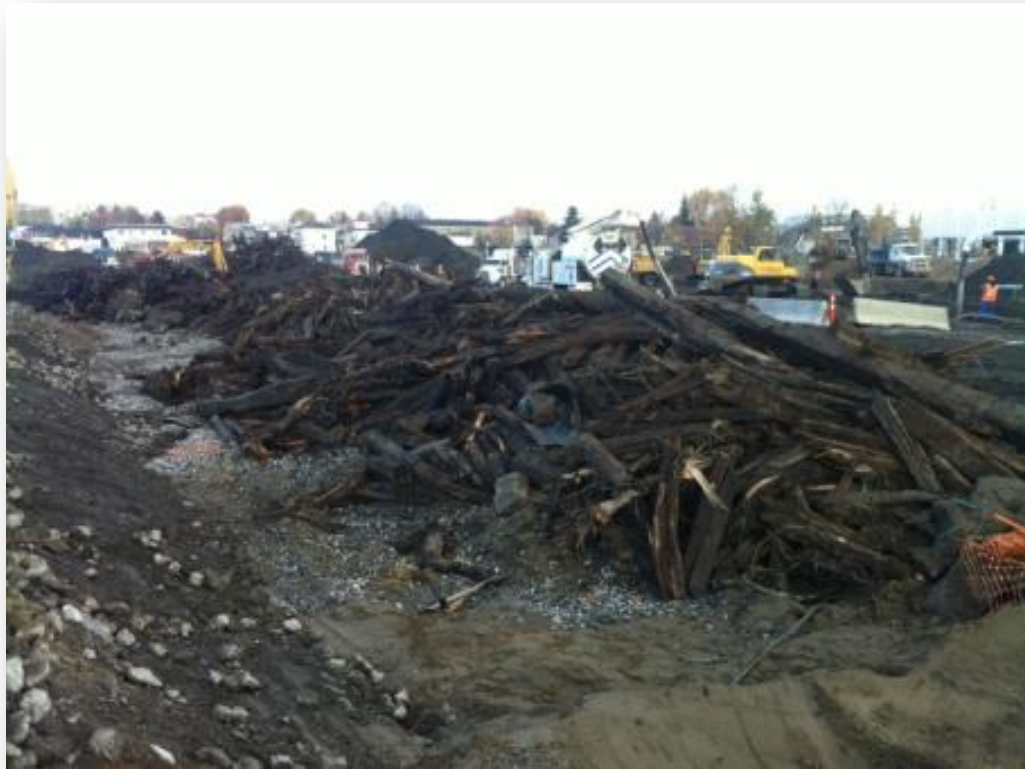
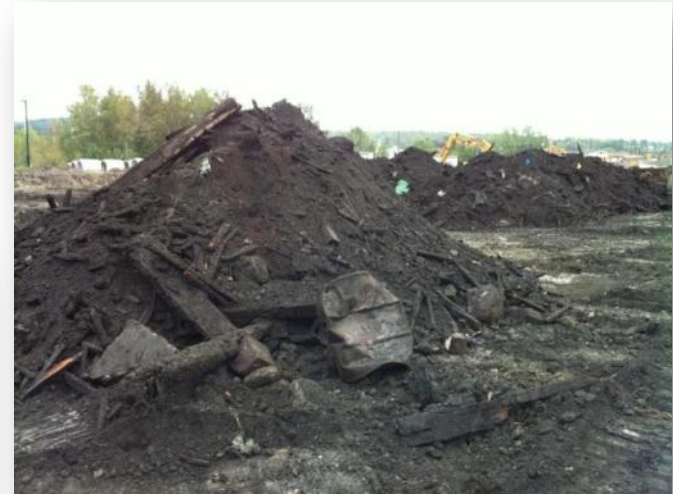
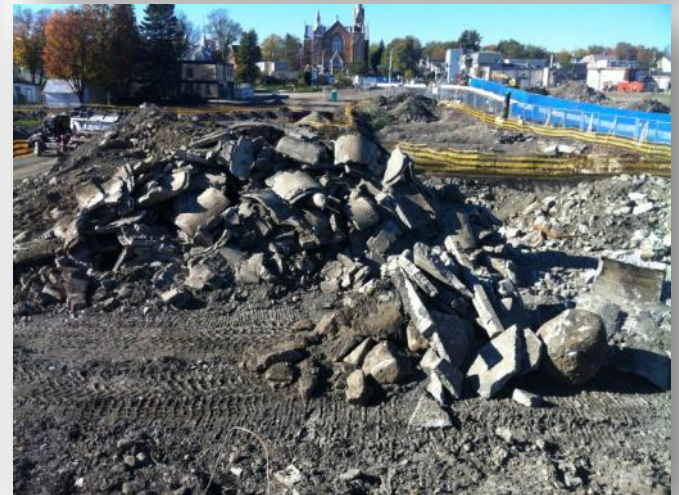
Significant debris to manage

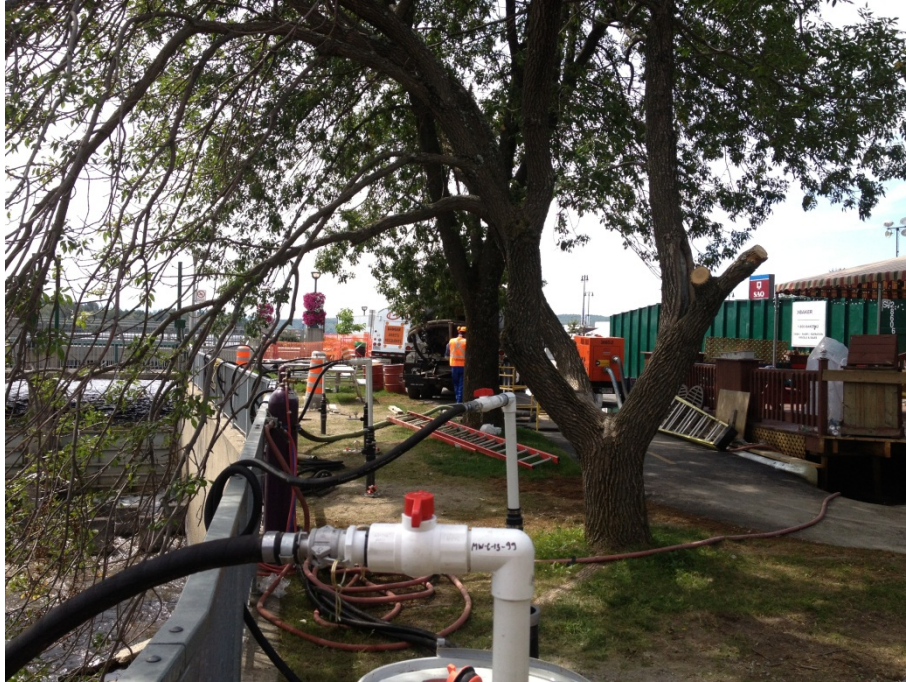
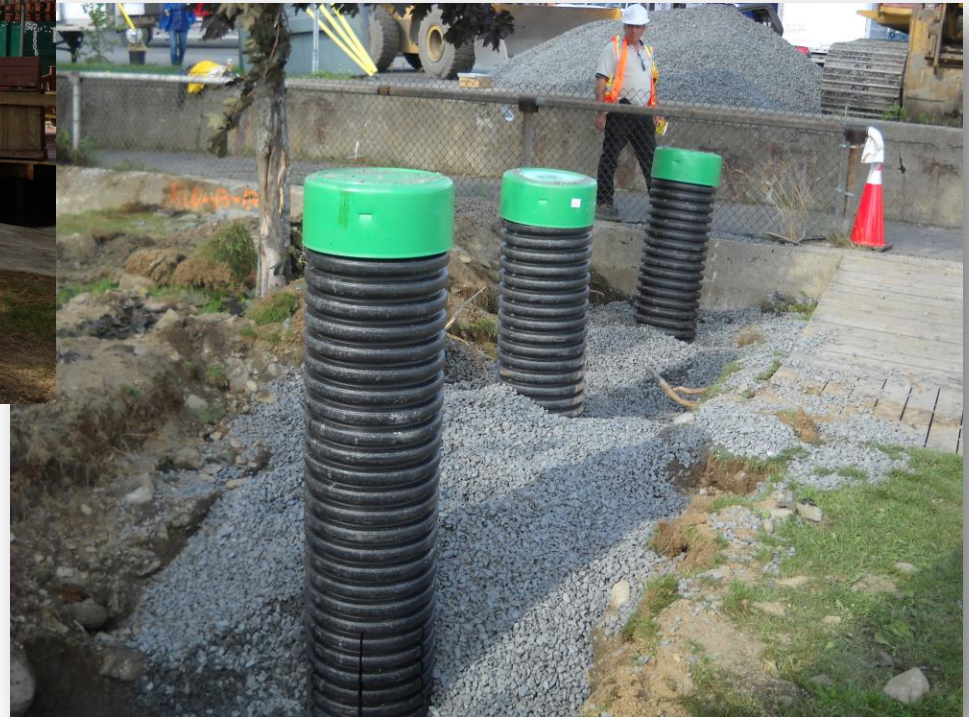
Le Citron Vert: Pumping of Free Product (pre-excavation)

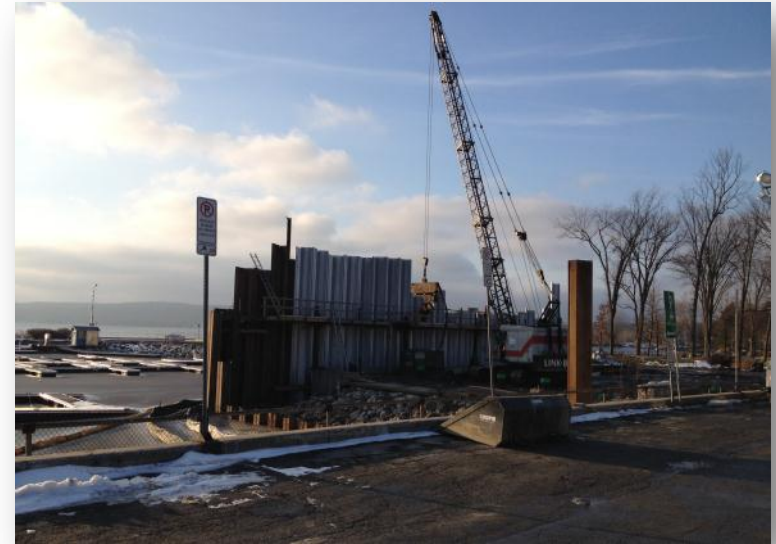
Installation of sheet piling

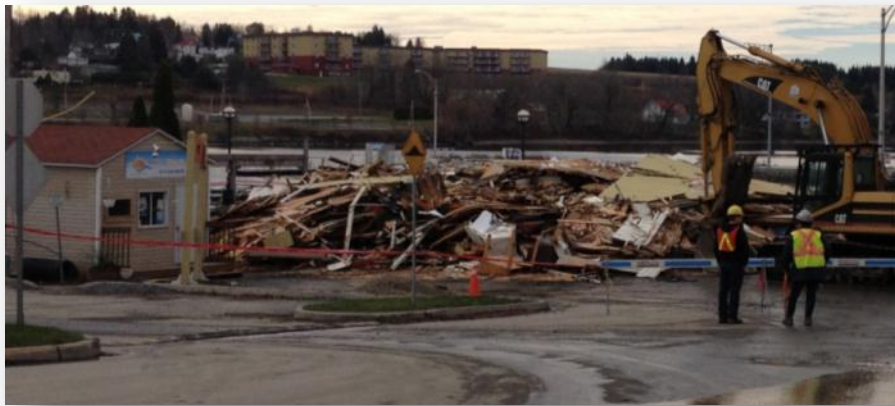
Demolition of Le Citron Vert

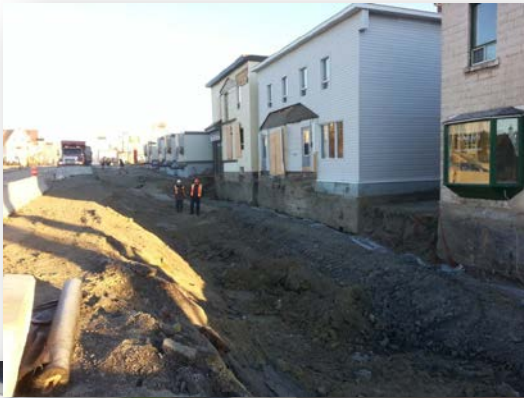
Installation of oil water collector pipes at foundation level of certain buildings.

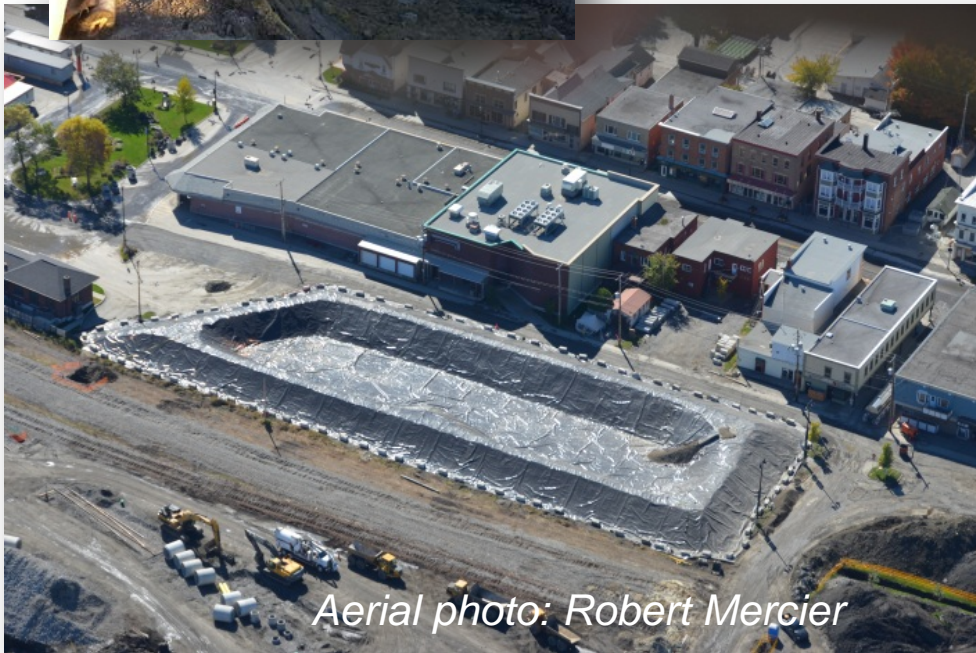
Construction of a 3,400 m³ retention pond with treatment facility.
