TREATMENT OF IMPACTED WATER FOLLOWING THE LAC-MÉGANTIC CATASTROPHE

Presented by
Jean Paquin, ing.

**REMTECH
ENVIRONMENTAL SERVICE ASSOCIATION OF ALBERTA**

Banff, October 16, 2014

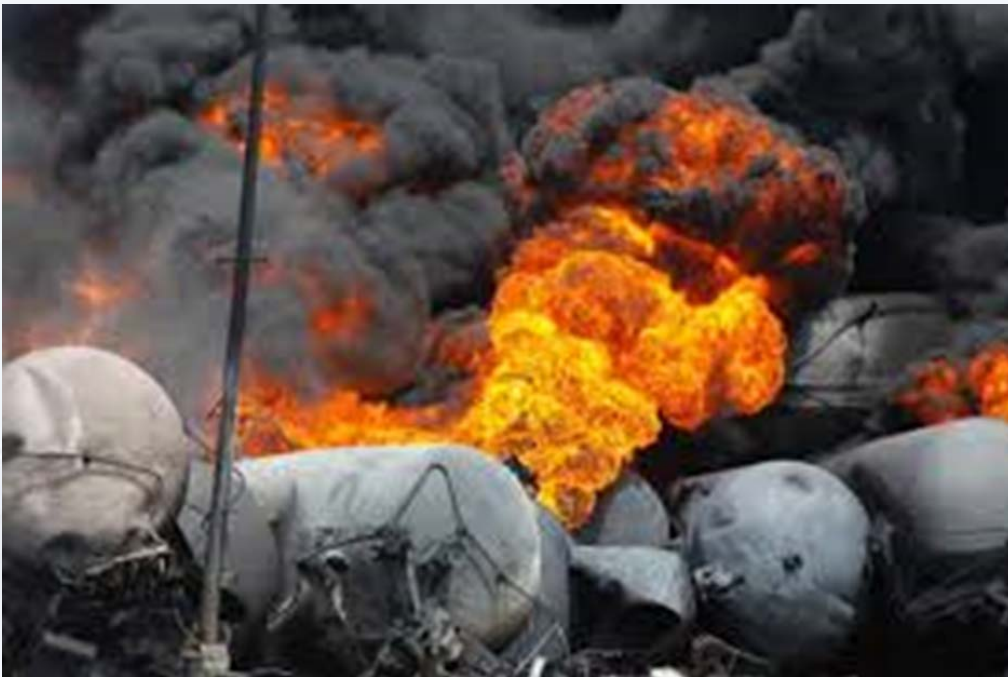
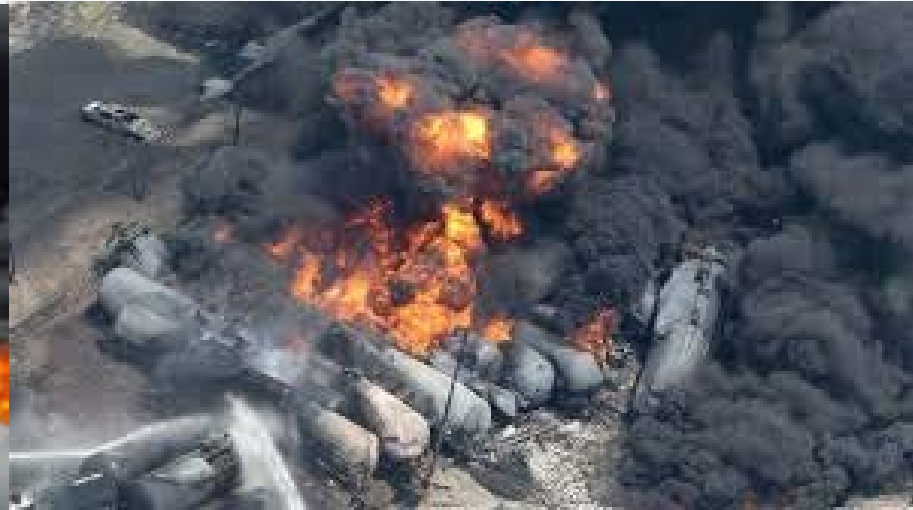
72 tank cars, carrying 8 million liters of light crude oil were involved in the train derailment

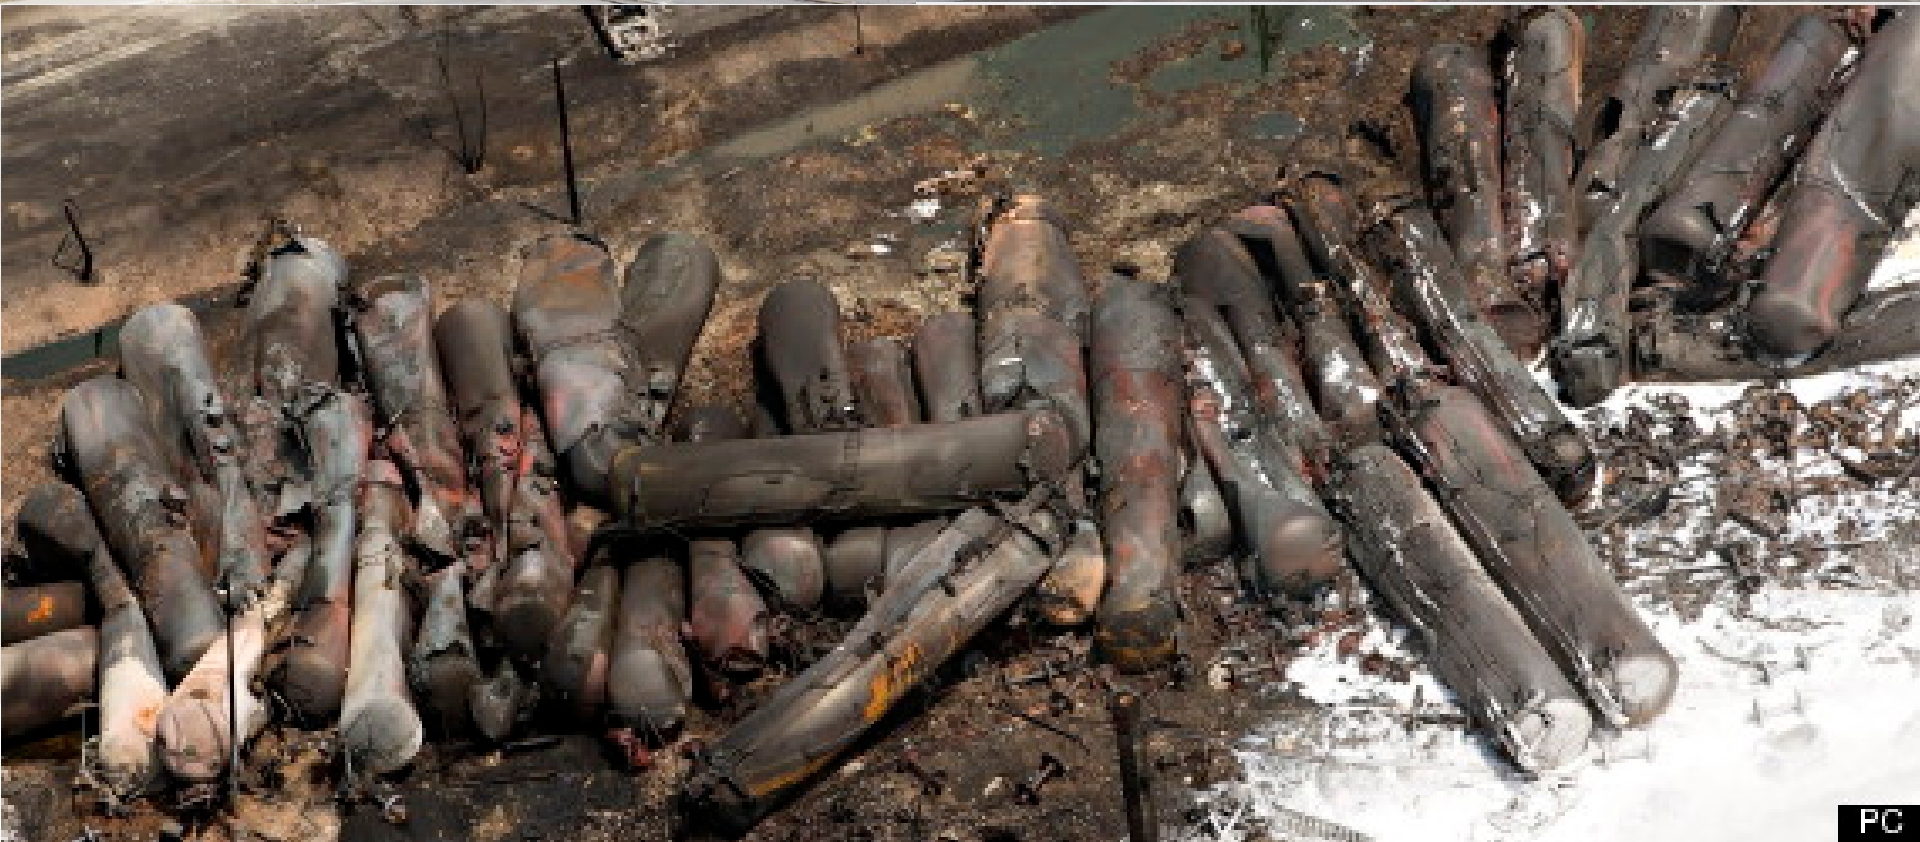
A large part of the downtown area was razed by the fire

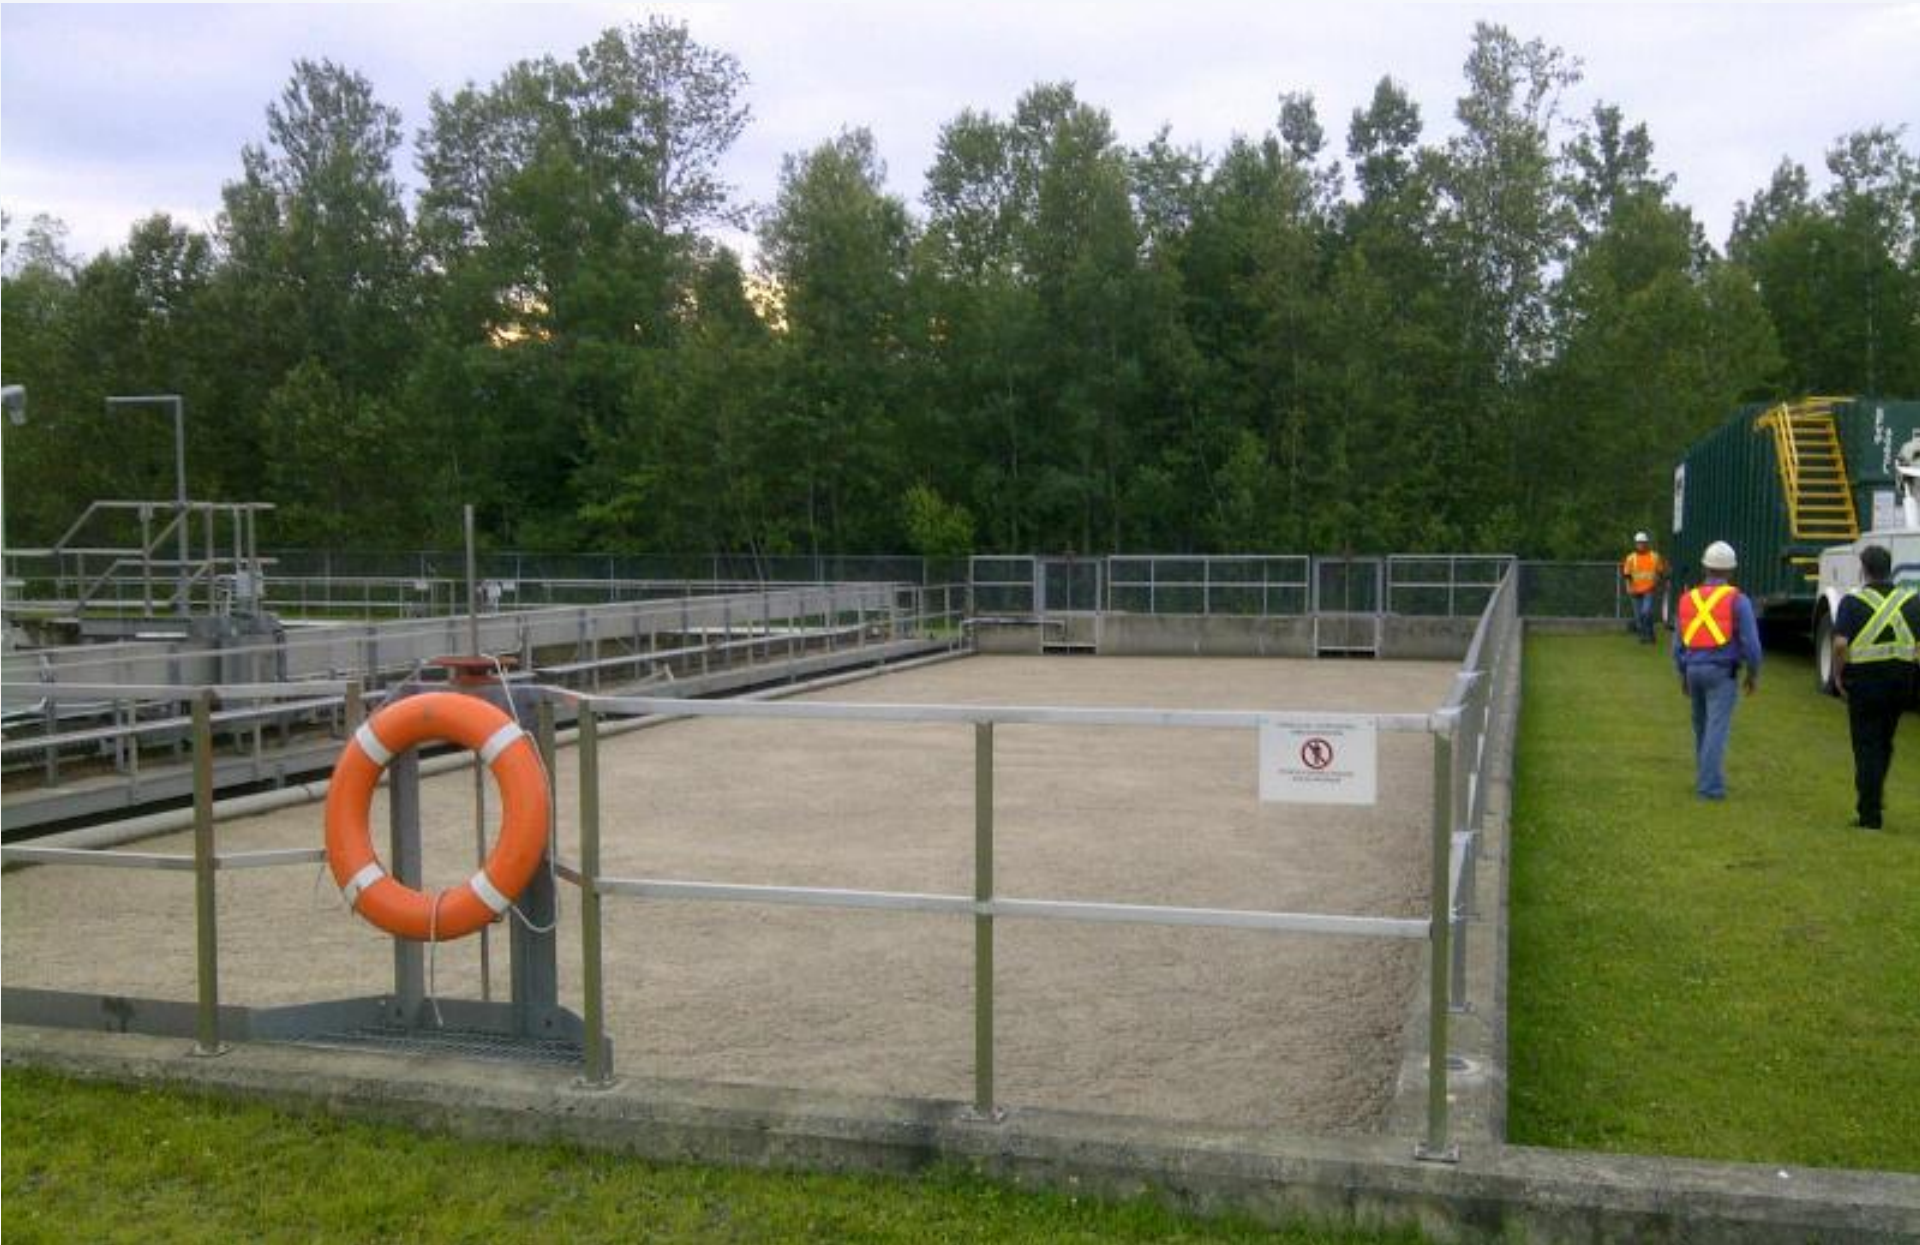
The operation of the municipal wastewater treatment plant was interrupted to prevent the release of oil to the Chaudière river

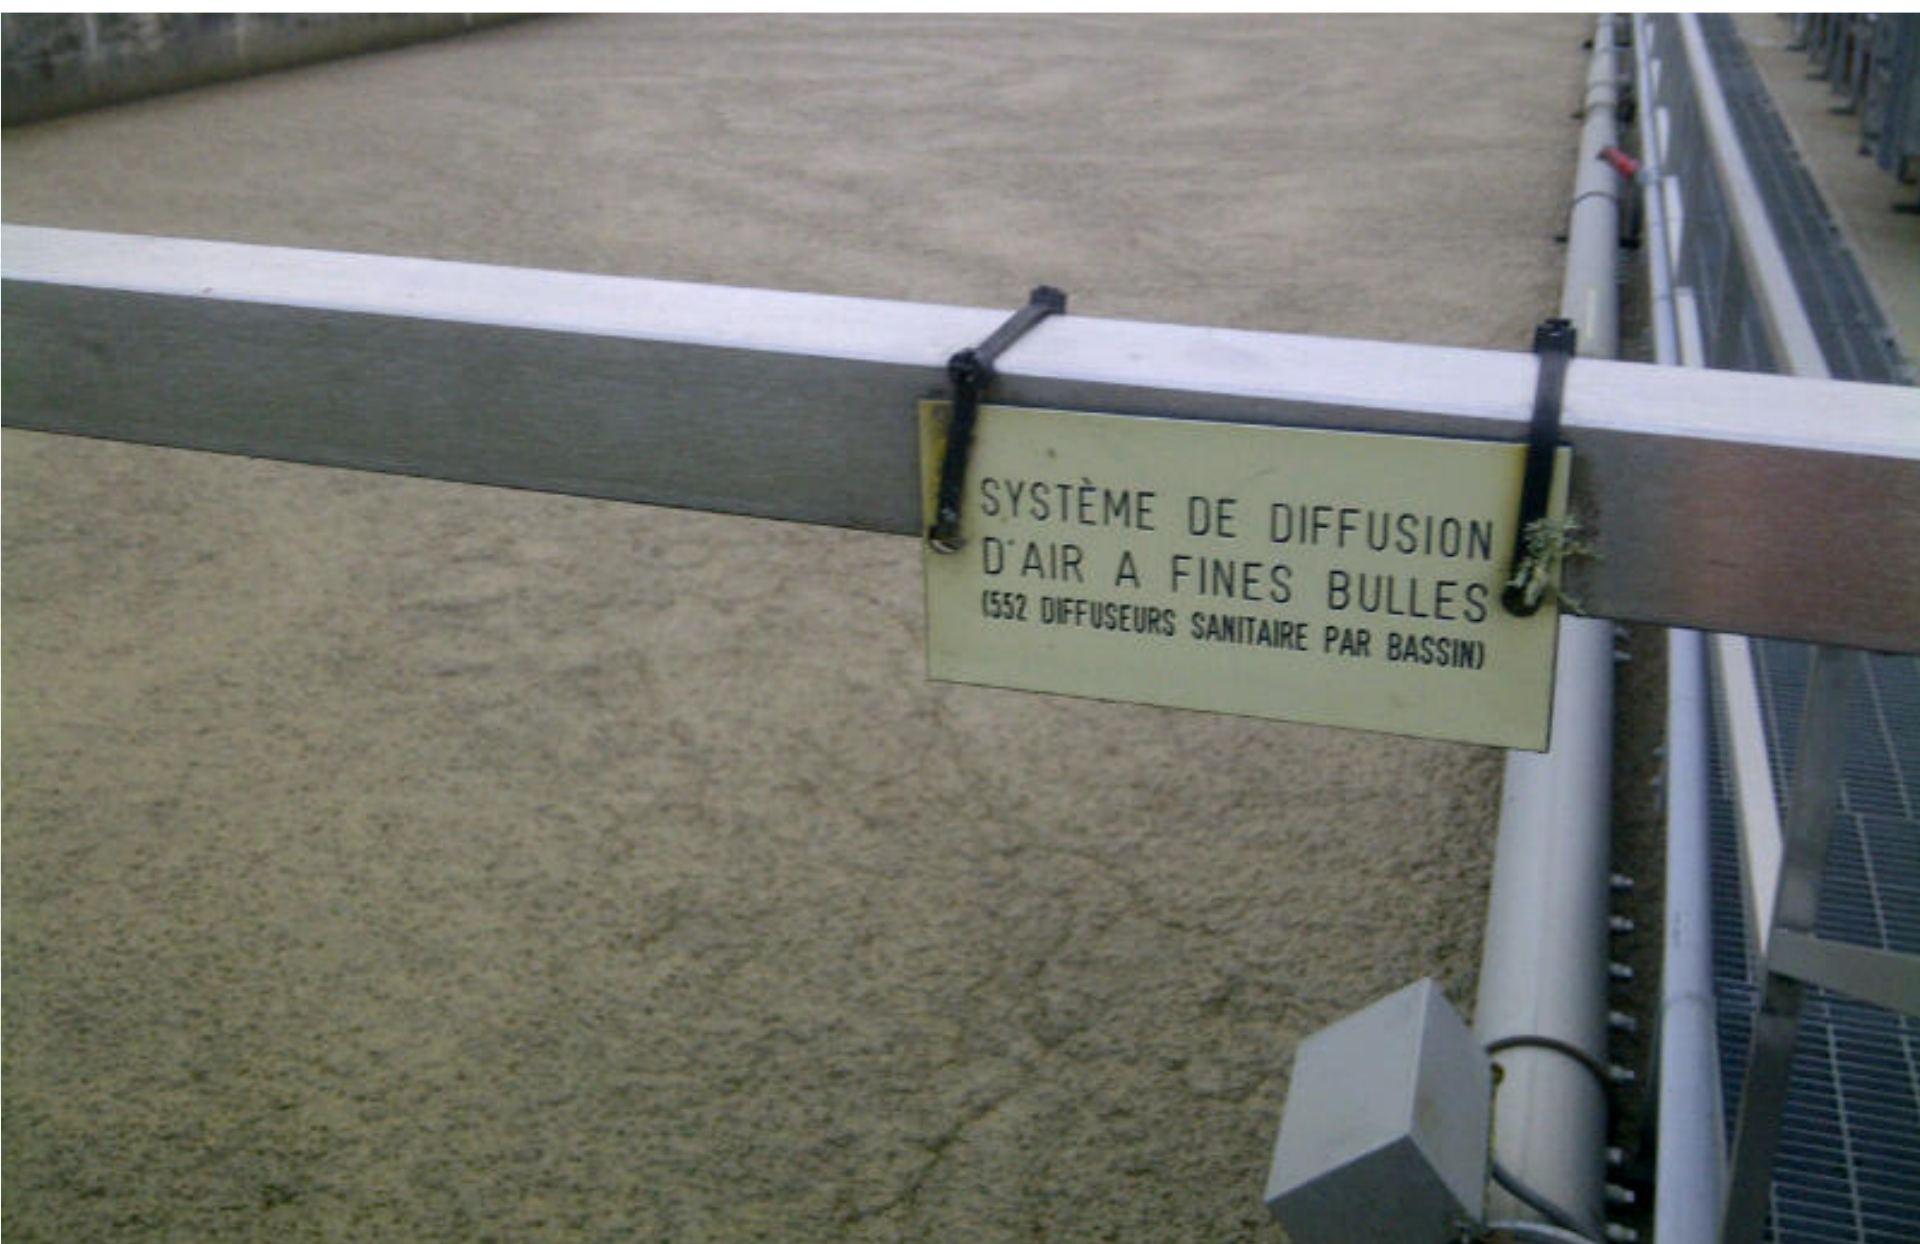
**A thick foam caused by the fire fighting agents covered
the 1 million liters of water**

Treatment at first of the municipal wastewater laden with the spilled crude oil to allow recommissioning of the facility.

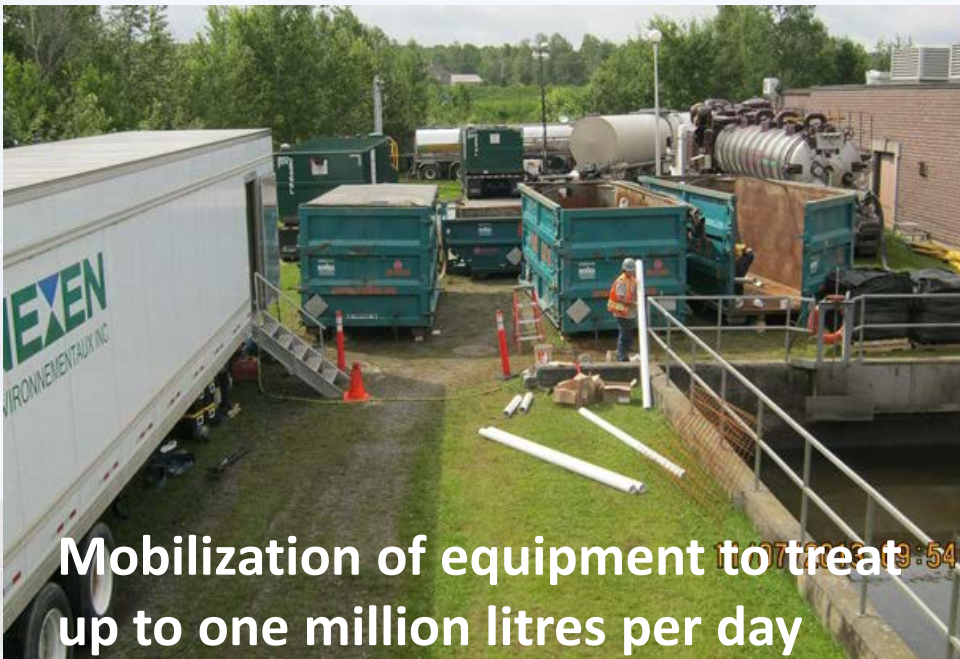
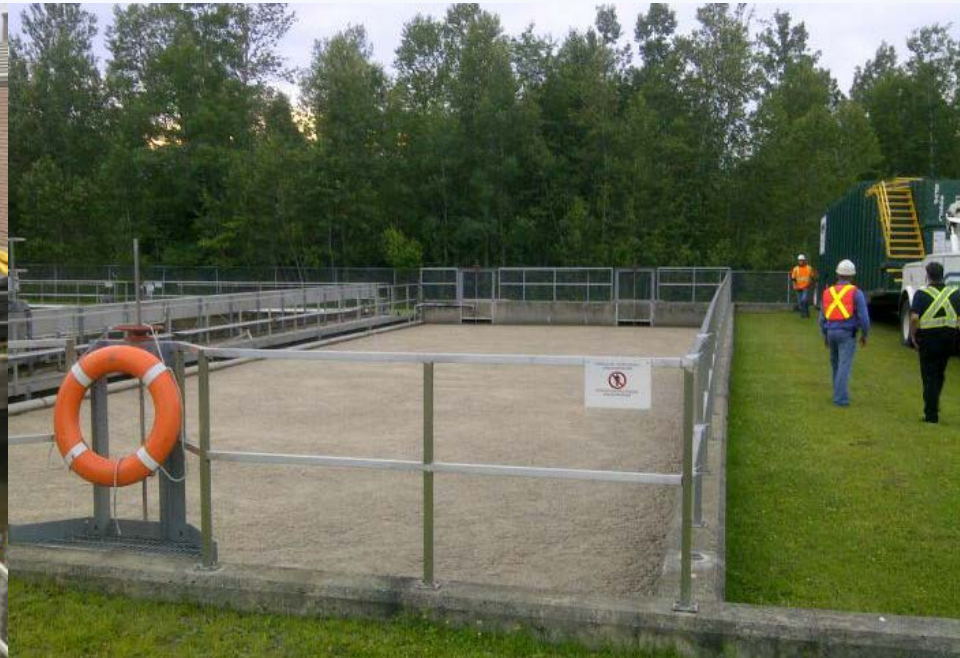
Mixture of water, crude oil and sludge recovered at the derailment site

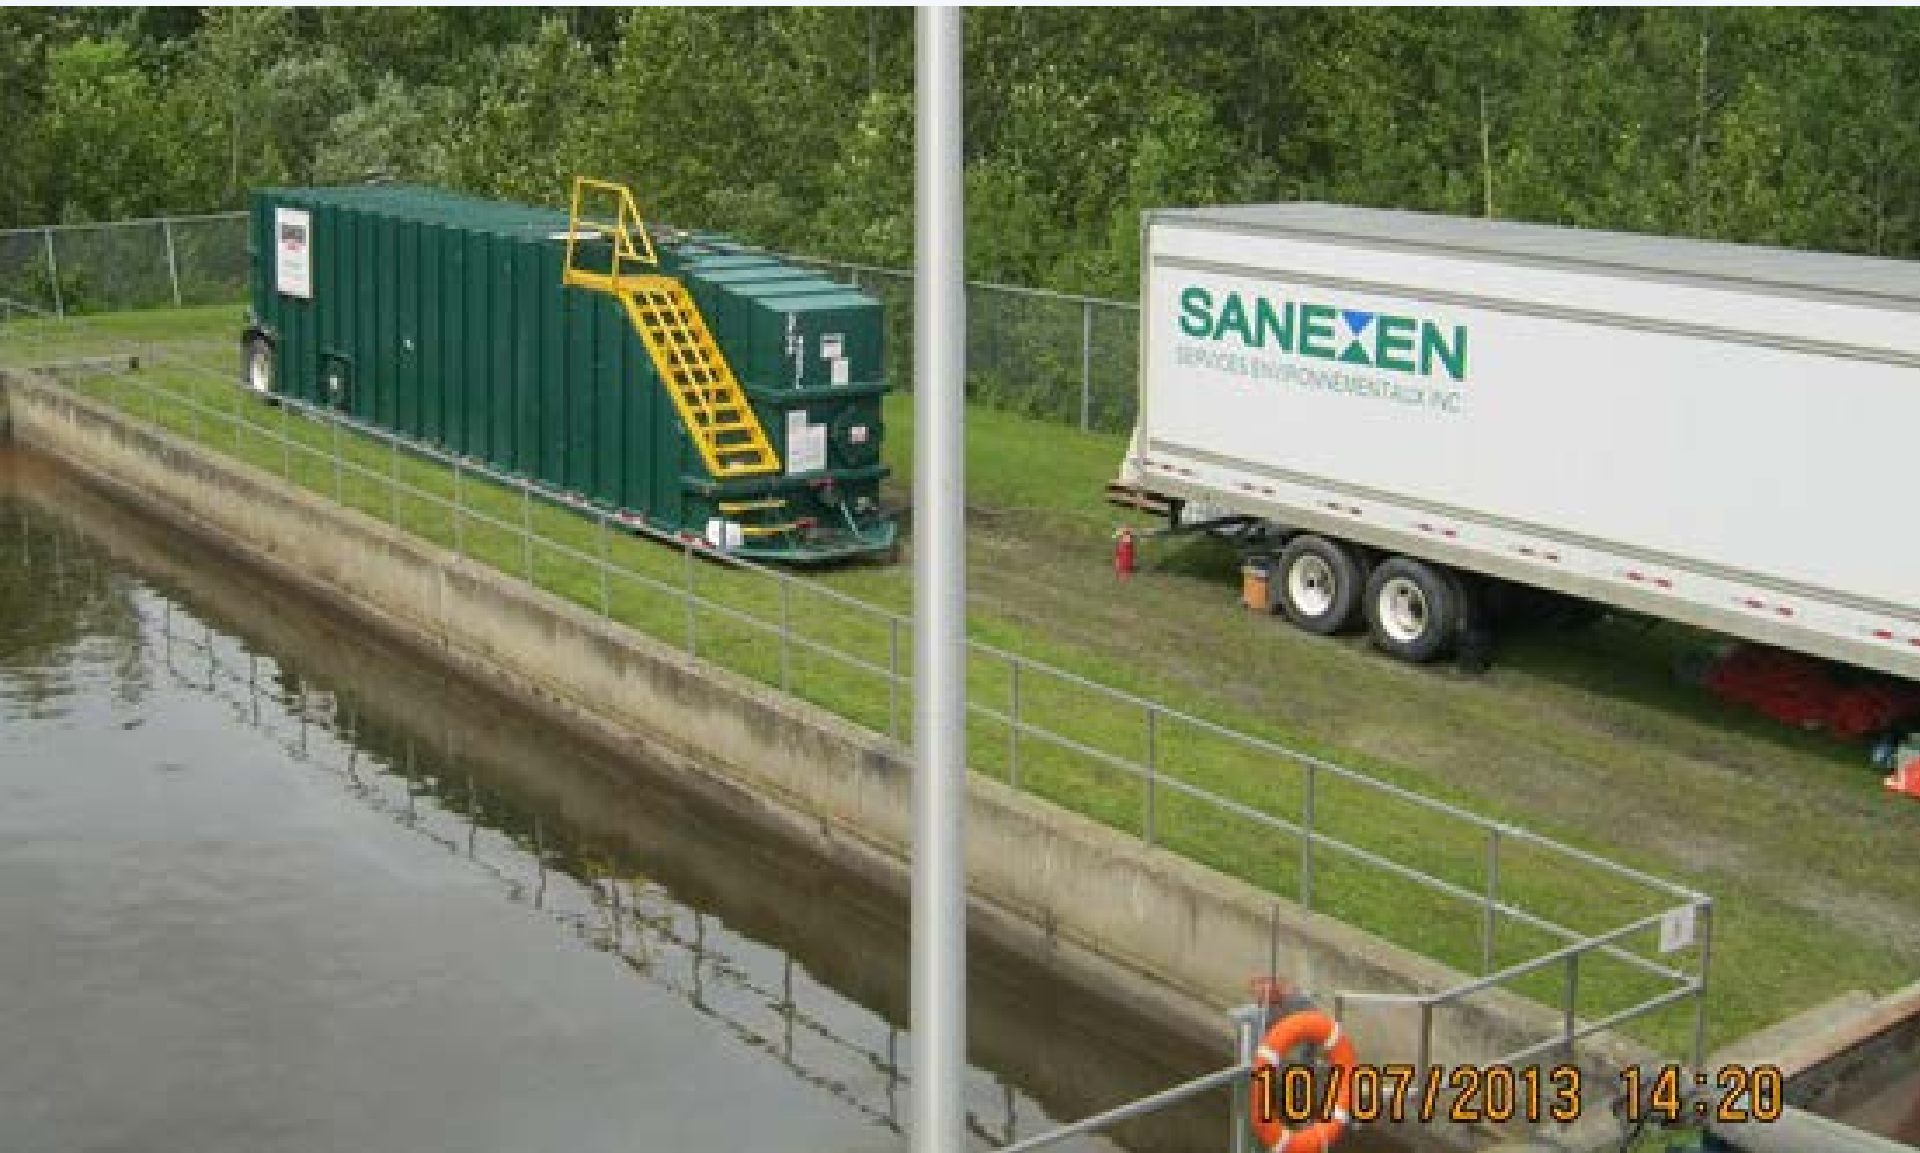
Water pumped to the mobile unit after settling

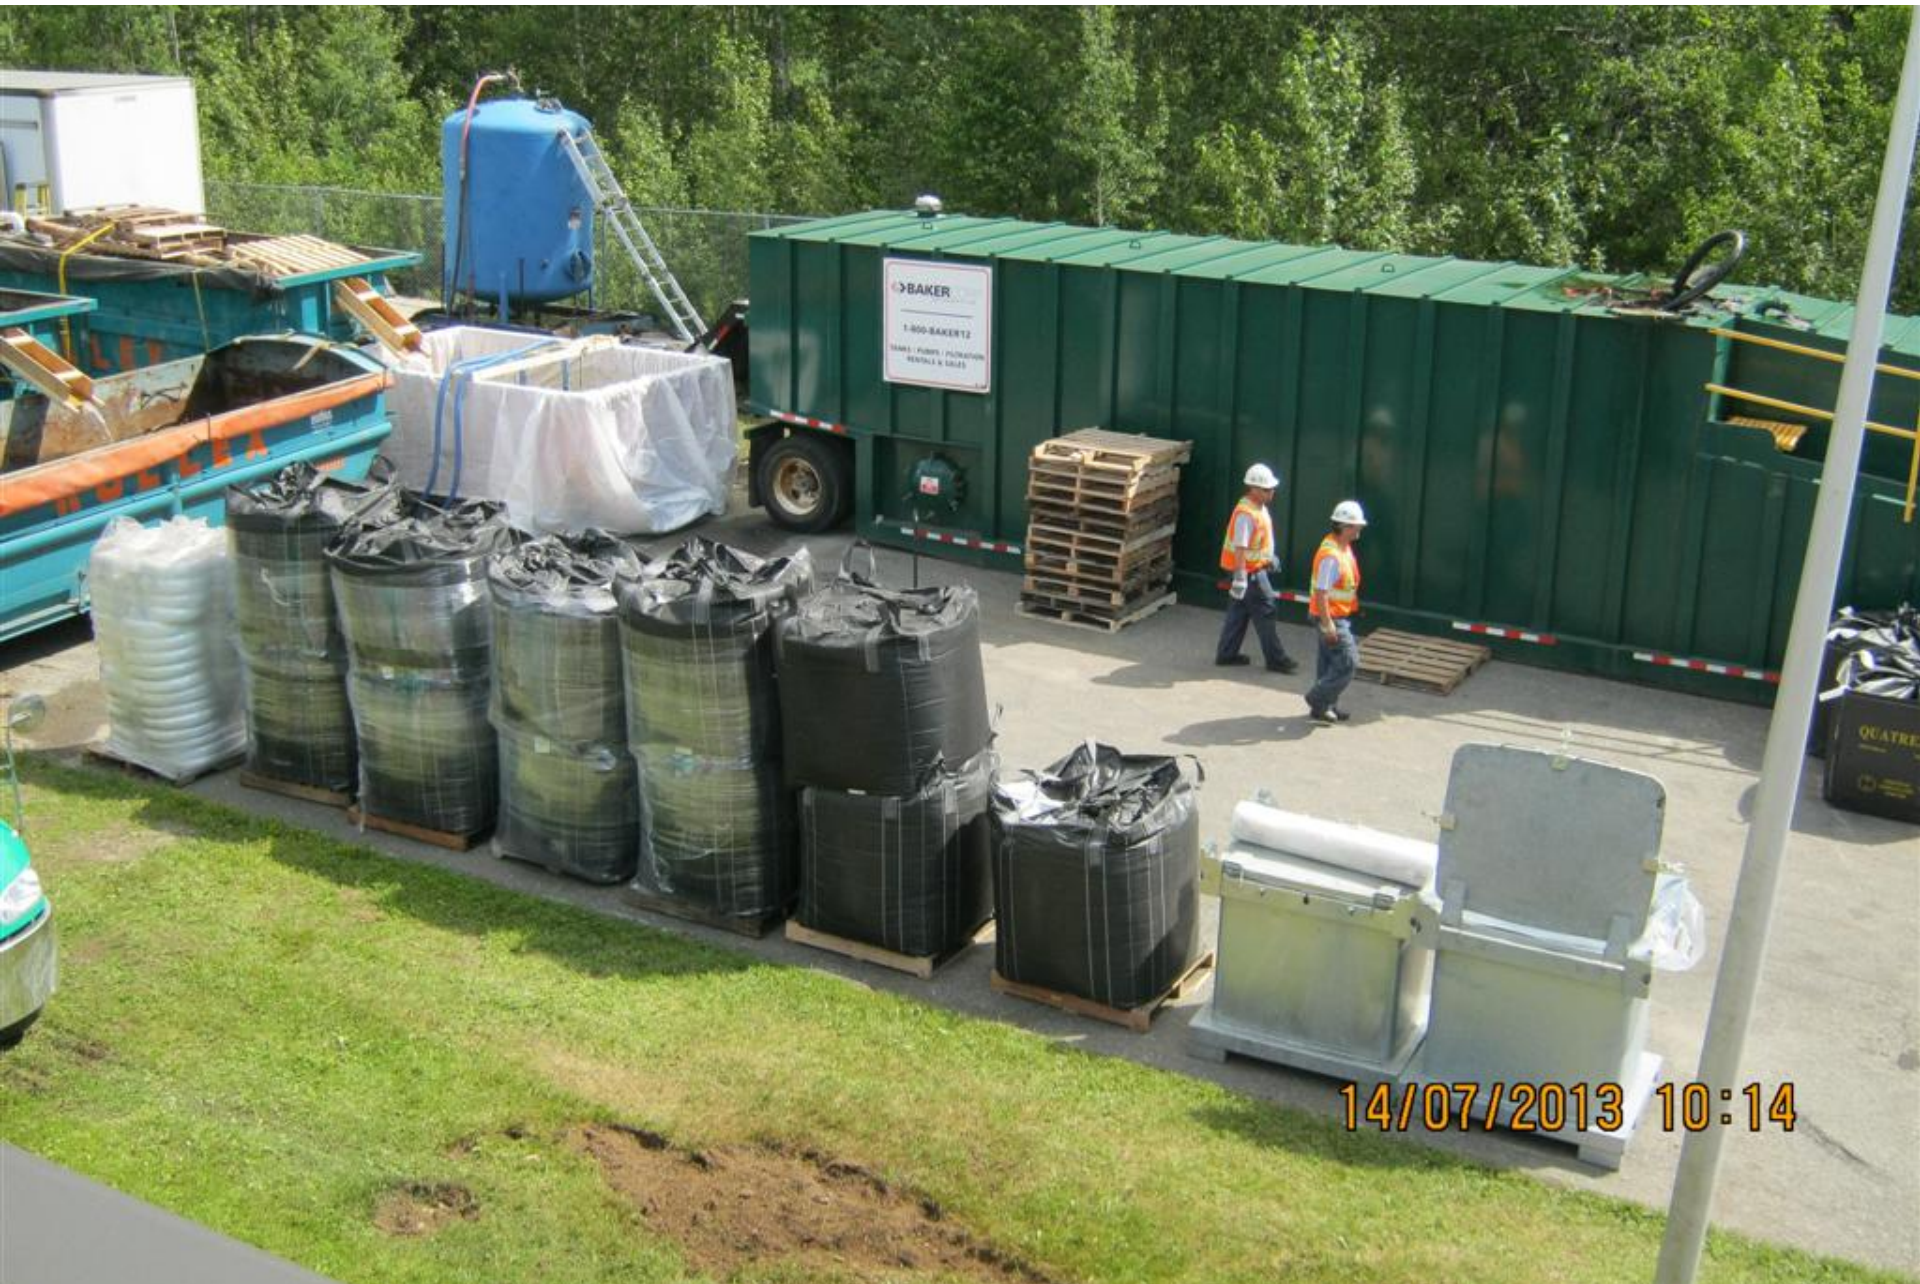
Large filters erected for the removal of colloids and soluble organics, each with a throughput capacity of 400 m³/day

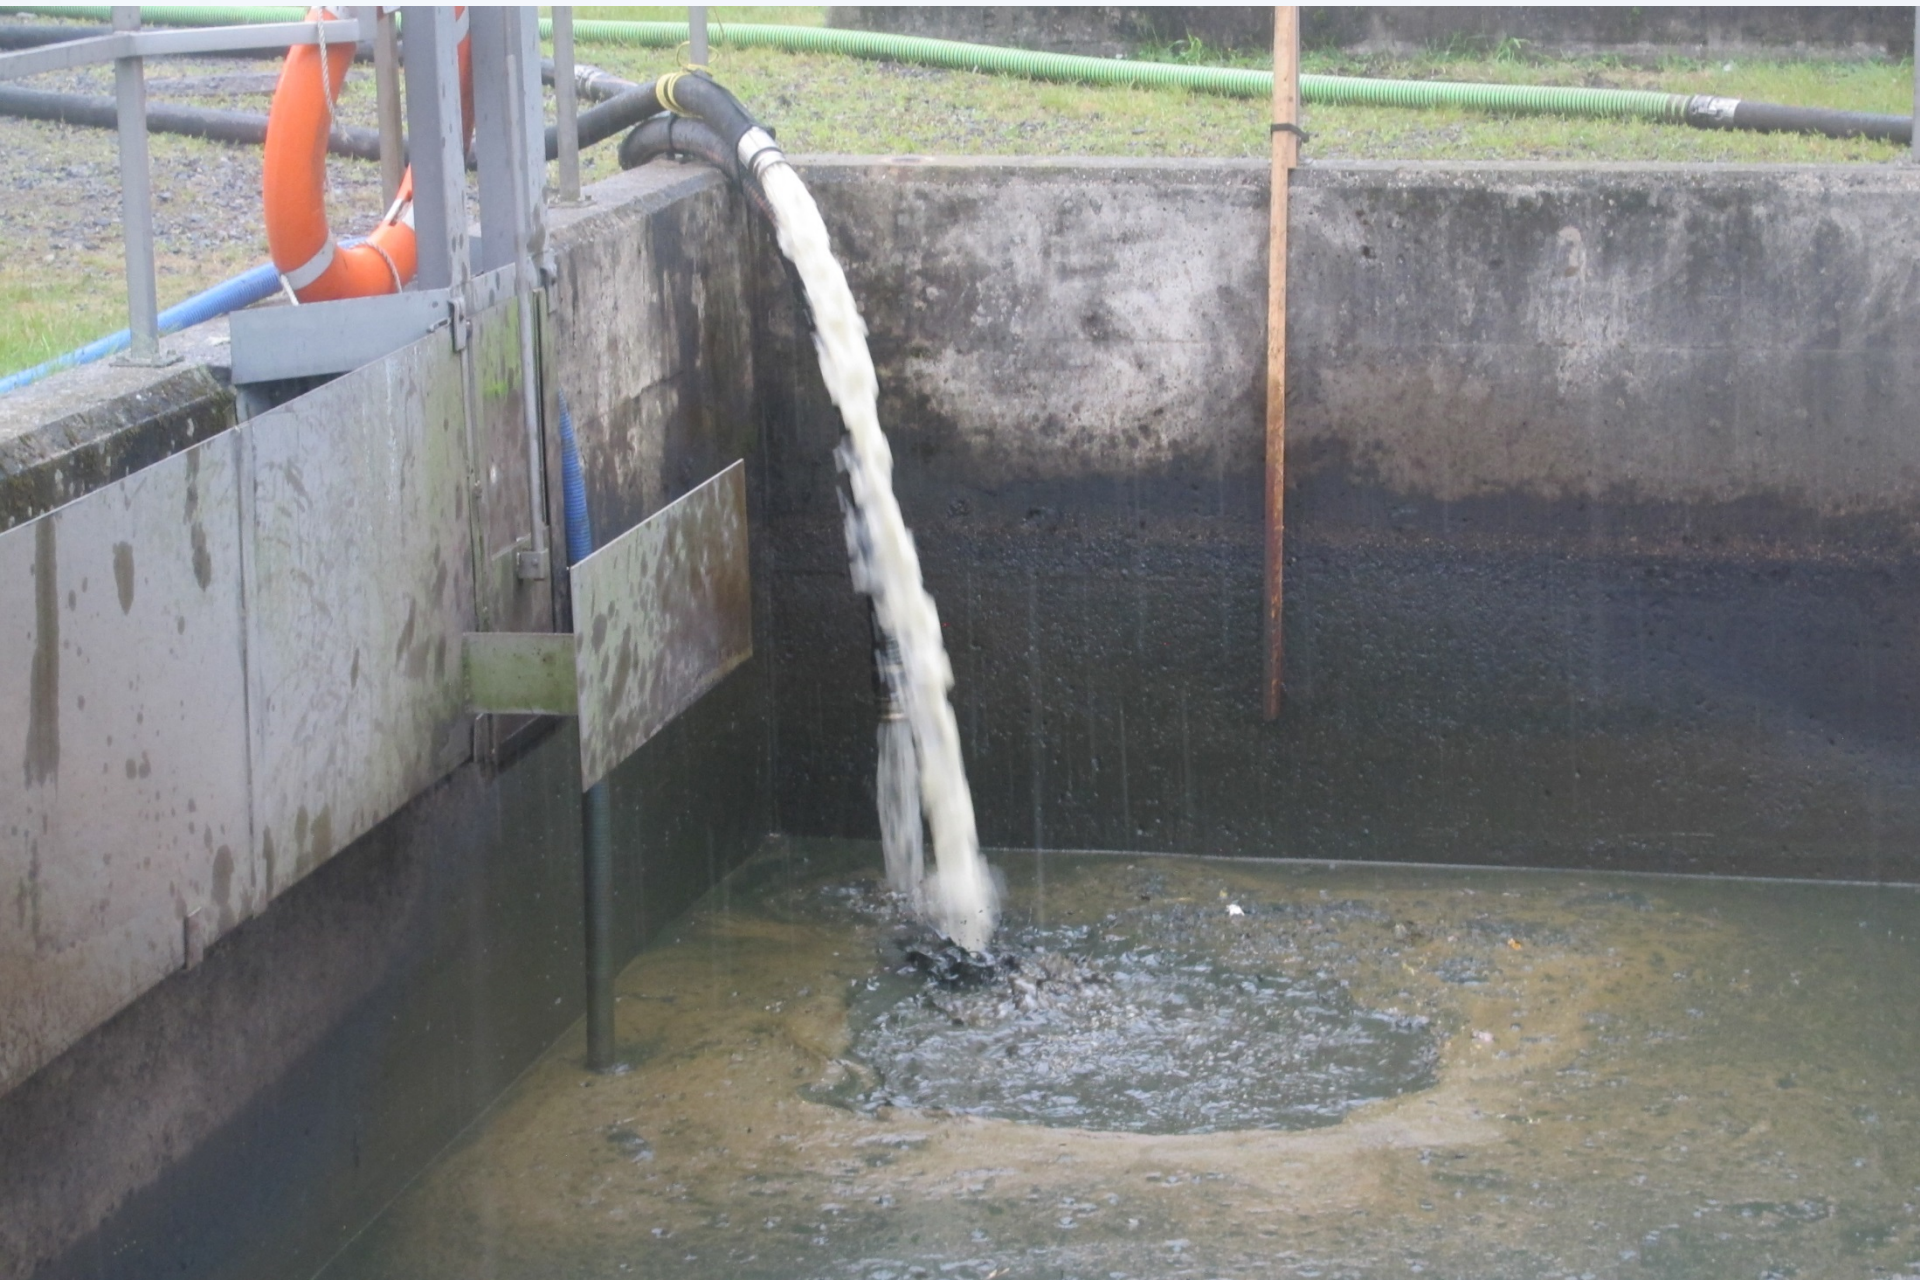
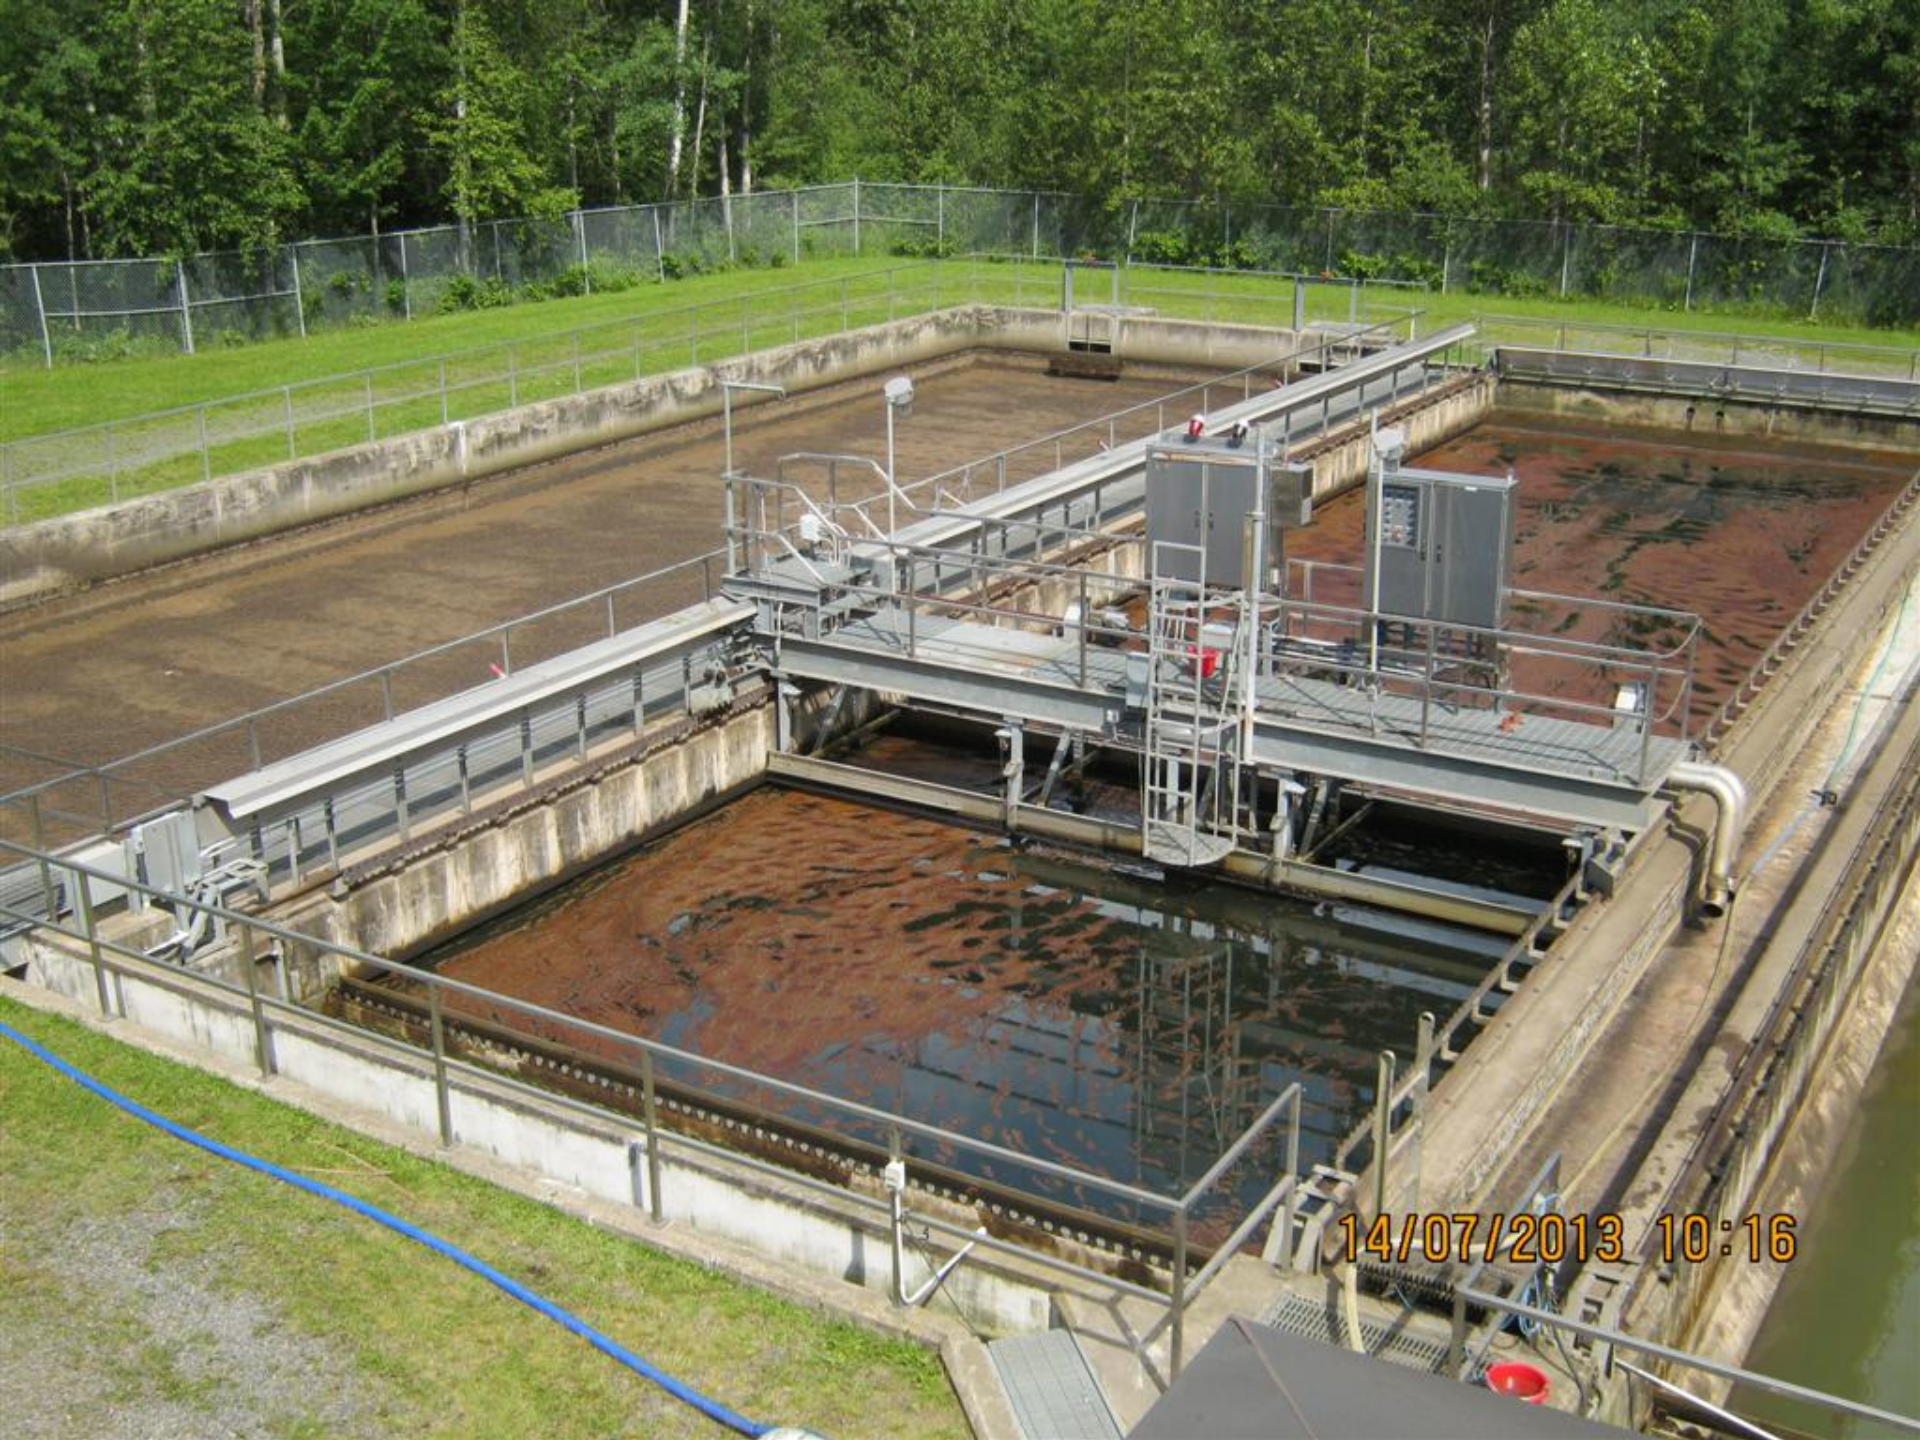
Incoming water

Varying water characteristics and oil/solids content for every shipment

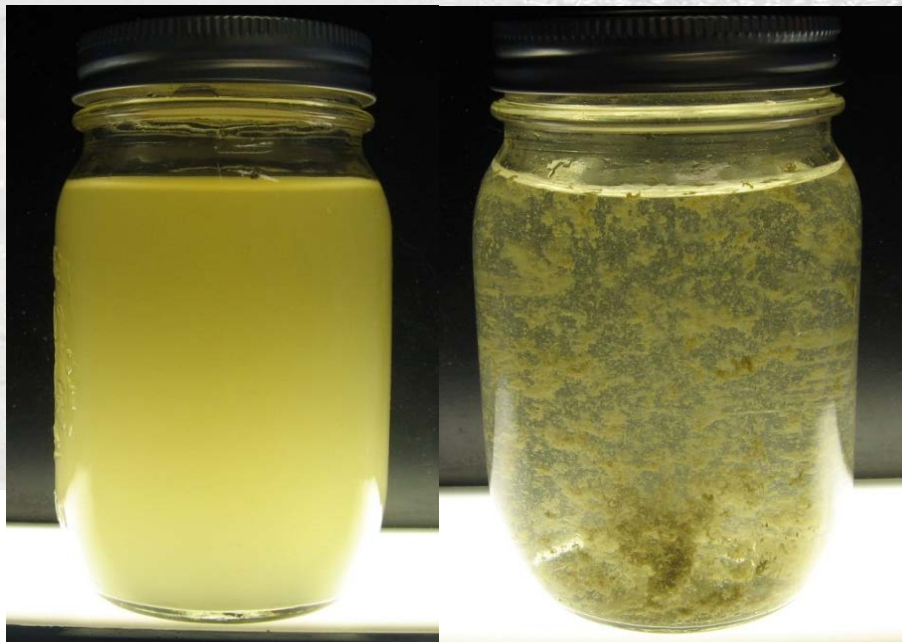
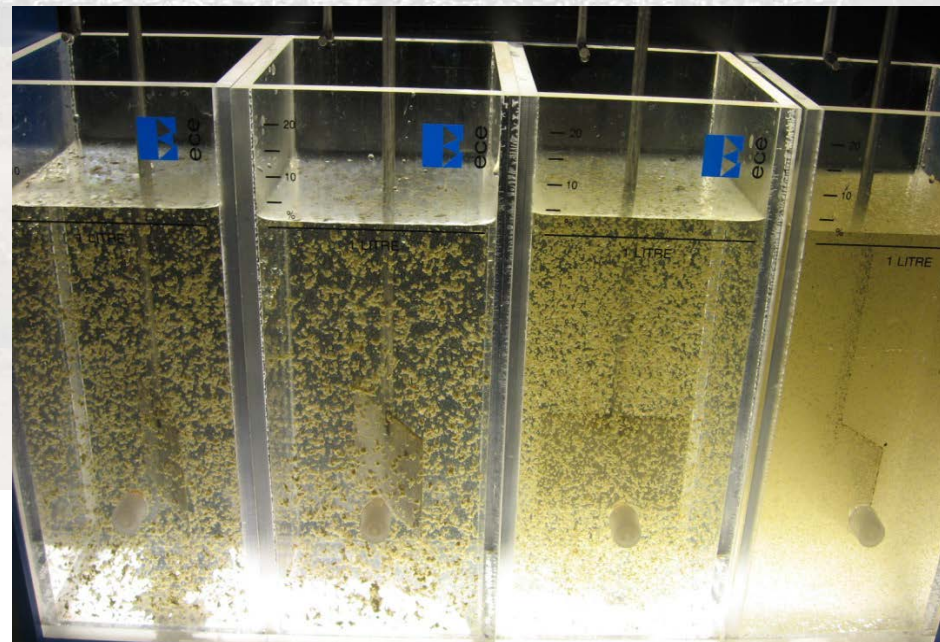
Coagulation/floculation tests conducted to identify how best to clarify the water in the pre-treatment step

The characteristics of the liquids received were highly variable.

Different selection of products and injection rates would ideally have been required from one day to the next.

The pre-treatment step could not be optimal and the subsequent filters had to perform better than usual to meet a good quality of effluent.

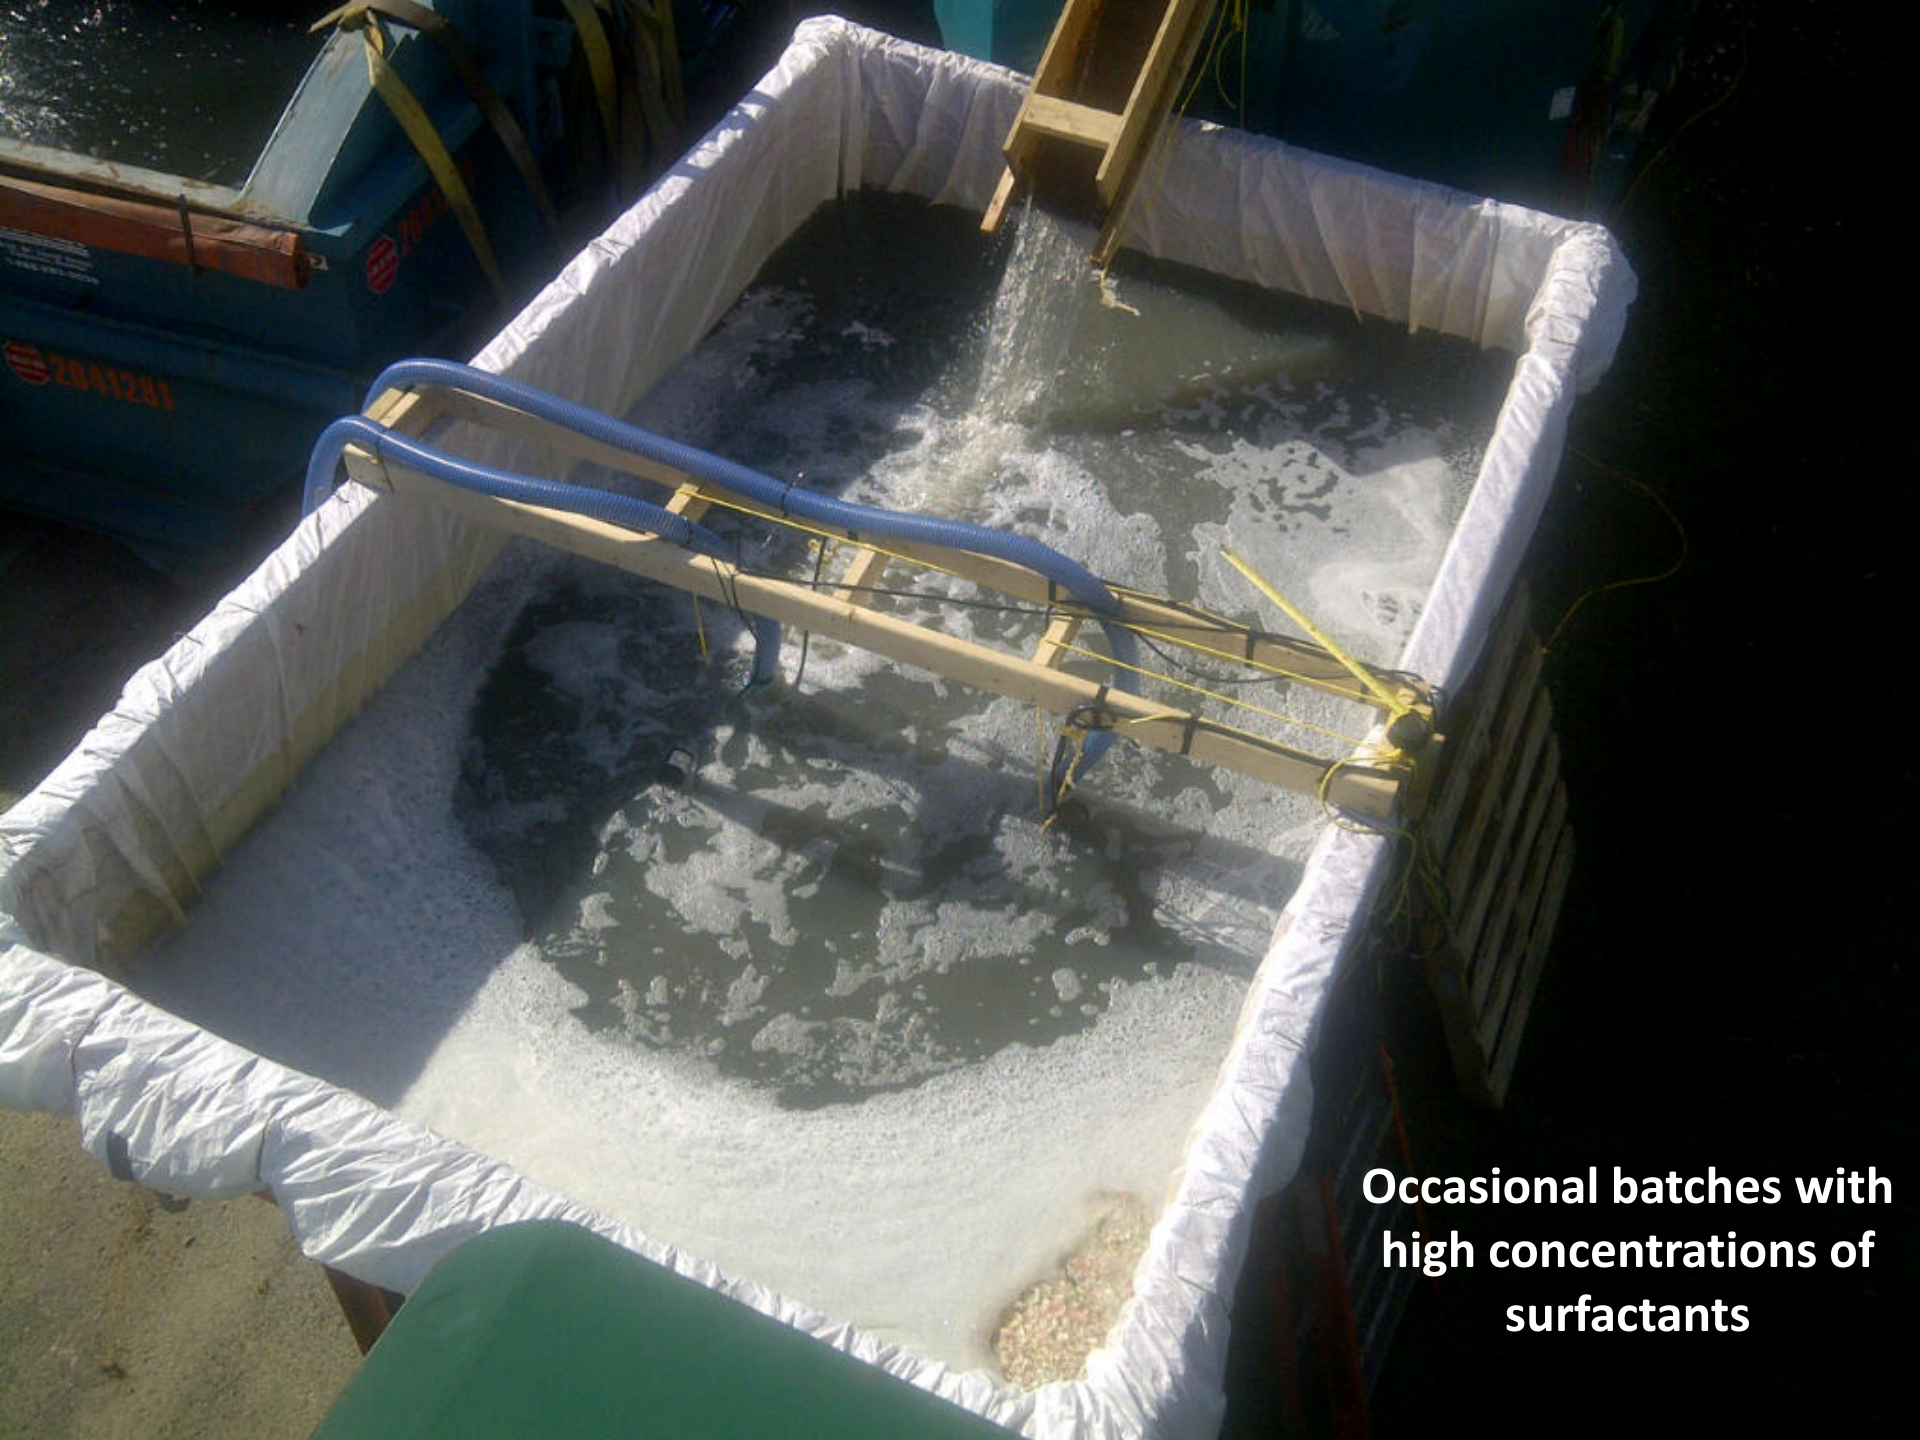
**Occasional batches with
high concentrations of
surfactants**
