TREATMENT OF IMPACTED WATER FOLLOWING THE LAC-MÉGANTIC CATASTROPHE

Presented by
Jean Paquin, ing.

**REMTECH
ENVIRONMENTAL SERVICE ASSOCIATION OF ALBERTA**

Banff, October 16, 2014

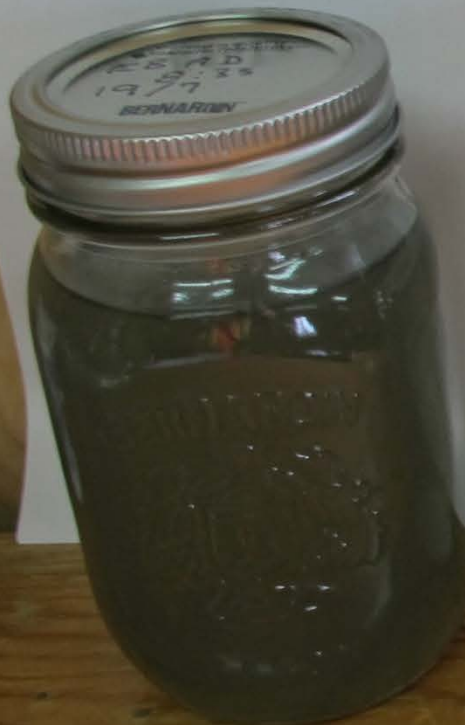
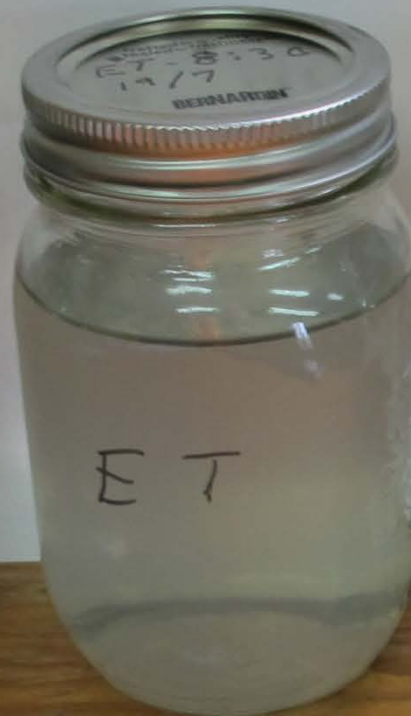
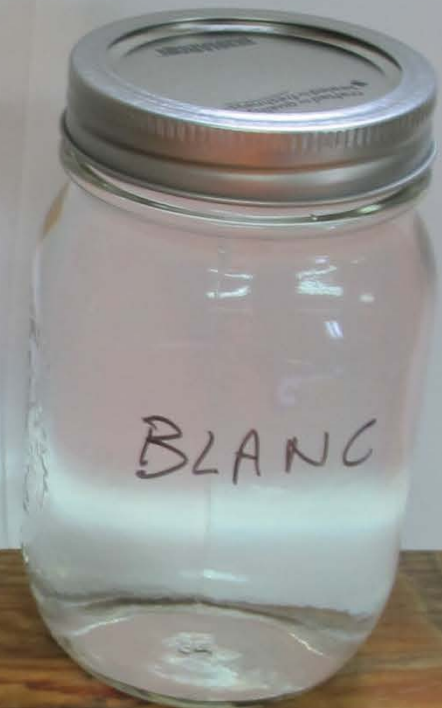
Surfactants make treatment more difficult,
but turbidity is a good indicator of water quality

TRAITEMENT D'EAU
LAC-MÉGANTIC - SANEXEN
RA13-310 19/7/2013
EAU BRUTE APRÈS
DÉCANTATION

EAU TRAITÉE
