Historical Spill Management Challenges at an Active 1950s Gas Plant

Environmental Services Association of Alberta
2015 Remediation Technologies Symposium, Banff, Alberta

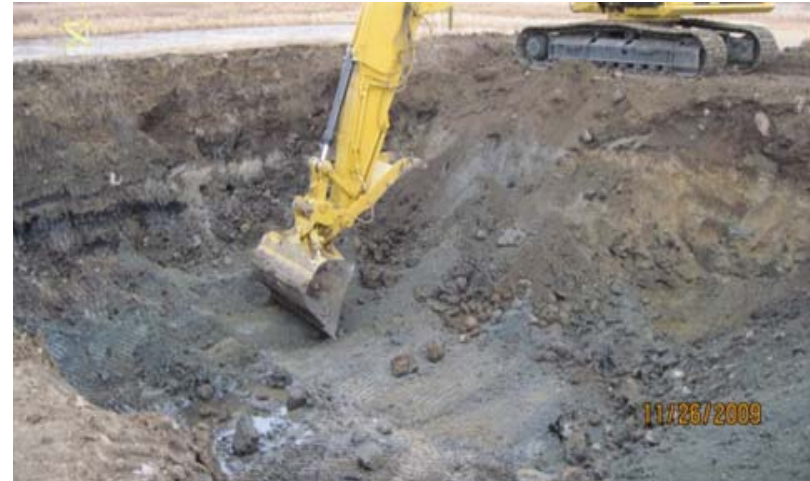
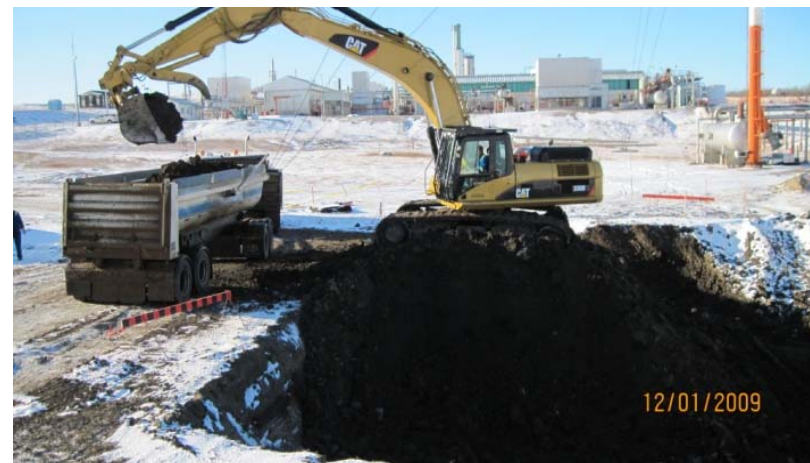
Flare Pit Remediation

- Winter 2009
- Challenges:
underground facilities
and the surface
retention pond

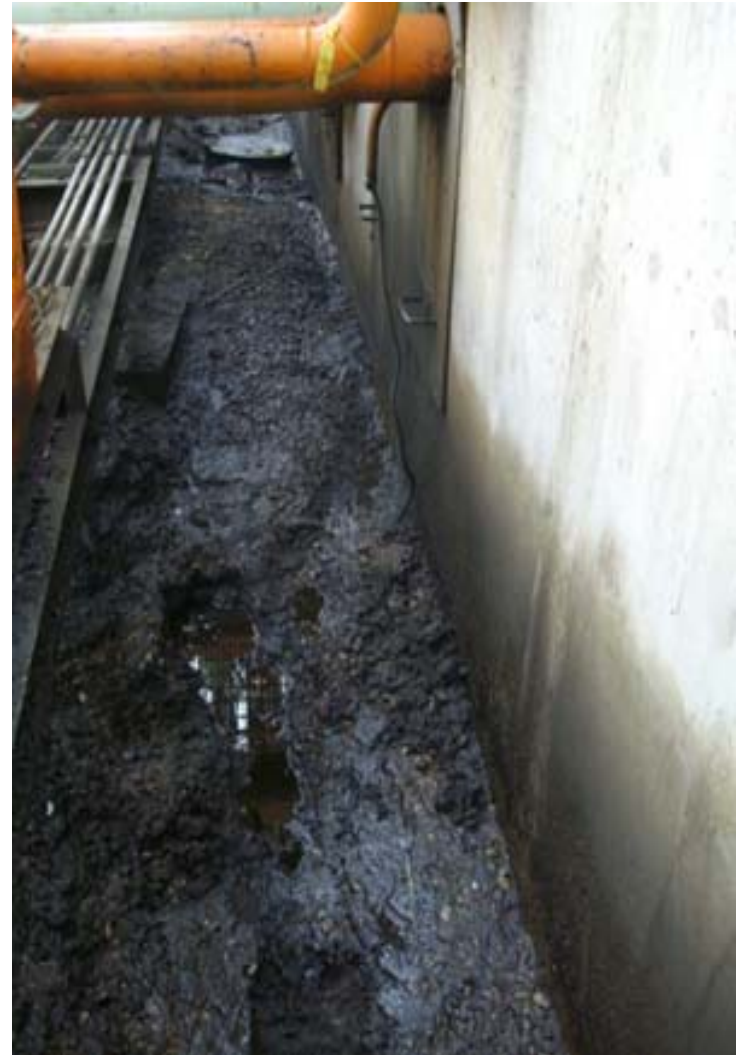
50 Year Release

- Historical compressor oil/lube leakage from late 1950's to mid 2000's
- Limited free product recovery

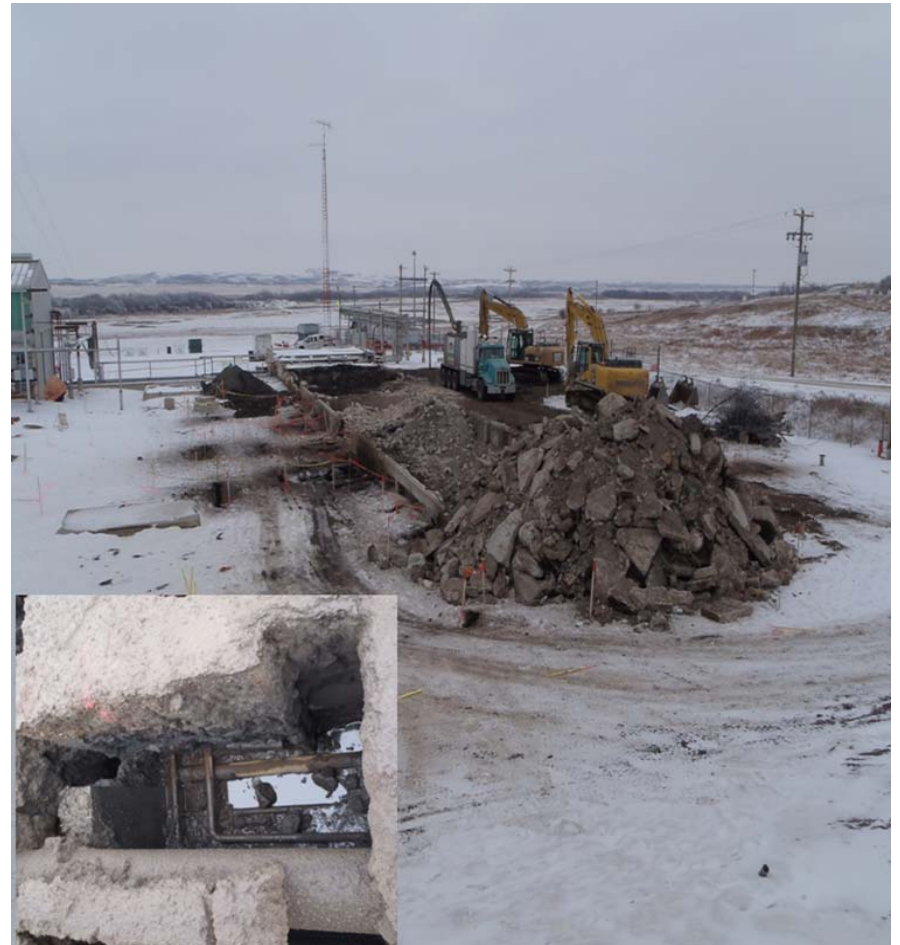
- Verified underground facilities were inactive
- Decommissioned underground facilities
- Concrete foundation was decommissioned
- 1,483 tonnes of concrete and associated debris were removed from the Site

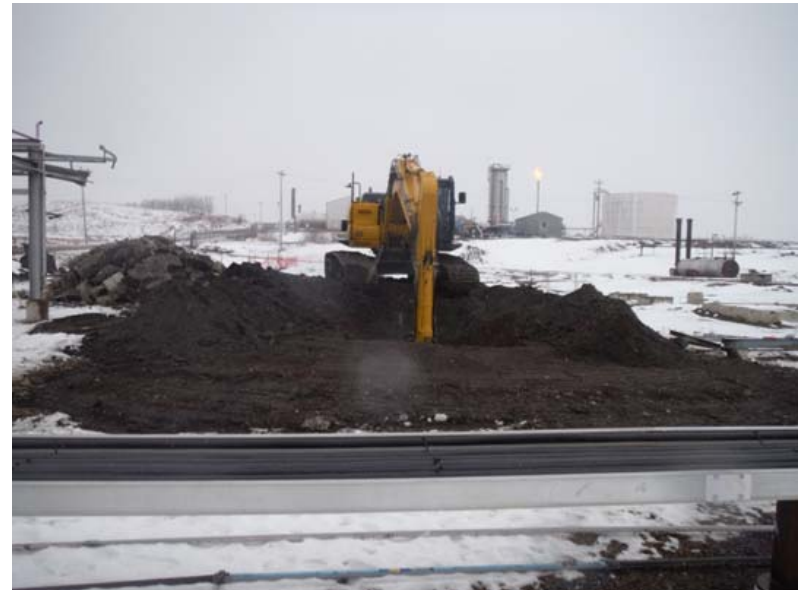
- Testpits were advanced within the former compressor building area
- PHC's > Tier 1 guidelines
- Soil > Class II landfill criteria
- Constructed berm to limit surface water infiltration

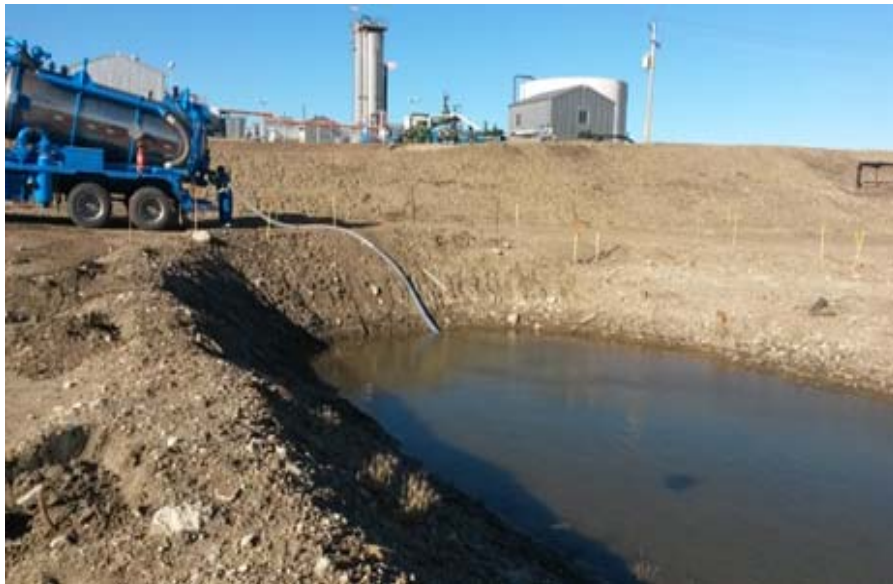
Surface water

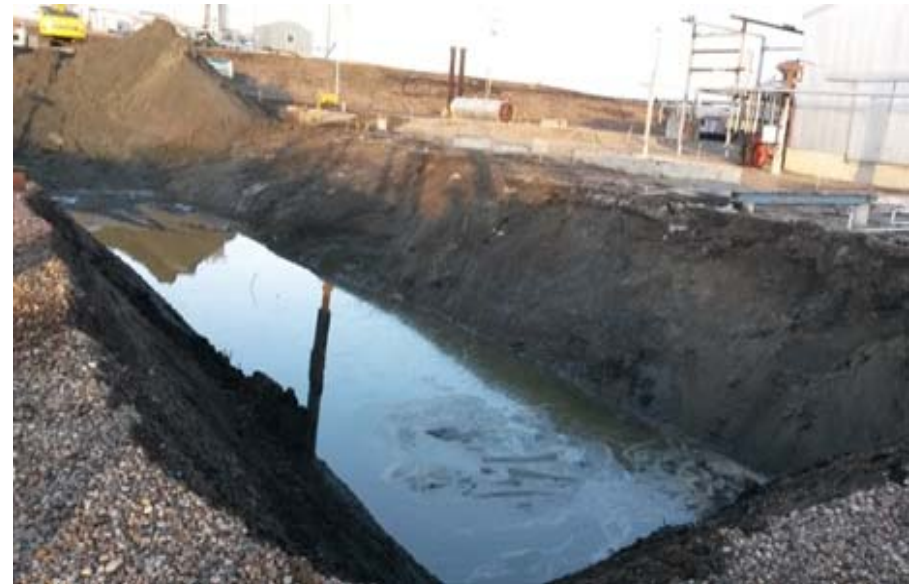
Groundwater
