Risk Management and Corrective Action Related to a Leaking Brine Pond

Frans Hettinga & Aziz Shaikh

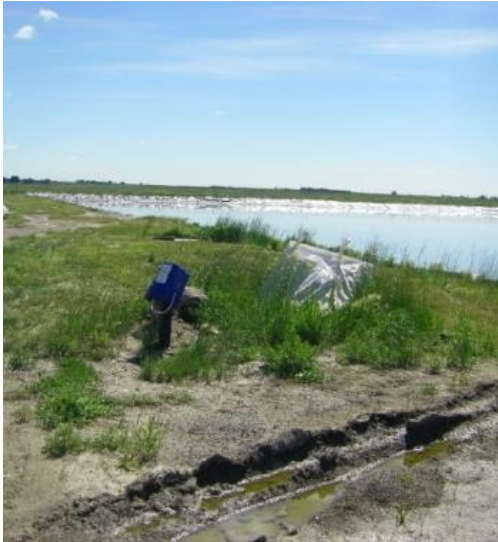
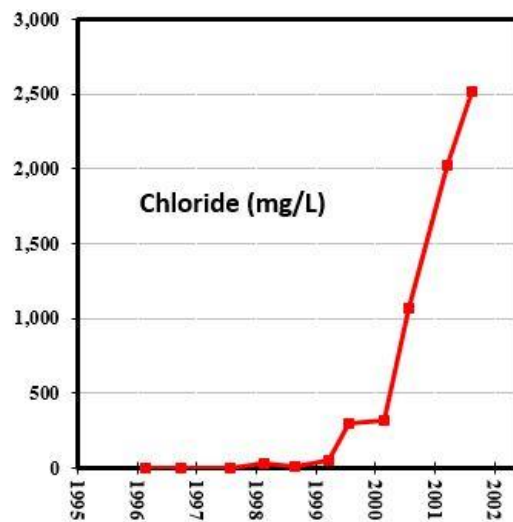
1998 Overflow Event

- Excessive rainfall in June 1998 and insufficient free-board caused brine to overflow berms to the south and east
- Chloride concentrations in groundwater increased
- Subsequent assessment work included: geophysical surveys (EM and resistivity), soil and groundwater assessments
- A Risk Management Plan (RMP) was prepared

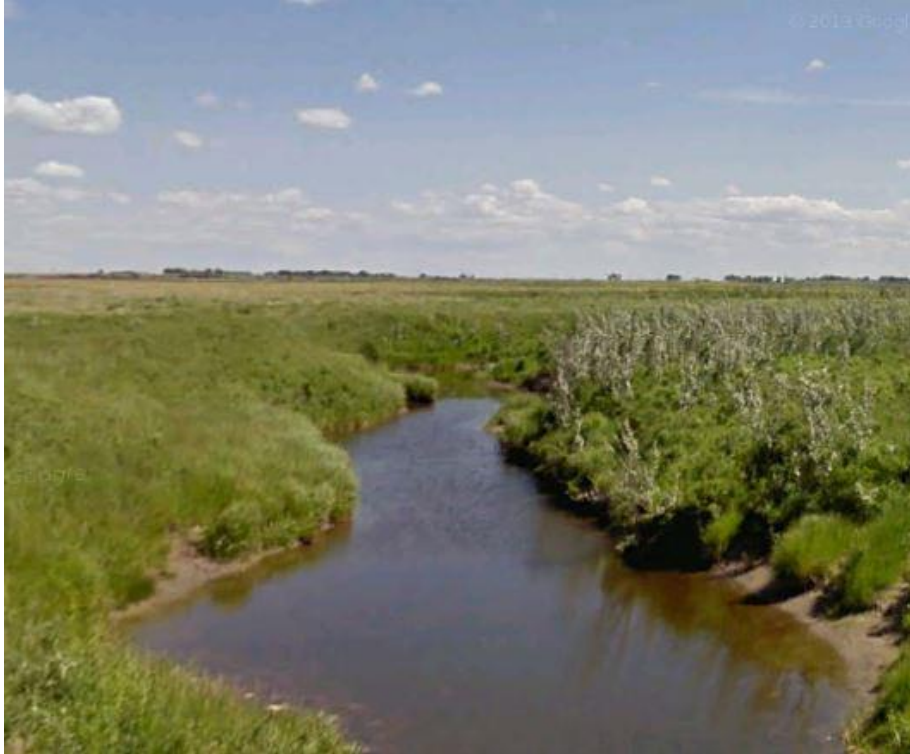
2012 - 2014

- Further repairs of leaks but groundwater quality not improving
- First time water quality impact in Creek in 2013 and further fresh water aquatic life guideline exceedances in 2014
- Spikes in chloride seem to occur when groundwater table is high and creek flows are low

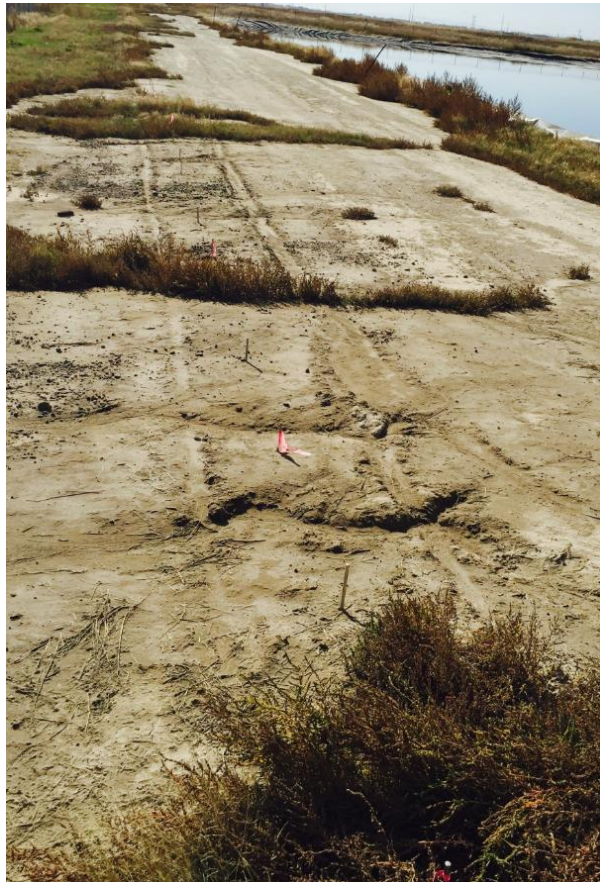
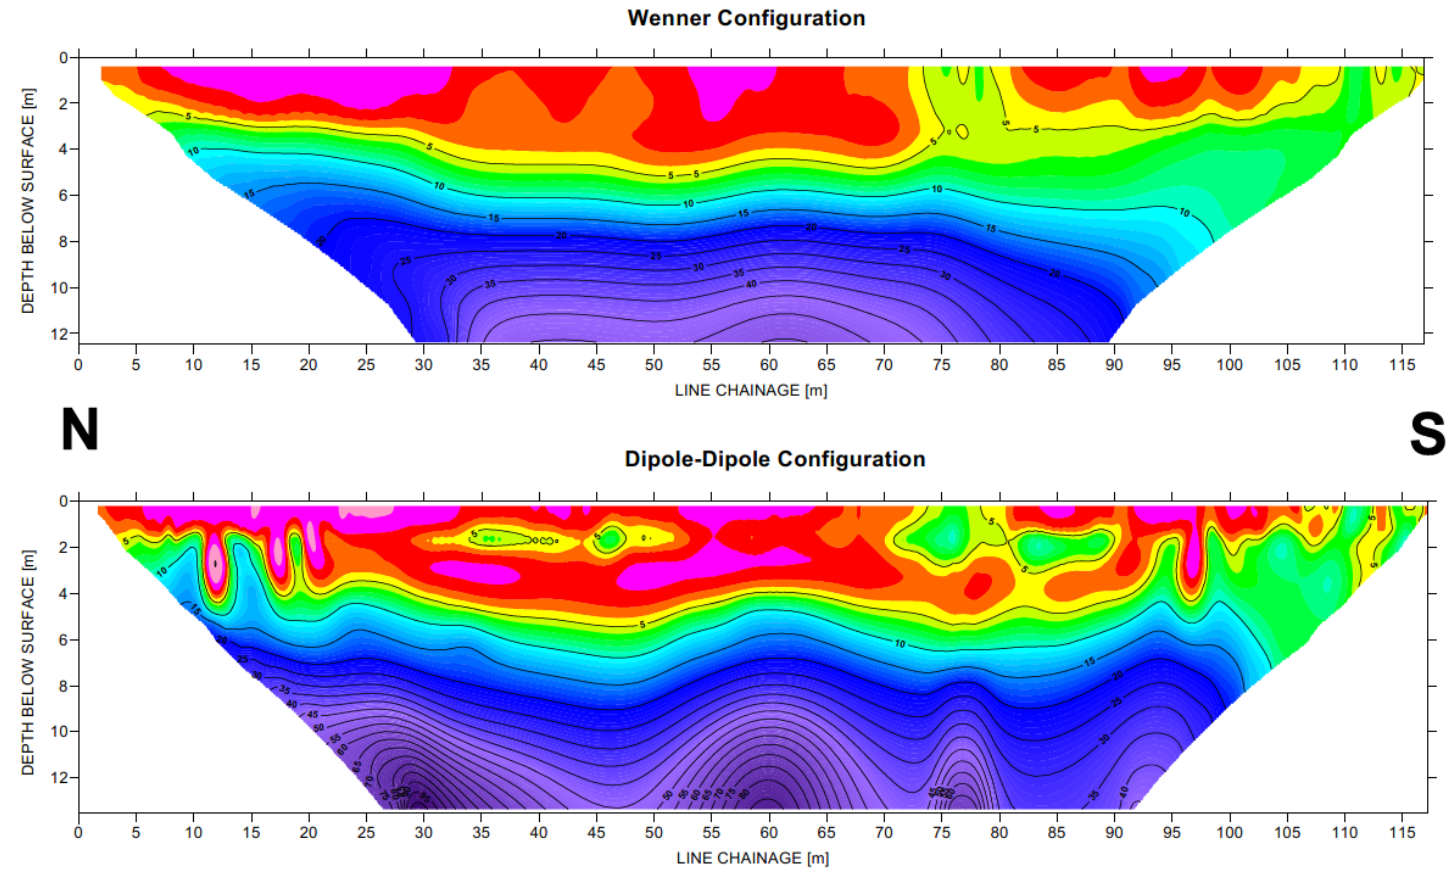
Electrical Resistivity Tomography (ERT)

Permanent array of electrodes to assess impact: for model input and to determine change over time

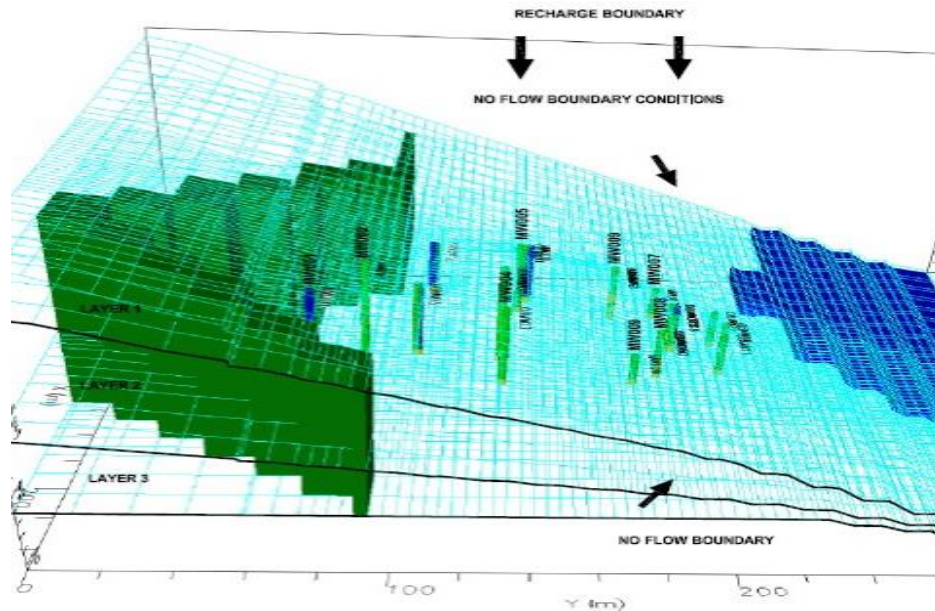
Groundwater Modelling

- Quantify movement of chloride-rich groundwater
- Calibrated against monitoring data since 1997
- Simulated concentrations up to 20 years
- Predicts decreases in chloride concentrations in groundwater near the creek, most rapidly (<1-2 years) when limited groundwater extracting takes place immediately east of the east brine pond and with no further leaks

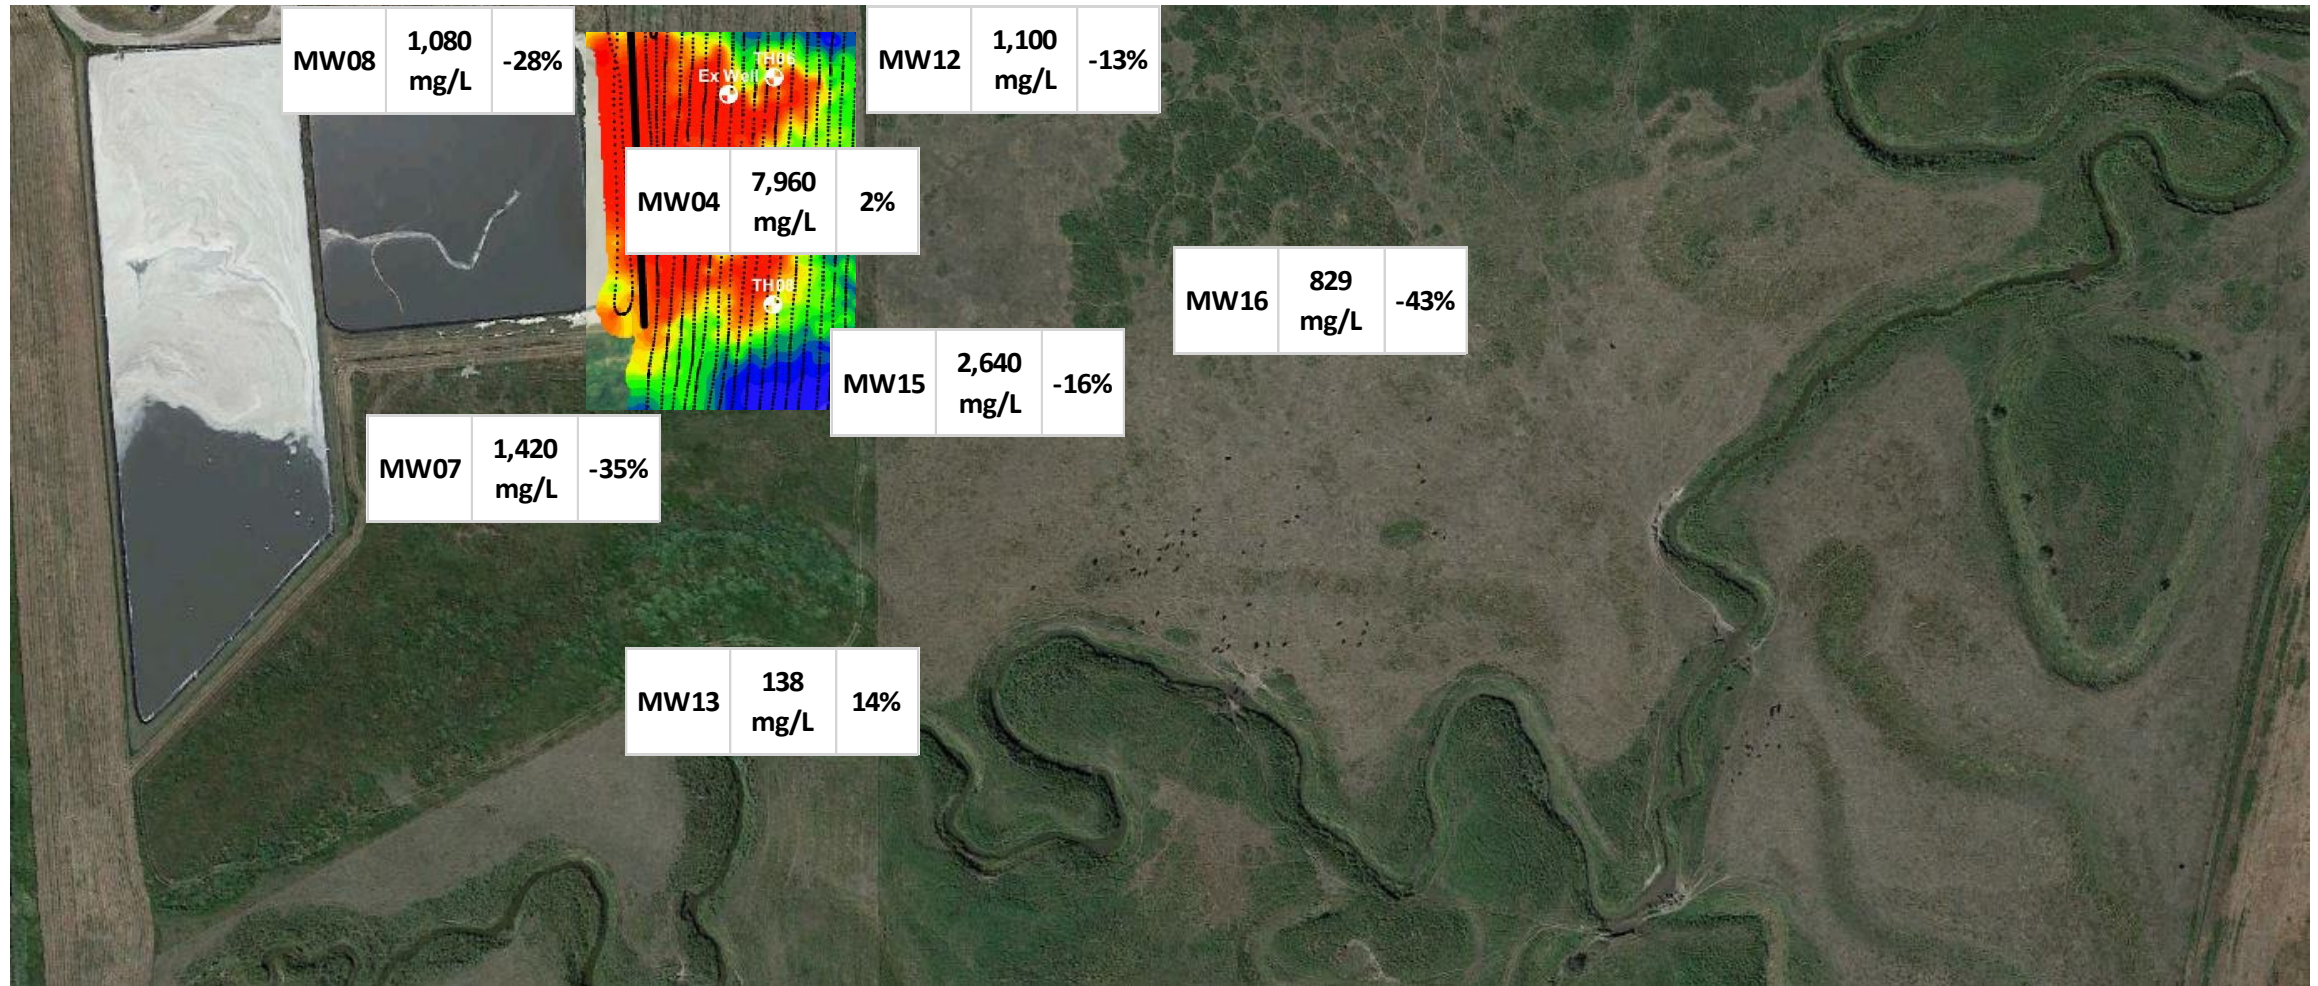
July 2016: Chloride Concentrations and Year-Year Change

- Proposed RMP is undergoing Regulatory review
- Leaky pond was emptied early 2016
- Pilot testing of new evaporator technology initiated to drastically reduce the total brine volume
- Two more groundwater and surface water monitoring events conducted
- Groundwater: overall 15% decrease in chloride concentrations
- Surface water: chloride well below guidelines (29 mg/L)
- Leak detection systems have been dry
