ASSESSMENT AND REMEDIATION OF A NON-AQUEOUS PHASE LIQUID HYDROCARBON PLUME IN FRACTURED BEDROCK

Ian Mitchell, M.Sc. P.Geo

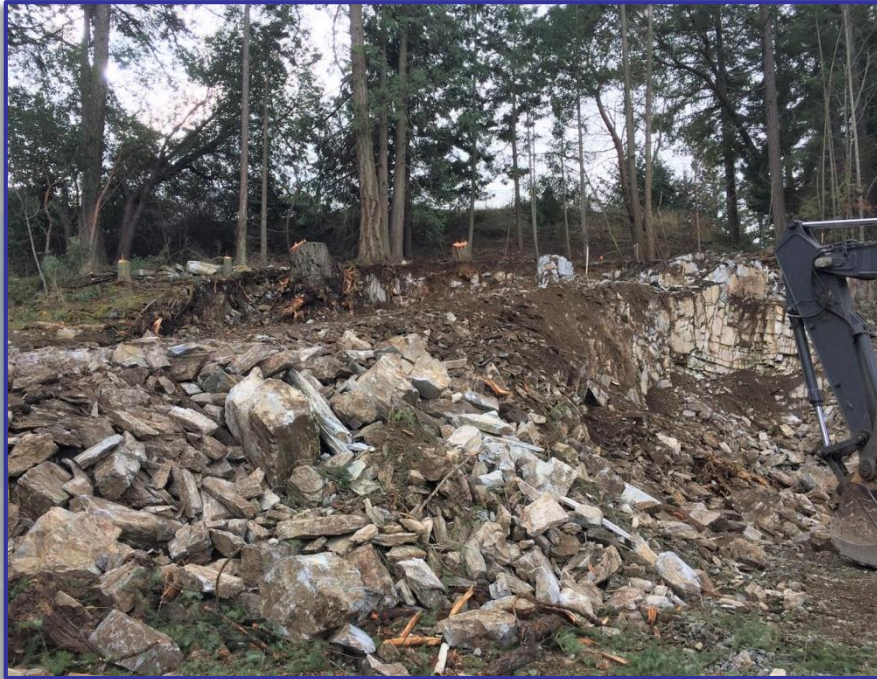
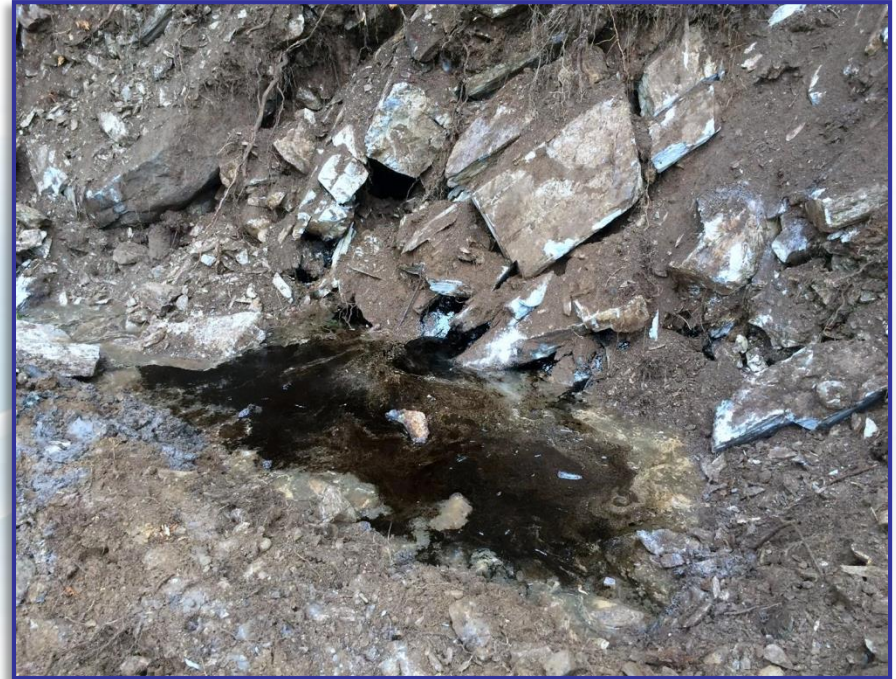
During road construction, a heavy-end non-aqueous liquid (NAPL) hydrocarbon product was observed oozing from fractures in a freshly excavated rock face

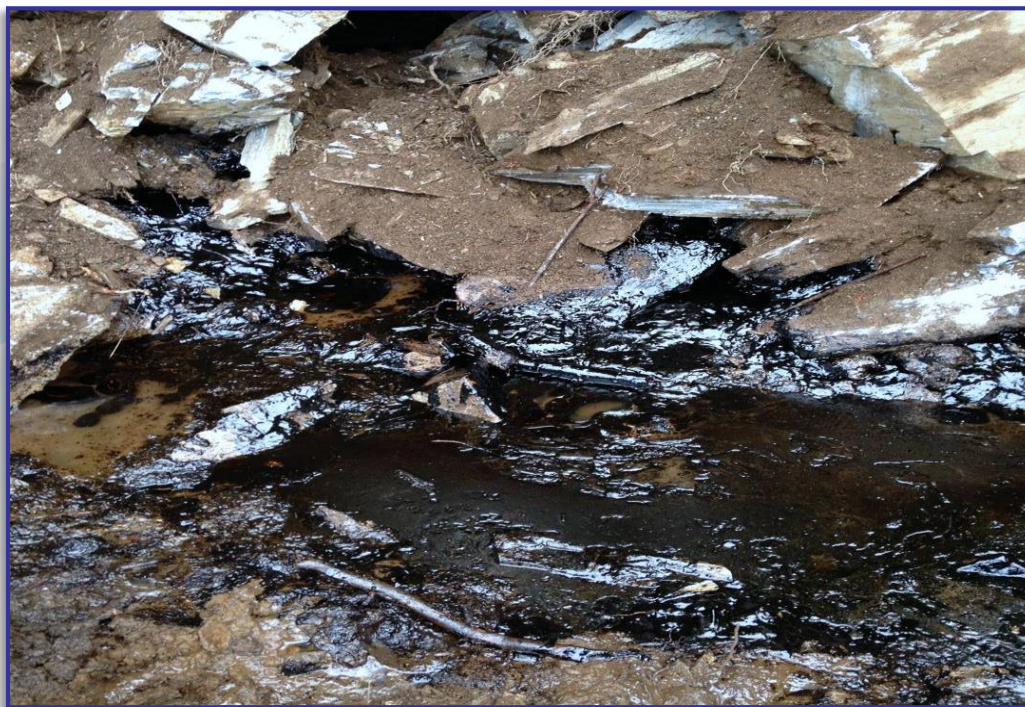
During road construction, a heavy-end non-aqueous liquid (NAPL) hydrocarbon product was observed oozing from fractures in a freshly excavated rock face
