Historical Spill Management Challenges at an Active 1950s Gas Plant

Anela Baig, B.Sc., P.Geo., Senior Environmental Scientist
Market Sector Lead, British Columbia
Partner

Date: October 15, 2020

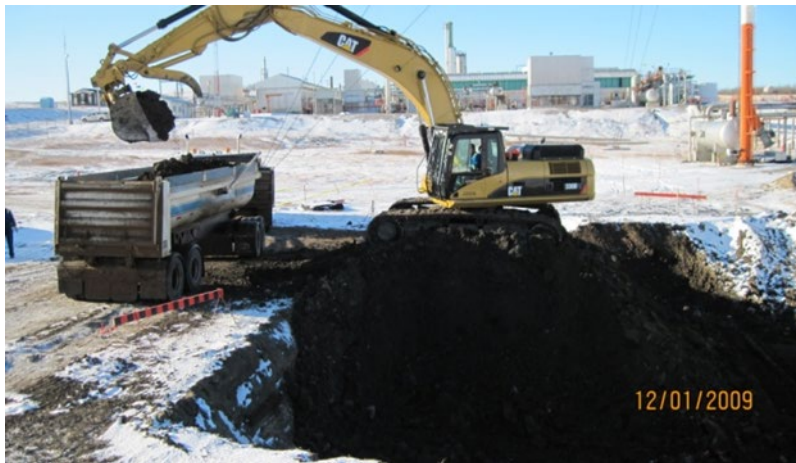
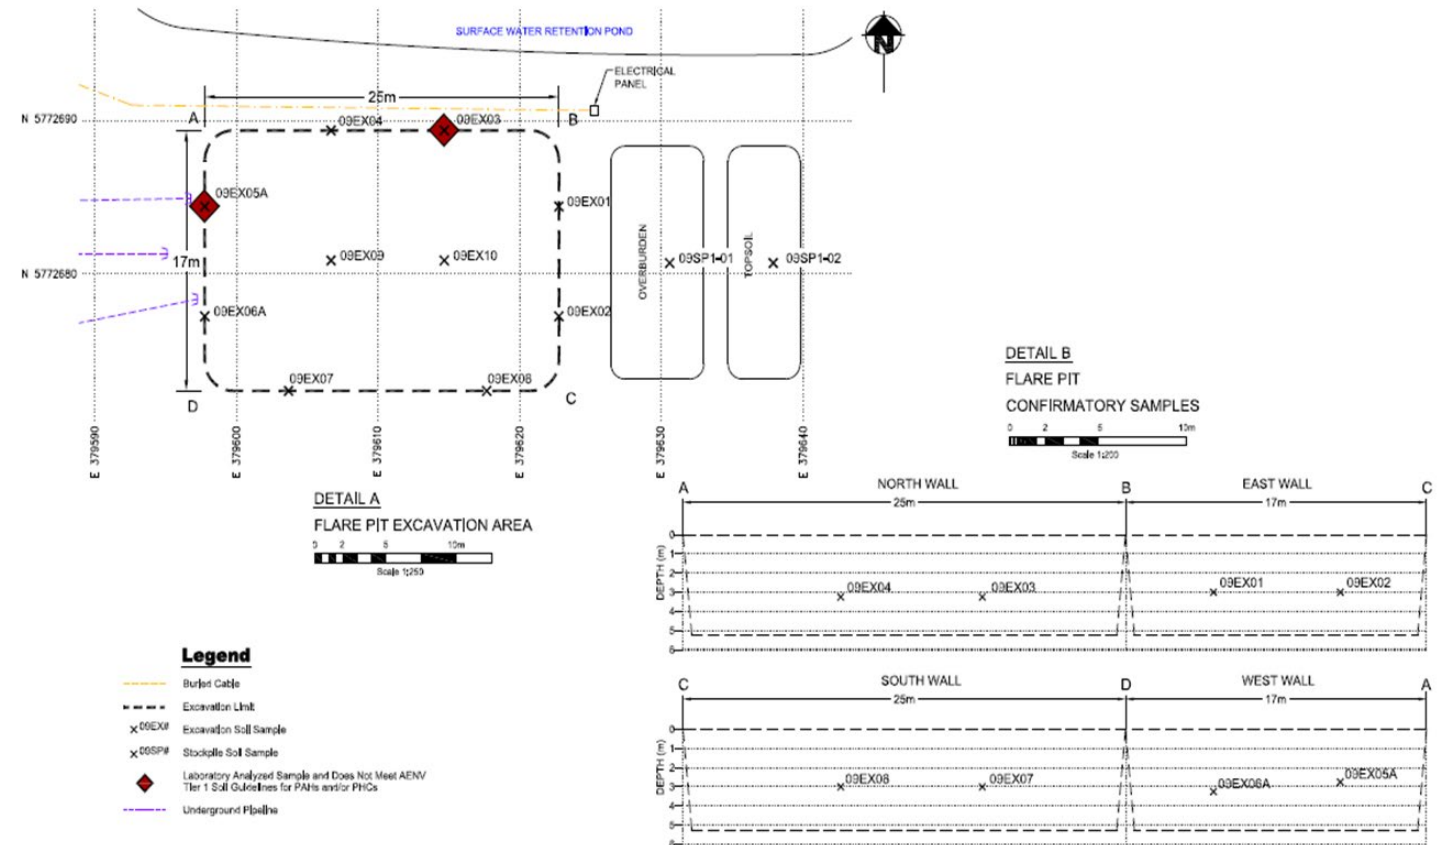
Flare Pit Remediation:

- Winter 2009
- Challenges:
 - Underground facilities and the surface retention pond

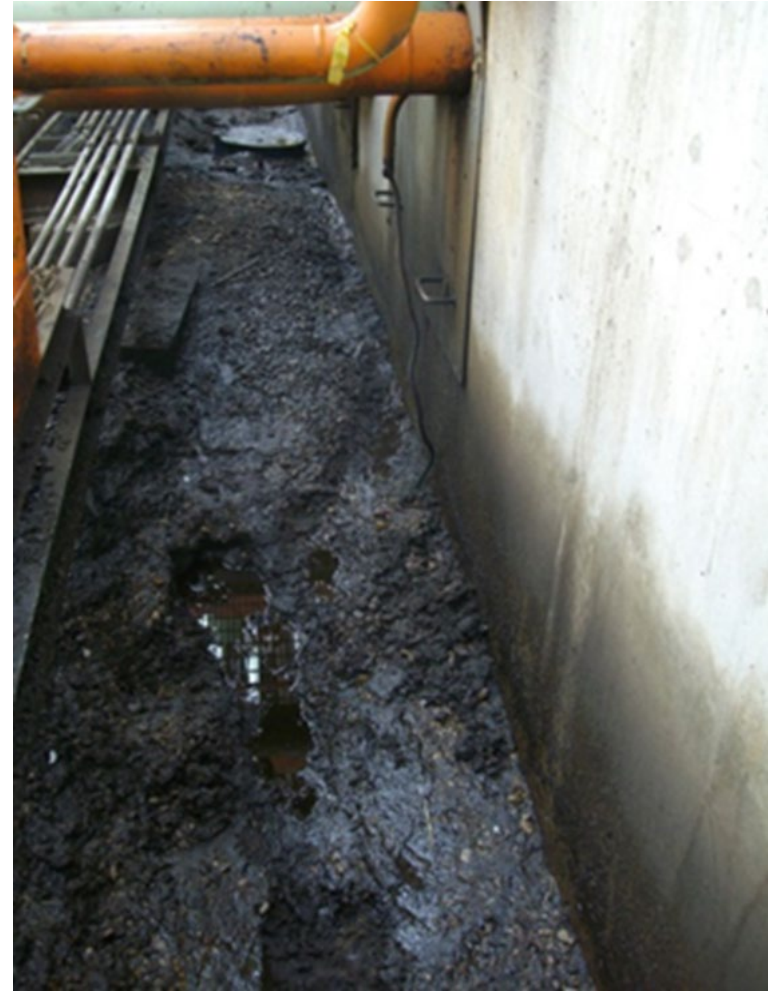
50 Year Release:

- Historical compressor oil/lube leakage from late 1950s to mid 2000s
- Limited free product recovery

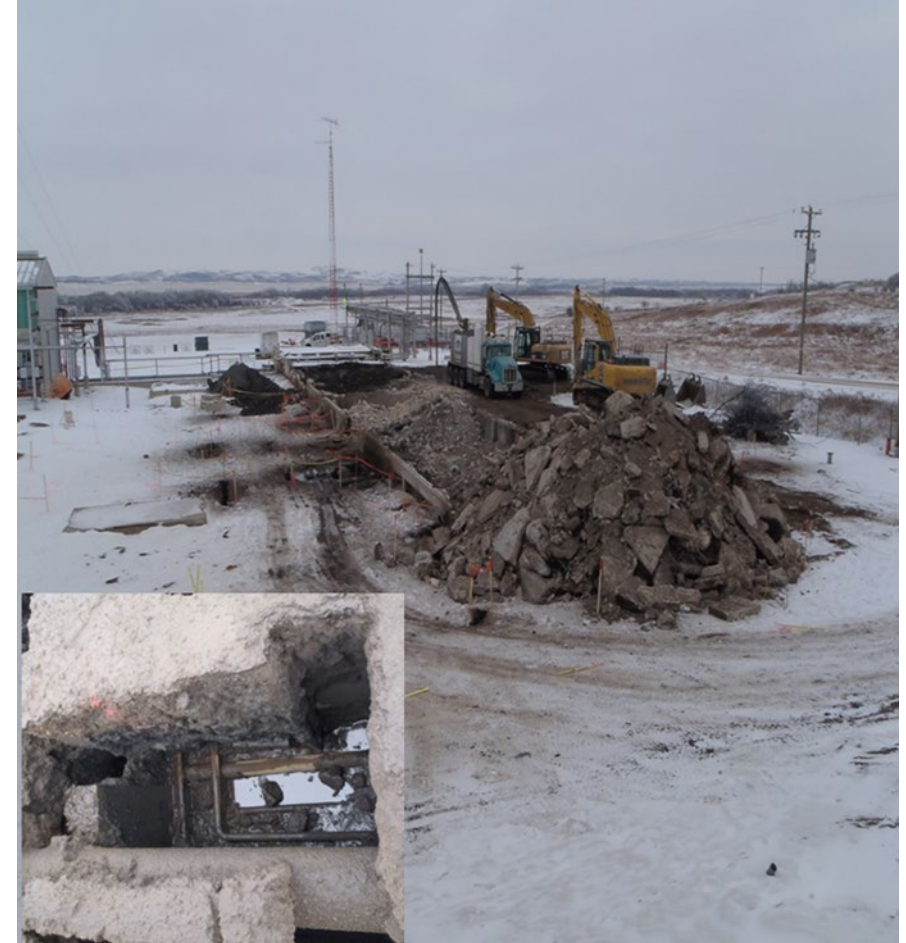
Fall 2012/2013:

- Testpits were advanced within the former compressor building area
- Petroleum hydrocarbons (PHCs) > Tier 1 guidelines
- Soil > Class II landfill criteria
- Constructed berm to limit surface water infiltration

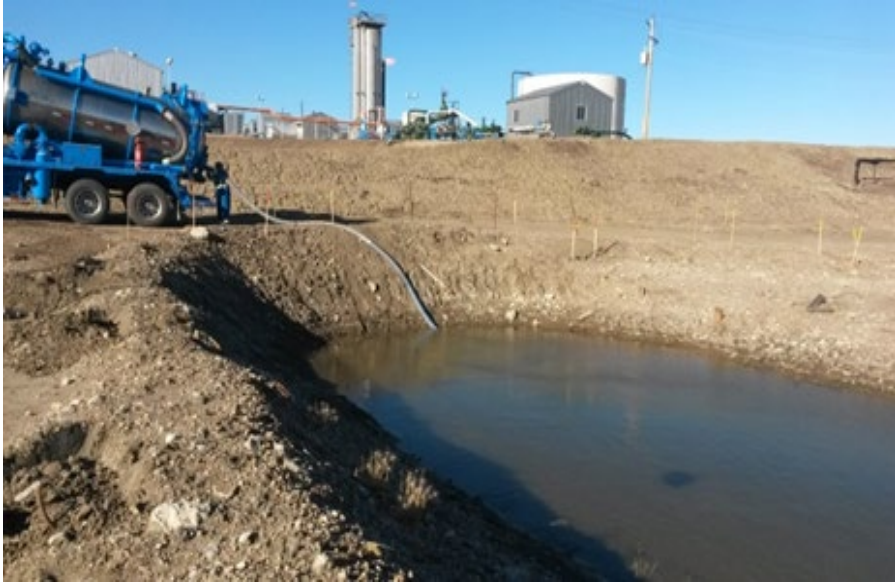
Surface water

Challenges: Water Management
