We Can Do Better

PHASE1ESA.CA
DUE DILIGENCE DONE RIGHT

CASE No. 1

CASE No. 2

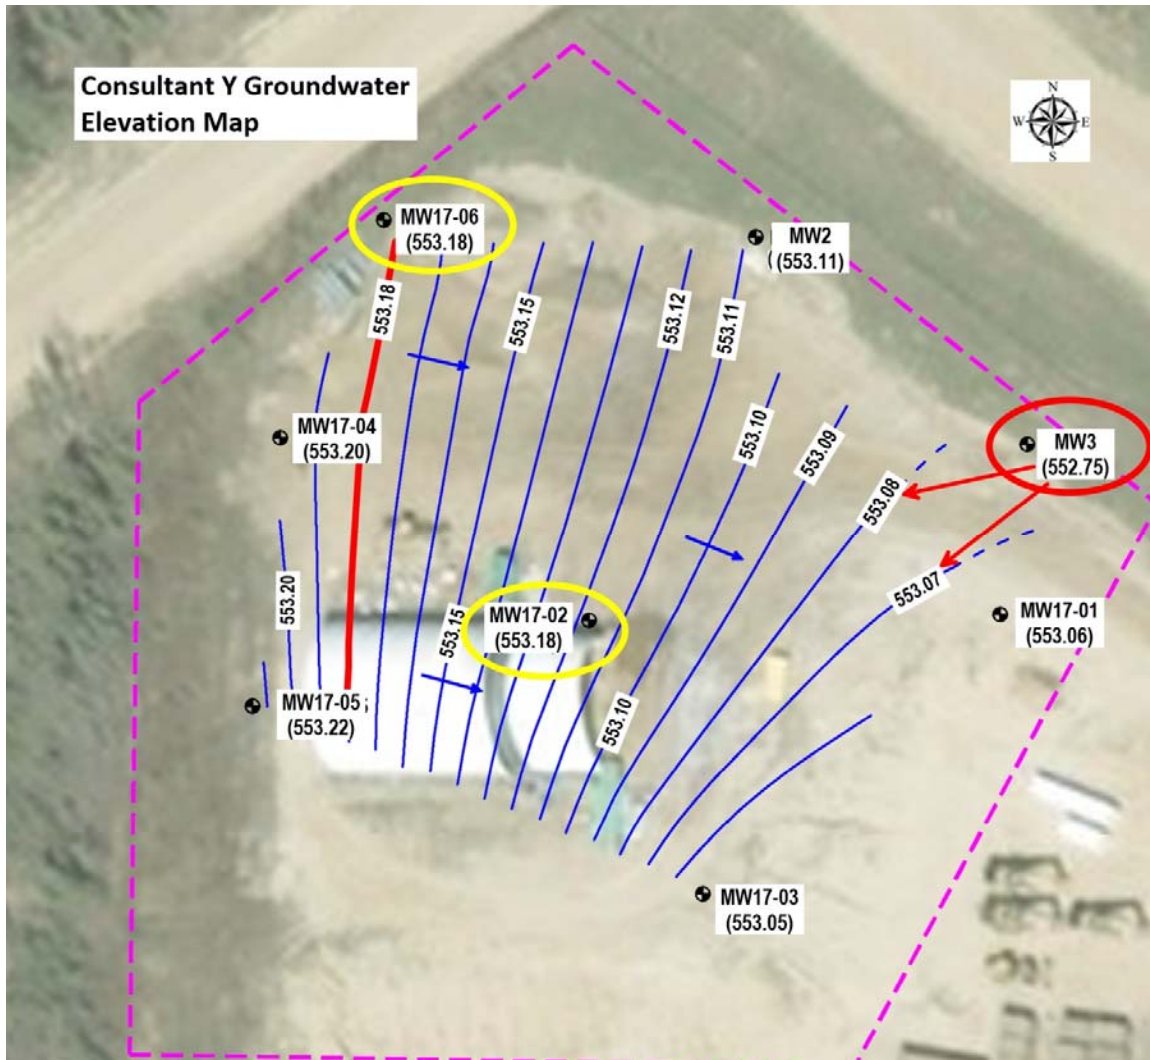
MW17-02's and MW3's elevations don't fit with the groundwater elevation contours. The map doesn't reflect the data. Two data points have been ignored in the plot but no explanation of why was given anywhere in the report.

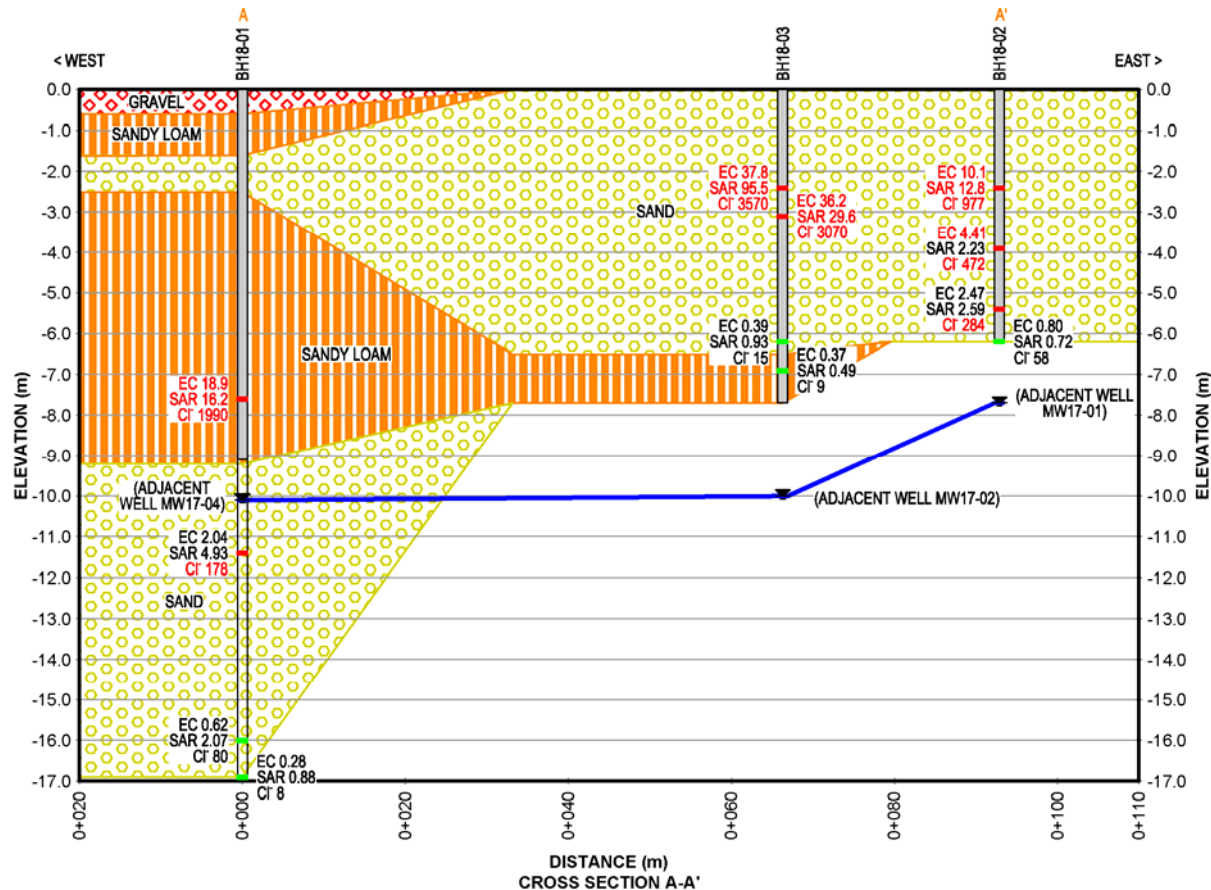
The total depths of all 3 boreholes are correct and the depths to the different zones from ground surface at all three boreholes are also correct. The problem is, all three wells are at different elevations with the difference in elevation between BH18-01 and BH18-02 being -2.17m.

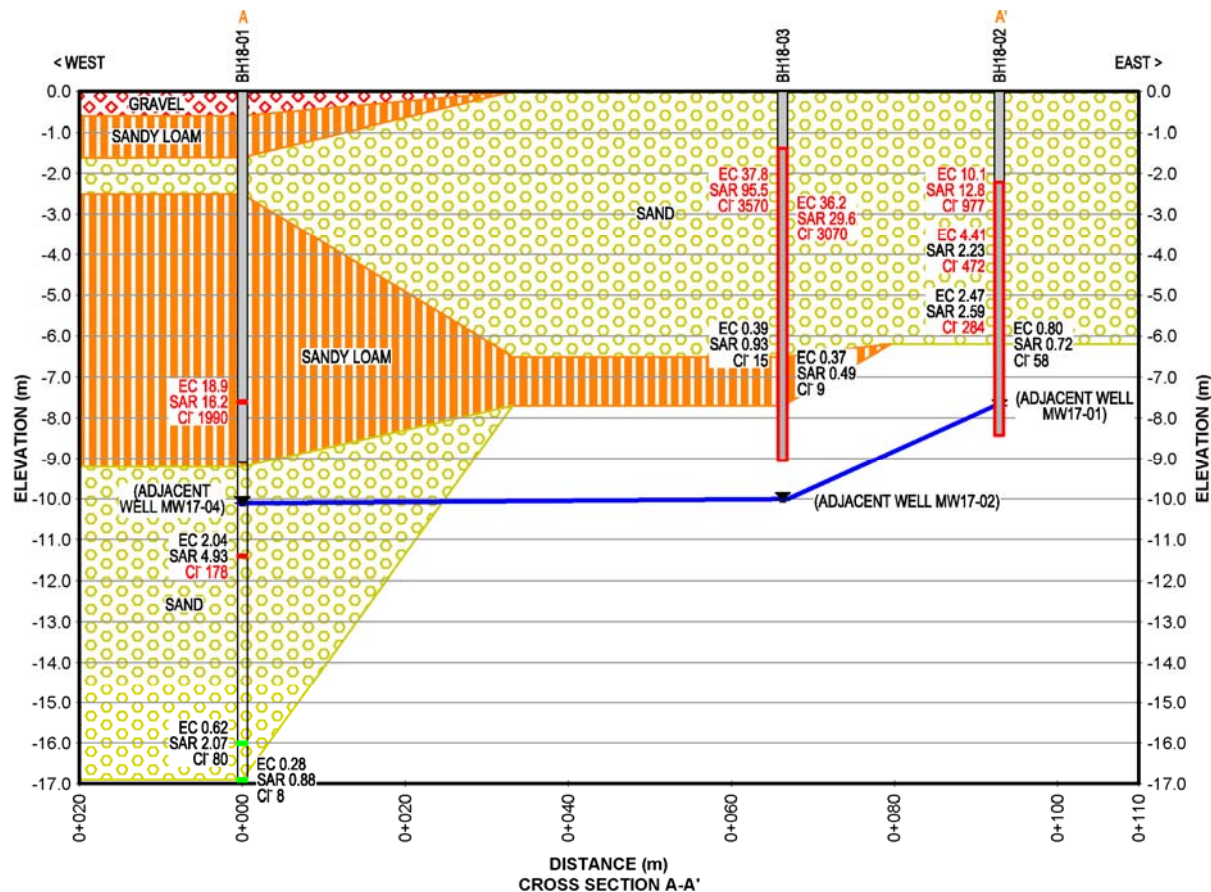
The X-section is **wrong and misleading**. The elevations of all the lithological contacts are incorrect at the east end of the X-section. The red outlined well bores show where the east boreholes should've been plotted. The zone contacts, etc., should be shifted downwards the same amount.

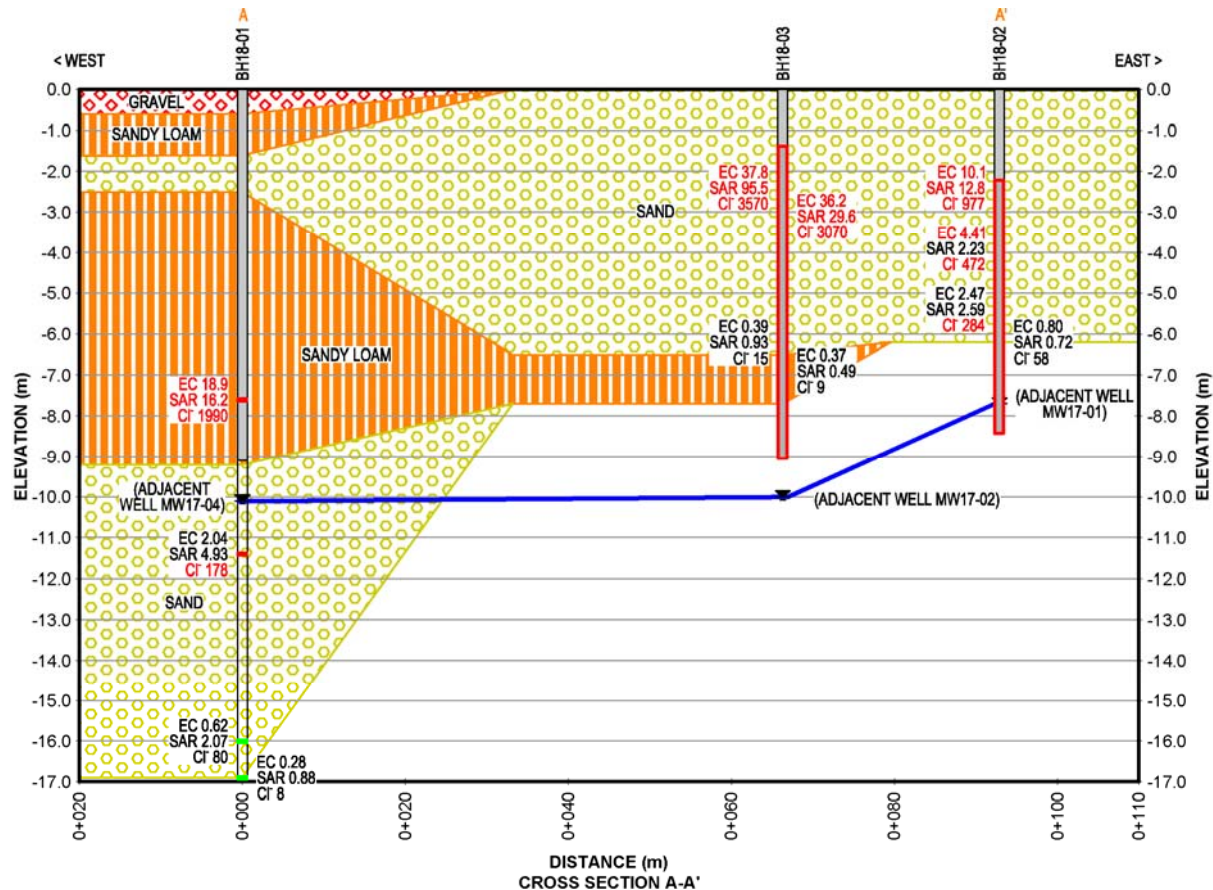
The groundwater elevations are wrong as well. The groundwater elevations at MW17-02 and 01 are 0.02 m and 0.14 m lower than at MW17-04, respectively. This figure shows that groundwater elevations are higher at the two east wells. This is false.

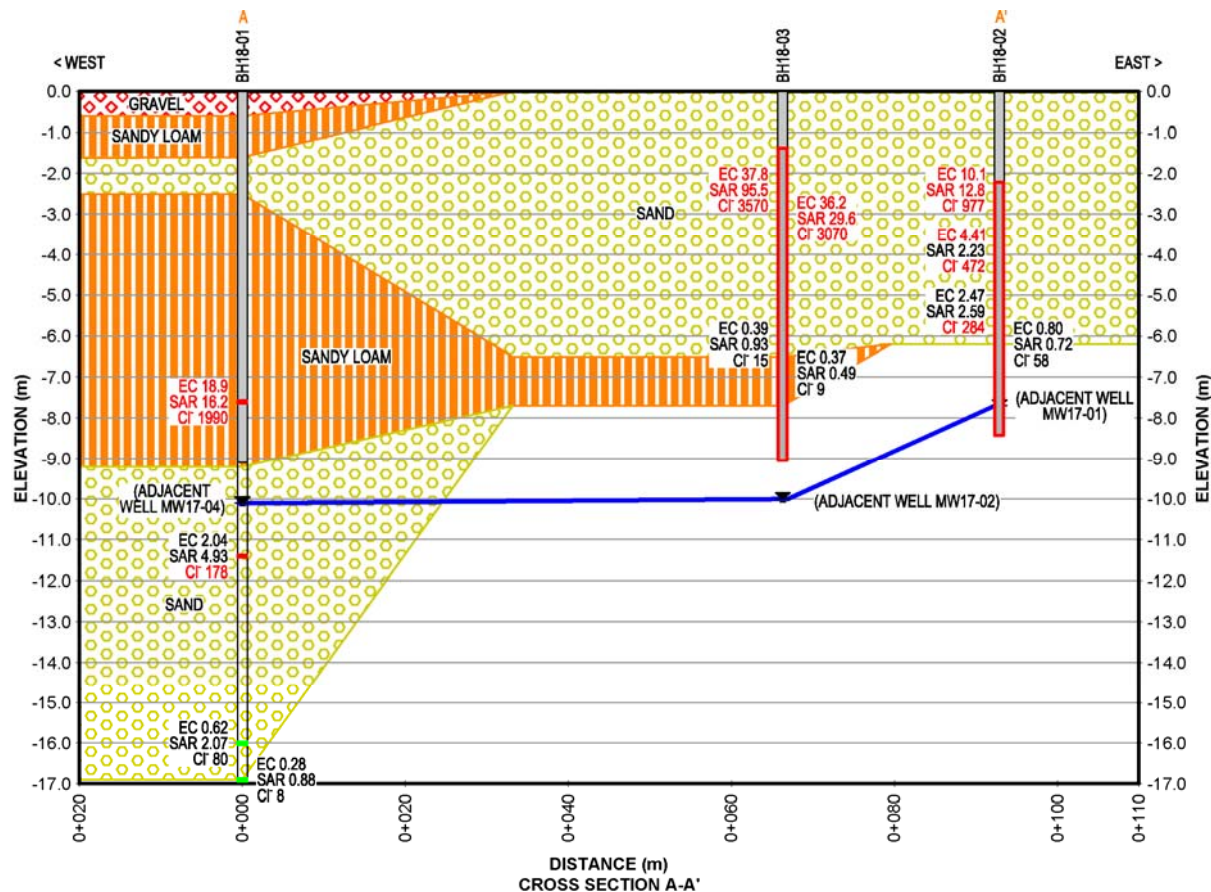
Remember how the groundwater elevation contour map clearly showed the groundwater flow direction was **west to east**? This cross section shows it flowing **east to west**.

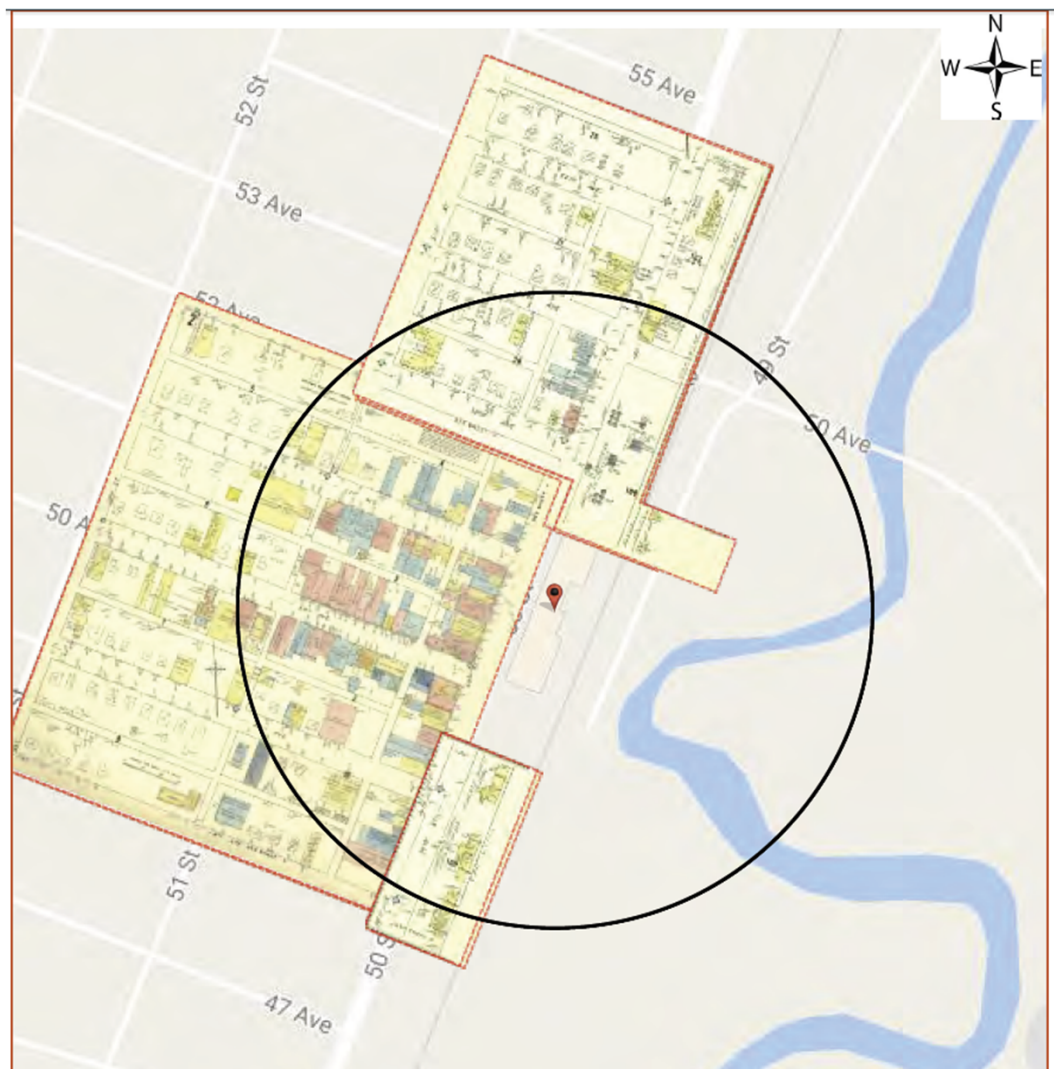
The RMS FIM search report in the appendix to the 2011 report clearly shows the available FIMS were NOT ordered by Consultant X. They were, however, ordered in 2017.

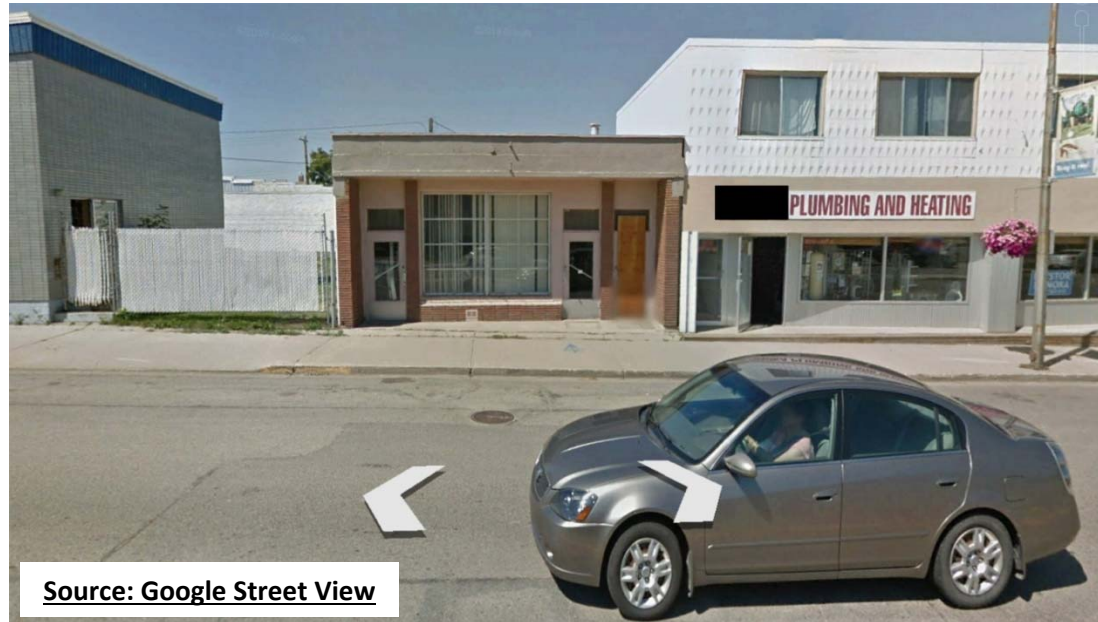
An abandoned and boarded up commercial property on a prime commercial strip often indicates a contaminated site.

The above Google Street View image is from 2015. The property was abandoned ~2007 so this is what they would've seen in 2011.

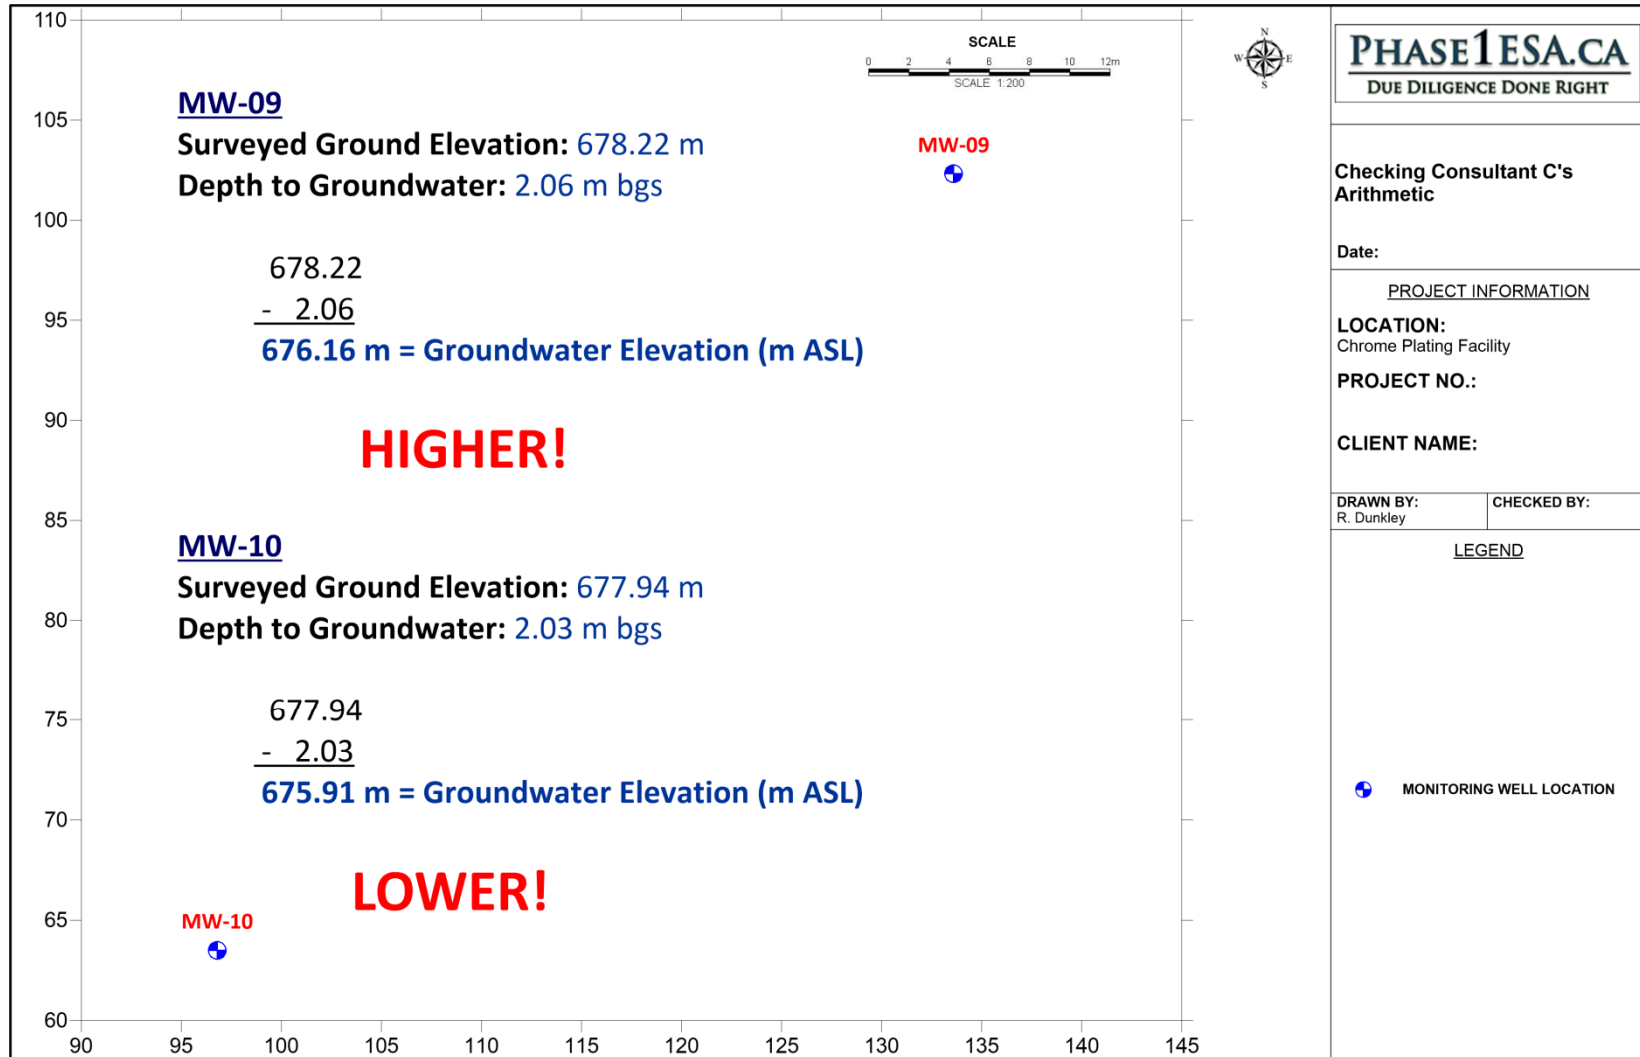
1. Groundwater cannot possibly flow northeast!
2. MW-10 **cannot be considered an upstream/background well**. In fact, it may be the **only** downgradient well in the entire network!
3. It appears that neither Consultant C's report writer or reviewer bothered to look at what their own data was indicating. No one checked the math.

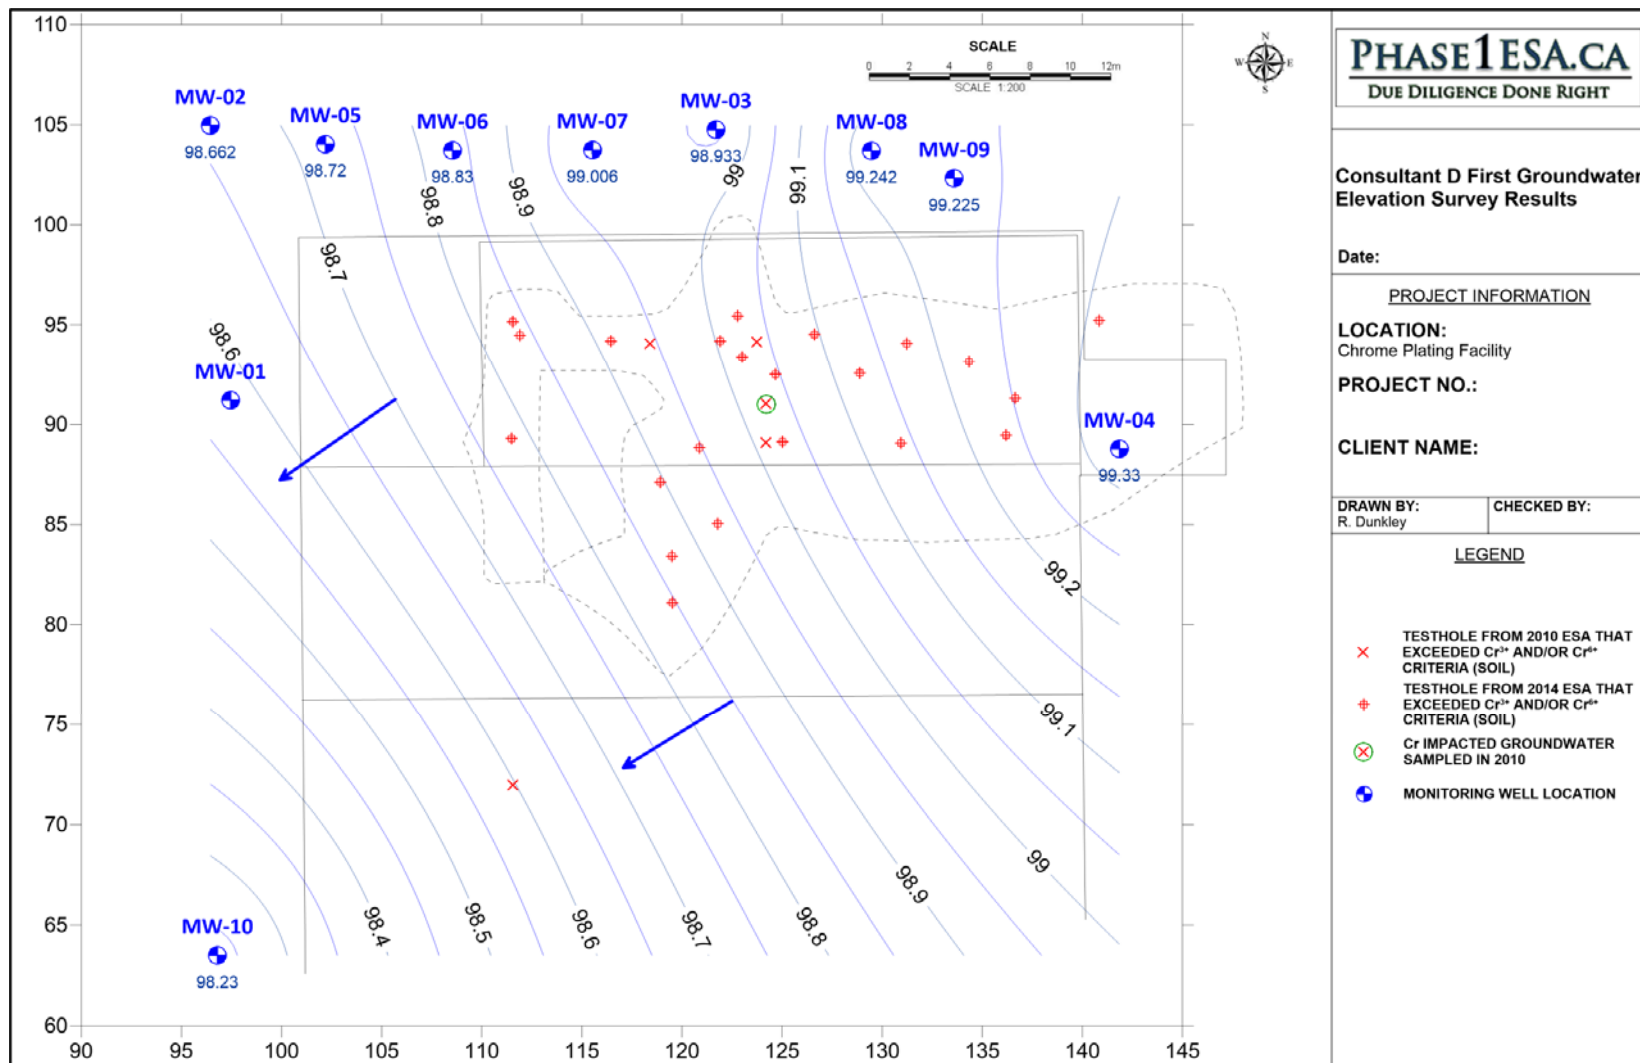
- 1. Not Northerly towards the Big River.**
- 2. Not East-Northeast towards the

Creek Ravine.**
- 3. Not North-Northeast either!**

I recommended doing a groundwater elevation survey to FINALLY determine the direction of shallow groundwater flow. Here's what we found:
