# Harrietsfield C&D Landfill

## Reclamation of a Former Construction Debris Facility

Presenter: Rob McCullough  
June 2022

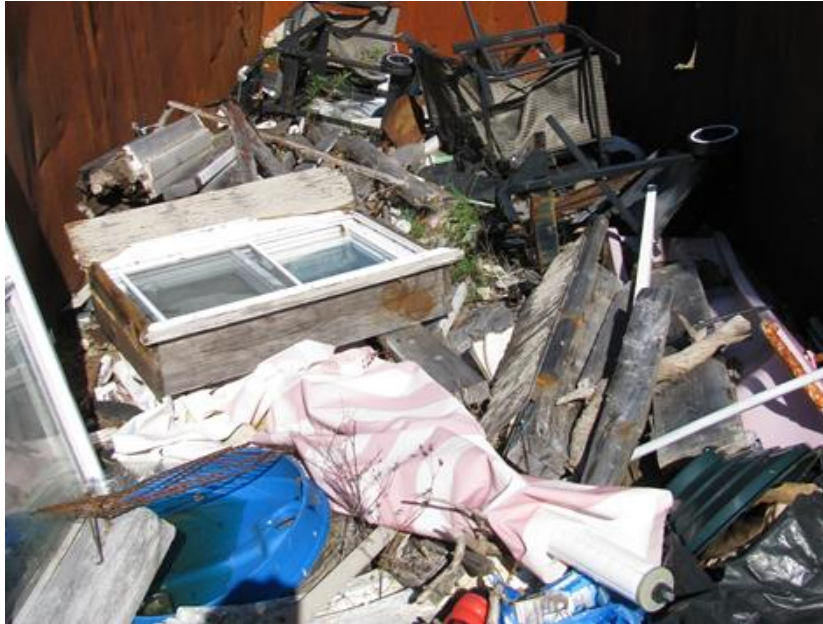
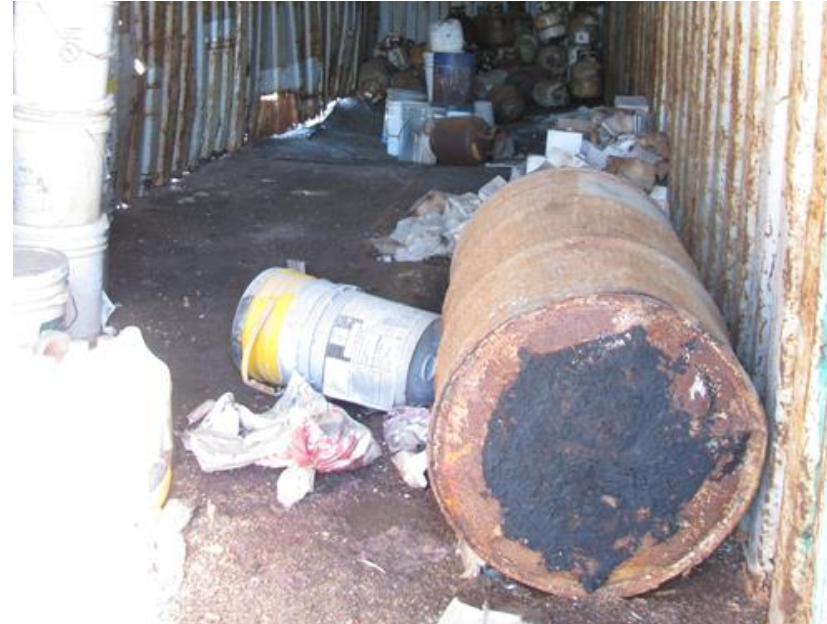
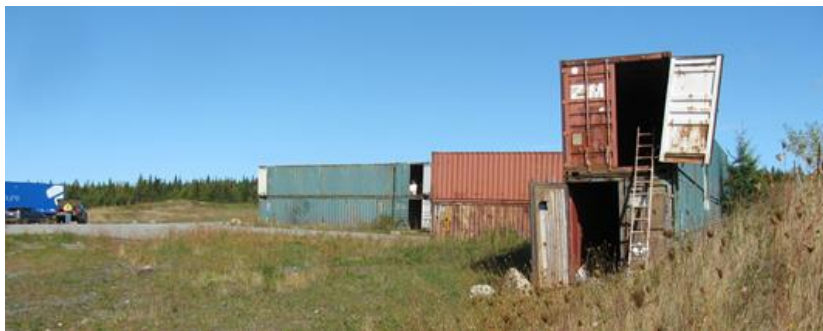
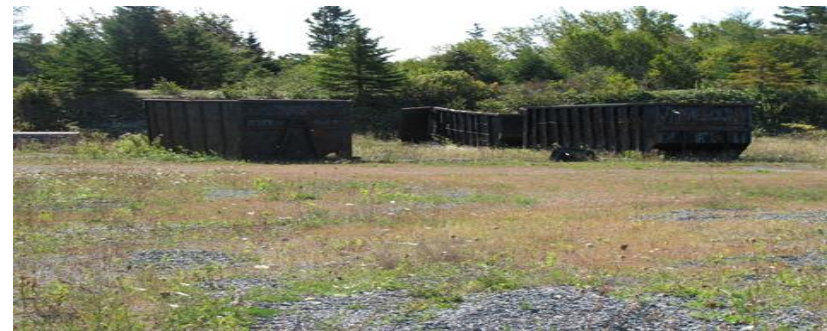
Seacans and Waste Bins Hazmat: asbestos, paint, tires, compressed gas, tar, hydrocarbons

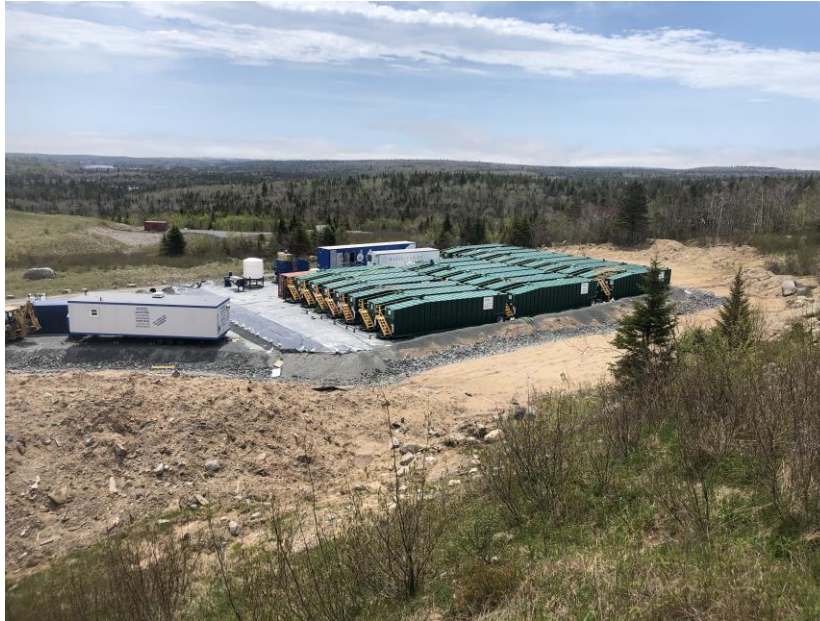
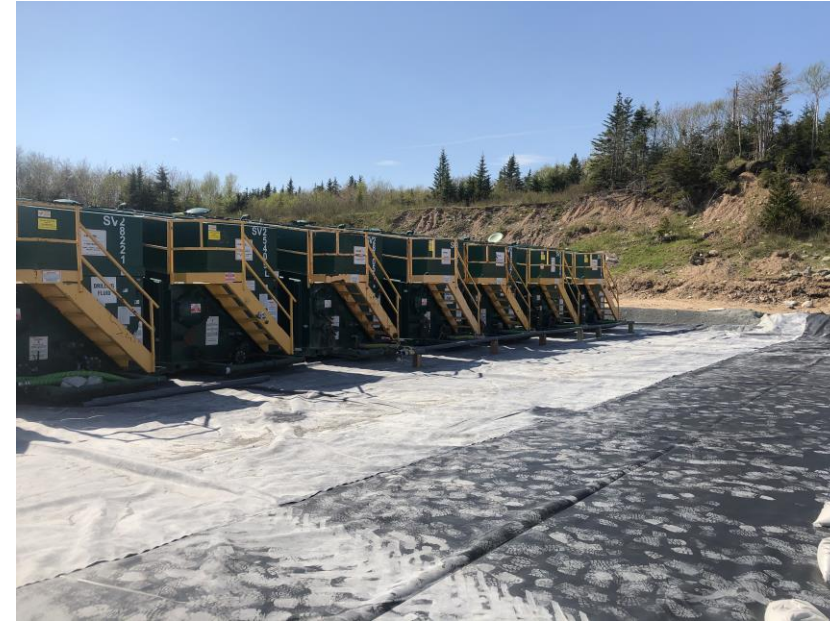
### **Terrapure (GFL) Water Treatment System on Containment Pad**

**Approximately 4 million (L) of leachate was removed from the initial drawdown prior to construction activities began on the cell.**

**2.7 million (L) was removed from the site as reject water that did not meet discharge criteria for treated Leachate.**

**Plant processed leachate and then site contact water throughout construction.**

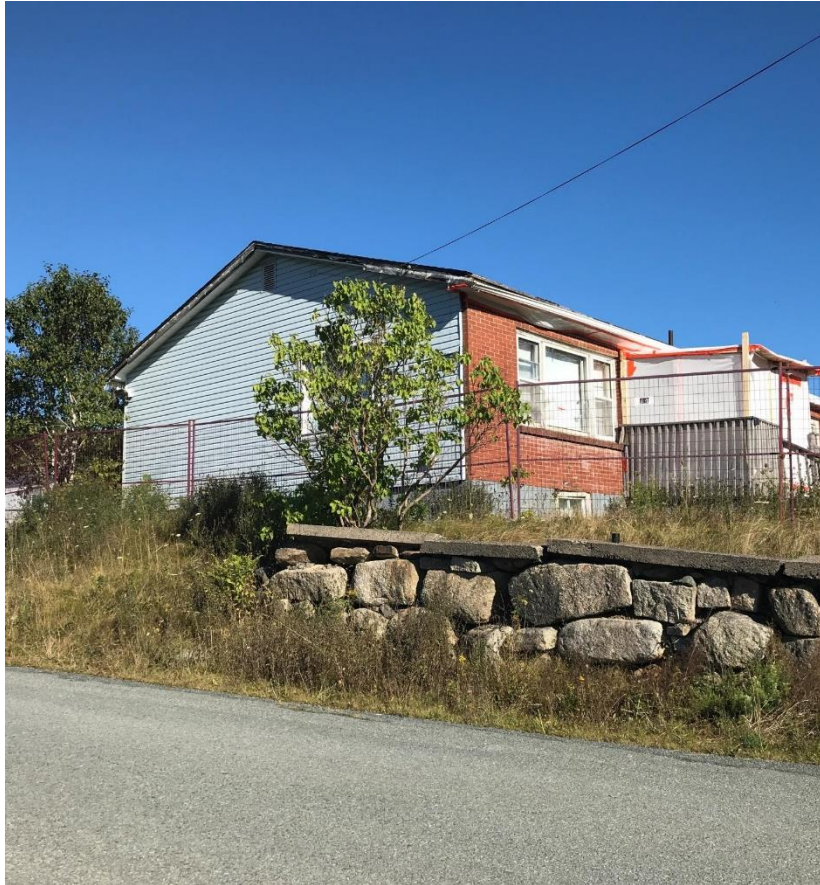
- Building HAZMAT

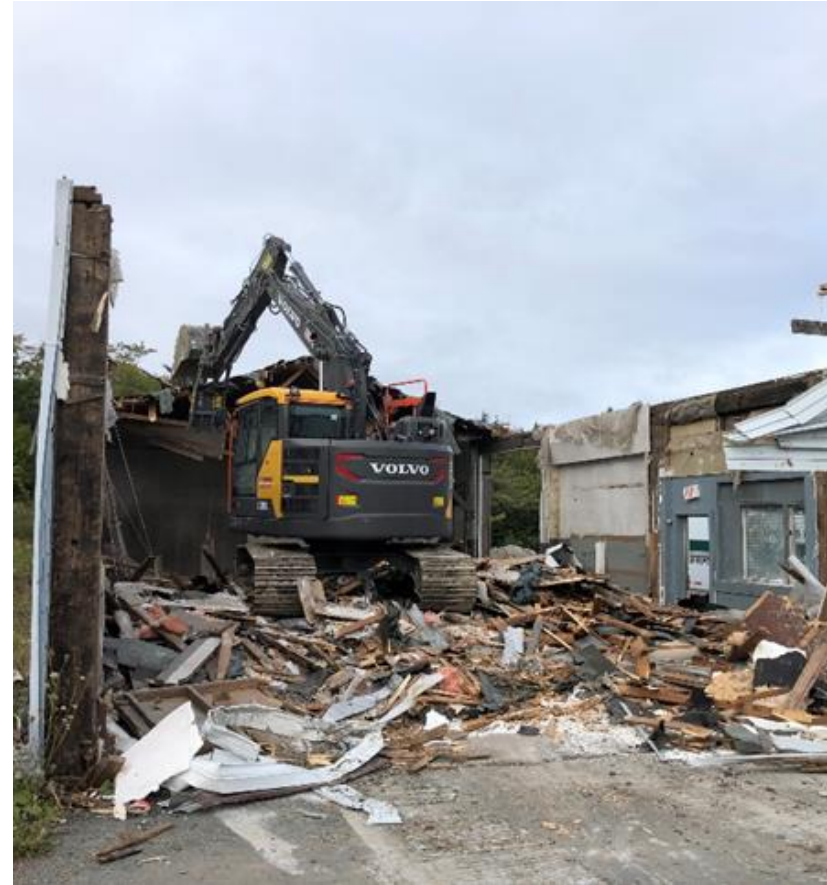
- Building Demolition

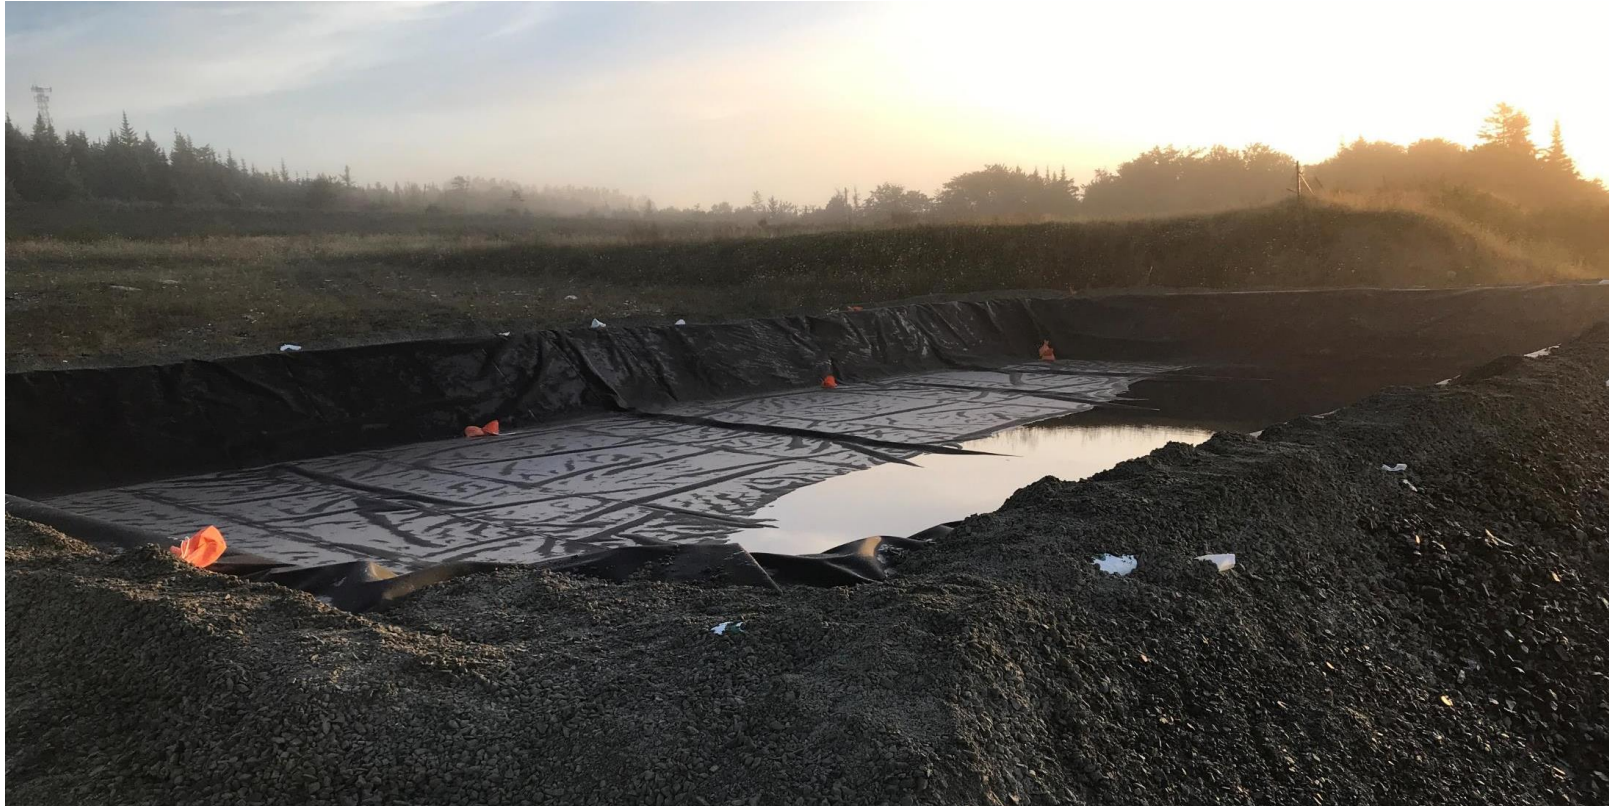
Contact water containment pond

1.1 million L of contact water was collected and treated through the construction phase

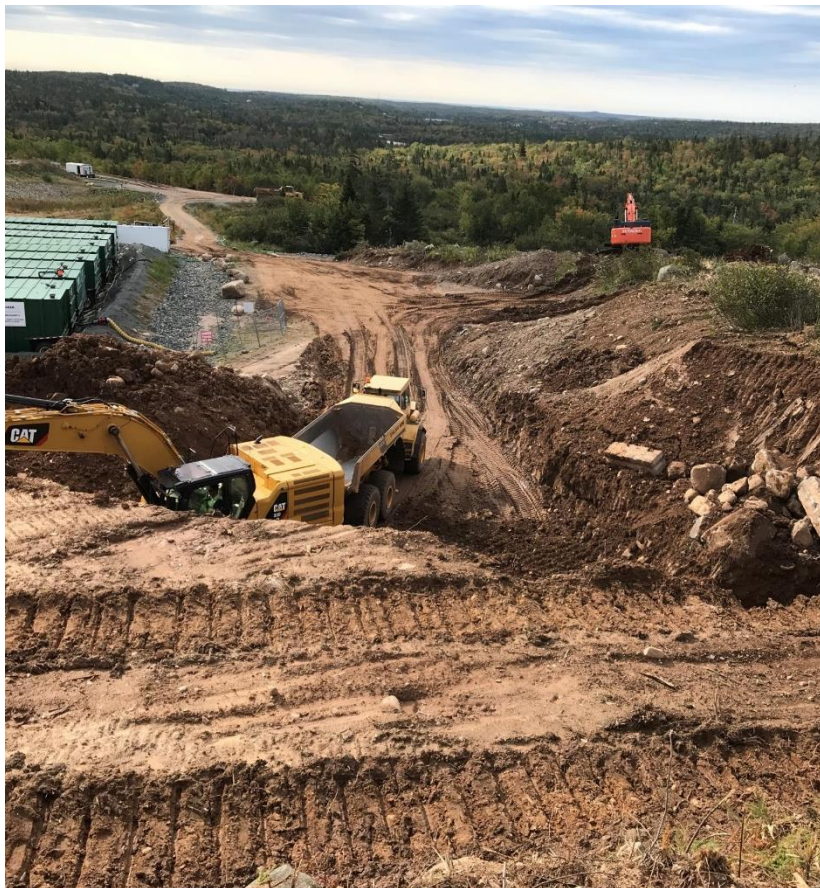
- Clearing of borrow area

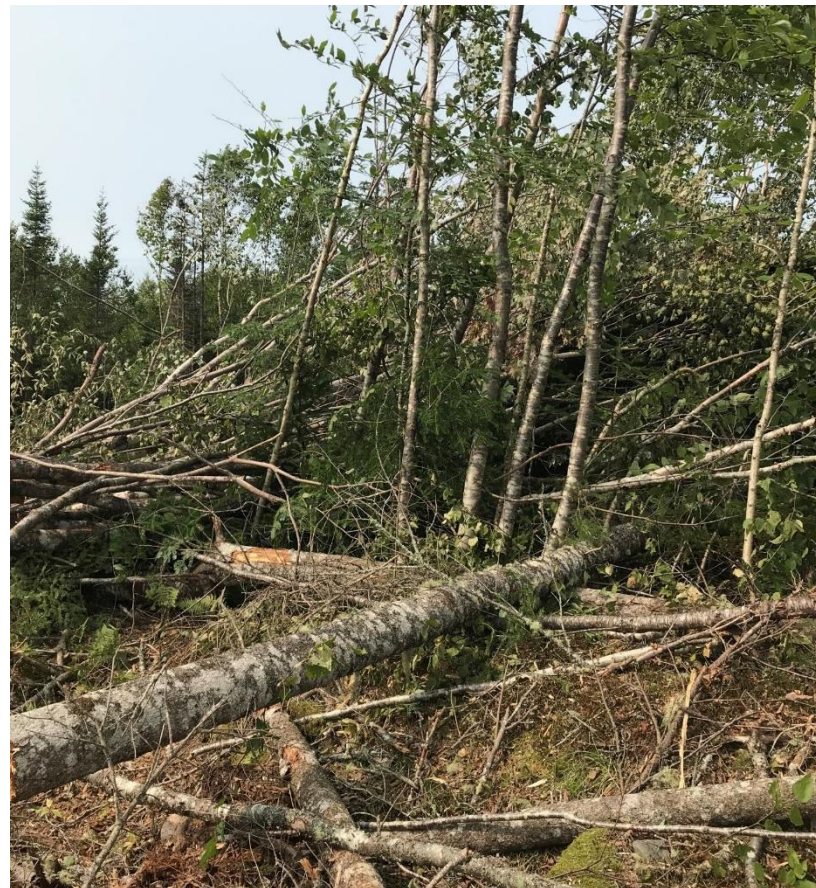
- Borrow source excavation and development

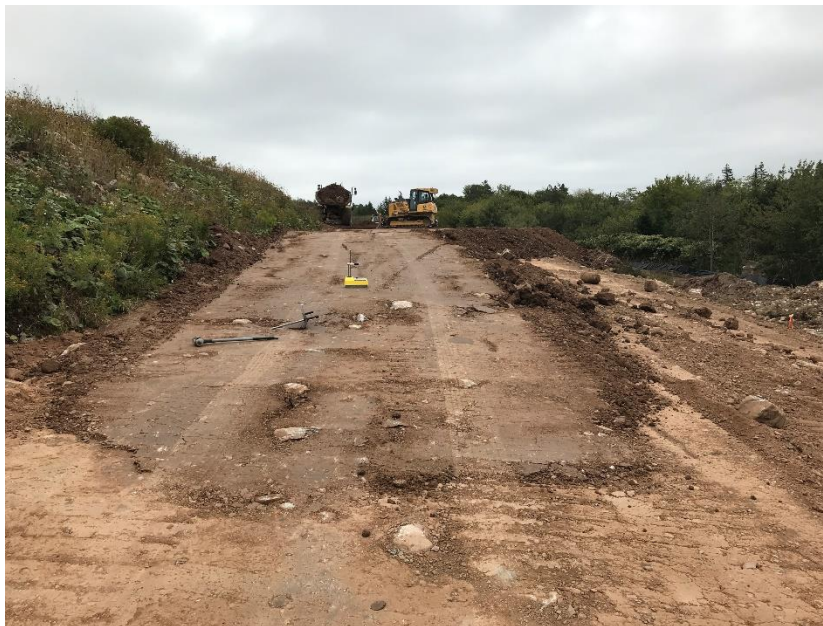
- Compaction testing on berm

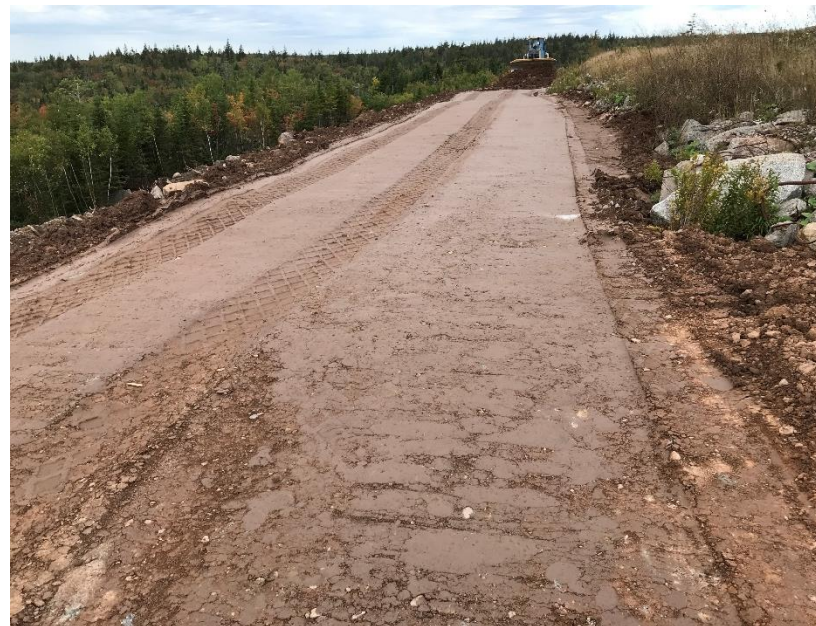
- Construction of perimeter berm

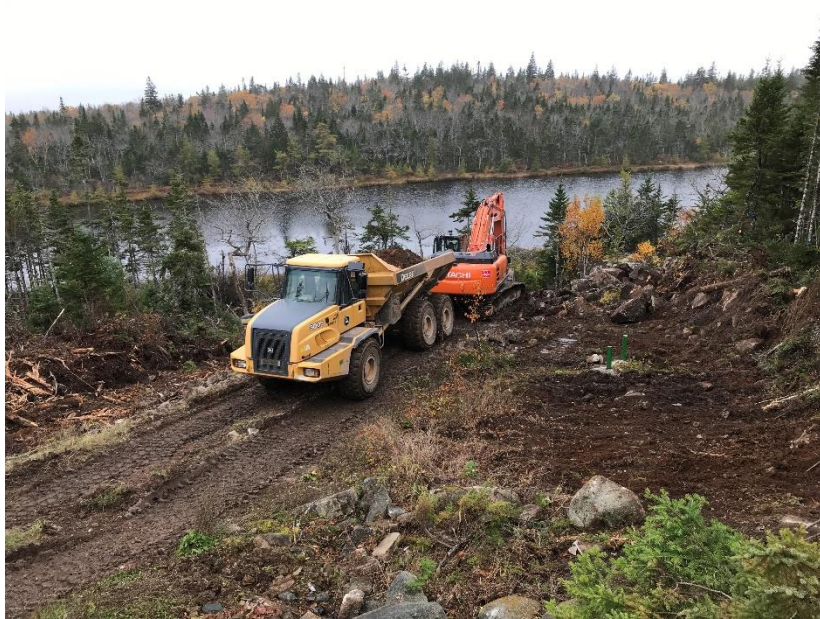
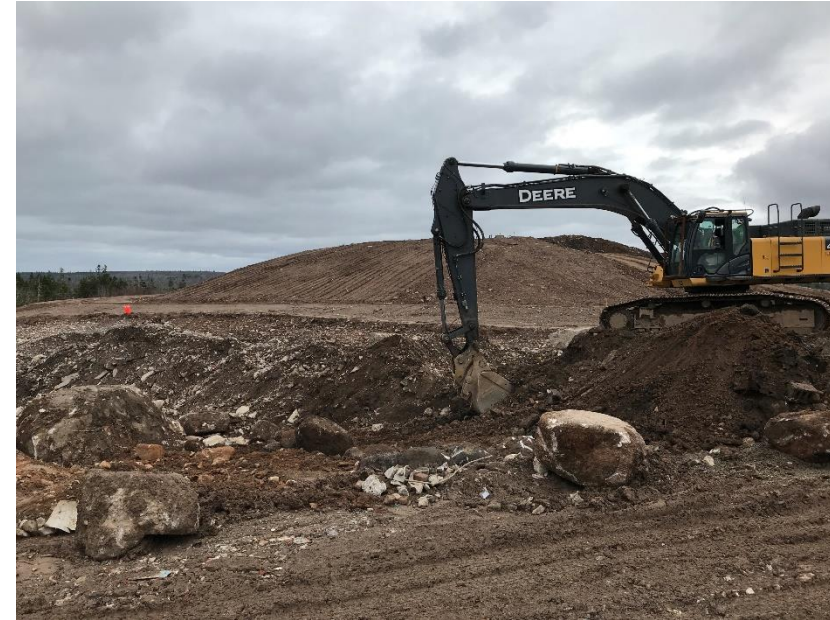
### Buried Debris Area (BDA) Excavations

BDA's were excavated and waste placed in the cell or removed off-site

One BDA was excavated at a time for on-site disposal thus not creating large areas of potential contact water generation.

Existing Landfill Cap Material Removed and Stockpiled

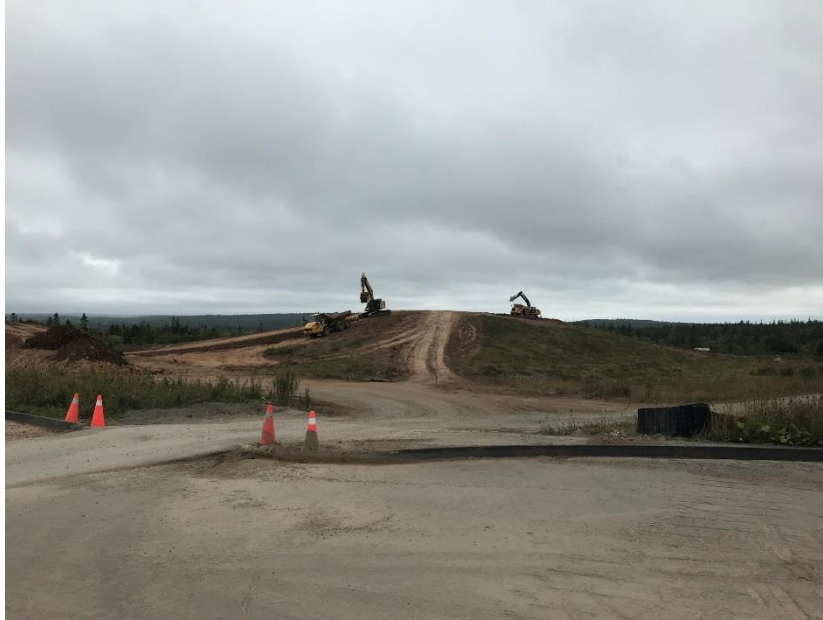
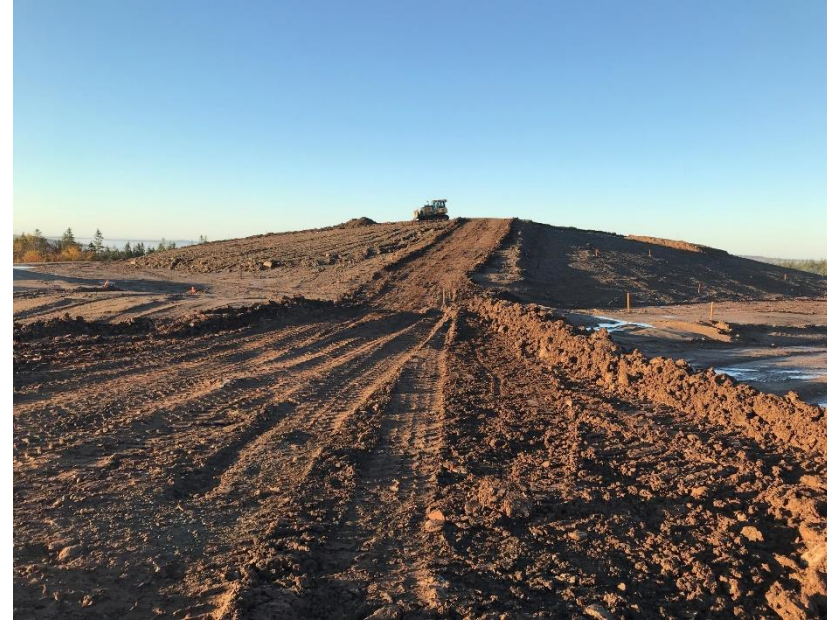
On-site waste disposal

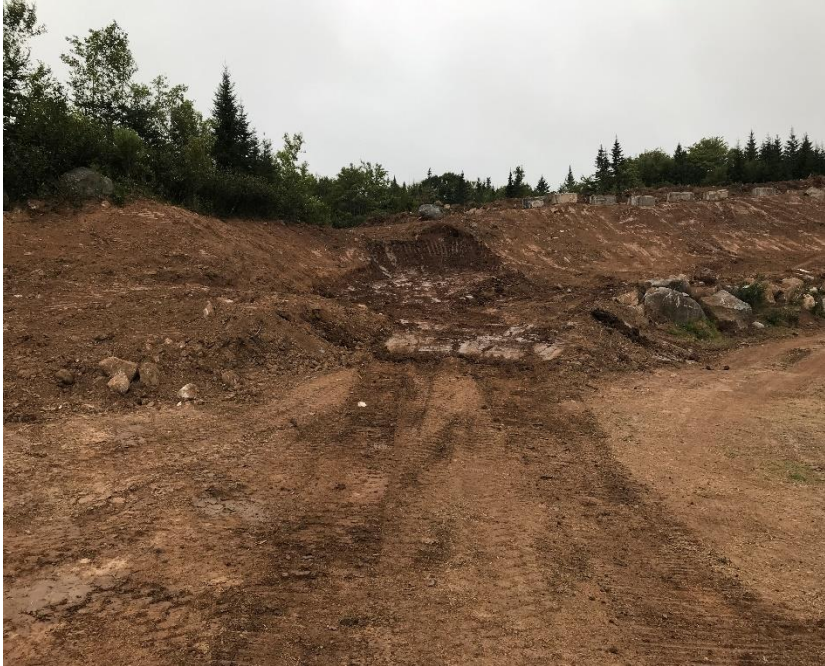
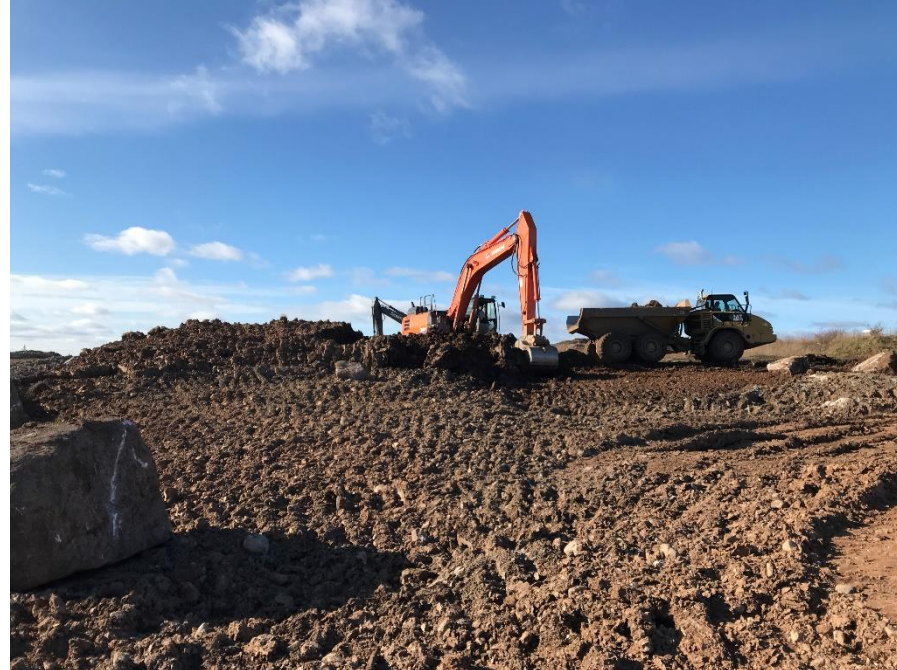
Confirmation samples were collected, areas were graded to as close to original ground as practical to allow restoration of site with acceptable drainage.

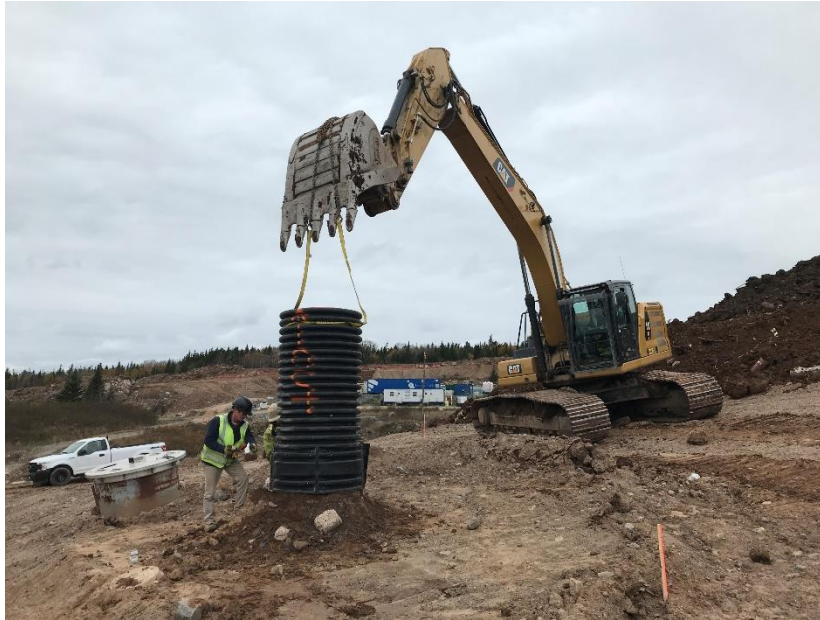
- Landfill sump extension

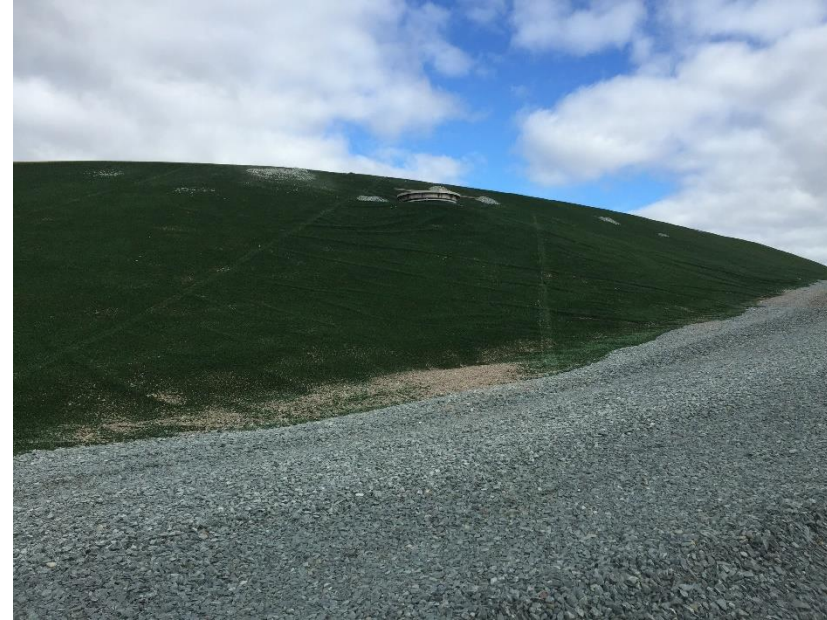
– Sump

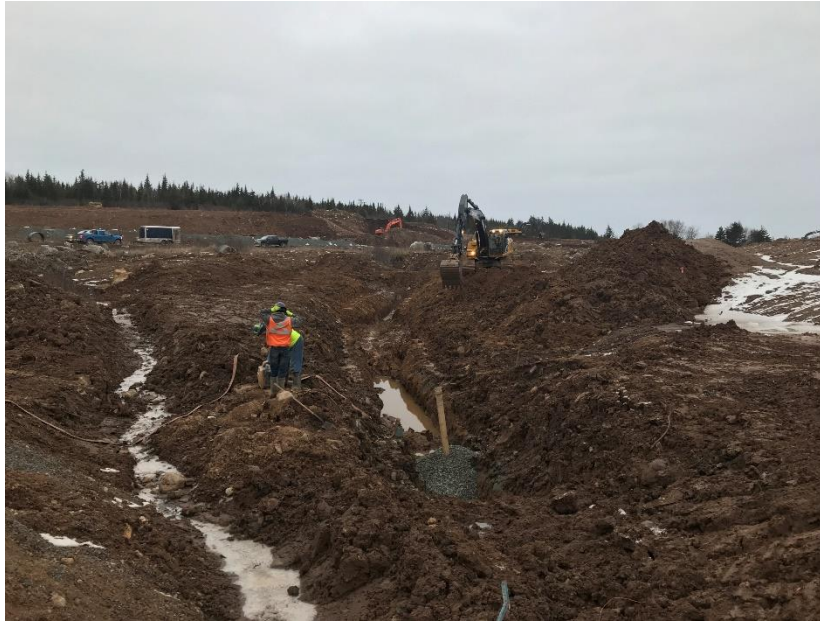
- Trench excavation for interceptor piping

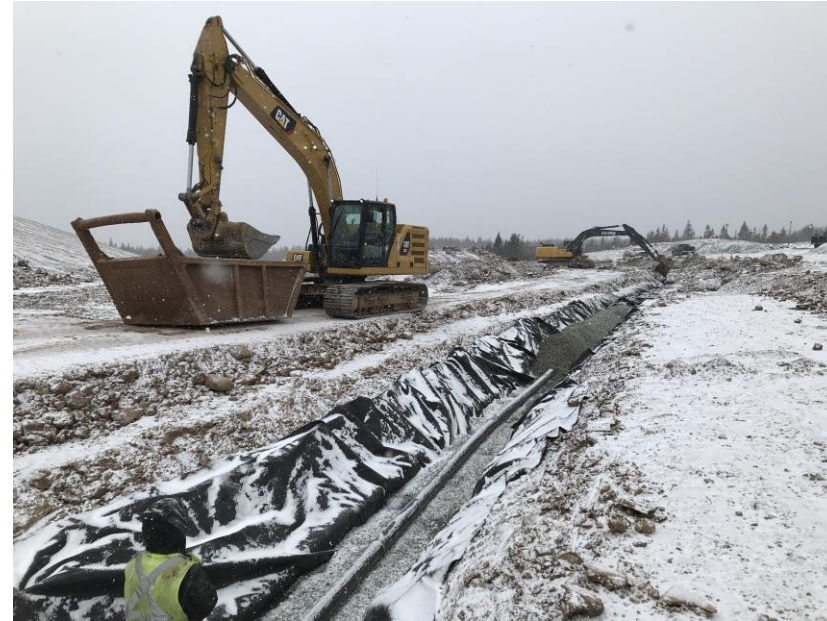
– Interceptor pipeline installation

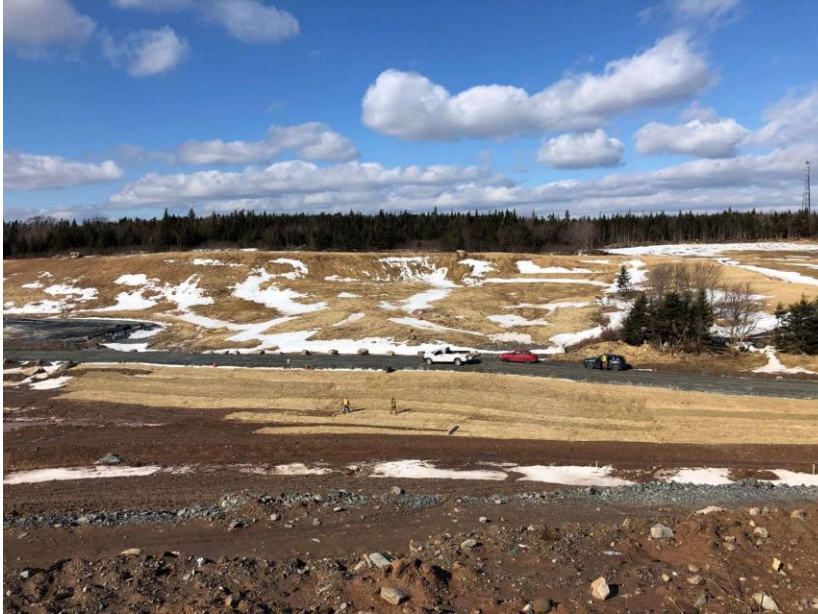
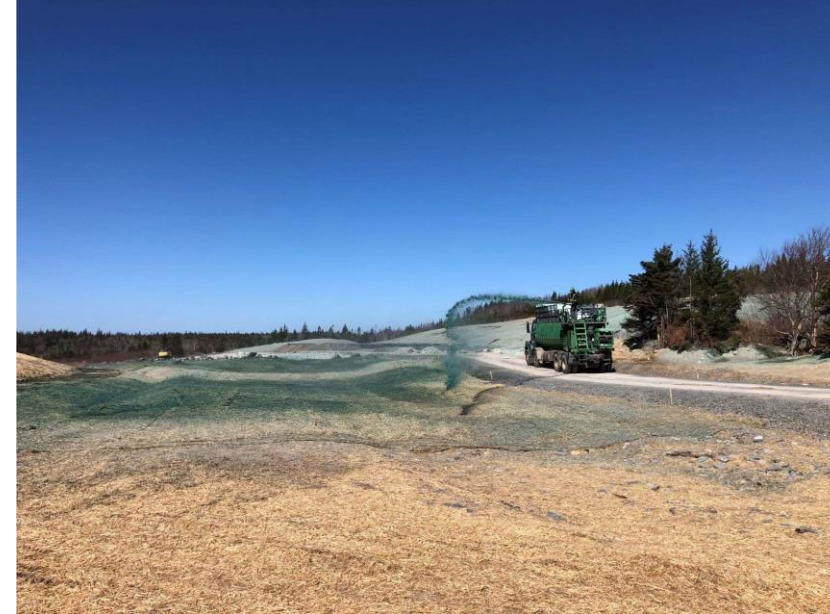
- Erosion control
  - Erosion Control, check dams, hay bales, hay mulch, hay blankets, coco mats and hydro seed were installed over the entire site for erosion sediment control of finished grades.
- Hydroseeding

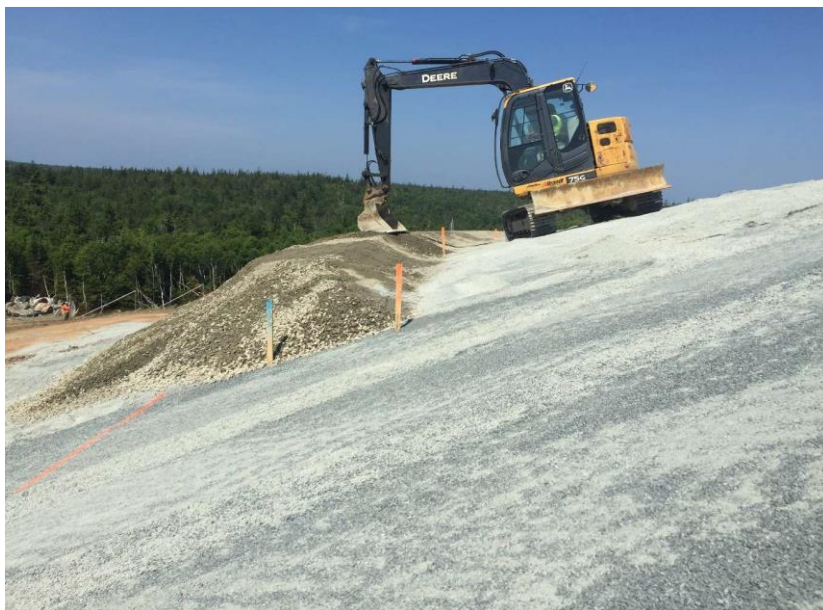
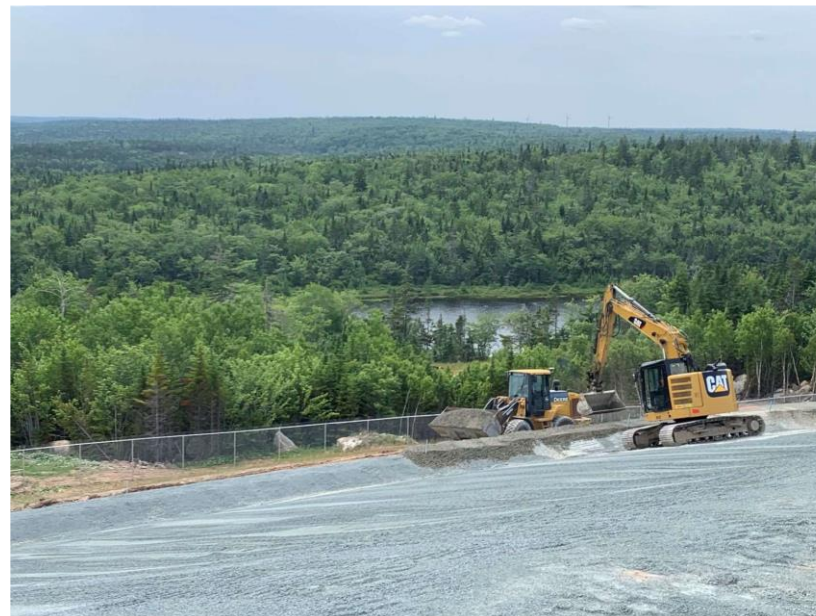
- Surface water diversion berm

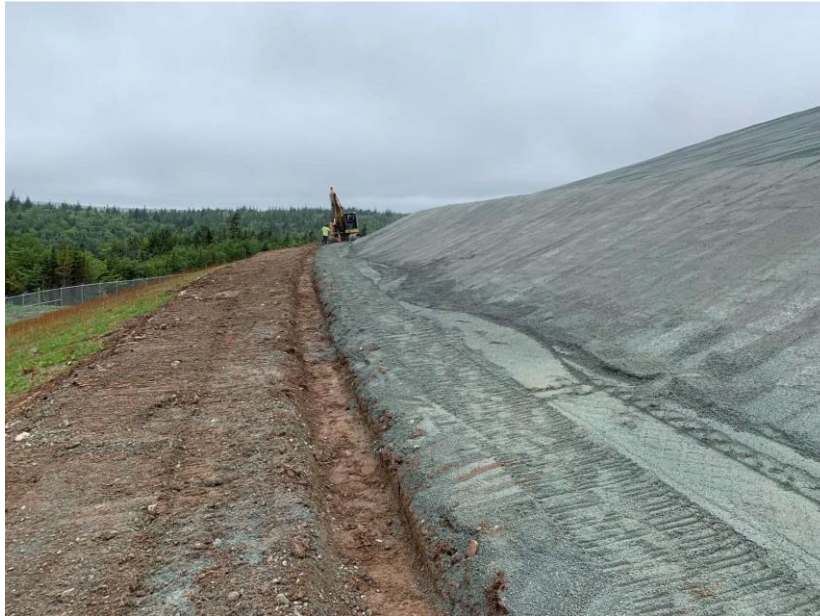
- Anchor trench for liner installation

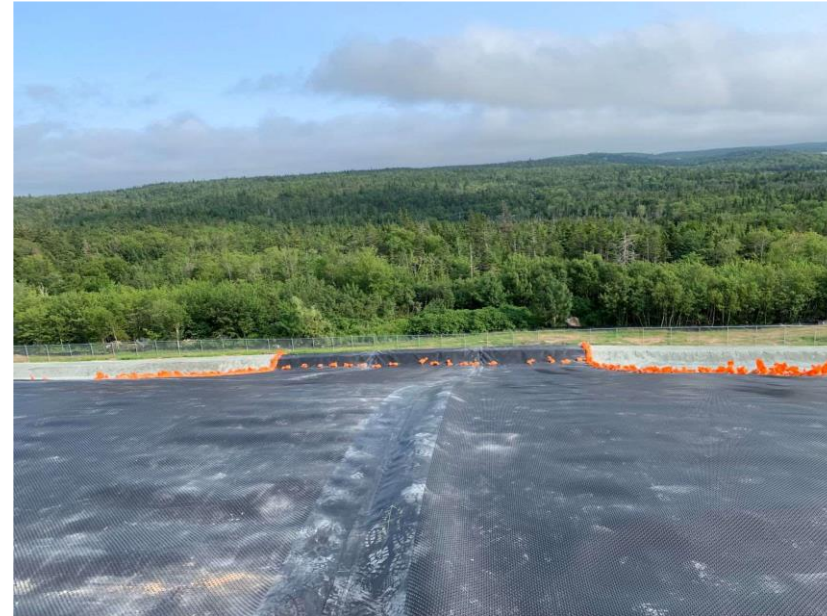
– Micro drain liner installation

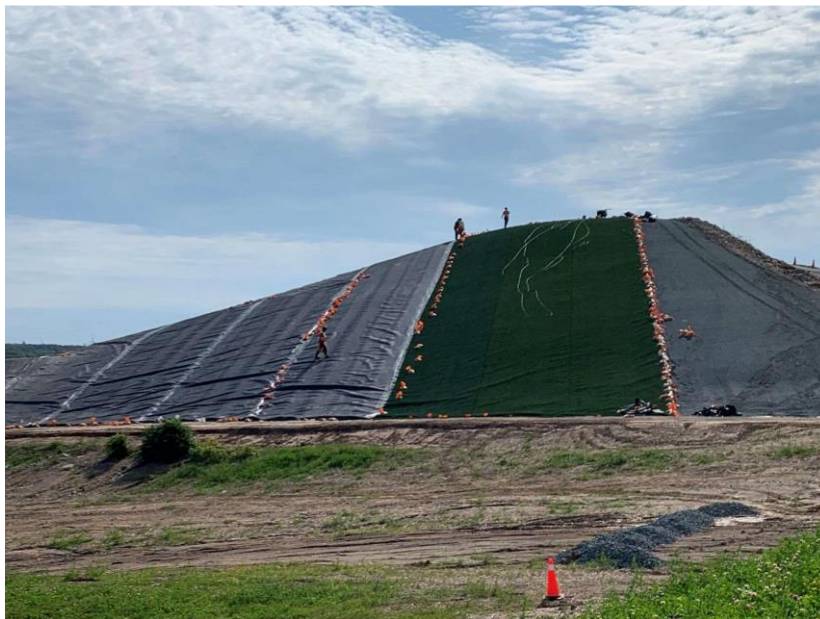
- Liner installation

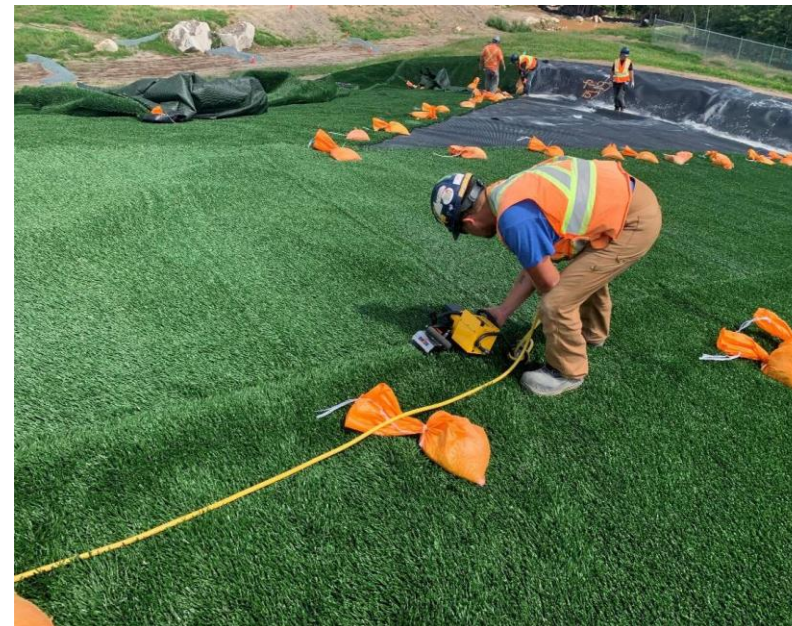
– Closure Turf installation

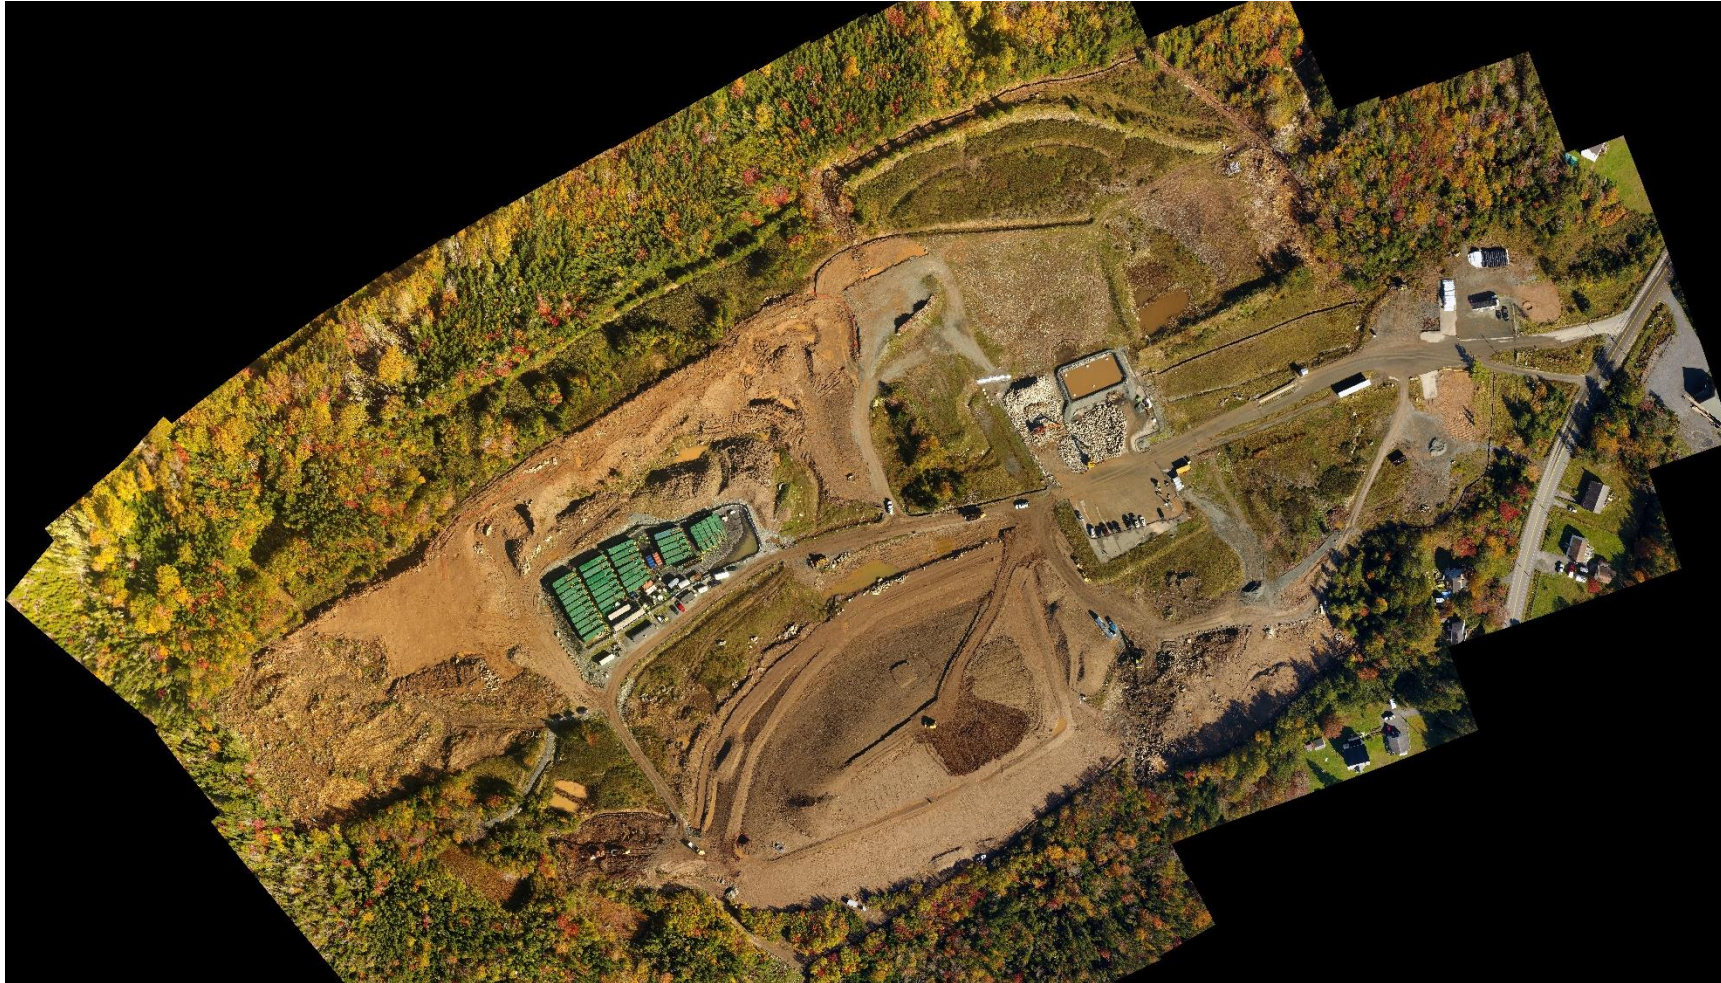
## October 2020- Cell Stripped and loading with new waste

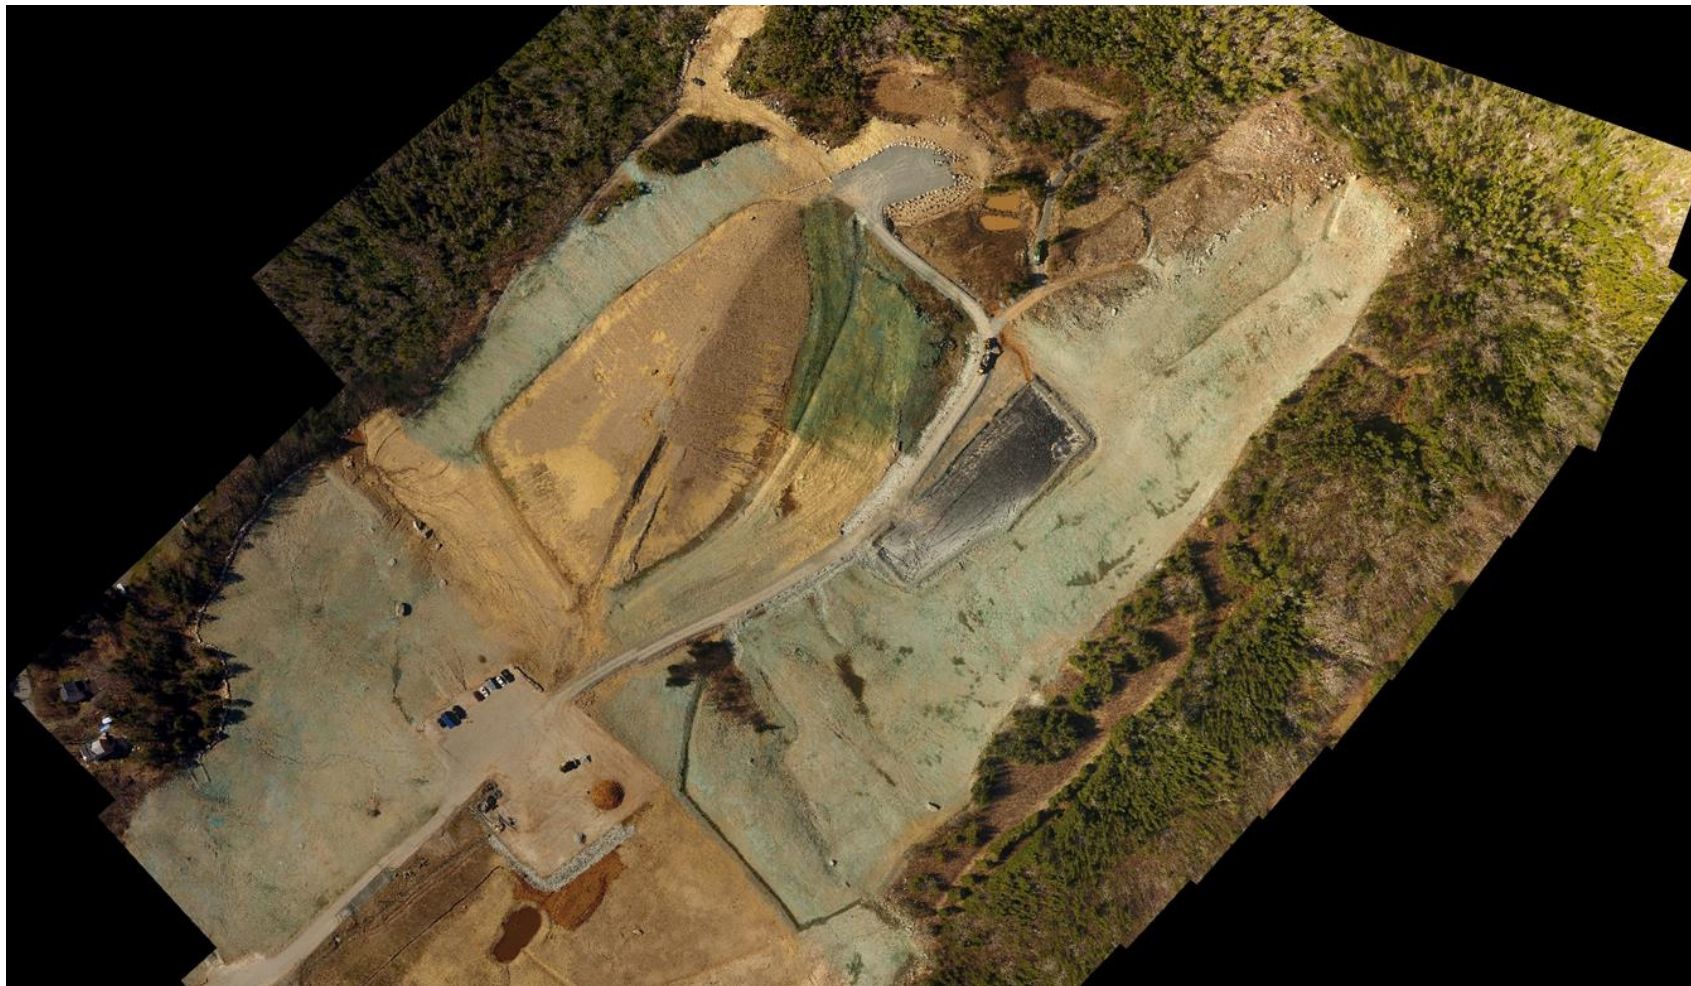
## April 2021- Waste complete Erosion control Hydroseed/Hay Mulch in place.

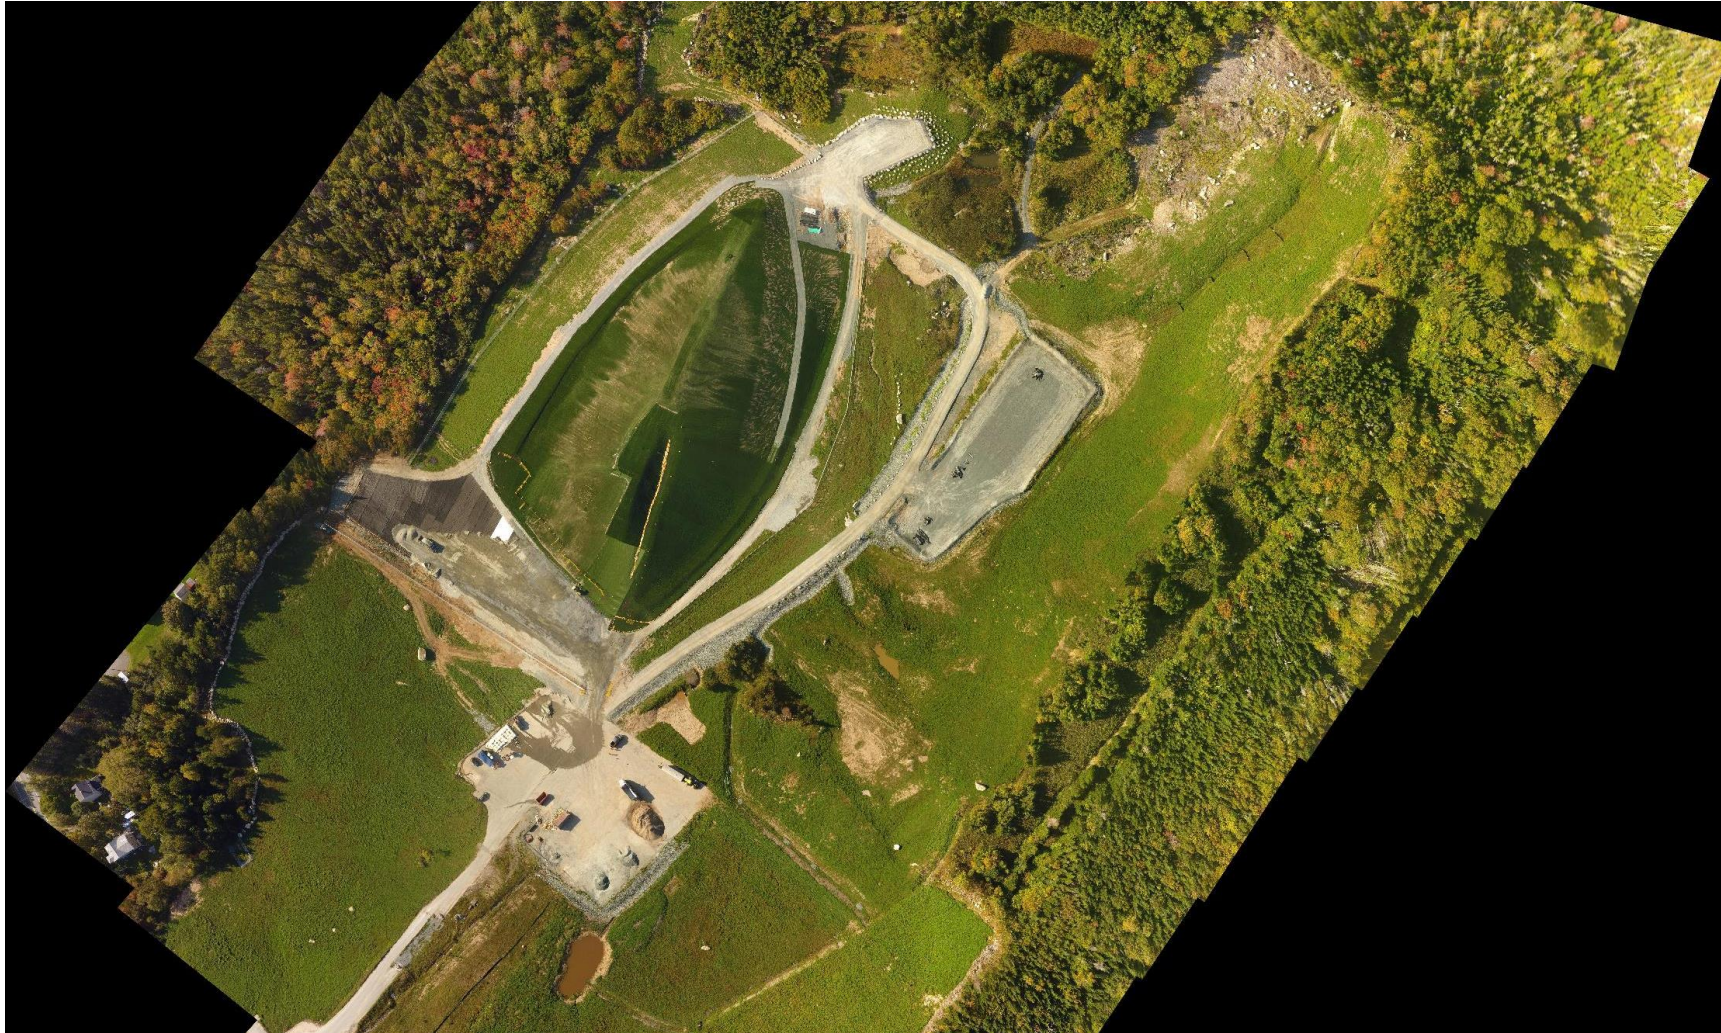
## October 2021- New cell cap in place and applying sand ballast. Vegetation cover established on site
