# A MULTIDISCIPLINARY APPROACH TO REMEDiate TETRACHLOROETHYLENE IMPACTS BENEATH A BUILDING

REMTECH EAST 2022

Prepared by: Kerry-Anne Pumphrey,  
M.Sc., EP, P.Geo., QP<sub>ESA</sub>

June 1, 2022

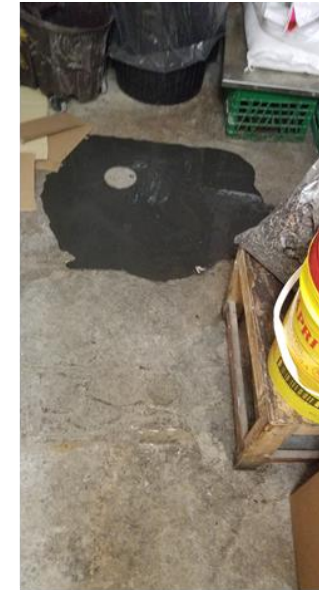
ZVI Daylighting

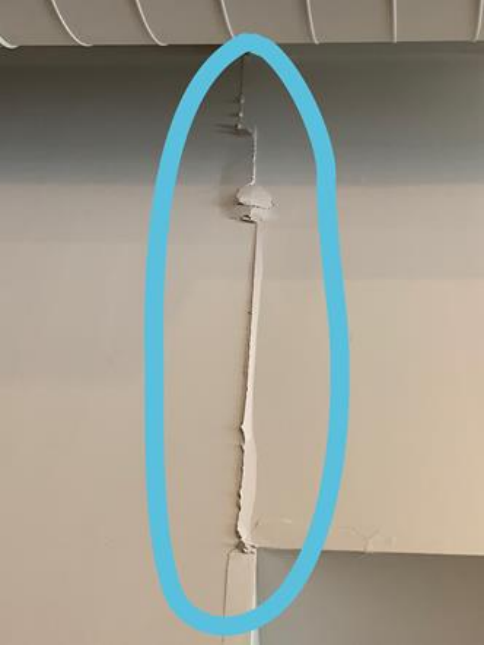
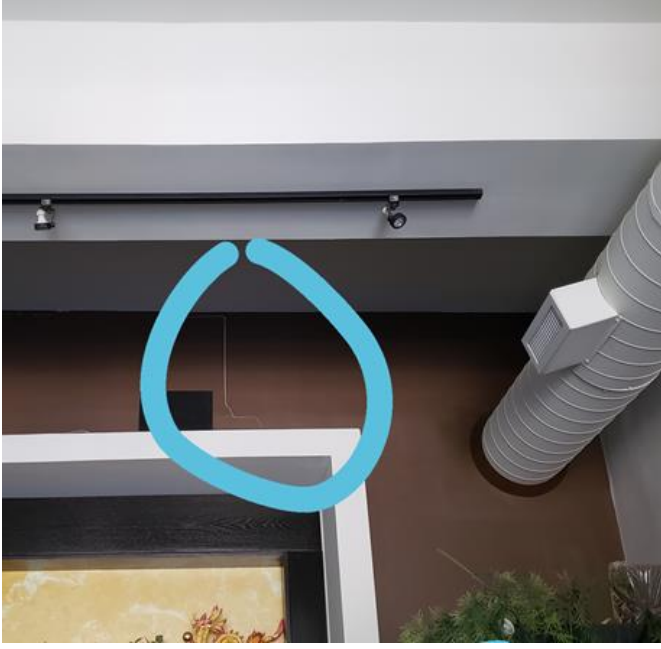
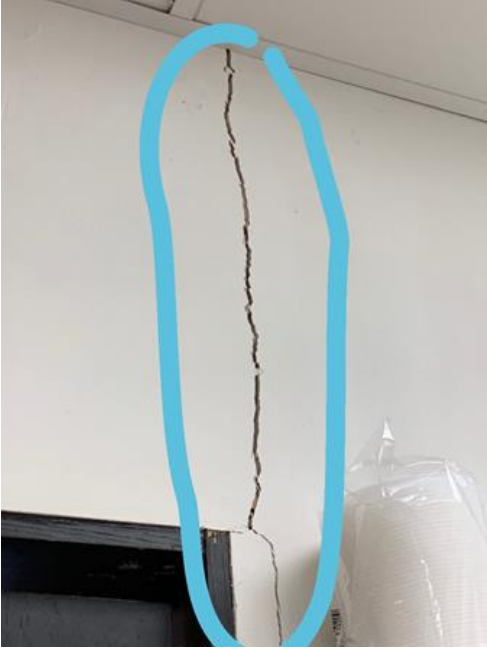
- Structural engineers assessed structural stability
  - Cracking was surficial (relief)
- Building plans were obtained from city archives
  - Foundations: Column and Strip Footings
  - Column above which dry wall cracking occurred was modified from its original design.

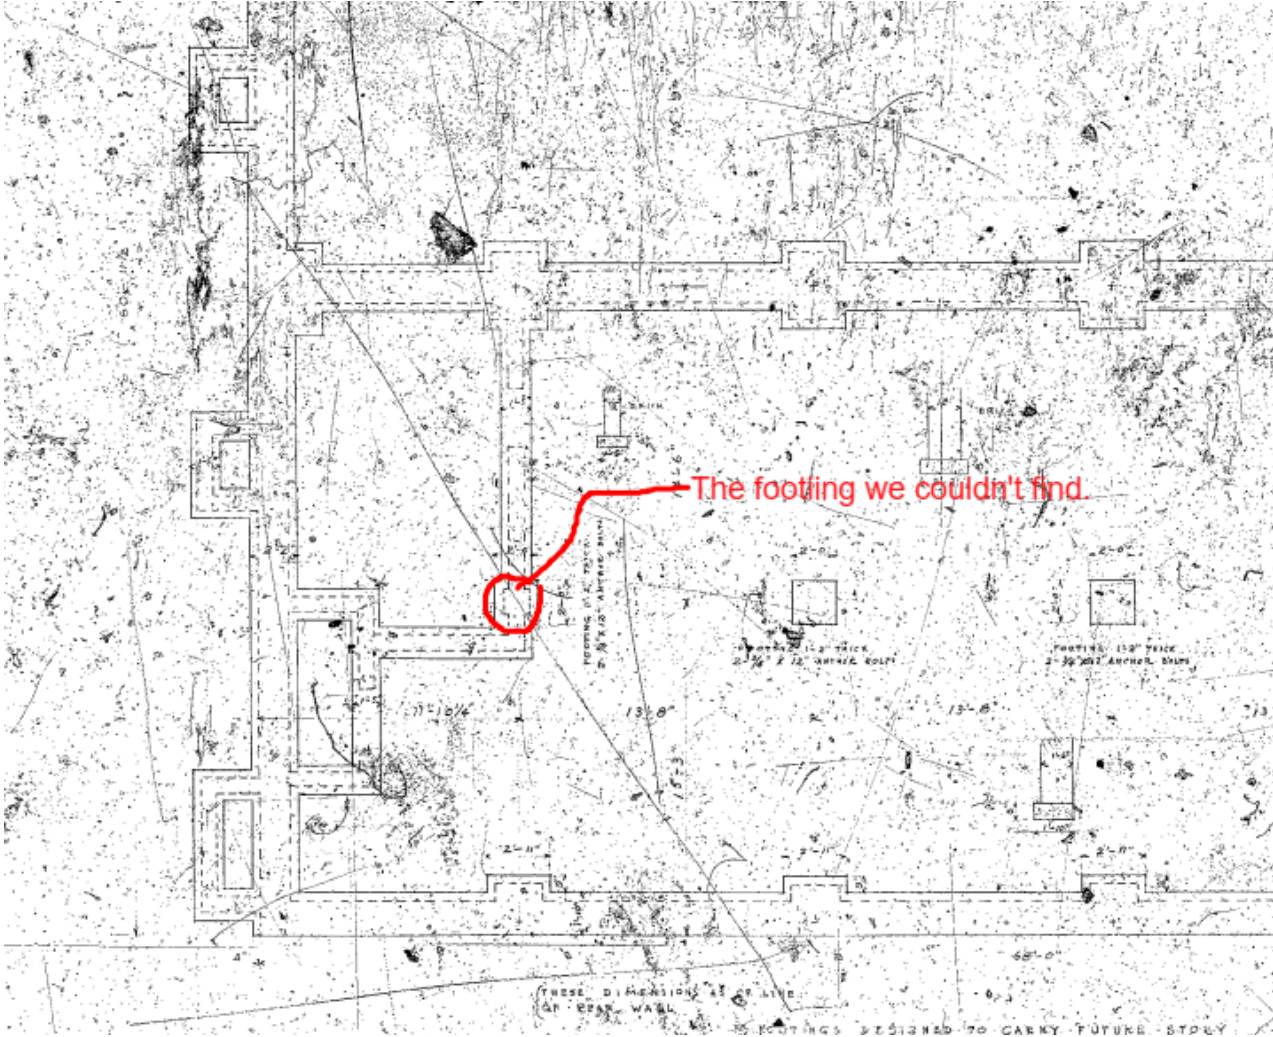
# The MIA Footing

- Depth to groundwater beneath the floor slab ranged: 0.3 to 0.6 m
- Poor drainage beneath the floor slab
- Soil compactness by SPT (no other equipment available would fit)
  - Loose soils ( $N < 10$ ) with some compact zones ( $N \leq 17$ ) between loose soils
- Soil has poor bearing capacity (factored ULS 70 to 115 kPa)
- Column and strip footings are 0.6 m wide
  - Footing beneath affected column is less than 0.2 m wide if present at all
- Shallow embedment of footings
