Remediation of the Gunnar Uranium Mine and Mill Site

Alexey Klyashtorin & Skye Muirhead
Saskatchewan Research Council

October 2022

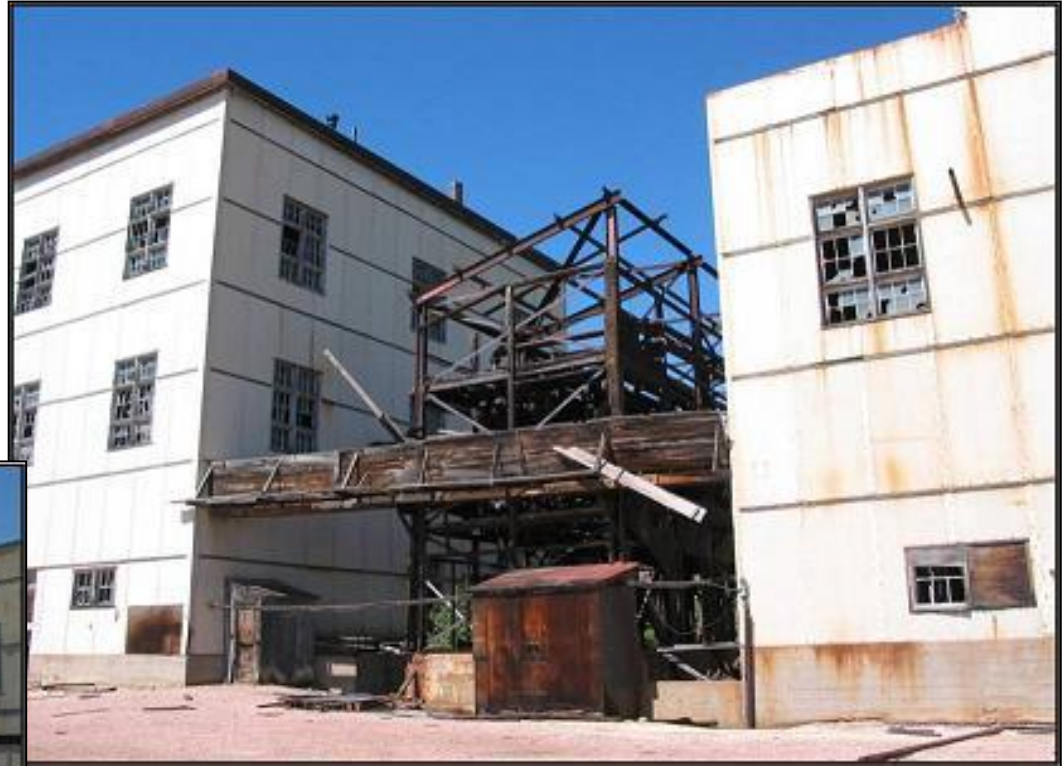
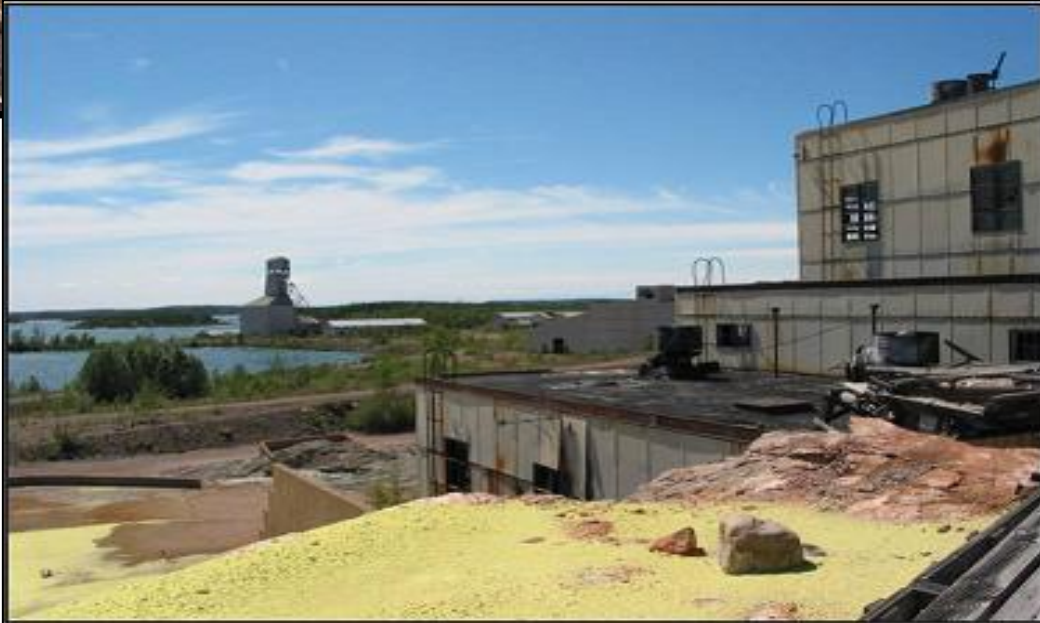
Mill buildings

Acid plant with residual
elemental sulfur

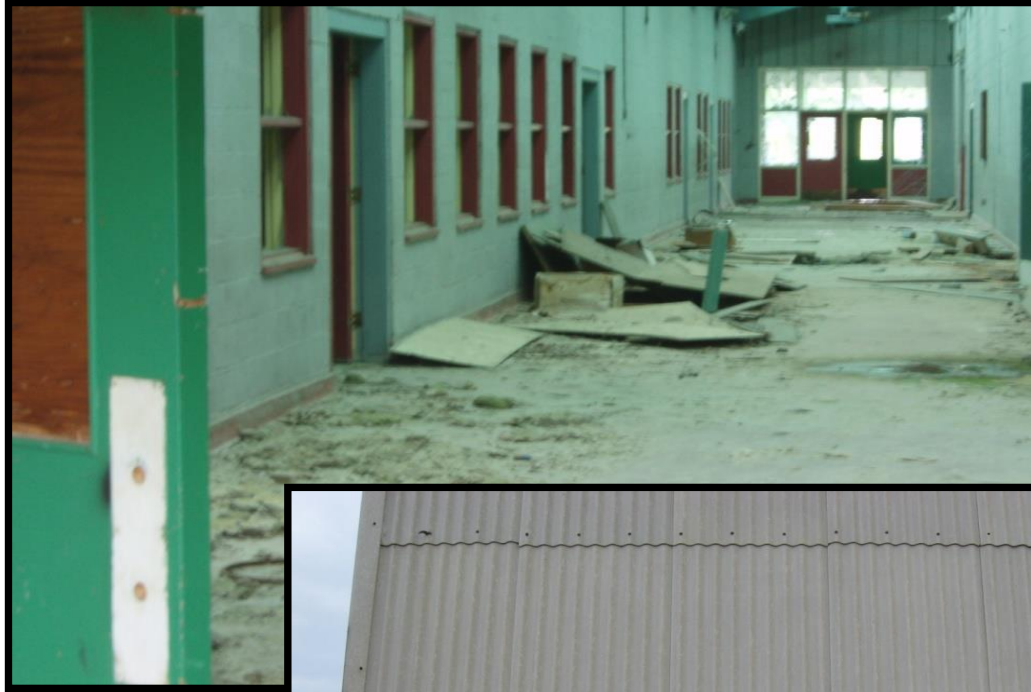
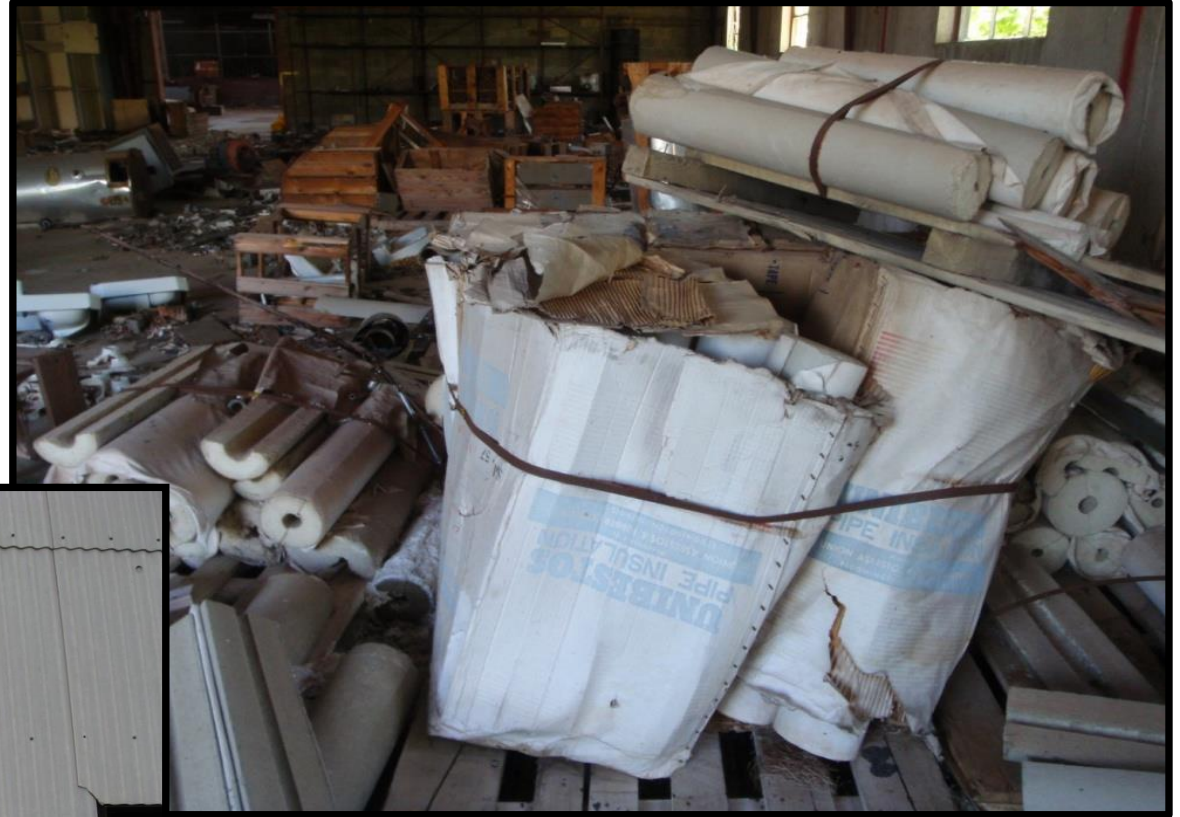
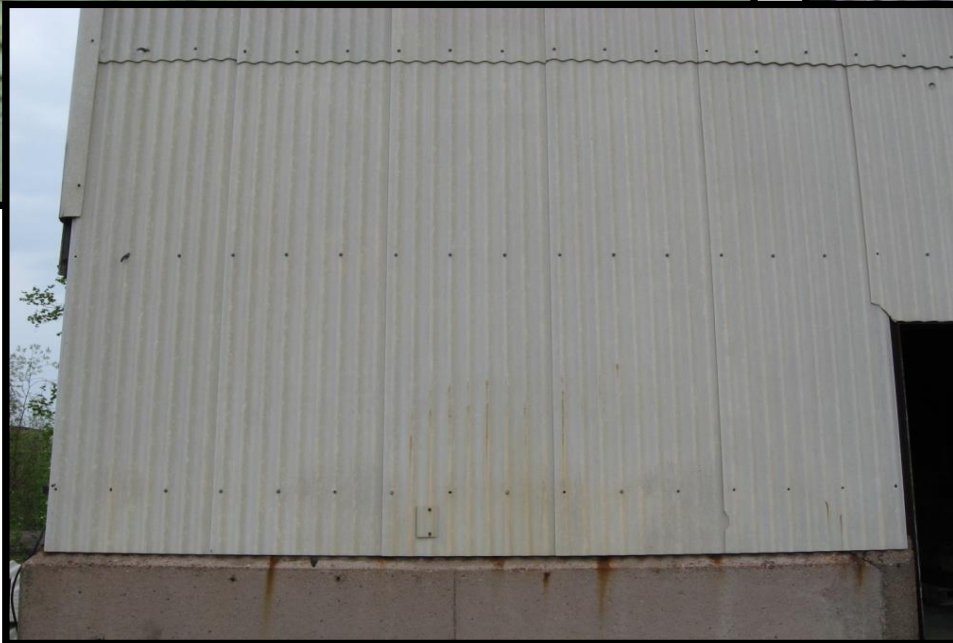
Asbestos wall and pipe insulation (friable)

Asbestos siding
(non-friable)

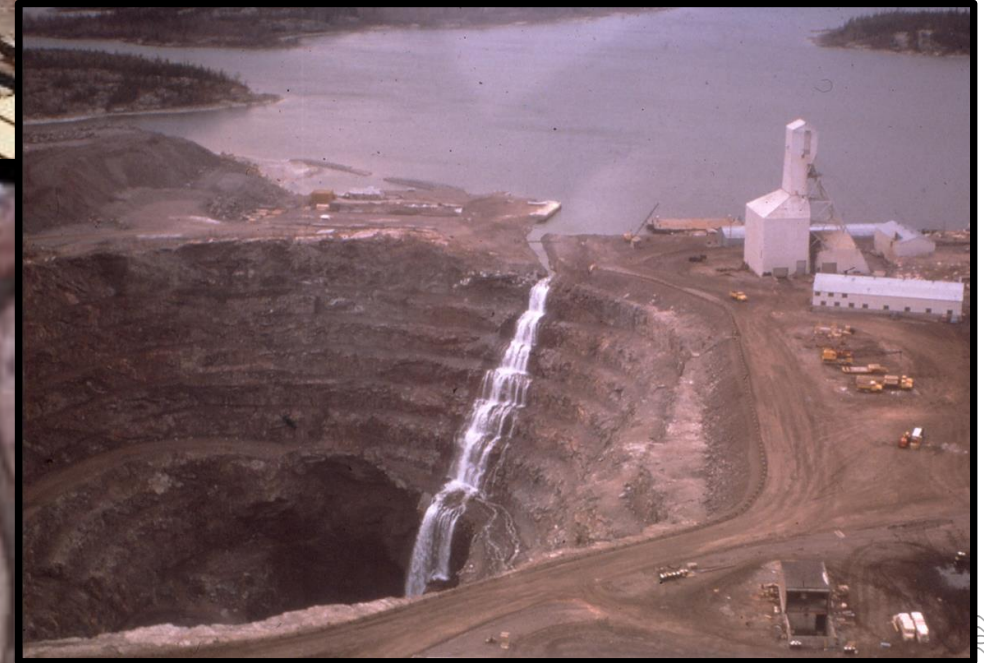
The pit & mineworking were flooded deliberately for safety reasons in 1964

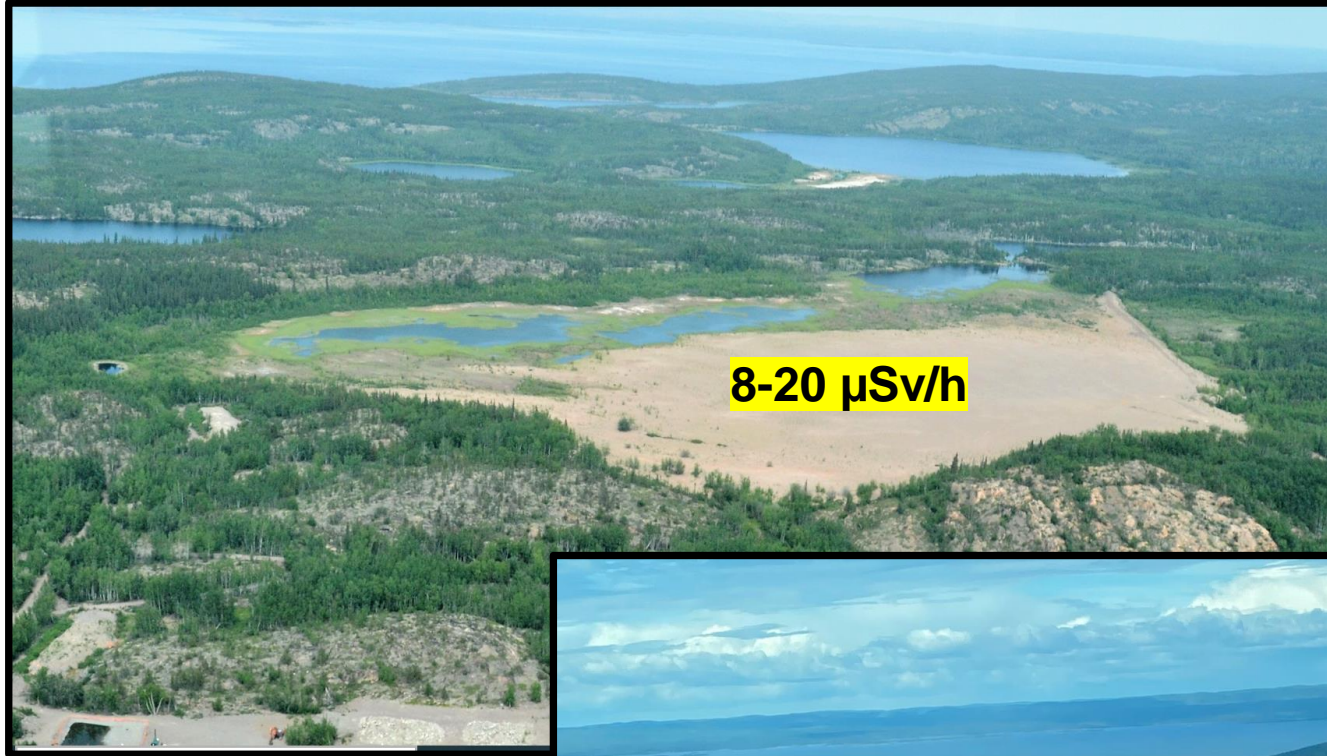
Tailings Cover Construction completed
