In-Situ and Ex-Situ Remediation of cVOC Impacts in Conjunction with Site Construction Activities:

*Challenges & Perspectives from
the Landowner, Consultant
and Remedial Contractor*

Remtech East 2023

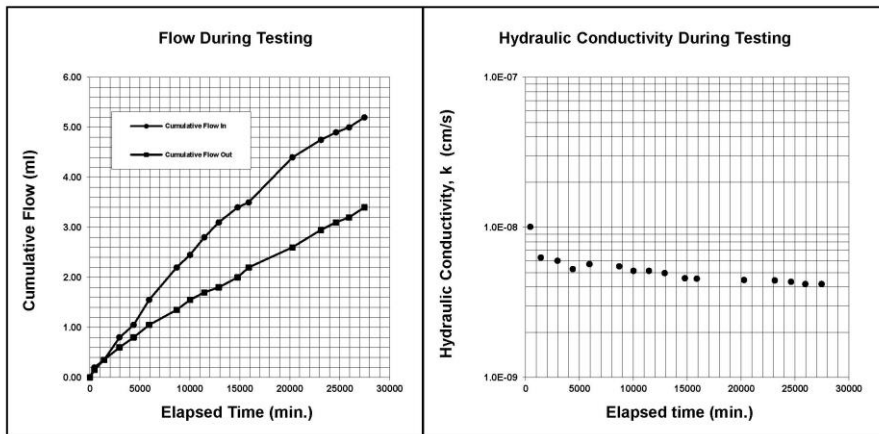
Hydraulic Conductivity (cm/s) = 4.3E-09

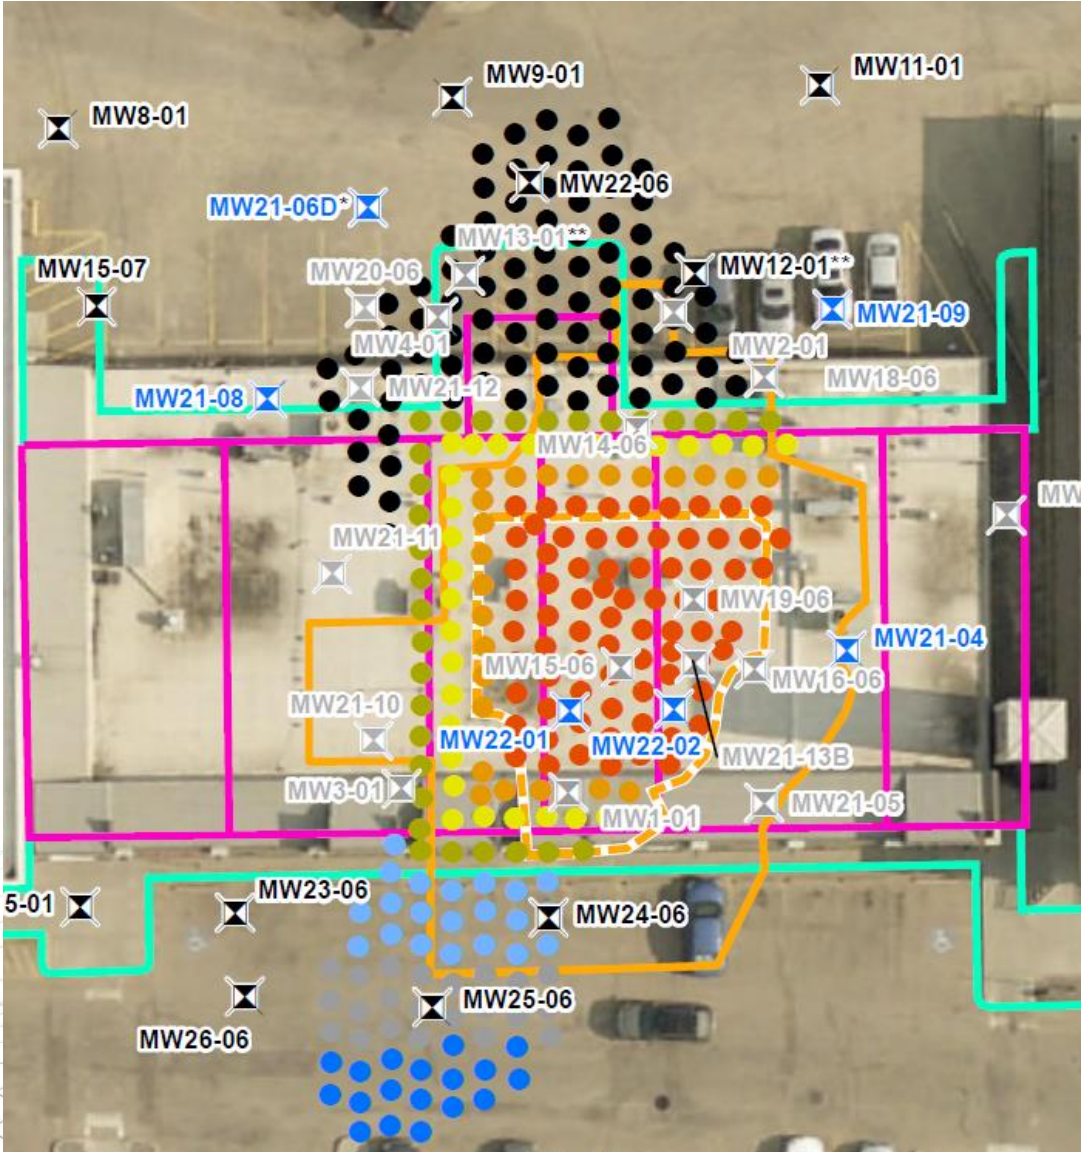
- Injection Location**
 - 2021 Monitoring Well
- Excavation Walls**
 - 2 - 9 mbg
 - 3 - 9 mbg
 - 4 - 9 mbg
- South Area**
 - 1.5 - 4.5 mbg
 - 1.5 - 6.5 mbg
 - 1.5 - 8.5 mbg
- Source Area**
 - 6 - 9 mbg
- North Area**
 - 1.5 - 9.0 mbg
- Environmental Borehole
- Existing Environmental Monitoring Well
- Former Environmental Borehole
- Former Monitoring Well
- Floor Plan
- Sidewalk
- Legal Line
- Excavation Extent
- Extent of Excavation Floor
- Site Boundary

- In-situ Chemical Reduction (ISCR)
 - Injection of EHC-L and KB-1
 - Microemulsion of a controlled-release, food-grade carbon, nutrients, and iron
 - Bioaugmentation species targeting all chlorinated compounds (Dhc)
 - Proposed 70,000 L in 300+ injections points
 - Source Area
 - Below the excavation walls
 - South Extent
 - North Extent

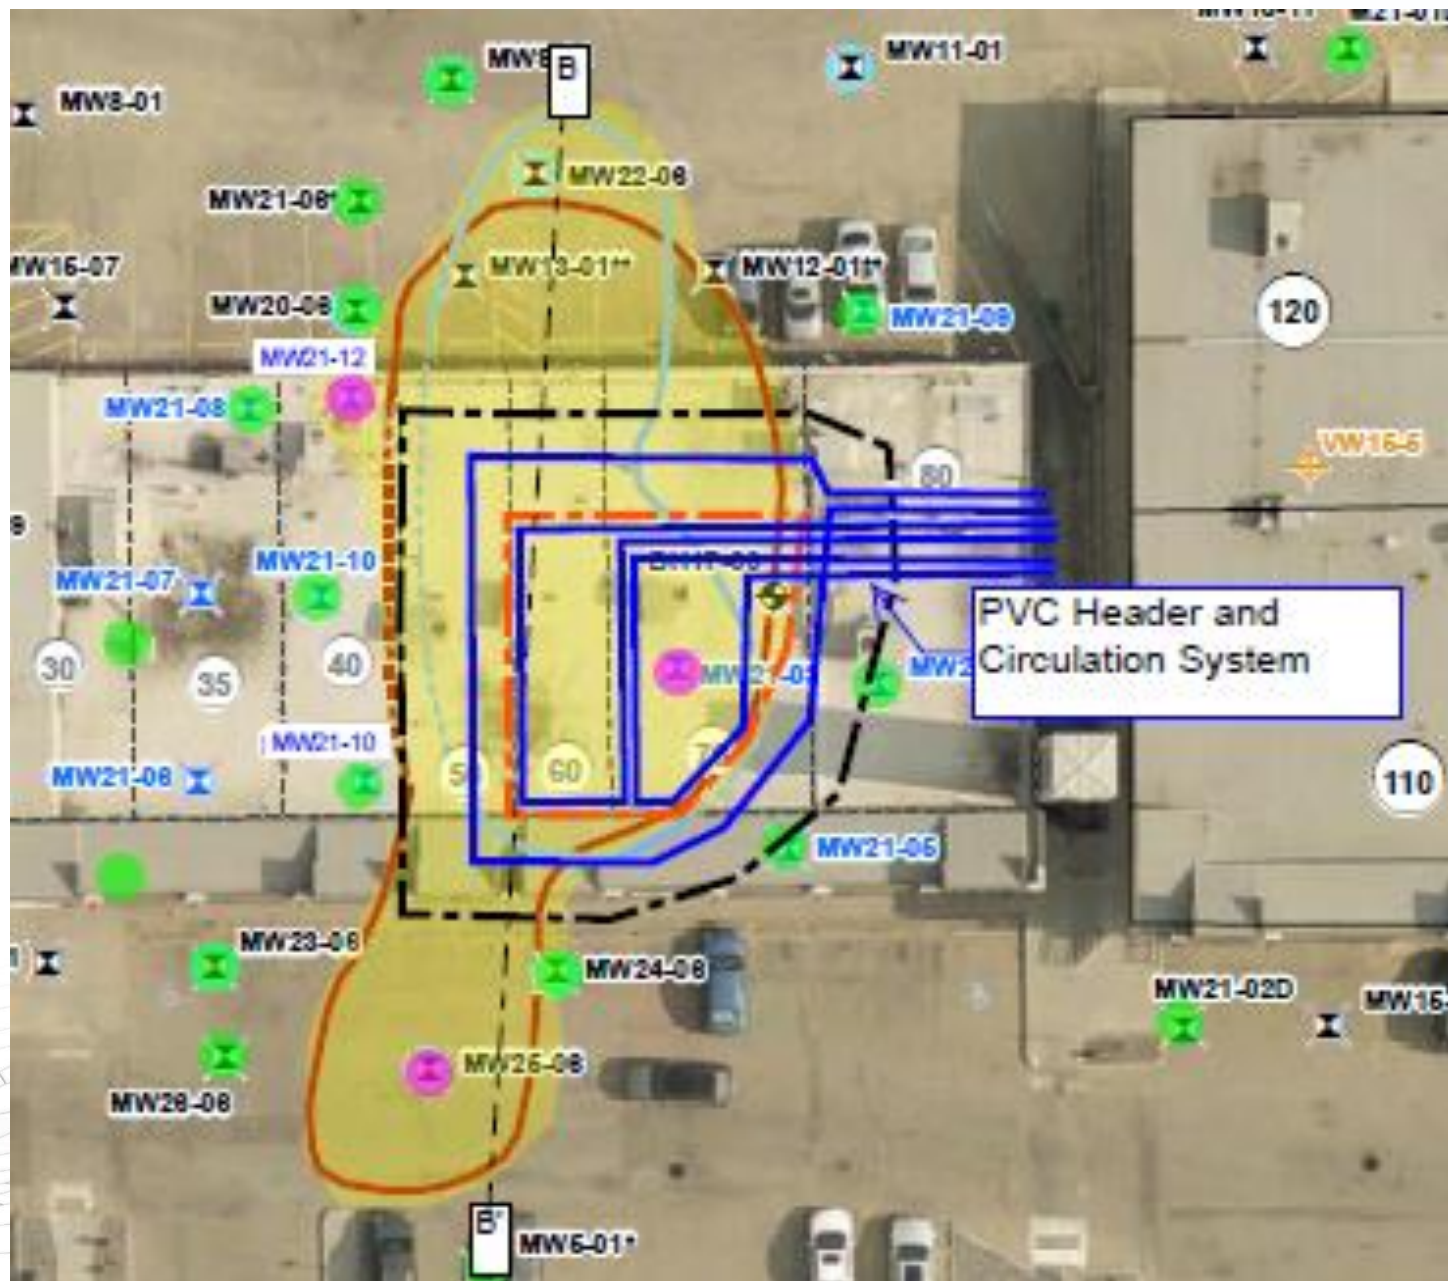
- Light blue – GW impacted area
- Brown – Soil impacted area
- Yellow – Soil and GW impacted area
- Black – Upper extent of excavation
- Red – Base of excavation
- Blue – Circulation system

- Ex-situ Remediation
 - Excavation of source area
 - Volumes determined
 - 225 m³ over burden (to be stockpiled onsite)
 - 1,400 m³ impacted soils
 - Hot loading
 - Amendment at base of excavation
 - Daramend - controlled-release fermentable organic carbon substrate combined with macro size zero valent iron (ZVI).
 - Re-circulation System
 - Install at base of excavation and 3 mbg
 - Tie in to east side of property for future access
 - Liner Placement
 - Backfill excavation
