REMEDIATION OF A PETROLEUM SPILL USING PURE OXYGEN

COLTER BAY VILLAGE MARINA TETON NATIONAL PARK, WY

John Archibald, inVentures Technologies, Inc J.S. Roemmel, SECOR International

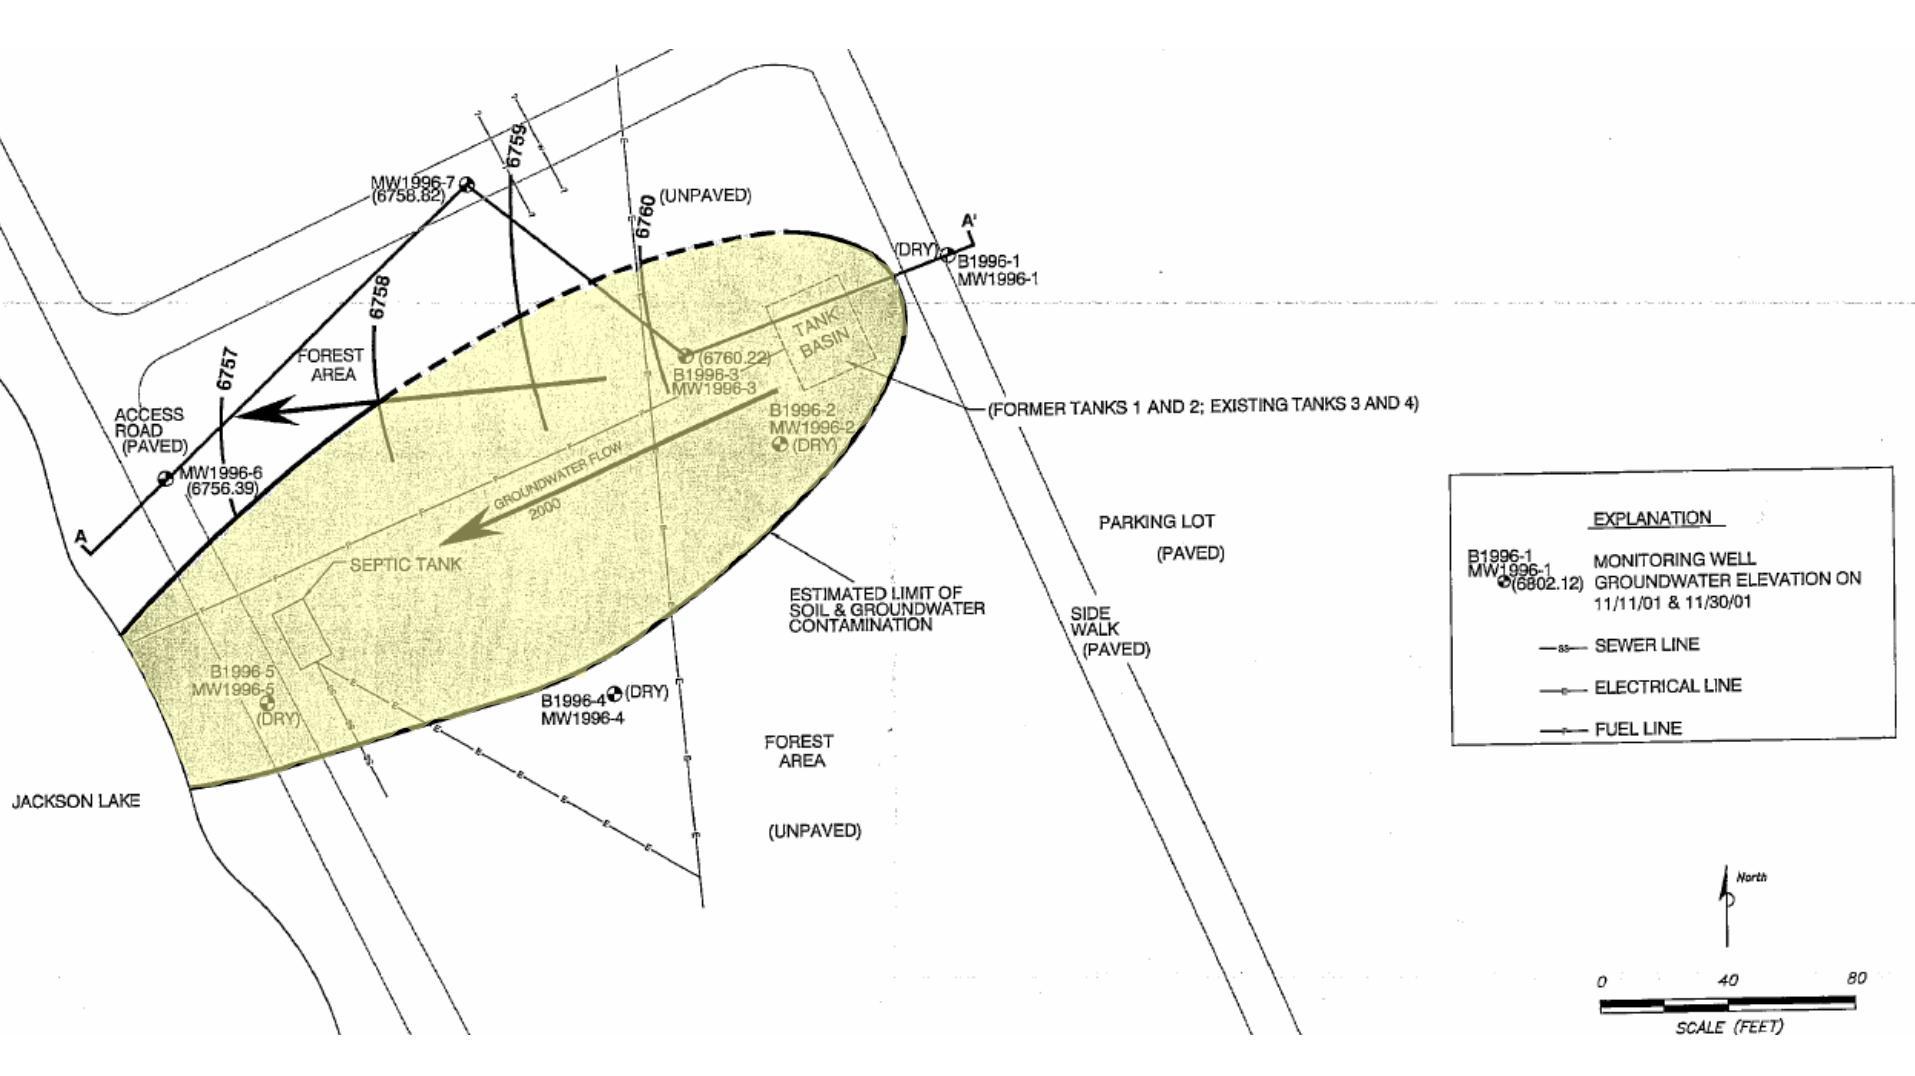
EXTENT OF CONTAMINATION - 2000

- Depth to water table fluctuates from 11 ft 30 ft below ground surface
- Hydraulic conductivity 2.3 x 10⁻⁵ ft/sec
- Generalized flow across site west to southwest toward Jackson Lake
- In 2000, petroleum contamination plume extended 250 ft downgradient of UST basin, with maximum width of 110 ft.

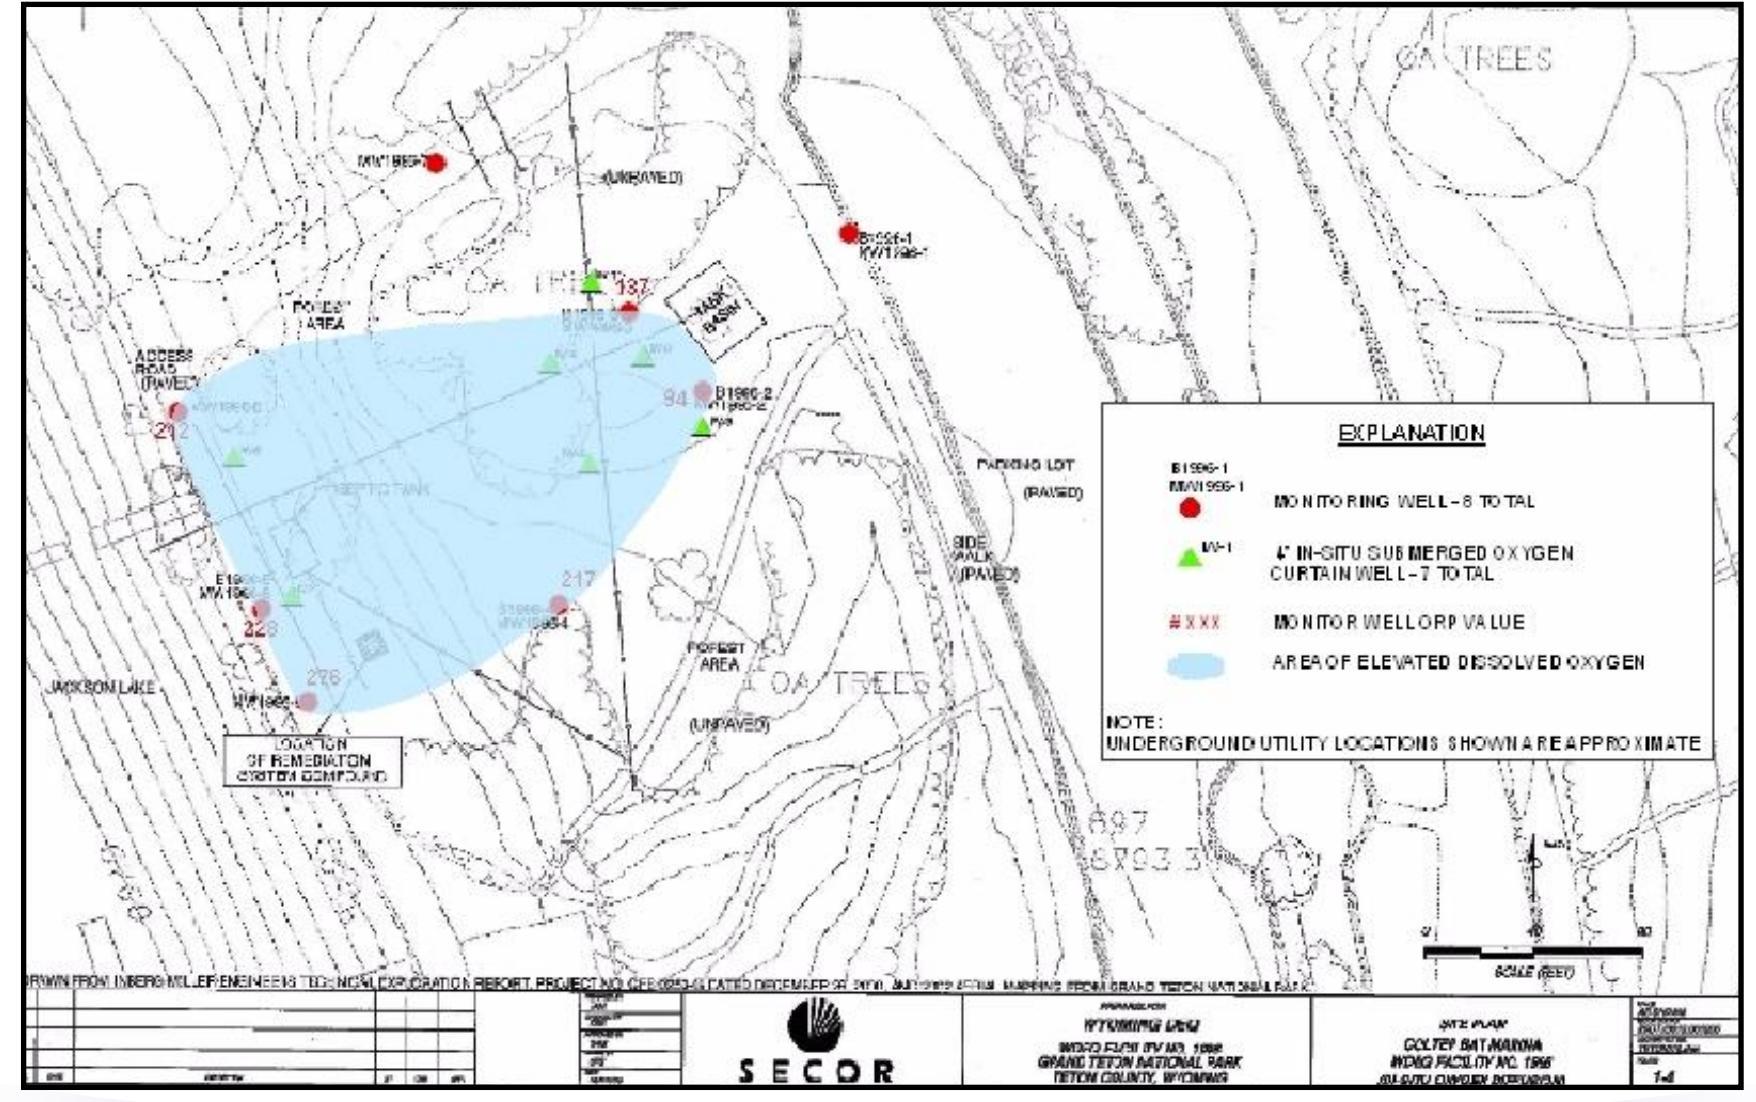
May 2, 2005: Oxidation-Reduction Potential in Monitor Wells

1	1	I.	1	
	MONITOR WELL NUMBER	OXIDATION- REDUCTION POTENTIAL (ORP)	DISSOLVED OXYGEN (DO) ppm	
	2	+ 94	0	
	3	+ 137	0	
	4	+ 217	2.77	
	_		-	
	5	+ 228	0	
			• •	
	6	+ 212	2.9	
	0	. 070	0.05	
	8	+276	3.25	
JUNE 21, 2005	iSOC Injectio	n Well Random DO	D Measurements (p	opm)
	,			
	INJECTION WELL NUMBER	DISSOLVED OXYGEN (DO) ppm	LOCATION	
	IW-3	54 ppm	Near Tanks	
	IW-7	16.1 ppm	Near Lake
