## Remedial Excavation of Metals-Contaminated Sediment and Creek Restoration

Melissa Hamilton, P.Eng.

RemTech 2011 Friday, October 21, 2011

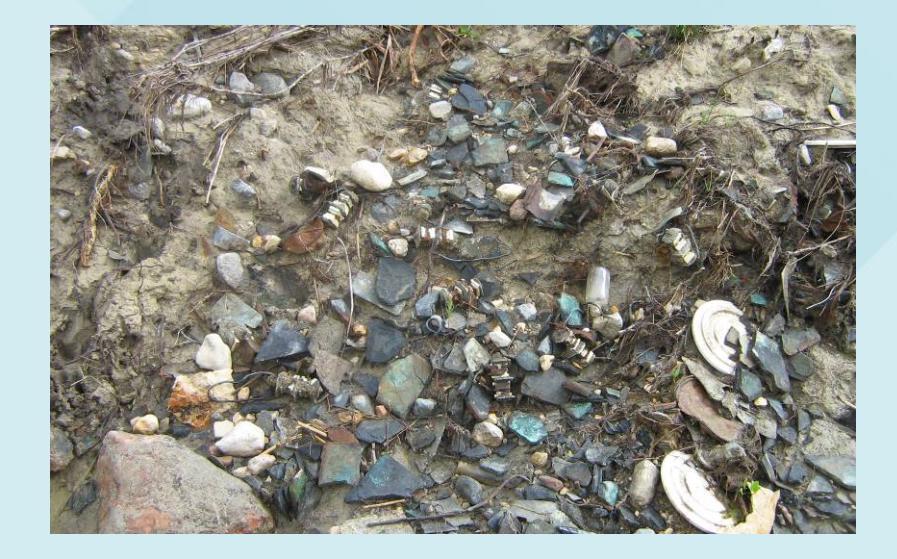
• Additional batteries on south bank of the creek (unearthed and deposited during flooding)

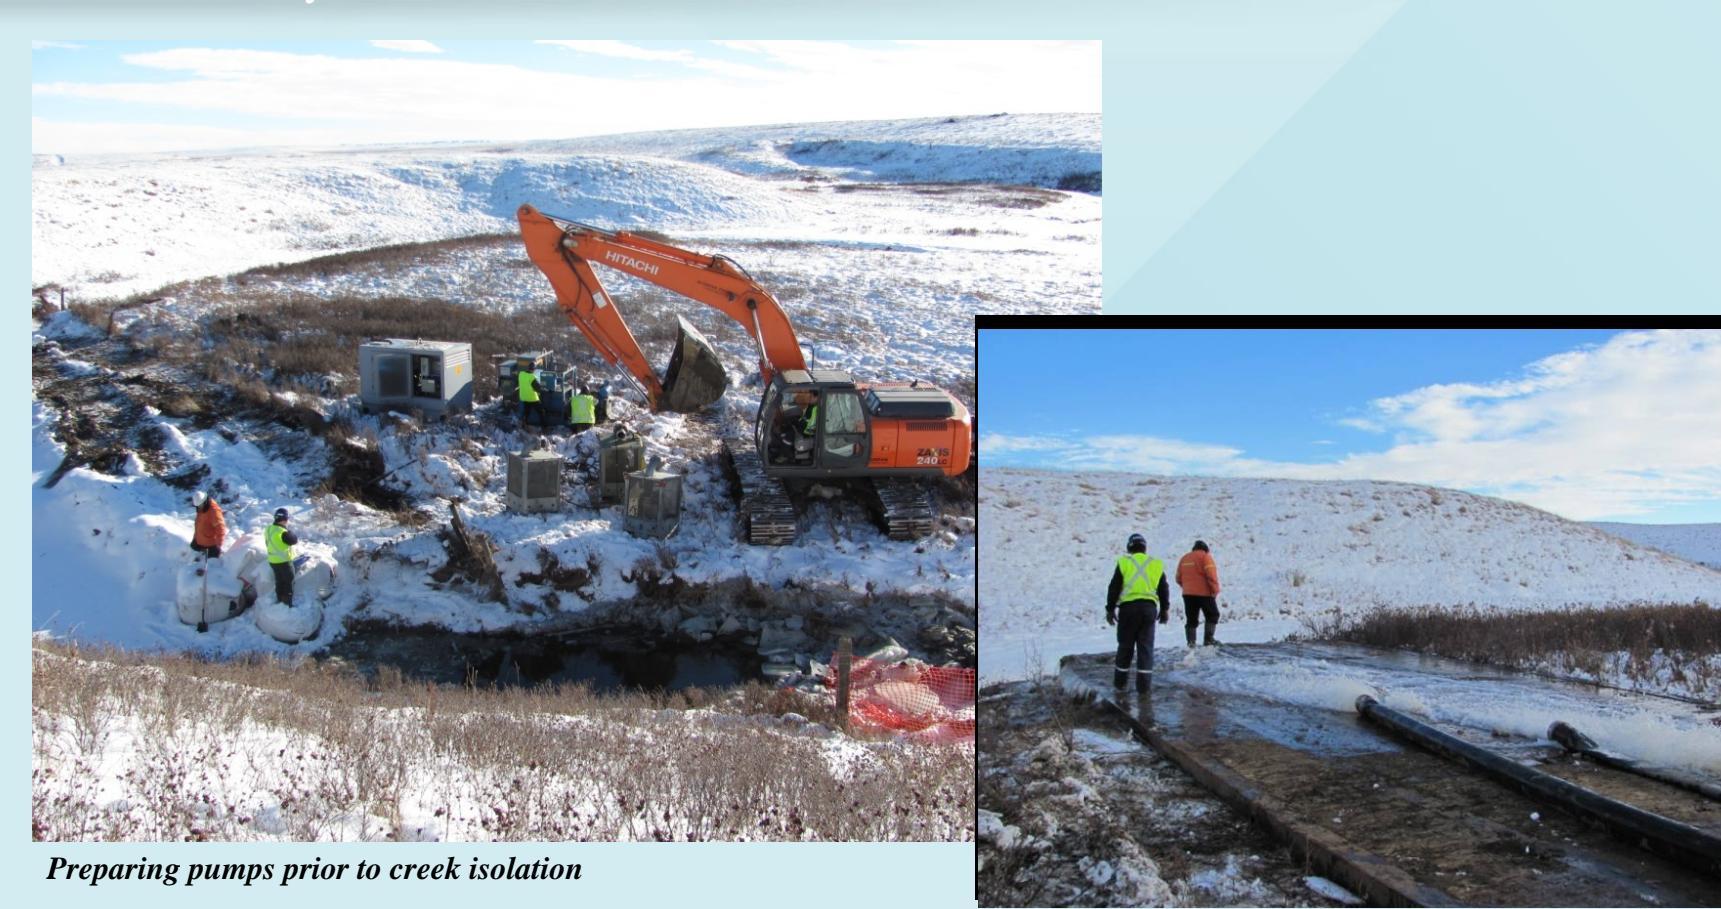
Installing rig mats for pump outlet

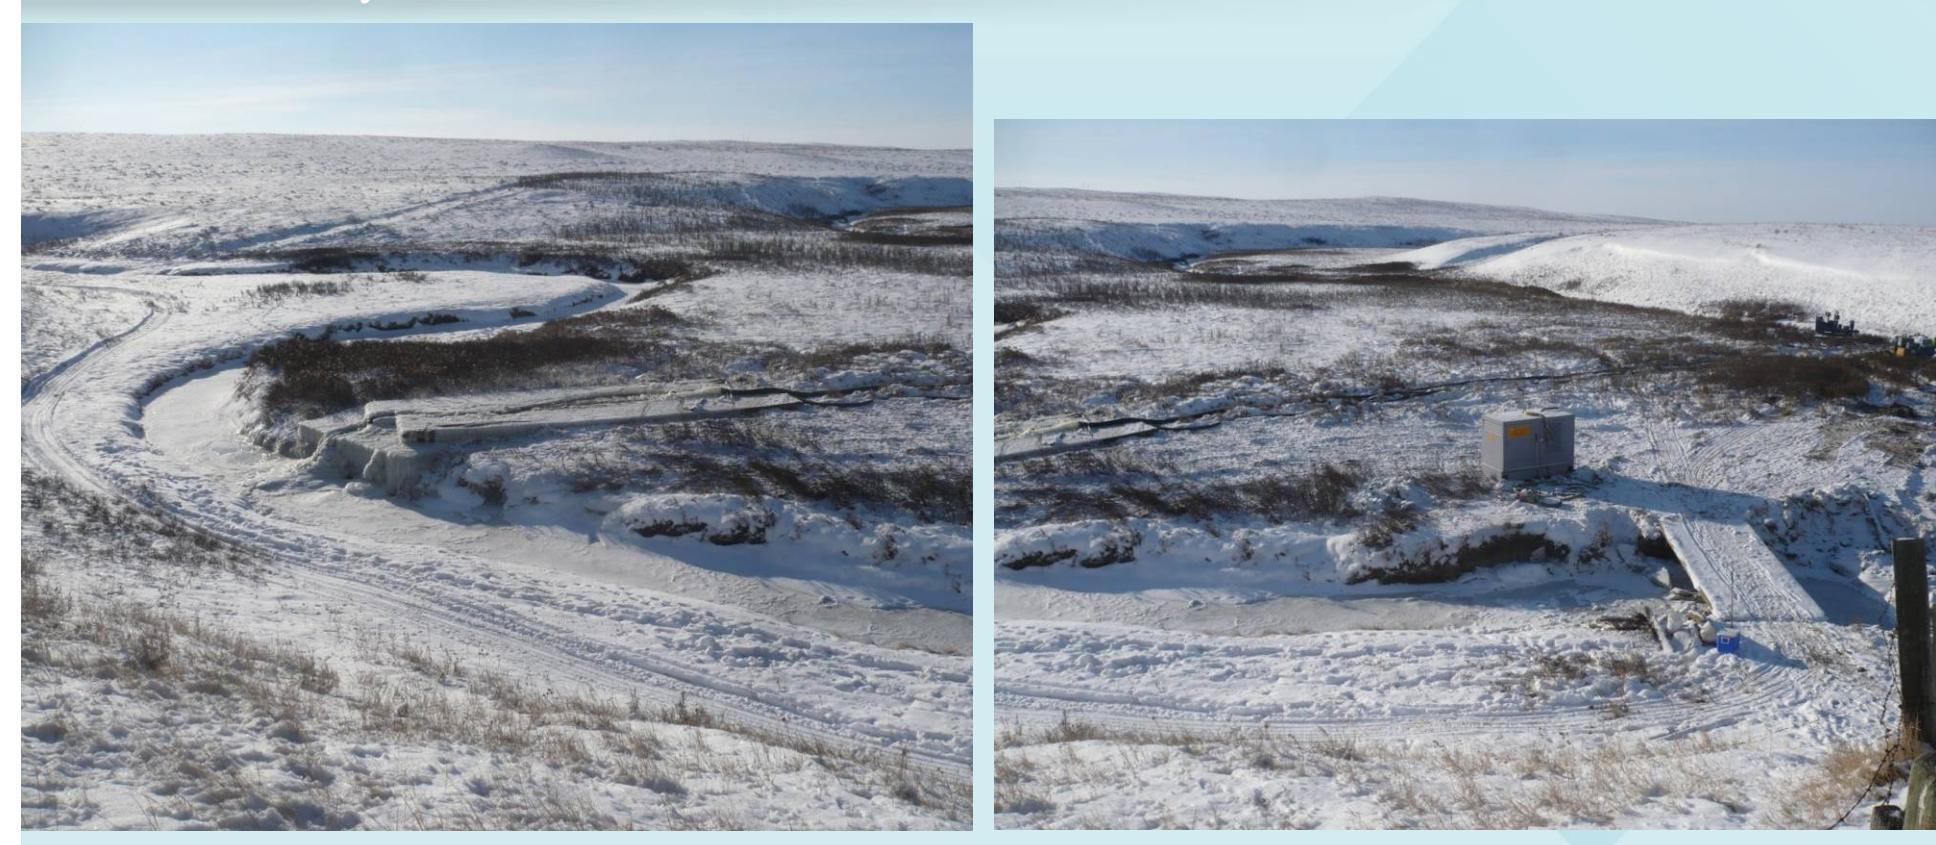
Ice forming at pump outlet

Temporary crossing for fuelling pumps

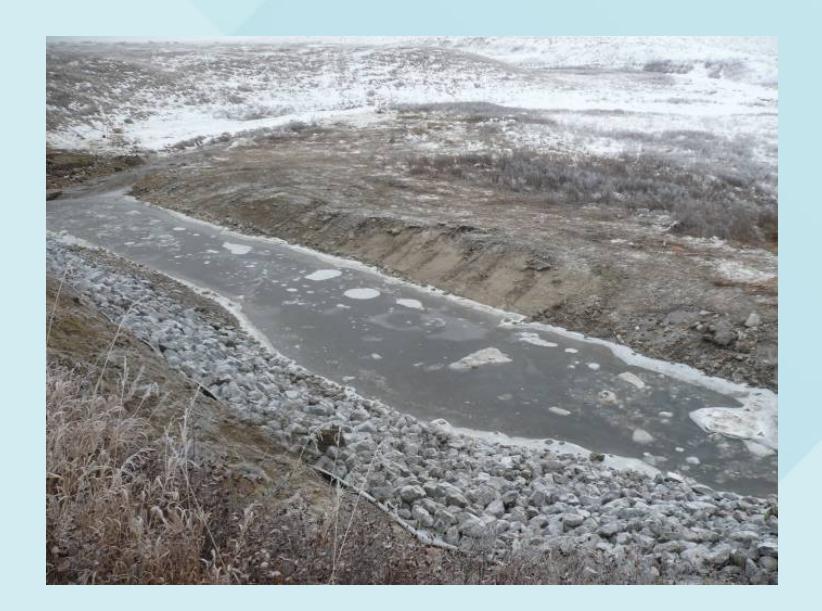
- Excavation of battery debris and contaminated soil and sediment on-site
- Creek bed and banks restored with approximately 1' of rock and 6" of small gravel to eliminate risk to aquatic life and prevent further erosion
