Remediation of an Abandoned Gold Mine in the Northwest Territories Colomac Mine

Caitlin Moore, P.Eng Environmental Monitor / Resident Engineer, Colomac Project 2010 – 2012

Greg Wright, M.Sc Project Manager, Colomac Project 2011 - 2013

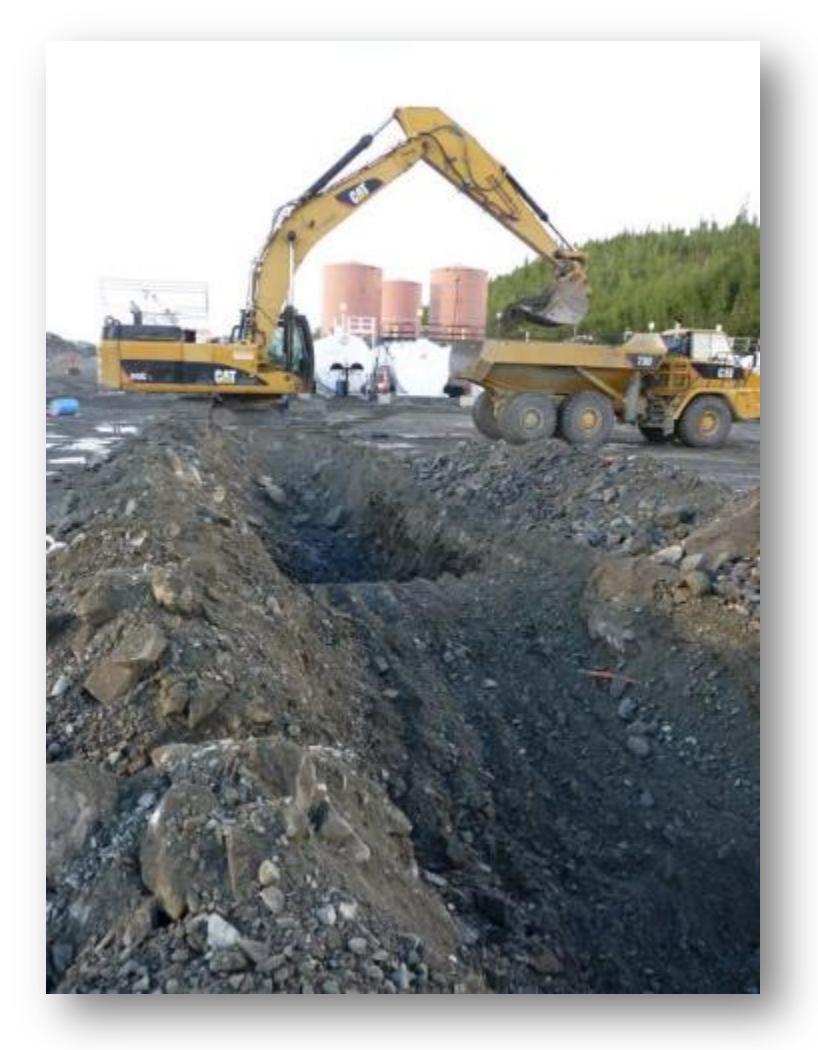
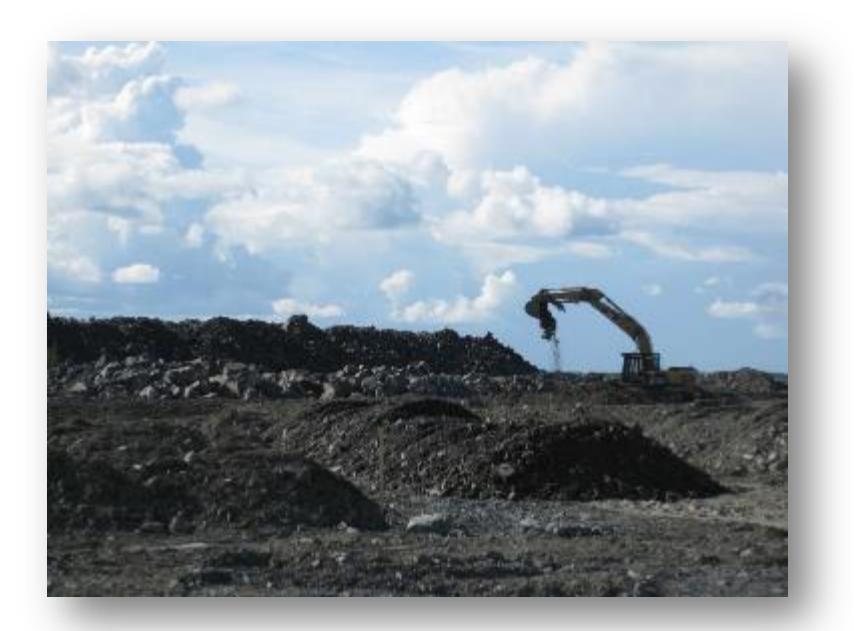
#### Petroleum Hydrocarbon Contamination

- An estimated 30,000 litres of fuel was spilled during mine operations
- Over 17,000 m<sup>3</sup> of contaminated soil was excavated and treated in an onsite landfarm.

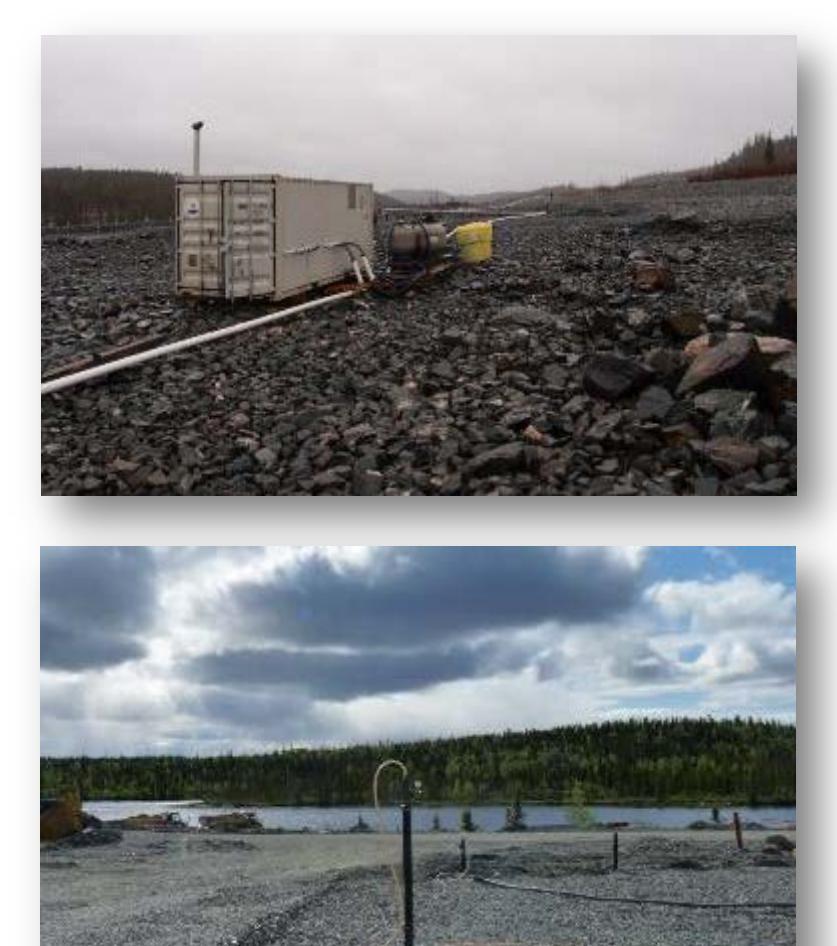
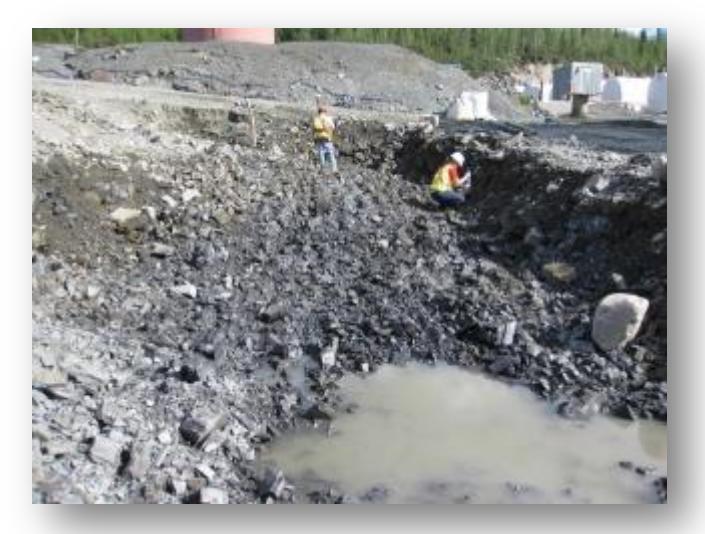
#### Petroleum Hydrocarbon Contamination

- Free product was present within the fractured bedrock and presence of free product was monitored in a network of over 240 monitoring wells across the site.
- Identified free product was extracted using a Multi-Phase Extraction System (MPE).

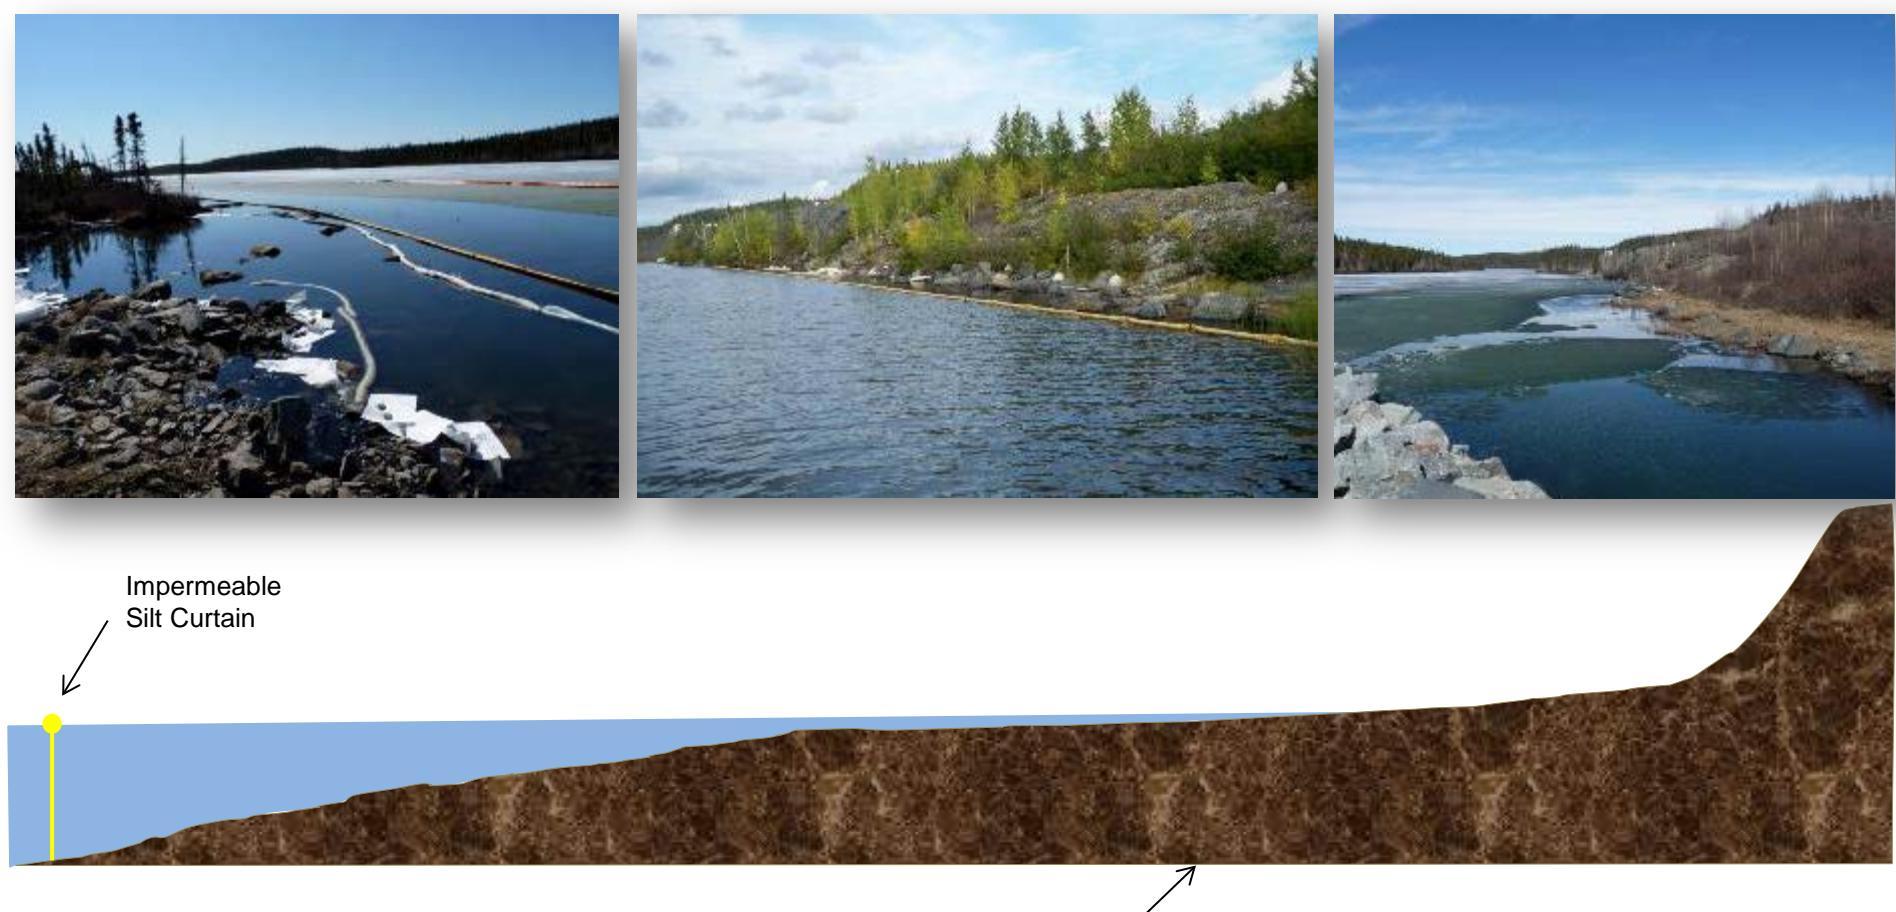
#### Steeves Lake Sediment Cap – Initial Conditions

Contaminated Sediments

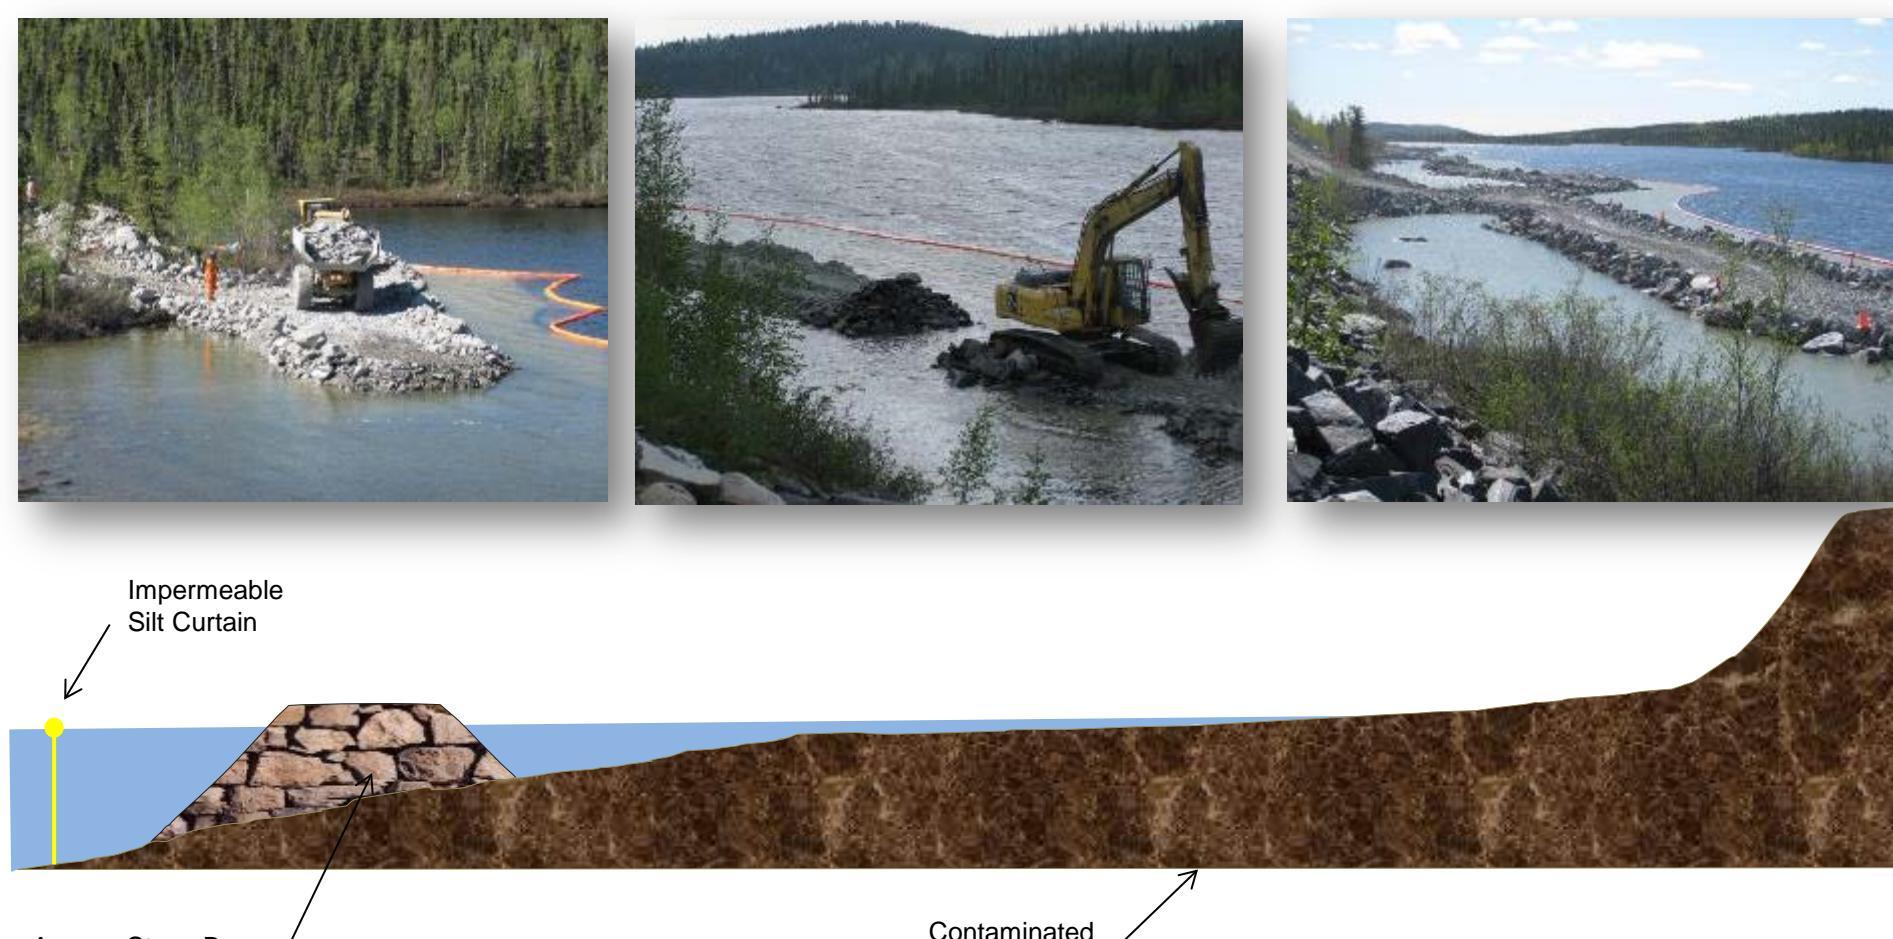
#### Steeves Lake Sediment Cap – Armour Stone Berm

Armour Stone Berm

Contaminated Sediments

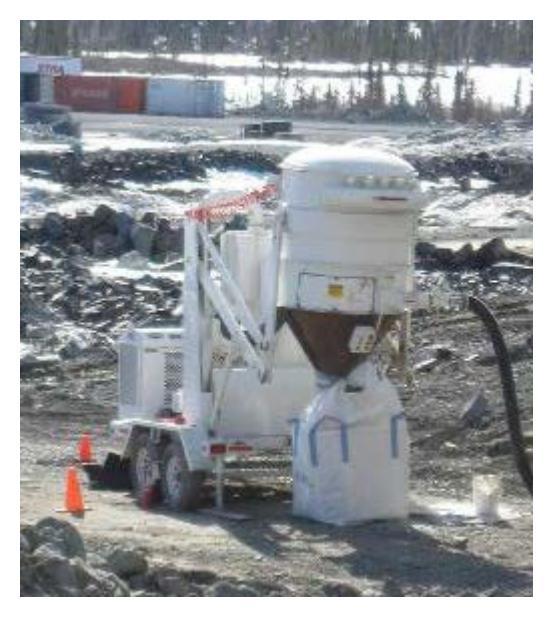
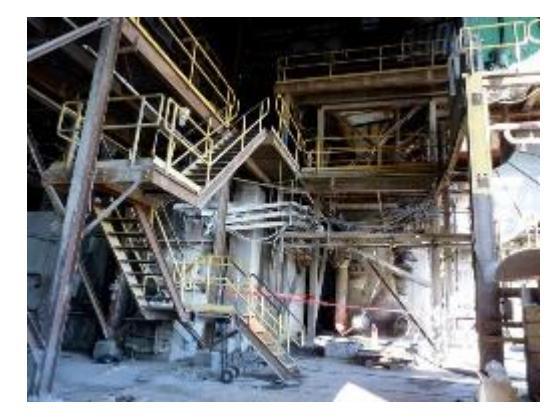
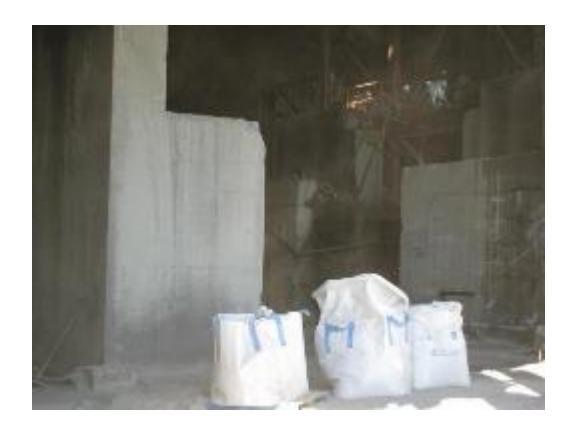
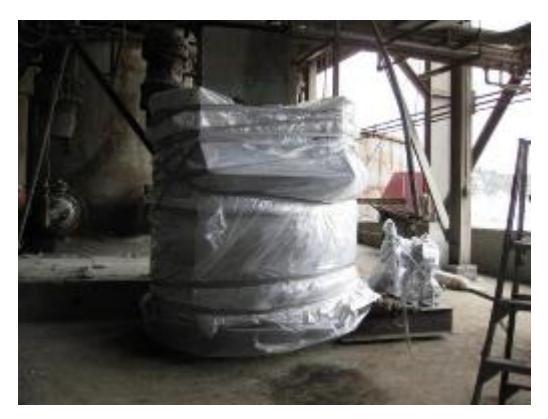
#### **Building Demolition – Decontamination**

- Cyanide contaminated dust was present in the mill complex
- Dust was removed with large vacuums with HEPA filters
- Cyanide contaminated materials were disposed of in a disposal cell in the existing Tailings Containment Area

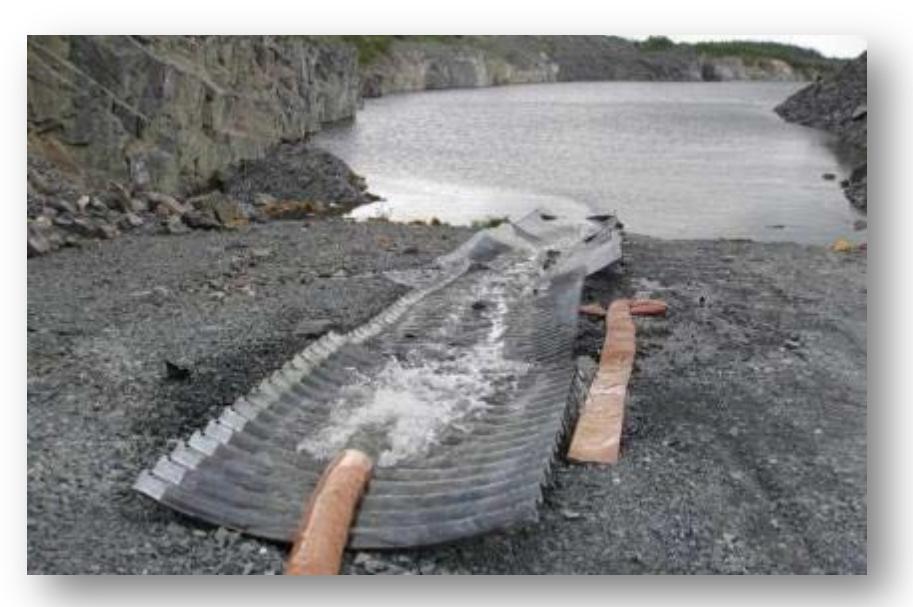
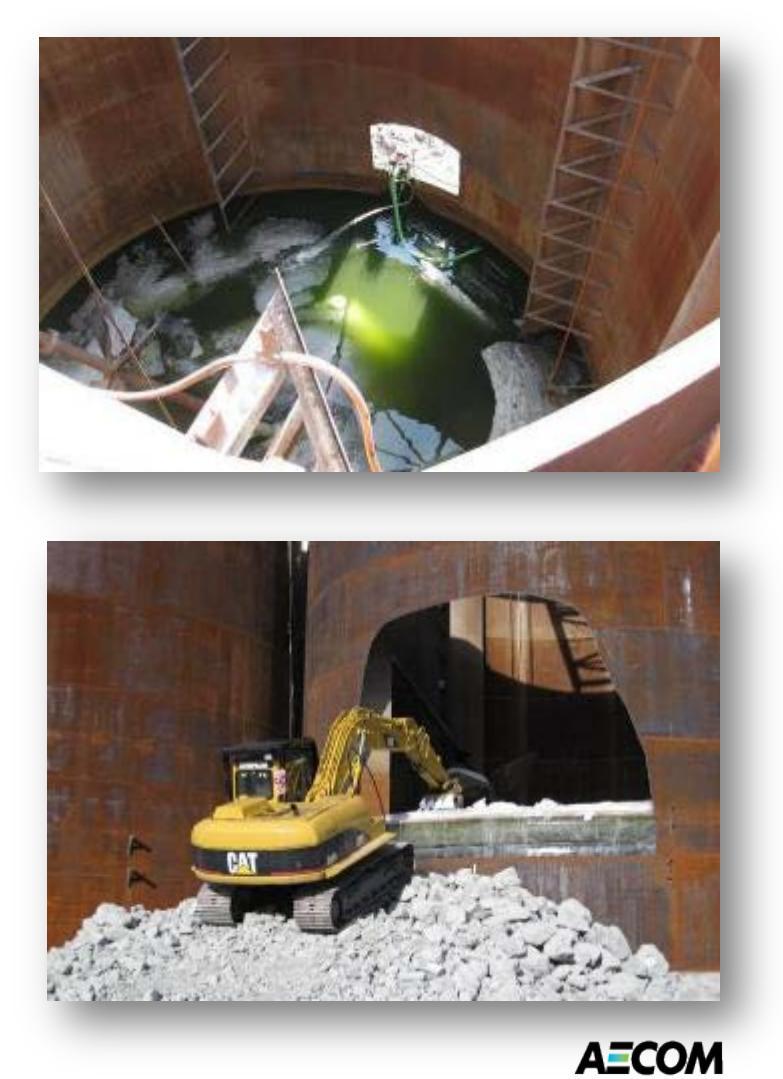
#### **Building Demolition – Decontamination**

- Twelve leach tanks were on site and were part of the cyanide leaching process
- 7,750,000 litres of liquid was present in the tanks.
- The liquid was pumped into an open pit on site

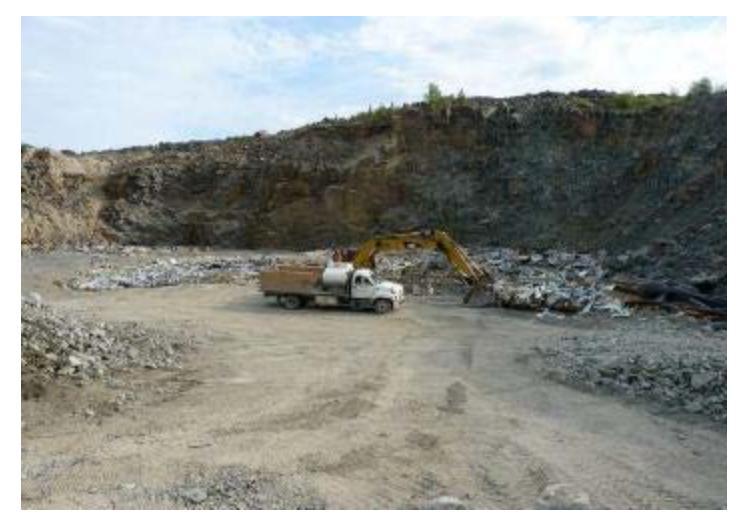
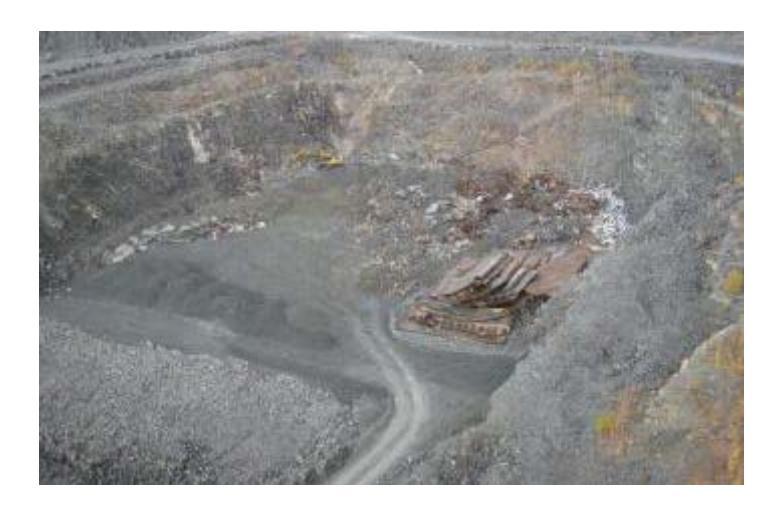
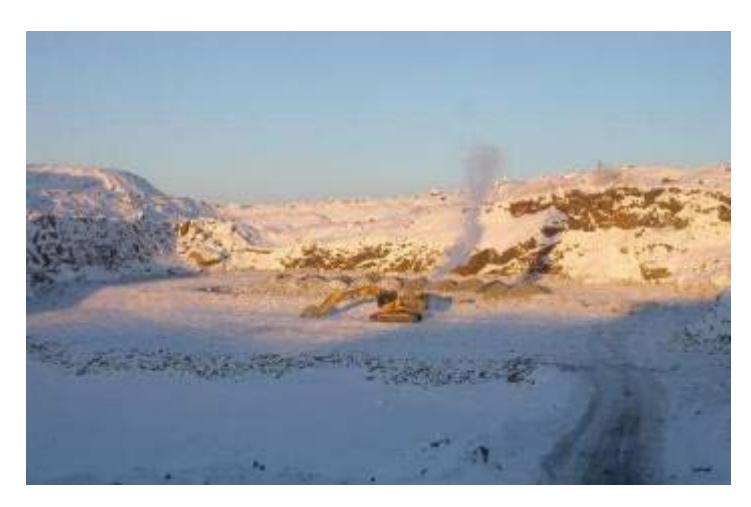
#### **Debris Removal**

- Debris was placed in an on-site nonhazardous waste landfill
- The landfill was constructed within one of the open pits left behind by mining operations.
- The landfill was contained on 3 sides by the walls of the pit and by an engineered berm on the fourth side.

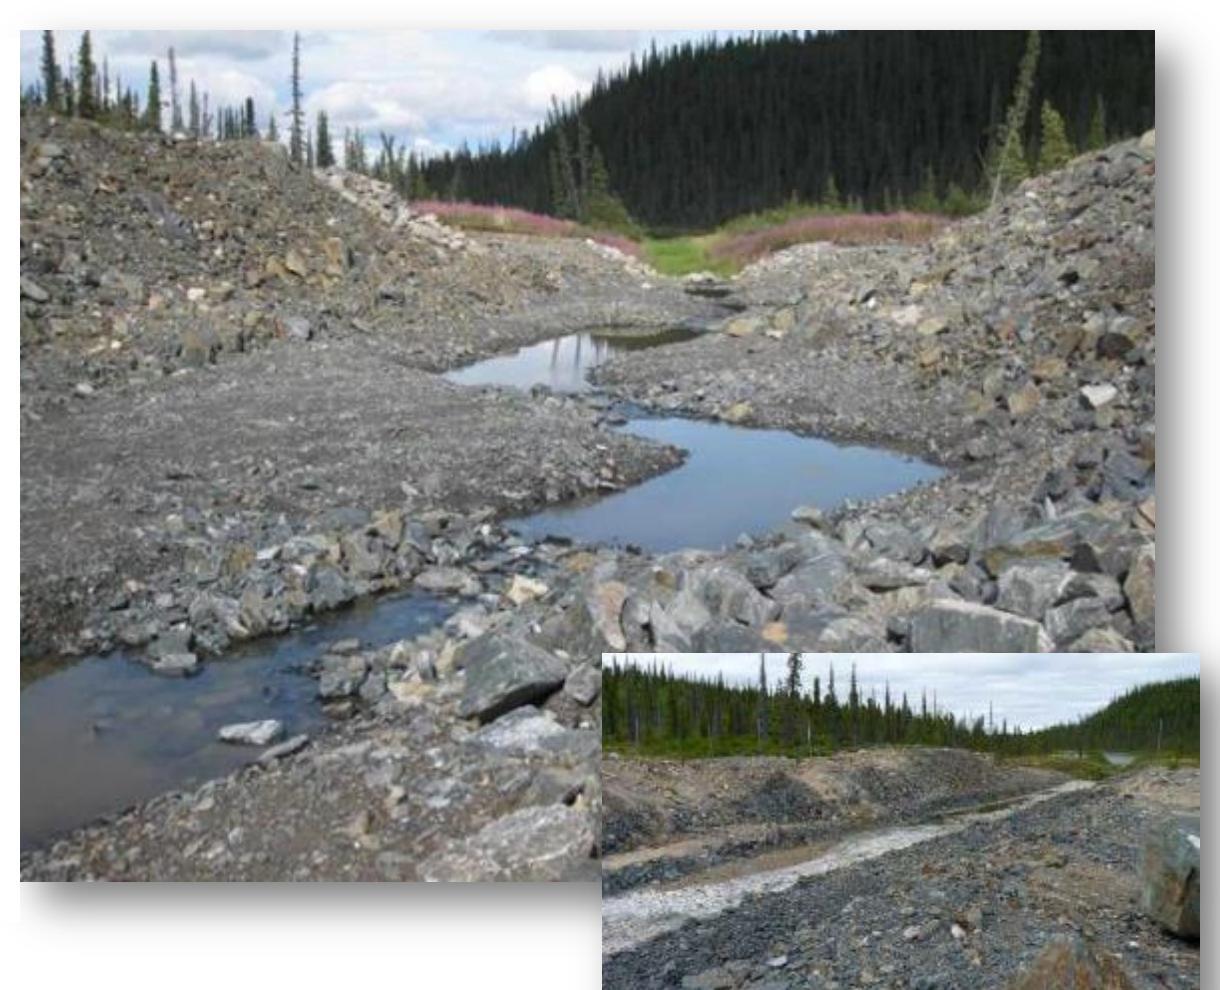
#### **Drainage Restoration**

- Eight drainage restorations were completed on the site
- Erosion and sediment control, fish salvage and re-vegetation work was completed in conjunction with drainage restoration work
- Created over 2,200 m<sup>2</sup> of new fish bearing habitat and over 3,400 m<sup>2</sup> of riparian habitat
