# Outline

# What is Soil Fracturing?

# Case Study- Background

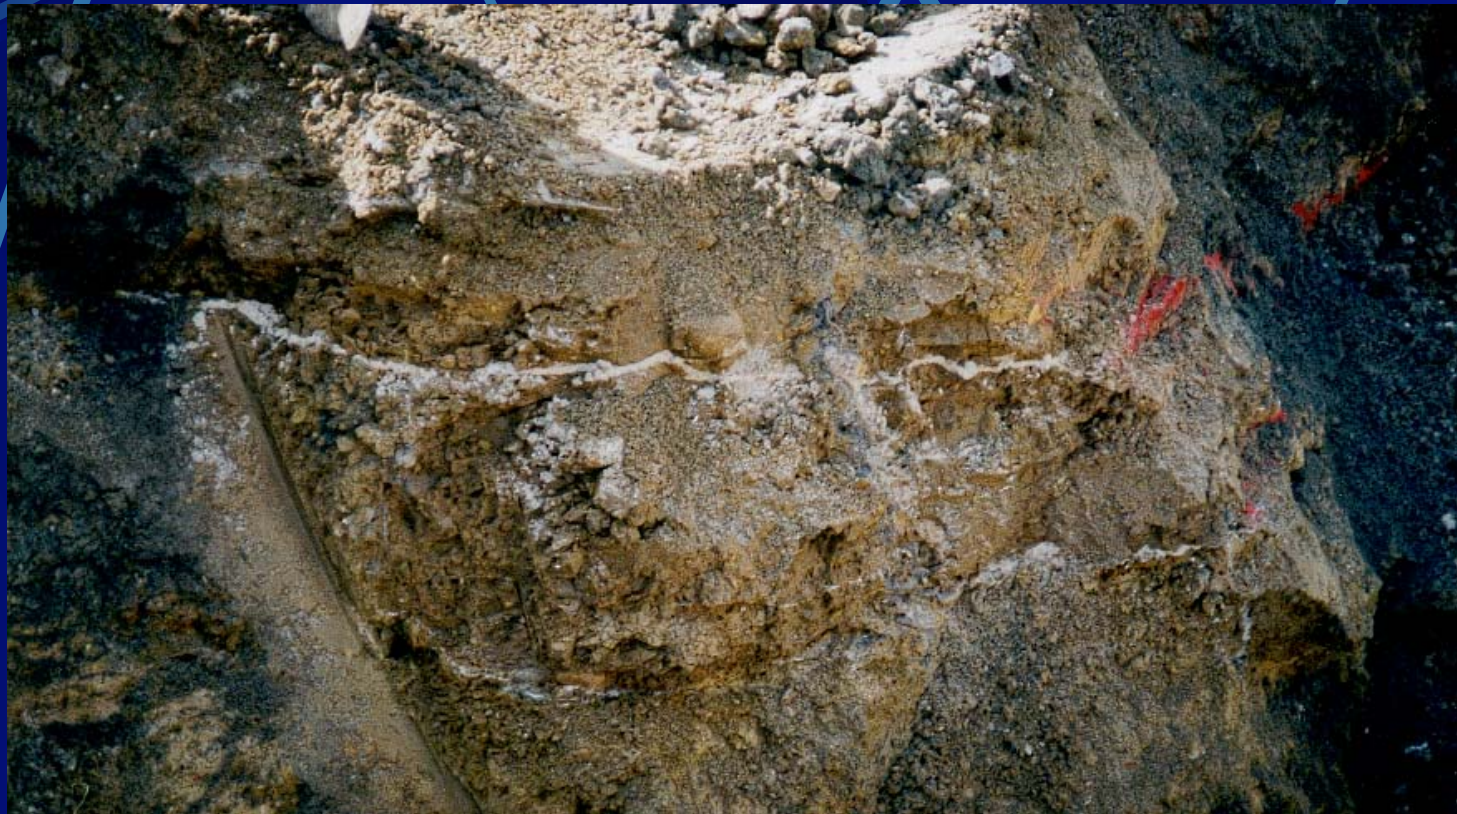
# Excavation of Fractures Placed in Clay Till

- It creates a network of highly permeable sand fractures in the contaminated soil mass which function as conduits for the expeditious removal or in-place treatment of subsurface contamination.
- Fractures serve as pathways for the delivery of reagents (e.g. nutrients, surfactants, oxygen, biological amendments) to enhance the in situ remediation of contaminants.

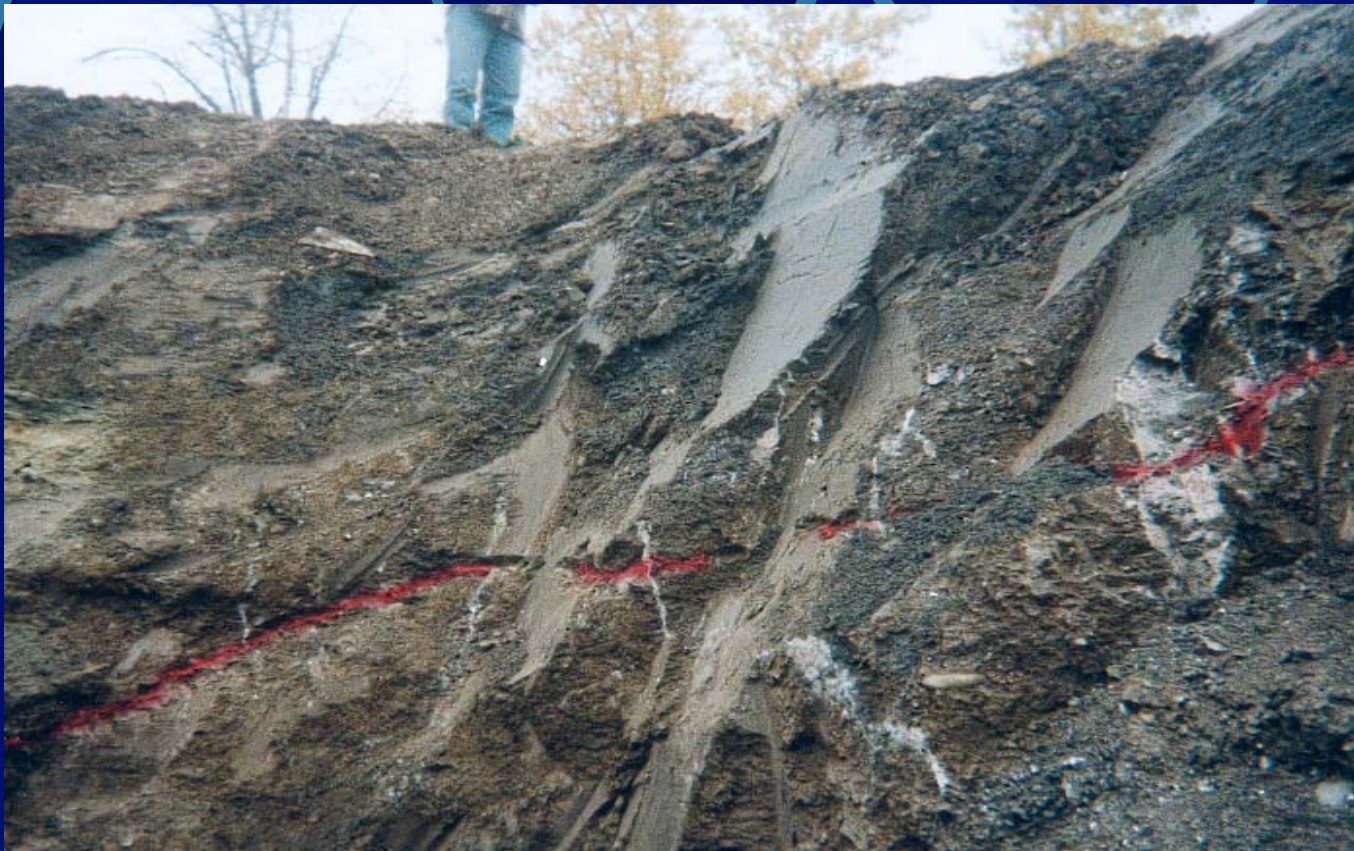
# **Sand Fracture (Red) in Clay Till**

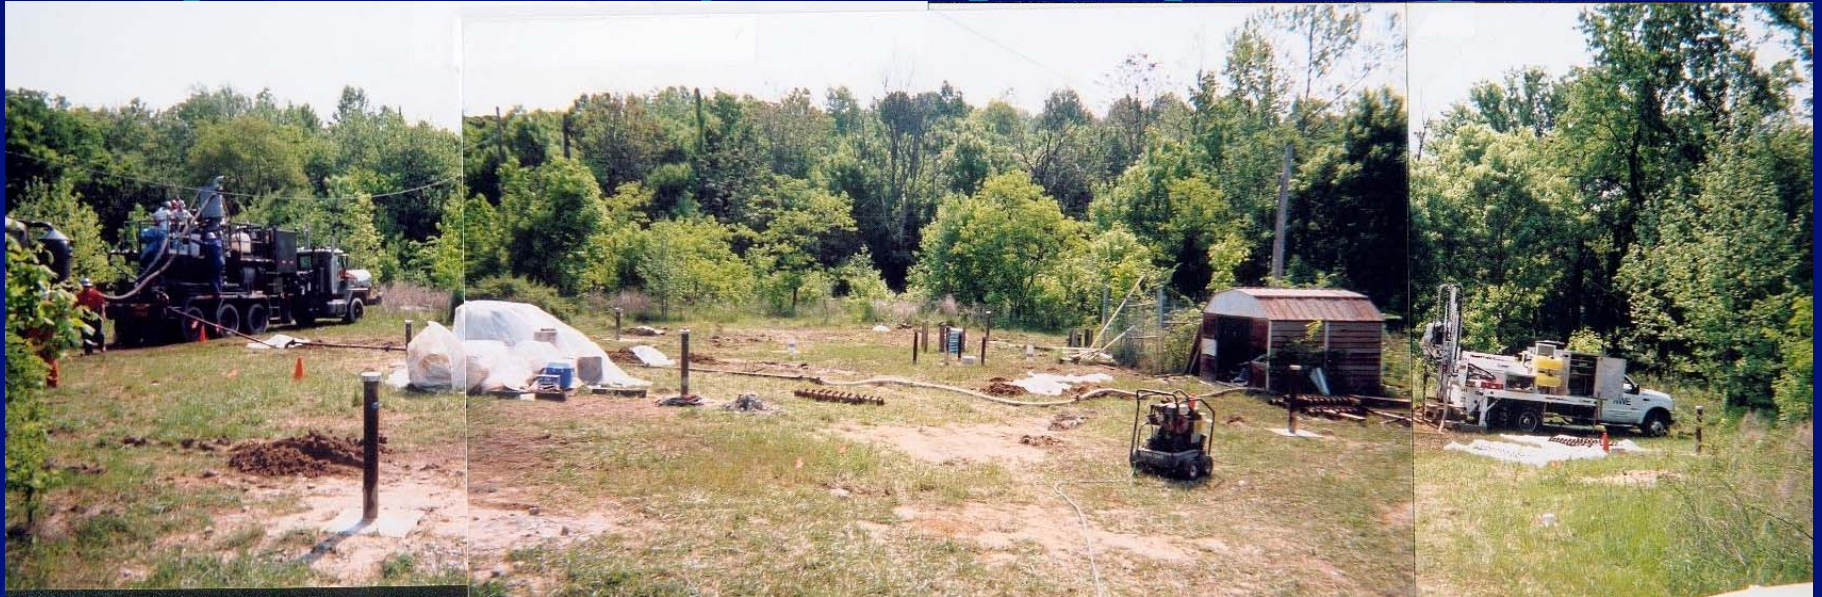
# Fracturing Operations at Distler Brickyard site

- Consisted of:
  - Soil fracturing and simultaneous injection of sand-chitin slurry
  - Three fractures containing chitin induced in contaminant source area
  - Fracture placement and geometry mapped remotely using tiltmeter geophysics and correlated with soil coring
  - Pump testing and groundwater monitoring

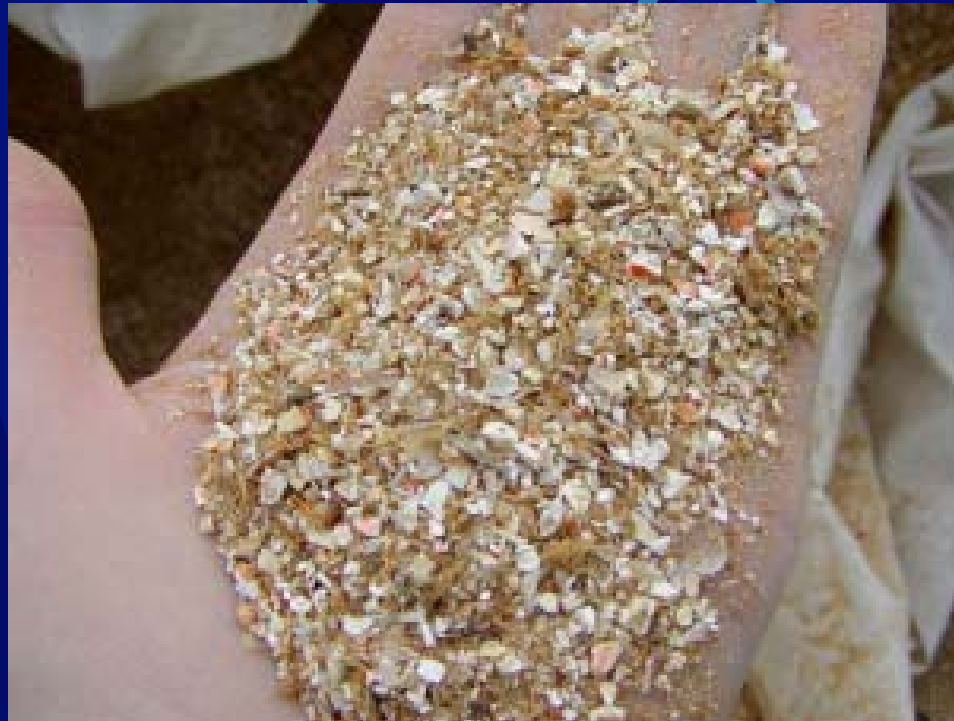
# Chitin Bioamendment

- Soil hydraulic fracturing to increase bulk soil permeability in contaminated zone
- Simultaneous injection of “chitin”, a natural polymeric organic material consisting of shrimp and crab shells
- Objective: to enhance anaerobic reductive chlorination (ARD) of chlorinated solvents.

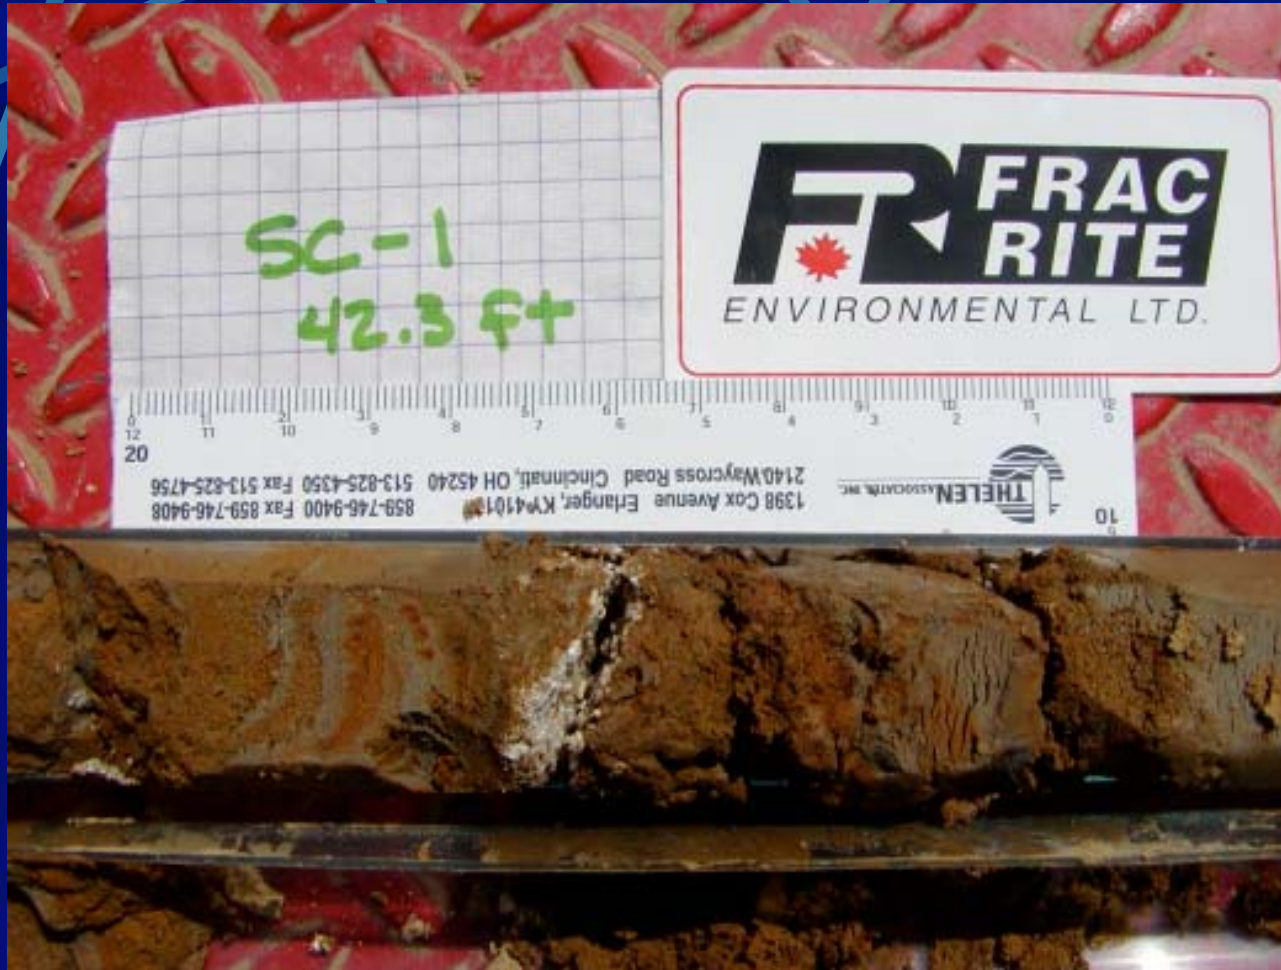
# Chitin filled Fracture

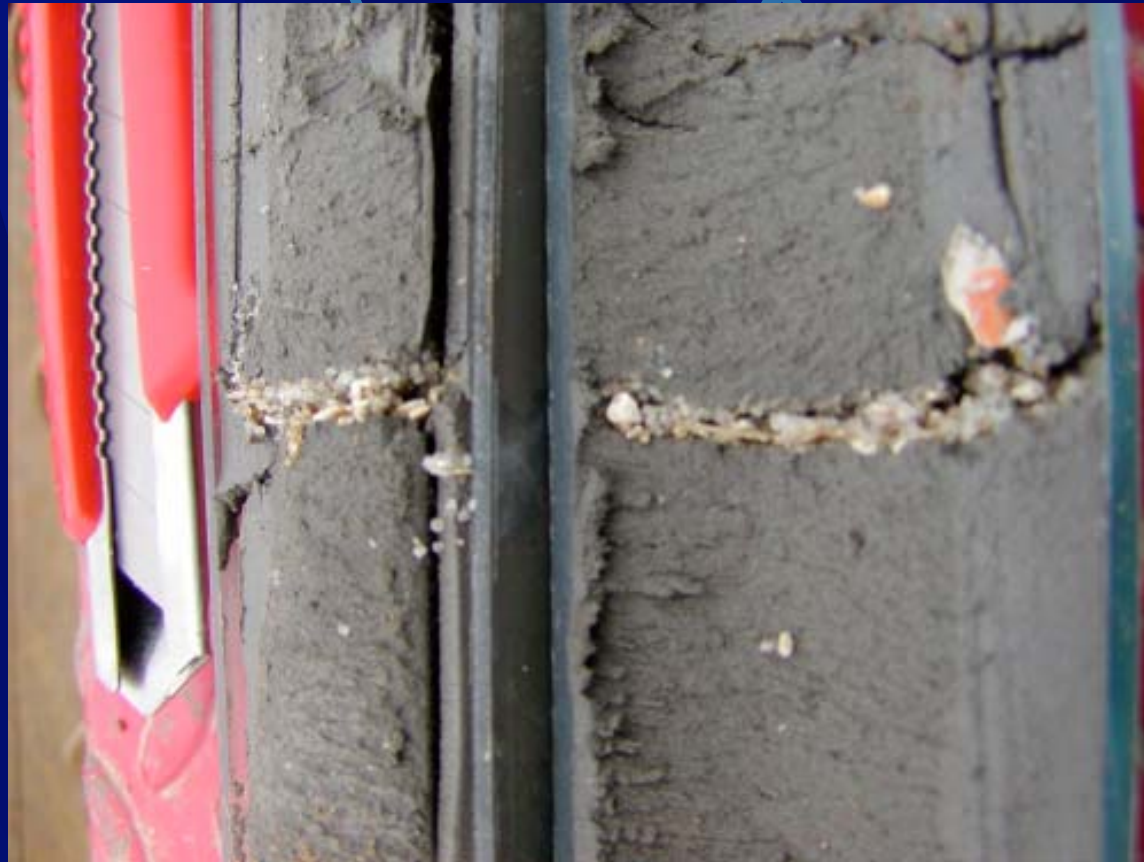
# Chitin Fracture in Soil Core

- Soil fracturing and injection of chitin bioamendment was successful in field
- Soil fracturing resulted in hydraulic connectivity and increased permeability
- Distribution of chitin was mapped using tiltmeter geophysics and soil coring
- Where distributed, chitin was effective in enhancing anaerobic biodegradation of chlorinated contaminants
