Decommissioning of Pyramid Mountain Microwave Facility

Masten Brolsma, P.Eng.
Senior Environmental Engineer

October 21, 2005

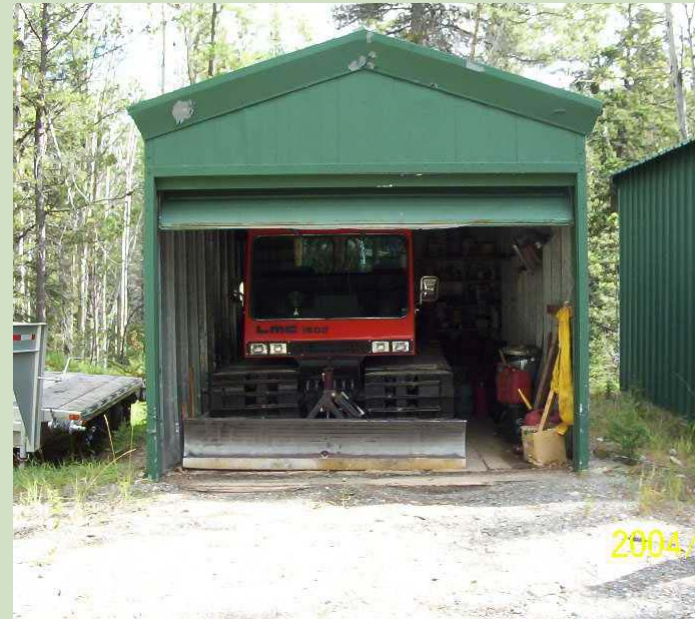
SnoCat Garage (elev. 4000' / 1220 m)

- Approx. 250 m off Pyramid Lake
- Storage of SnoCat to plow road for all-season access
- Minor vehicle maintenance / lubricant storage

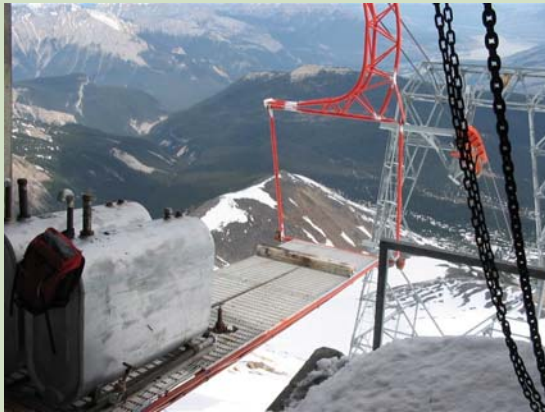
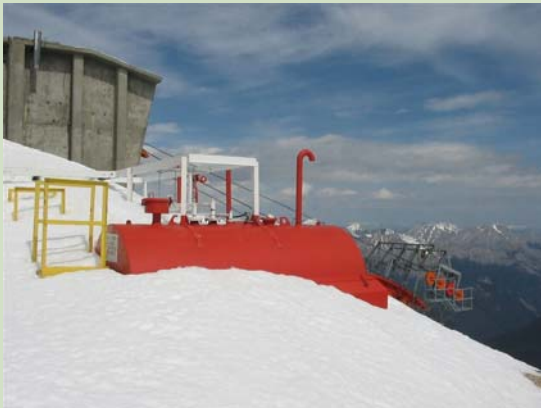
Summit

- Generator for Microwave
- Bulk Fuel Storage
- 4 x 10,000 L USTs replaced with 3 x 9000L ASTs in 1994
- Remedial excavation of UST basin in 1994
- Tram ASTs for fuel transfer

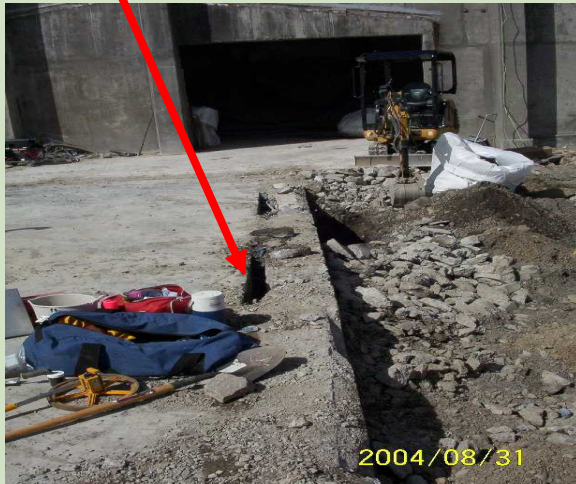
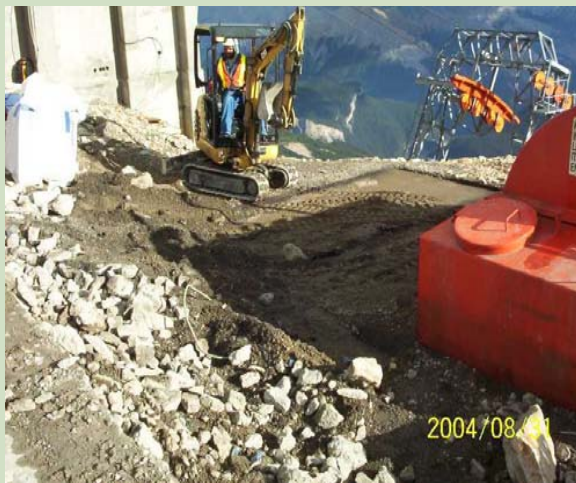
Summit – Assessment

Insulation interstitial space

AST Area

- Hand augers
- Testpitting with mini-excavator
- Visible staining and elevated soil vapours

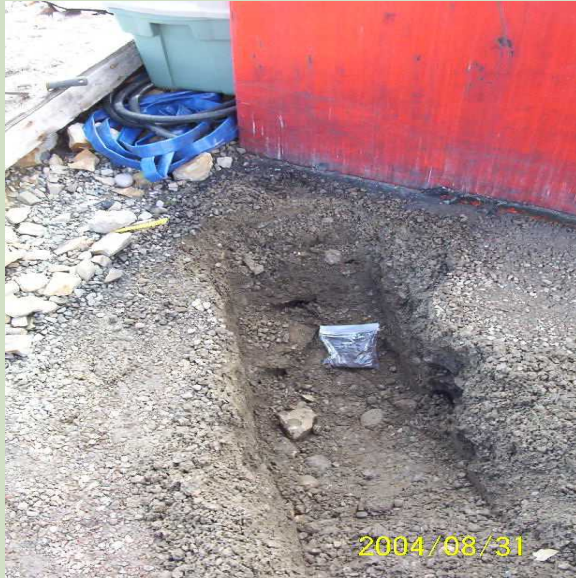
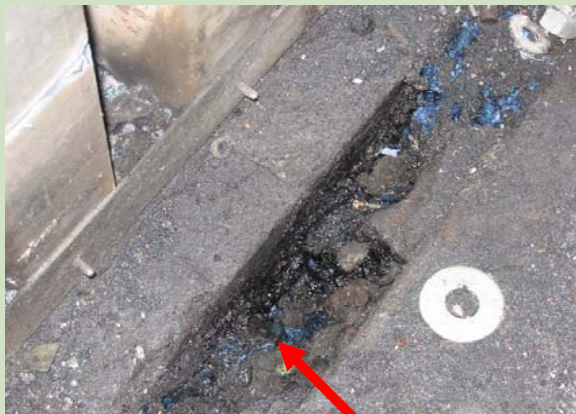
Summit – Assessment

Results

- Visible staining and elevated soil vapours
- Diesel impacts identified in AST nest
- Probable impacts under slab

Hydrocarbon staining in interstitial space

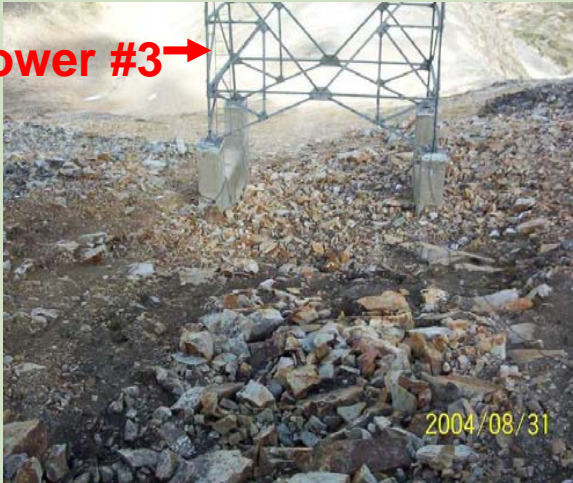
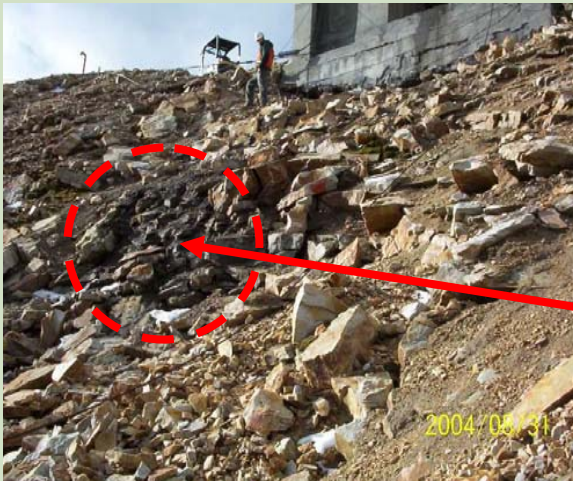
Summit - Assessment

Tower #3 →

Slope Below Tram Station

- Surface Sampling
- Visible staining
- Waste Oil impacts (F3 & F4 Petroleum Hydrocarbons and barium)

Surface Staining

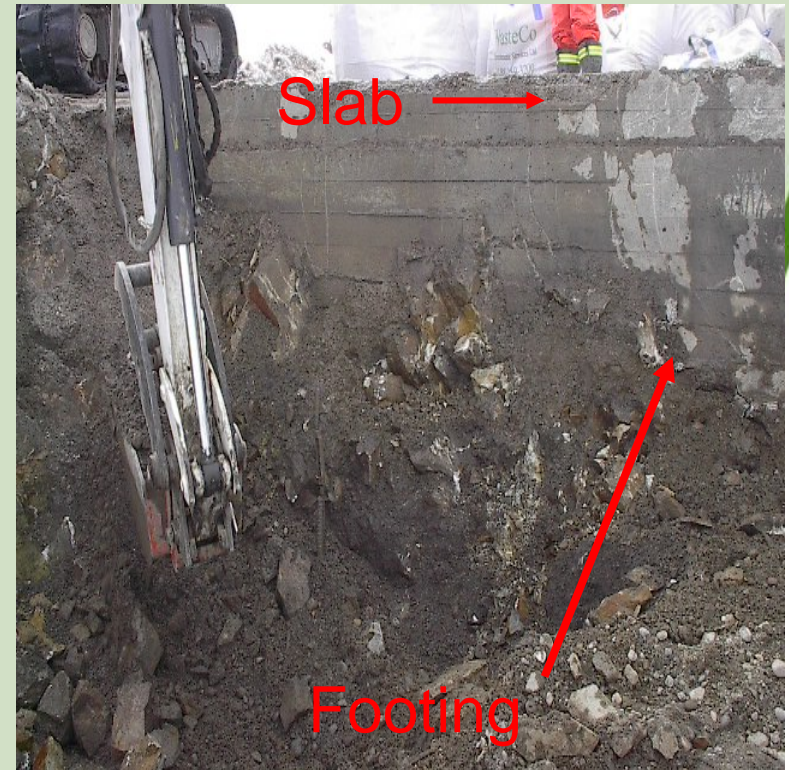
Summit – Remedial Action Plan

AST Area

Slab to remain for future use
Economics of Removing Slab
Footings

Excavate Accessible Soils

Screening Level Risk Assessment
&
Risk Manage Residual Impacts

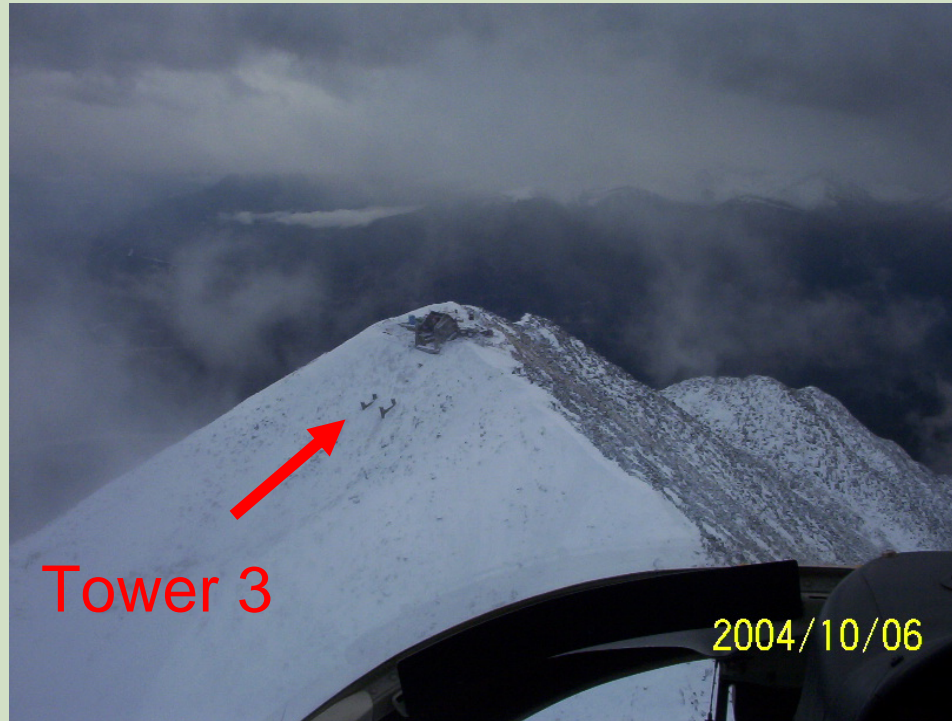
Summit – Remedial Action Plan

Slope Area

- Limited Access due to slope angle
- Limited ecological or human exposure pathways
- Screening Level Risk Assessment
- Cover with Clean Backfill

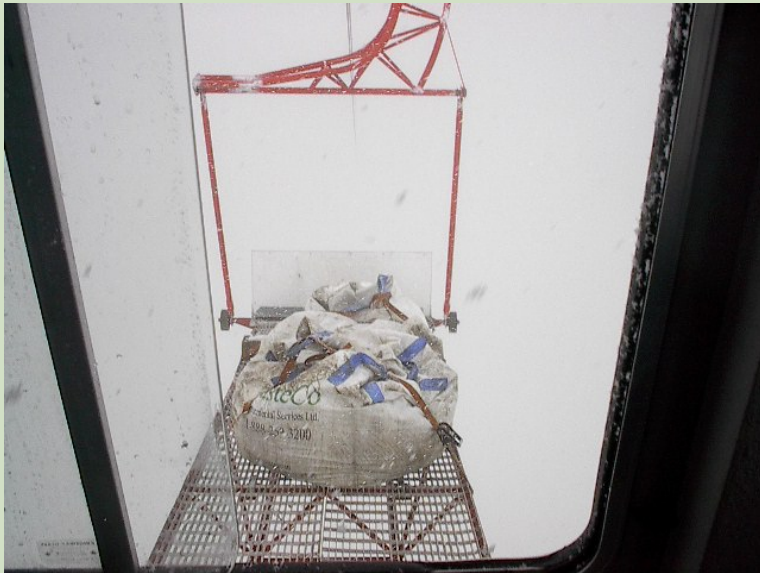
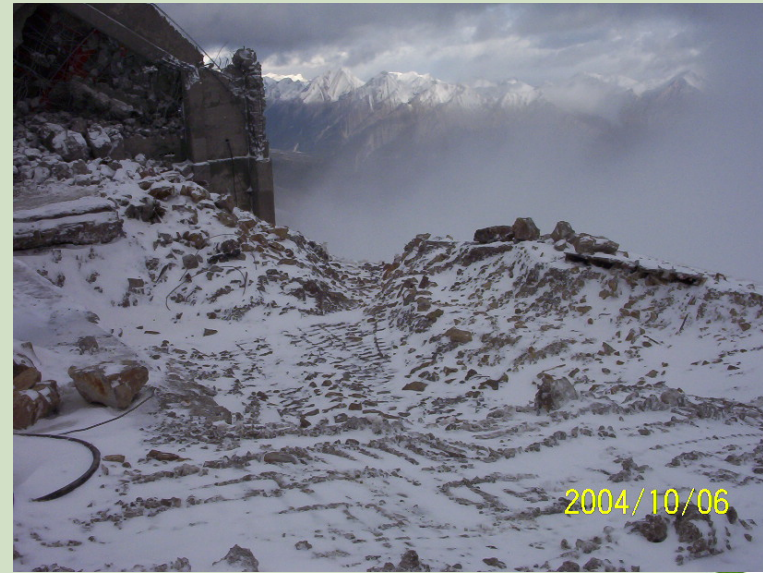
Summit – AST Remediation

- 80 m³ (160 tonnes) excavated
- 900 kg (2000 lbs) per/ tram load to base
- Tandem trucks to landfill outside Jasper National Park

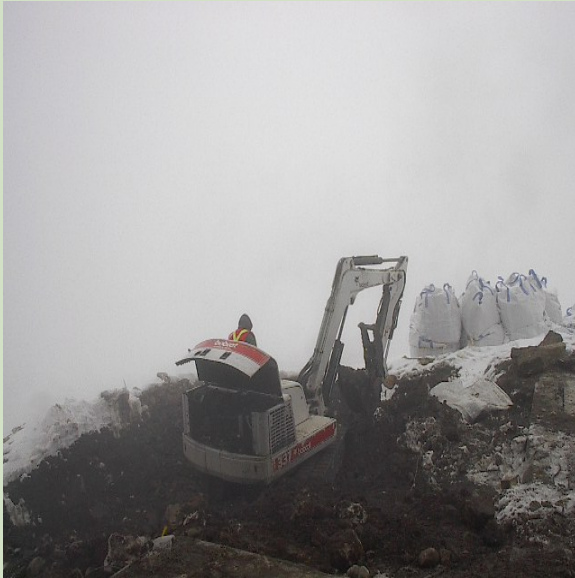
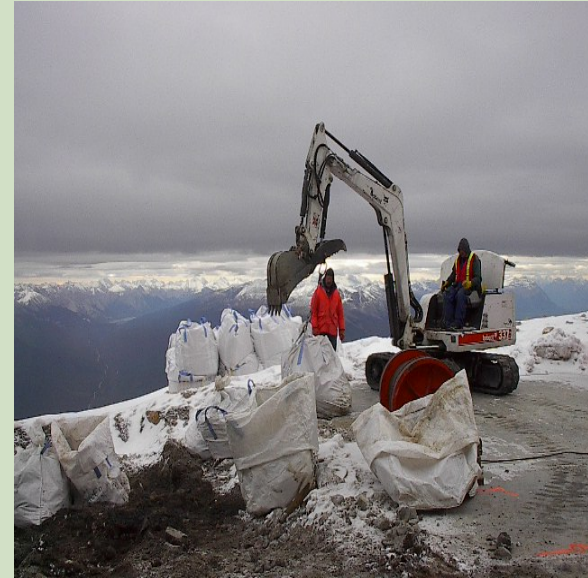
Summit – AST Remediation

- Confirmatory Soil Sampling finds residual F1, F2, F3 > CCME CWS
- Regulatory Update
- Environmental Liner Installation then Backfilling

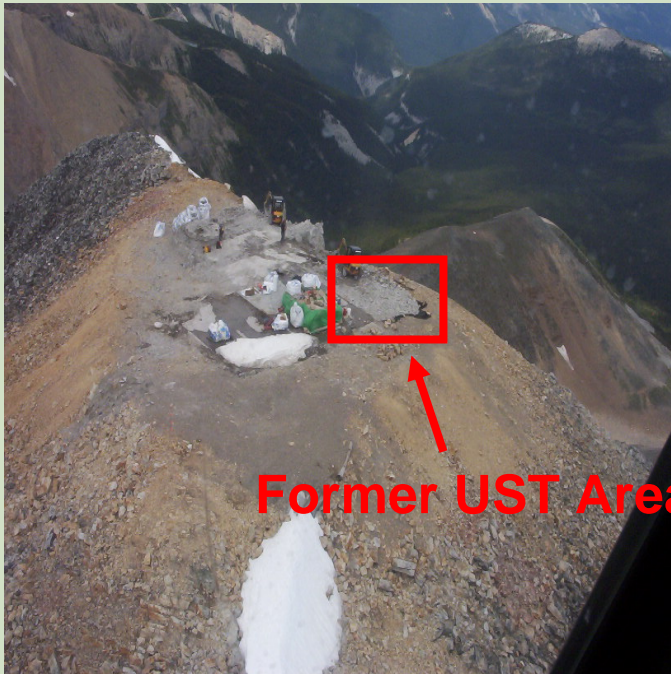
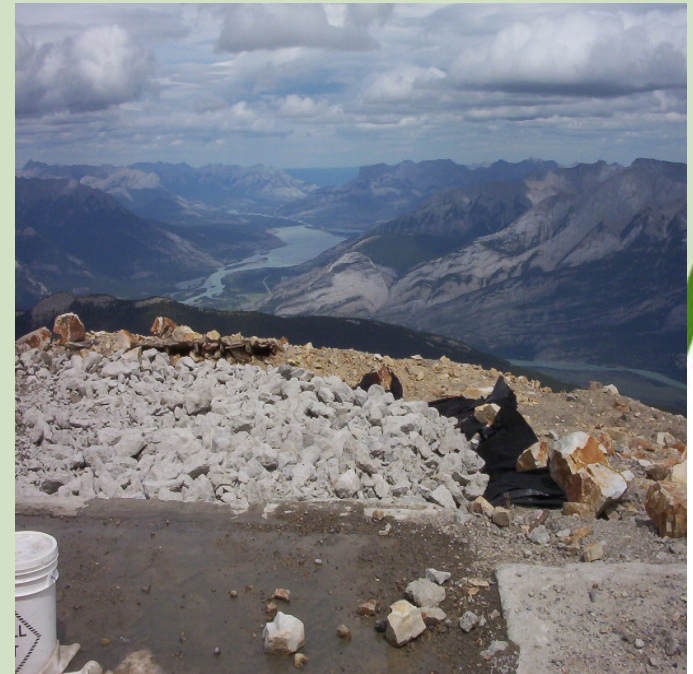
Summit – AST Area Remediation

Former UST Area

Drainage from Excavation
Cover of Liner with Clean Backfill

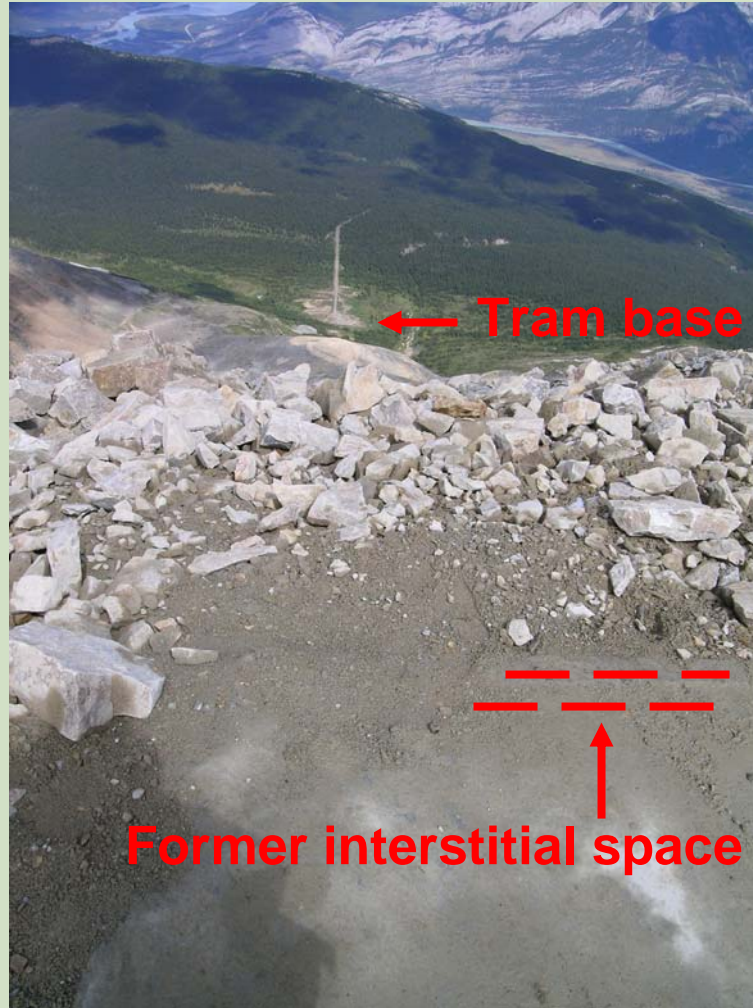
Summit – AST Remediation

Grouting of Interstitial Space

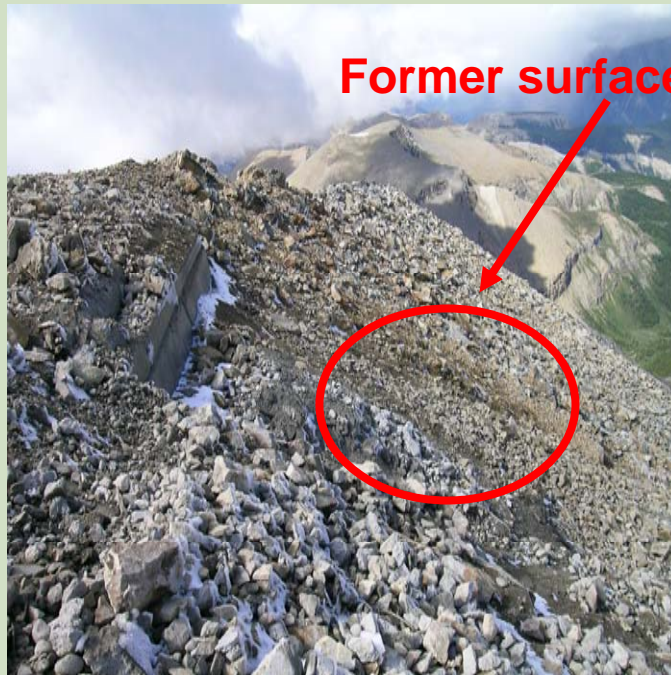
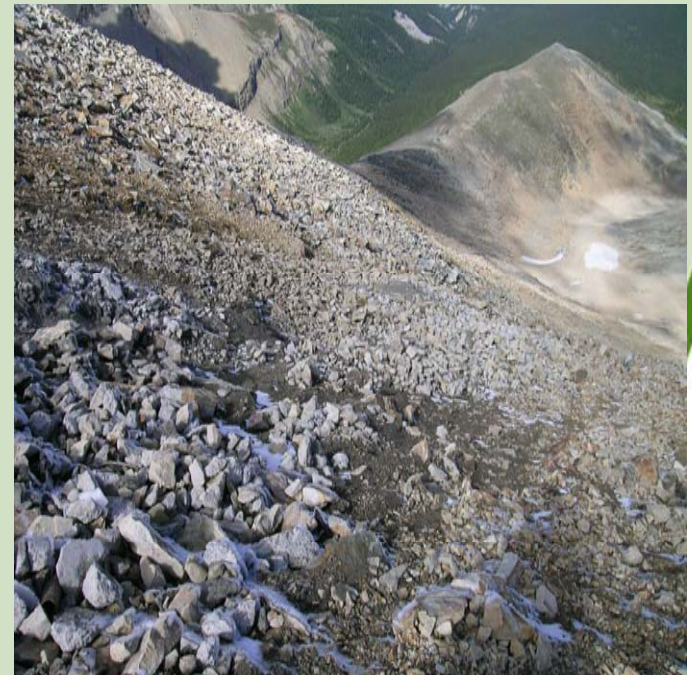
Summit – Slope Remediation

Minimum 0.5 m of clean cover

No rebar in concrete backfill or visible debris

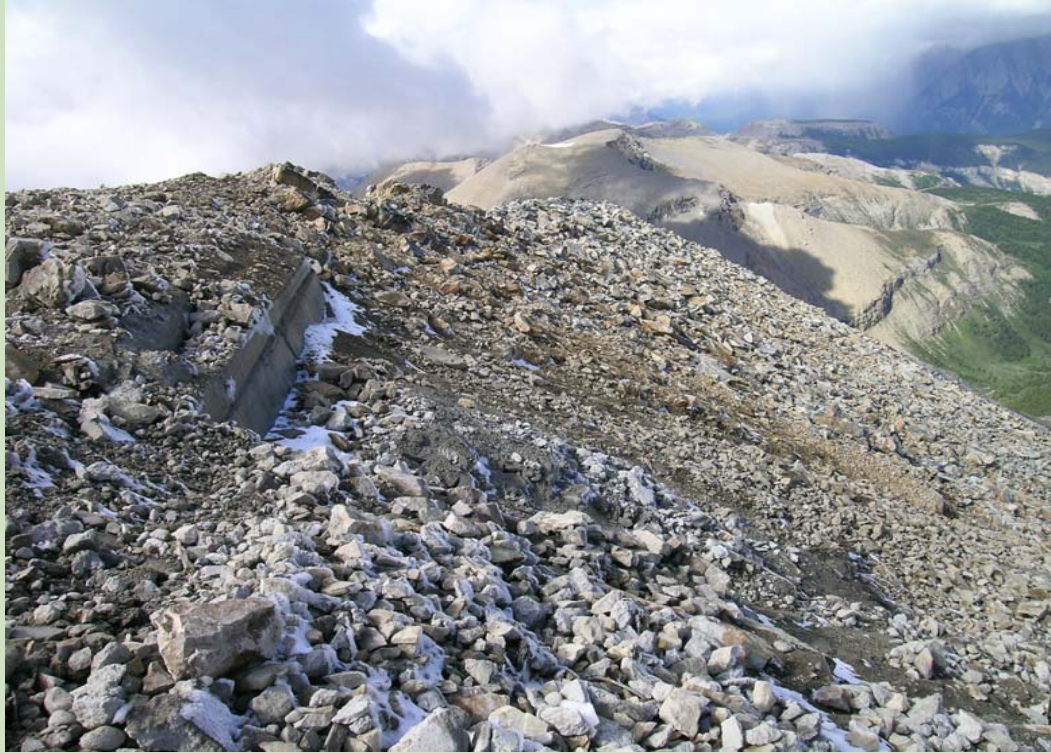
Pathways

Ingestion/Dermal contact – soil/dust

Ingestion/Dermal contact – ground/surface water

Ingestion of vegetation

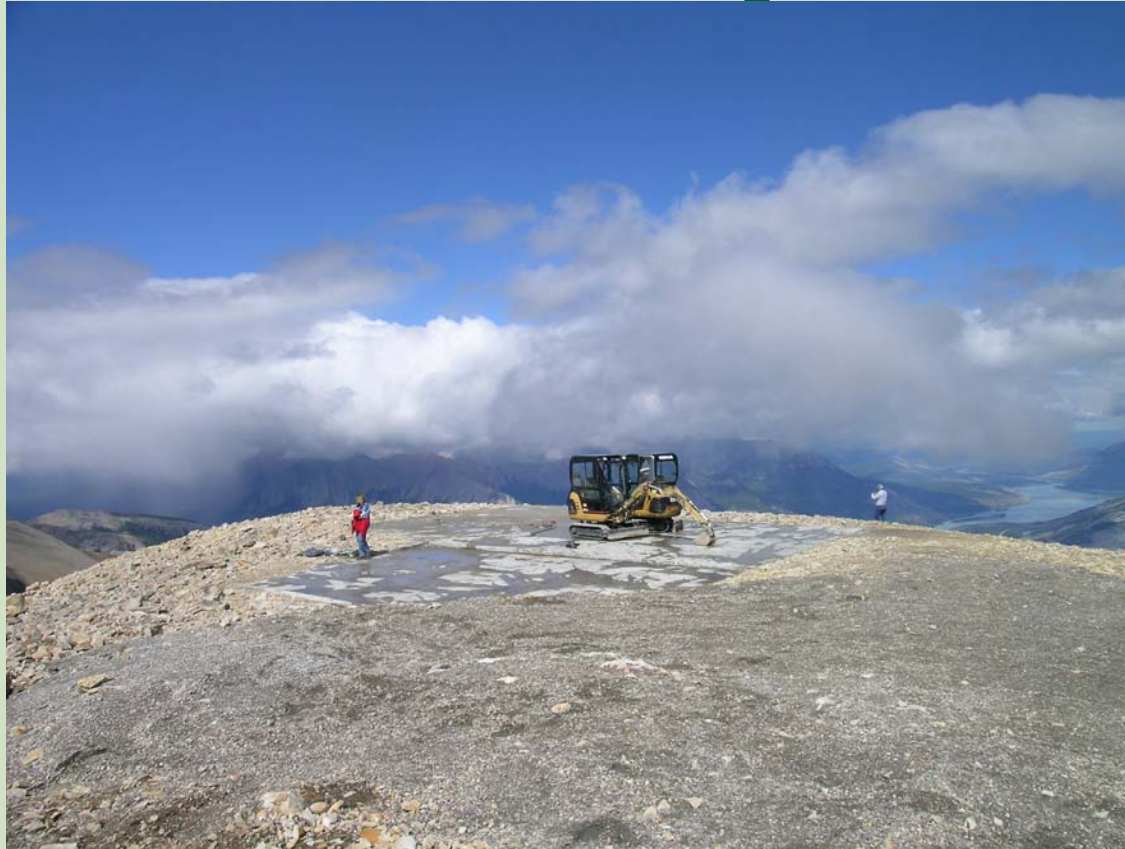
Pathways

Inhalation of vapours (indoor and outdoor air)

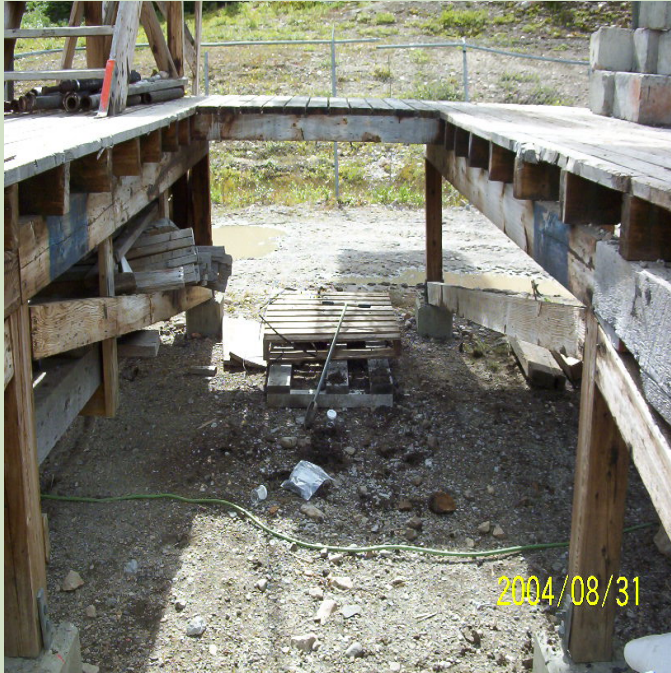
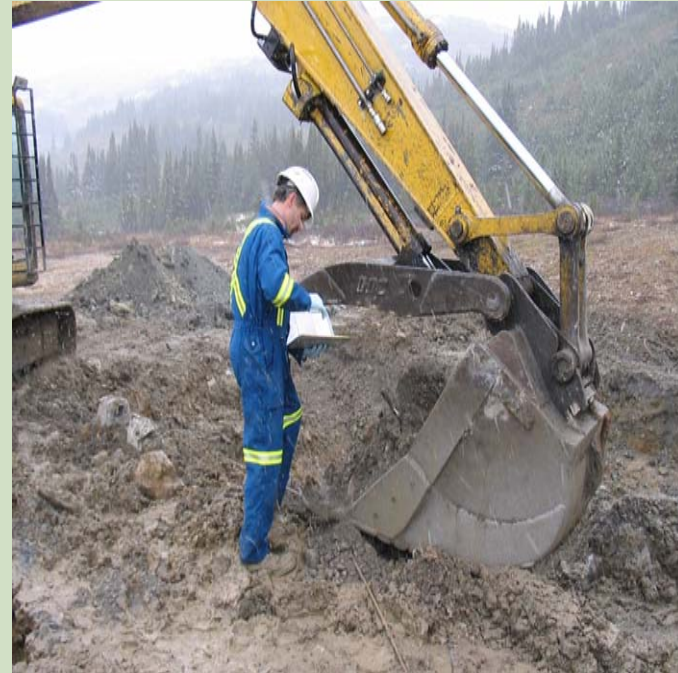
Tram Base – Assessment

- Hand Augers for Surface Stained Areas
- Testpitting for Deeper Impacts
- Monitoring Well Installation with Excavator

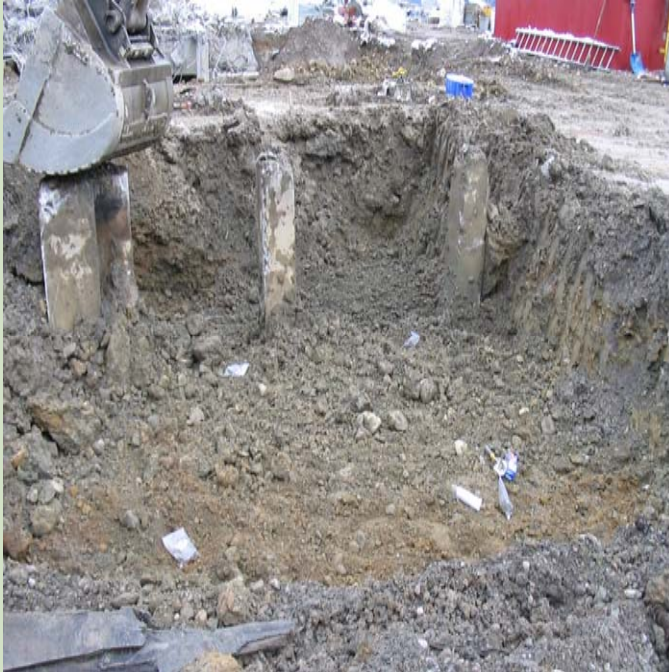
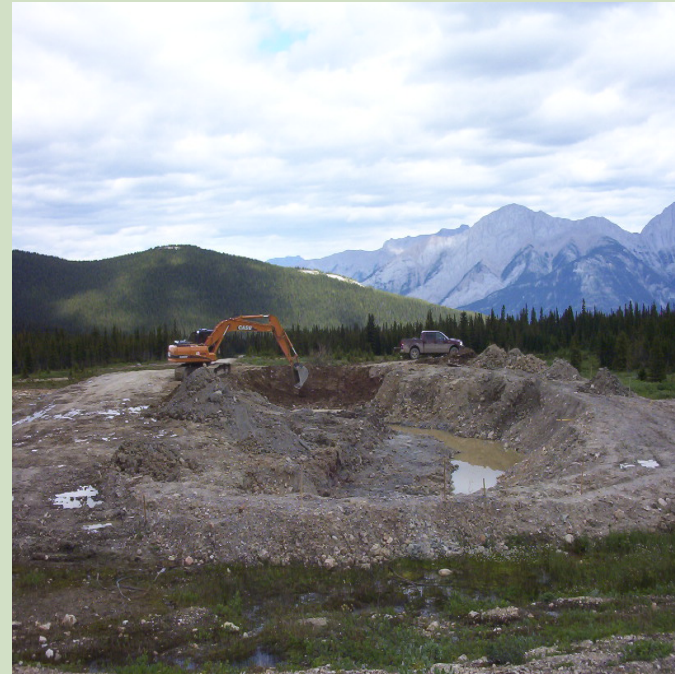
Tram Base – Remedial Action Plan

- Cold Climate
- Long Term Liability and Monitoring Costs
- Potential Freshwater Exposure Pathway
- Quantitative Risk Assessment / Site Specific Target Levels vs. Generic Criteria Based Remediation
- Owner Decides on Criteria Based Remedial Excavation

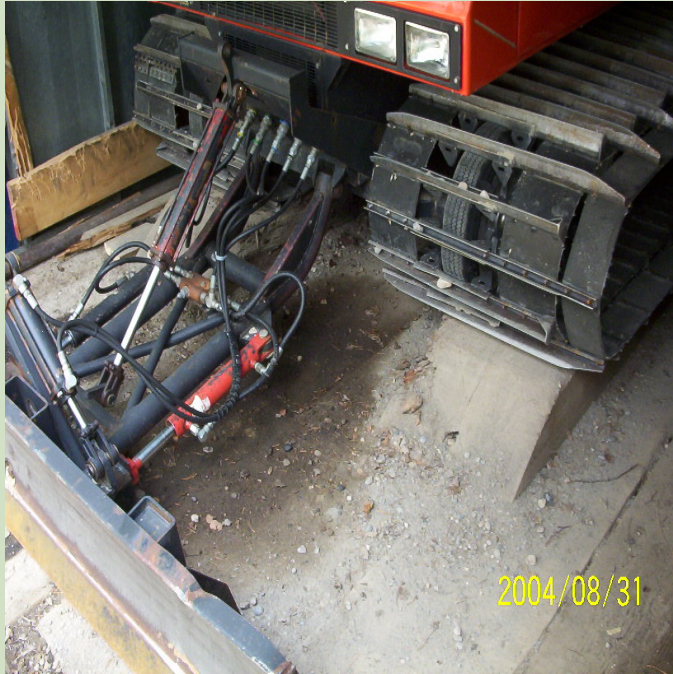
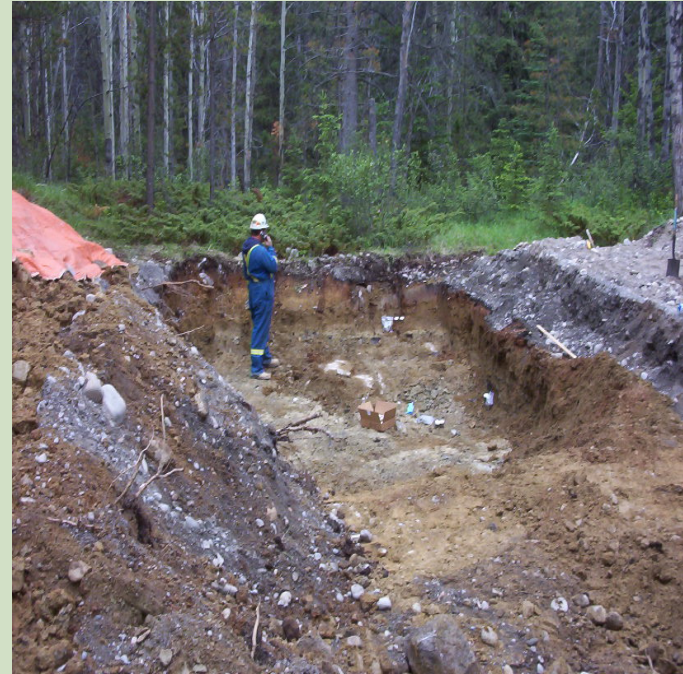
Garage – Remediation

- Surficial sampling → Hydrocarbon Impacts
- Excavation → Confirmatory sampling
- Impacted Soils to landfill
