# Drilling Sump Restoration Santa Maria Valley California

presented by Julie Doane-Allmon URS Corporation, Santa Barbara, CA, USA Heather Boyd ConocoPhillips, Houston, TX, USA

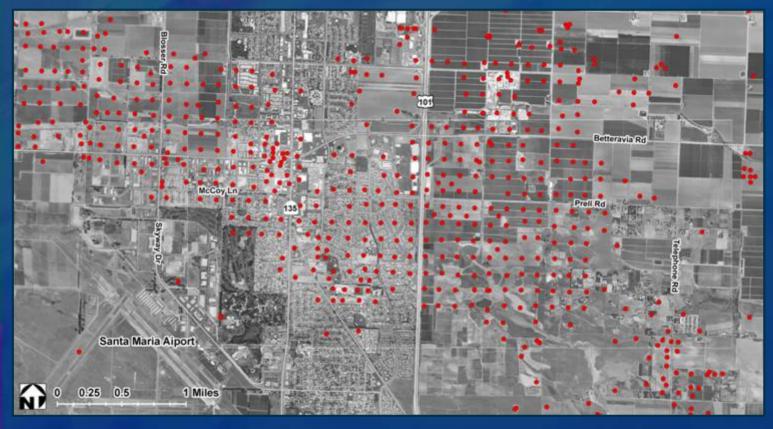
# Santa Maria Valley Agricultural and Oil Exploration History

Created by URS Corporation. Source of basemap: AirPhotoUSA, 2000. Source of oil well locations: DOGGR Map 312. September 2002.

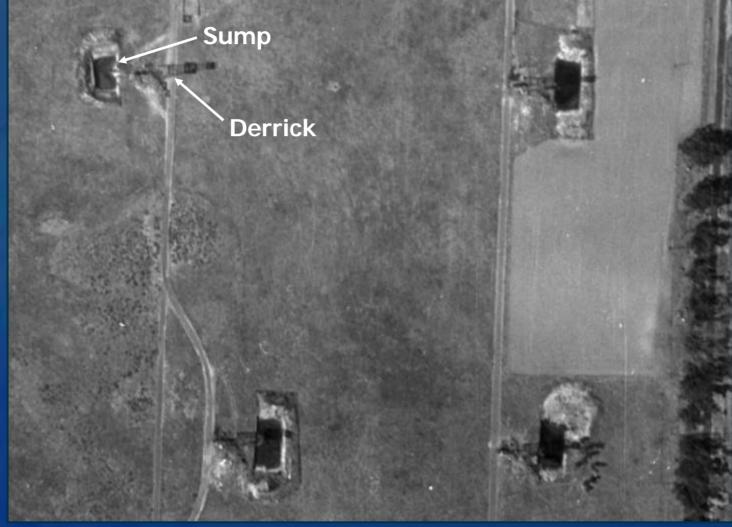
## **Sump Abandonment Practices**

Source of historical photograph: Santa Maria Historical Society Museum. Created by URS Corporation. Source of aerial basemap: PAI-US-101, 1952.

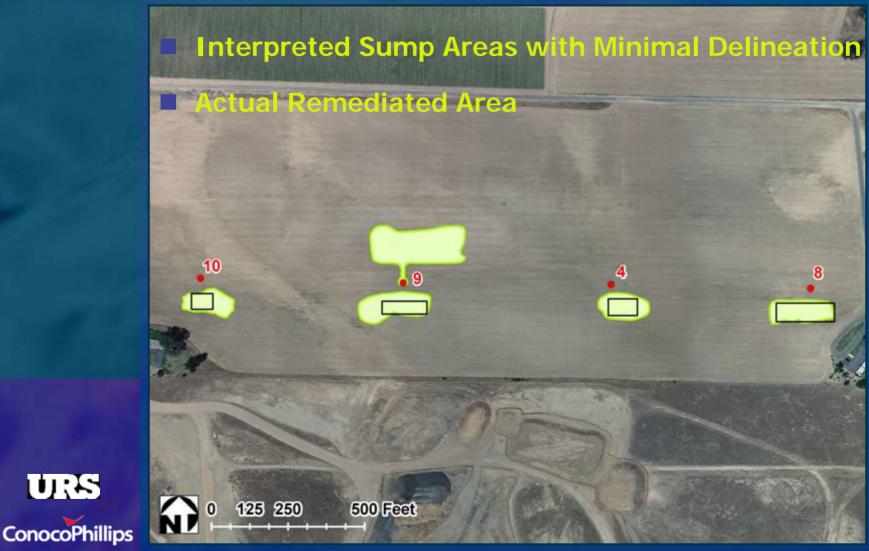
# Sump Identification and **Delineation Challenge**

Created by URS Corporation. Source of aerial basemap: AirPhotoUSA, May 2002.
