Case Study

Gasoline Spill Remediation

Sears Gas Bar

Soil Vapour Extraction System, Prince George, BC
Liliana Jerade, M.Eng., P.Eng.

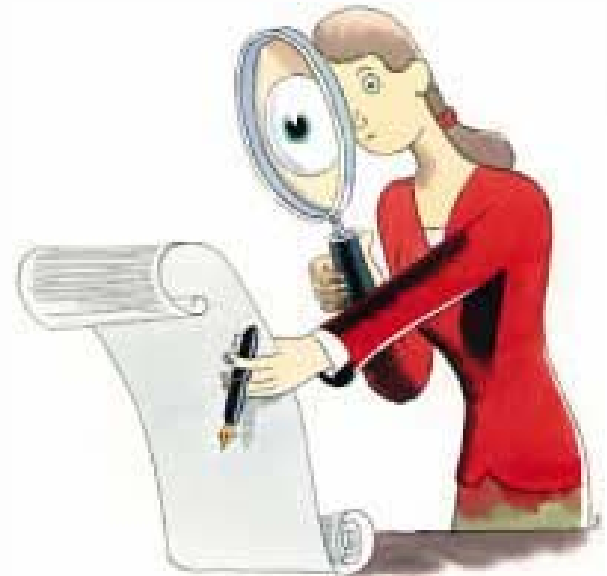
- **The Site is located within the boundaries of a shopping centre and Sears has been leasing it for 30 years.**
- **The shopping centre was sold and the new owner wants to redevelop the entire property.**
- **In order to obtain the required permits, the existing contamination needed to be remediated.**

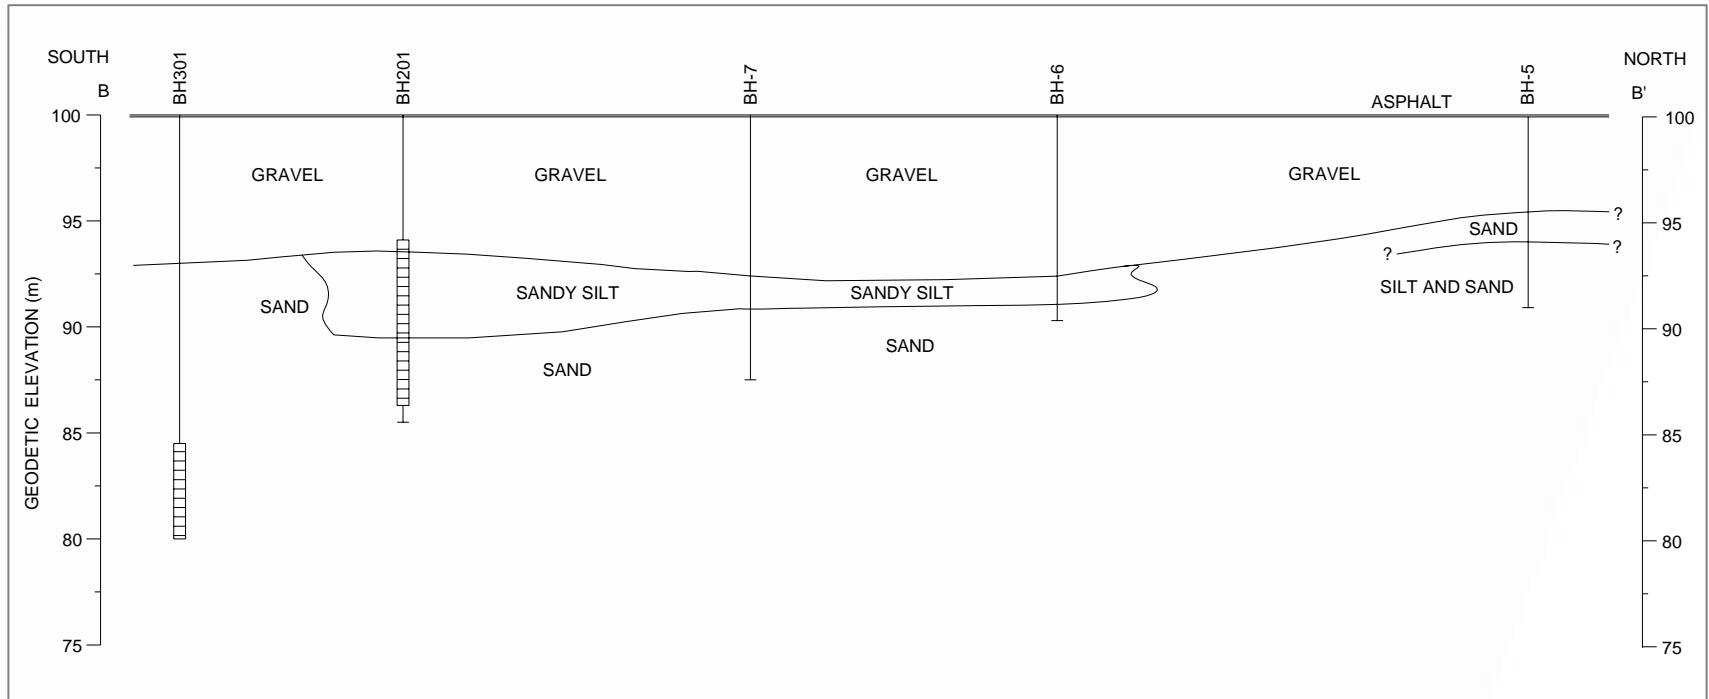
Stratigraphy, cont.

- **The stratigraphy at the Site consists of:**
 - sand and gravel to 7 mbg
 - sandy silt from approximately 0.6 to 3.0 m in thickness
 - grey fine sand to the maximum depth investigated.
- **The sandy silt layer acted as a confining layer absorbing the gasoline from the spills.**

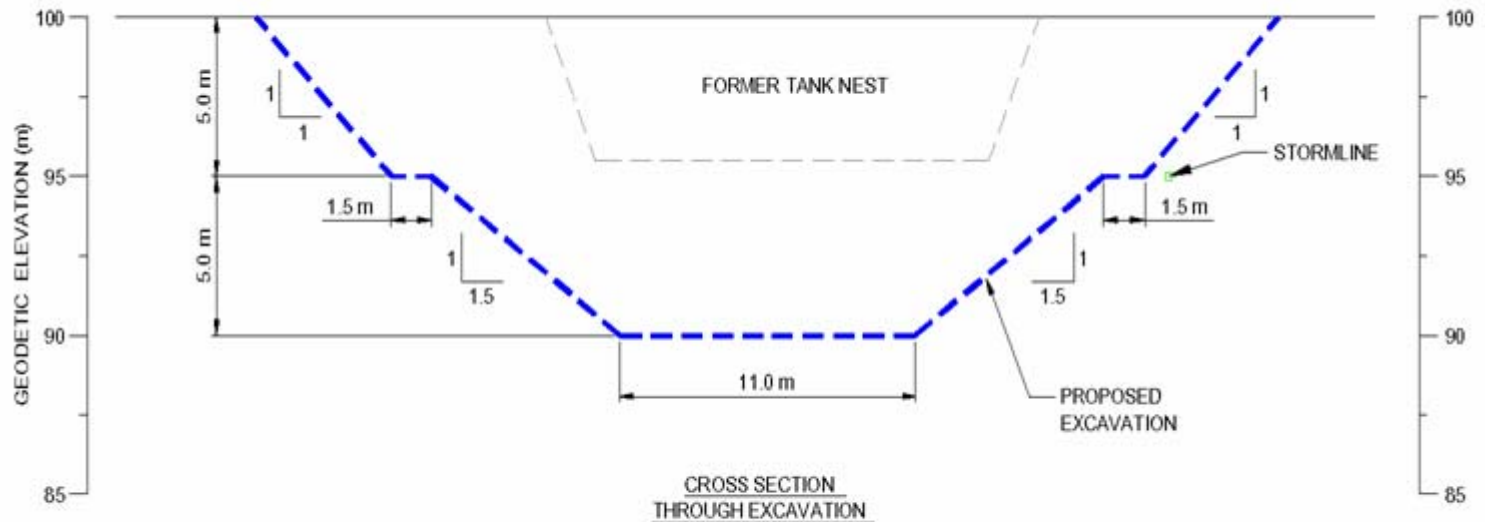
Excavation Dimensions

- ZOC 1 - Excavated to 5 mbg and soils transported off-site
- Excavation expanded to 10 mbg to conduct horizontal drilling program to remediate ZOC 2

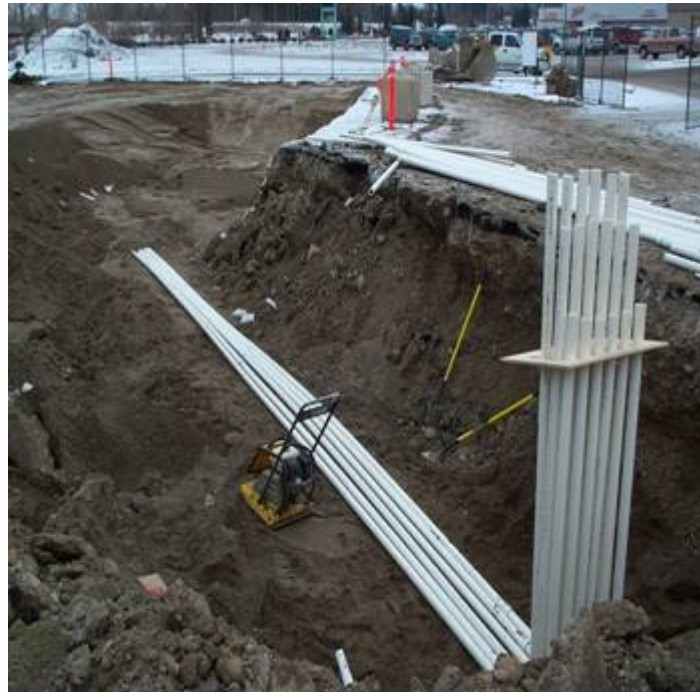
Horizontal Well Network Completion

- Each well brought up to grade individually and was completed in 4 separate headers of 6 wells each

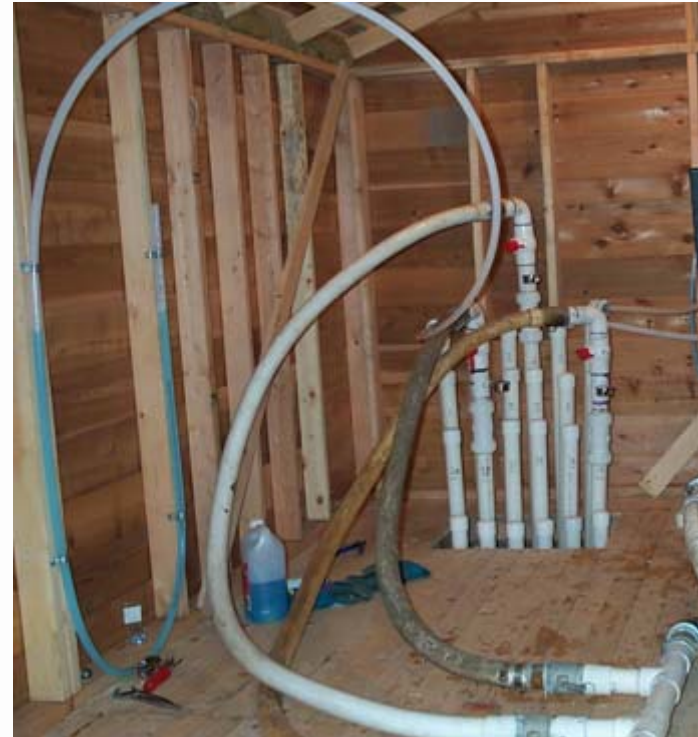
Horizontal Well Network Pilot Test

- **A series of pilot tests were conducted in order to:**
 - determine the radius of influence
 - the size of equipment that would be required to run the SVE system

- **Based on the results from the pilot test the equipment required was:**
 - Two 350 to 500 scfm blowers to provide 10 to 15 inHg of vacuum,
 - Two 300 scfm catalytic oxidizers or two 2000 lb activated carbon vessels to treat the extracted vapours

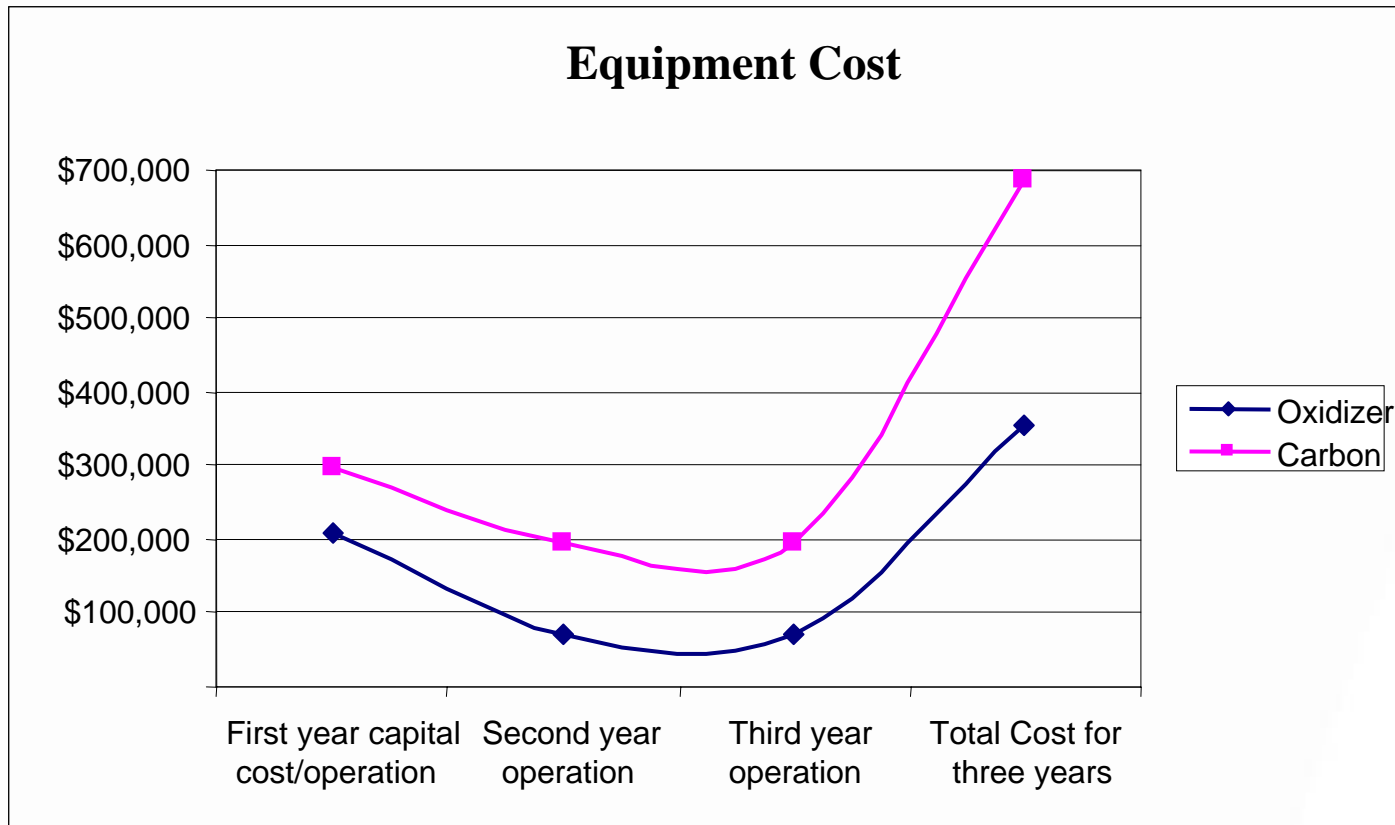
Cost Analysis

- Catalytic oxidizers
 - require less maintenance and are more reliable than activated carbon
 - no risk of breakthrough
 - high initial capital cost
- Activated Carbon
 - low initial capital cost
 - Initial savings offset by high cost in operation and disposal of used carbon

Note: Carbon consumption was estimated assuming extraction levels would decrease to 100 ppm after the first year of operations

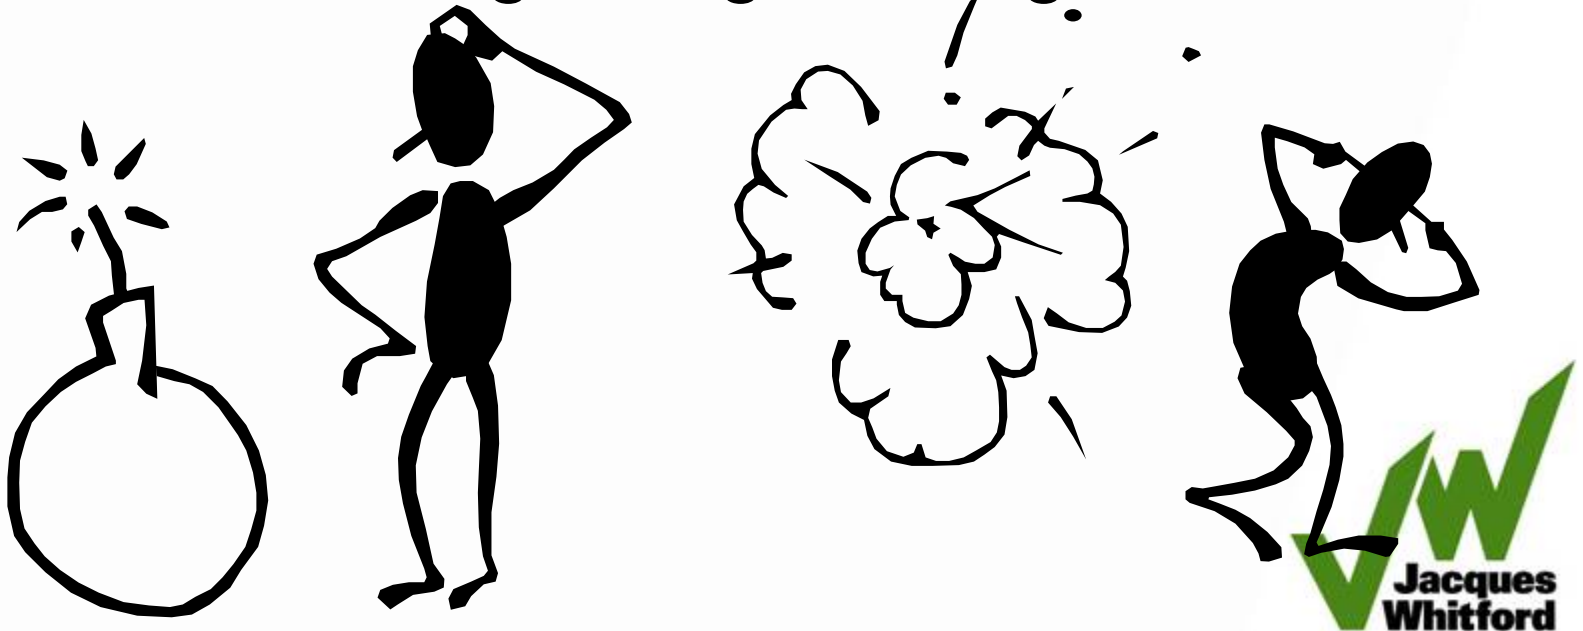
- After the start up of the system, several challenges were encountered:
 - Maintaining vacuum from the blowers between 10 and 15 inHg,
 - Keeping minimum temperature required at the oxidizers.
 - Cycling of the vacuum blowers causing them to overheat and turn off

- One month after start up of the system, one of the vacuum blowers (Side A) had to be completely replaced due to a failure with the bearings.
- A month later, the other blower (Side B) had to be replaced due to a broken shaft

- **A month after the blower from side B was completely replaced, the bearings had to be replaced...again**

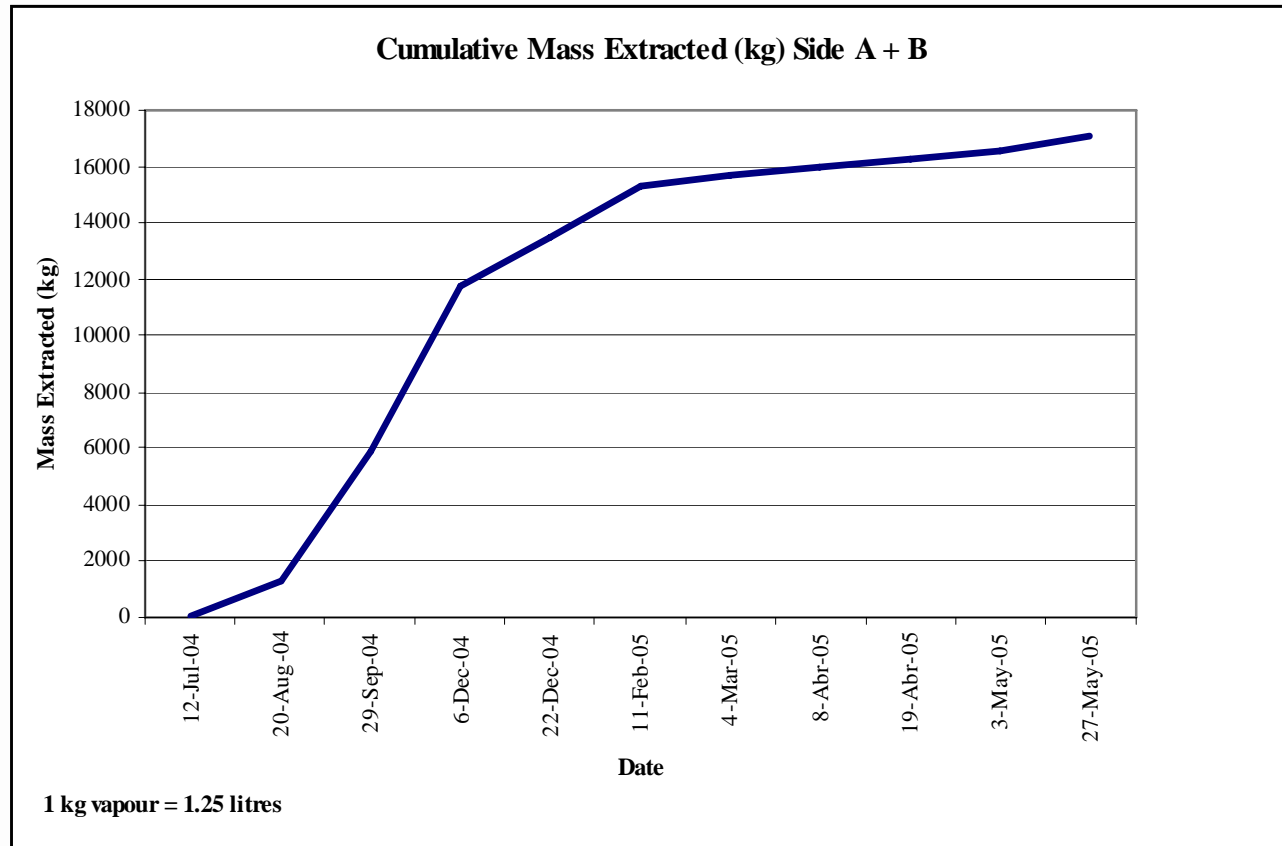
Mass Extracted to Date

- An estimate of 22,250 L of product have been remediated with the SVE System
- Approximately 60% of the released gasoline has been removed after 14 months of operation
