INVESTIGATION AND REMEDIATION STRATEGIES FOR A DNAPL IMPACTED SITE IN STRATIFIED SOILS

SEACOR
ENVIRONMENTAL INC.

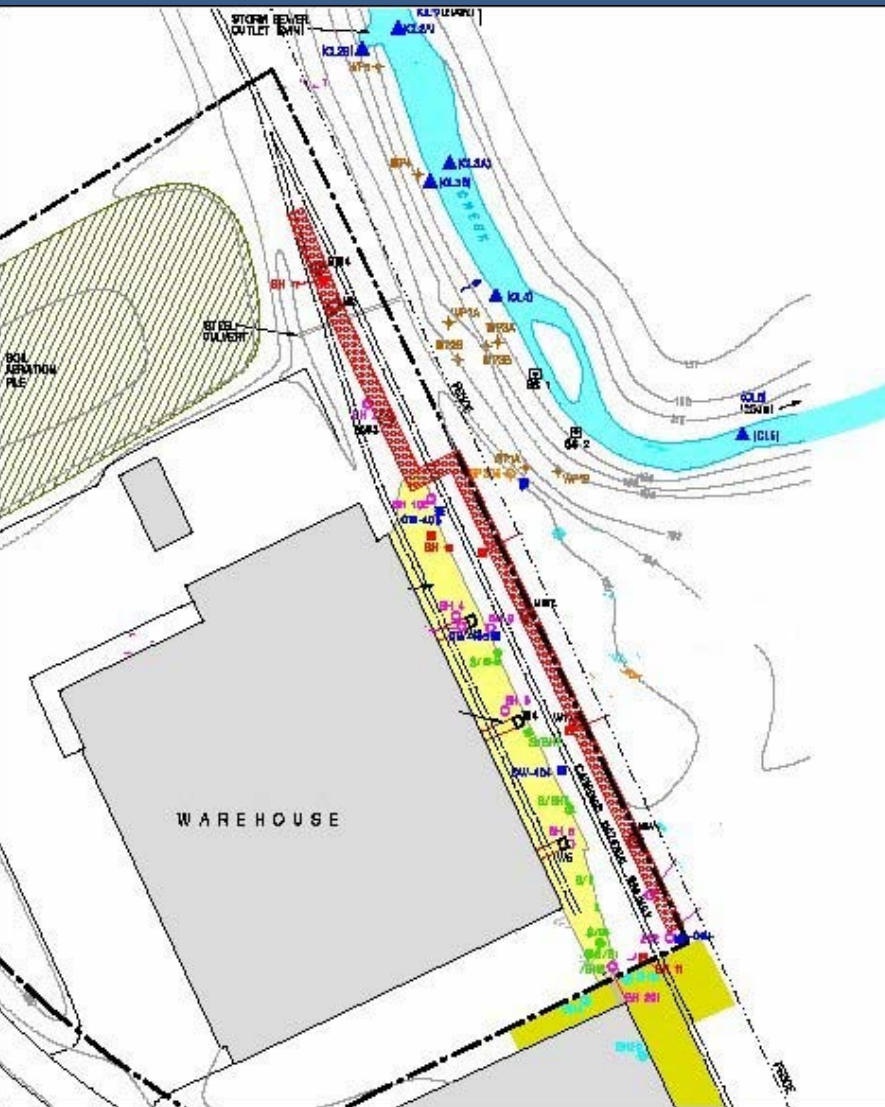
Case Study: Chemical Company Early Cleanup Measures

- Excavation zone
- Excavation zone II
- PCE collection trenches

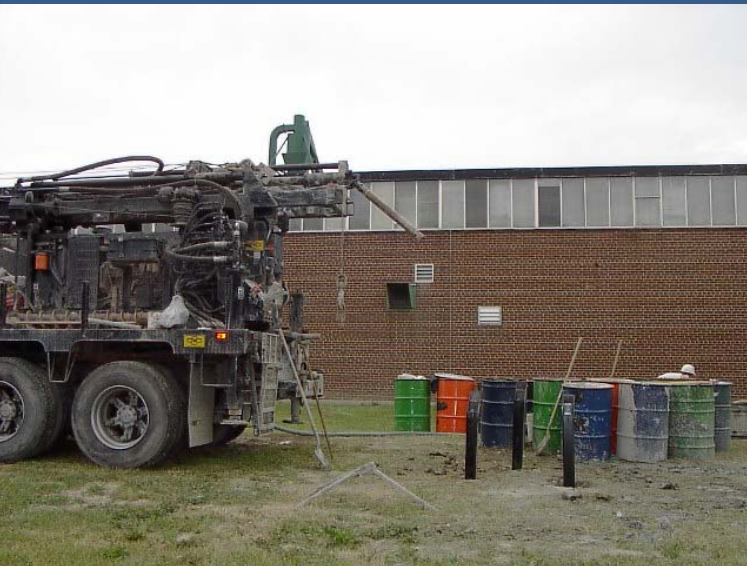
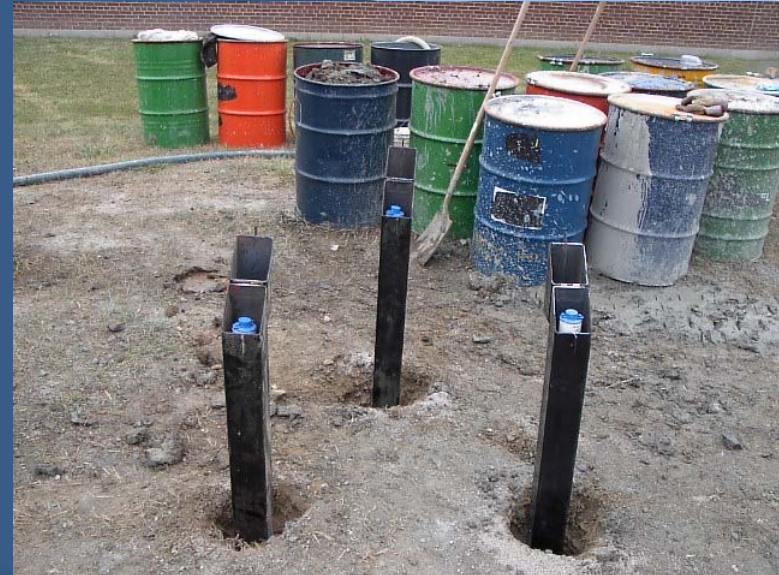
- Fourteen locations drilled in nests of three
- Consultant installed seven off site nests and SEACOR installed seven on site
- 2" PVC nests consisted of a well at 22' (7m), 45' (14m) and 65' (20m)

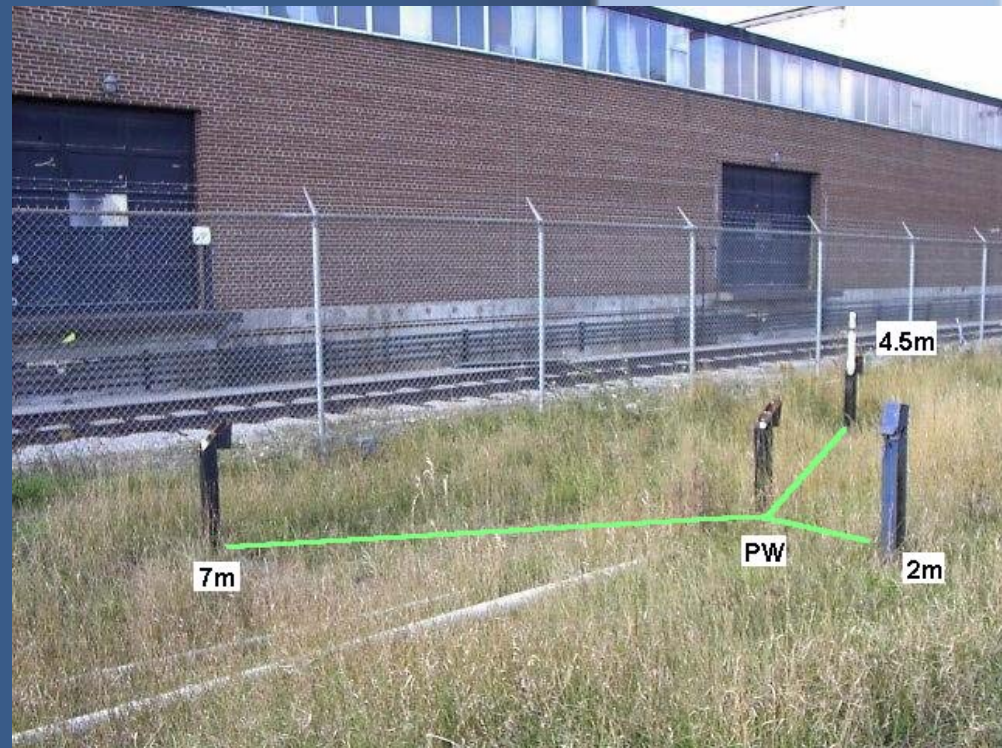
Proposed Pilot Test

- SEACOR proposed installing 2" extraction and radius monitoring wells to test each zone's response to VEMPE in turn
- Extraction wells installed in each Zone with 2m, 4.5m and 7m radius monitoring wells

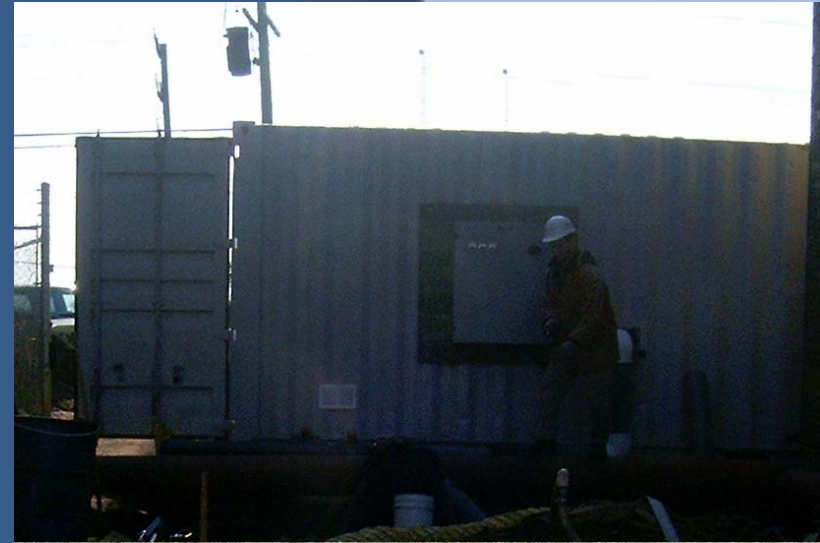
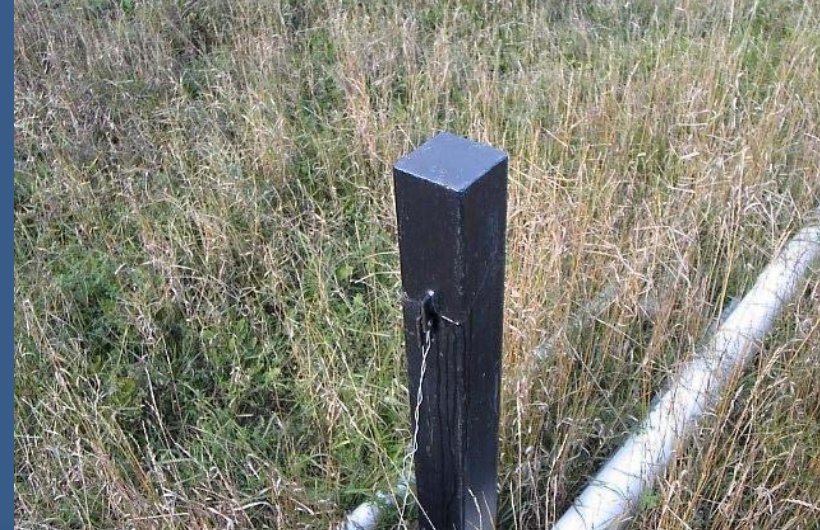
The System:

- Skid-mounted, 25 hp liquid ring vacuum pump unit
- Header line of 4" PVC ran from unit to each extraction well
- Liquid and air streams were collected and tied into existing remediation room air stripper and GAC

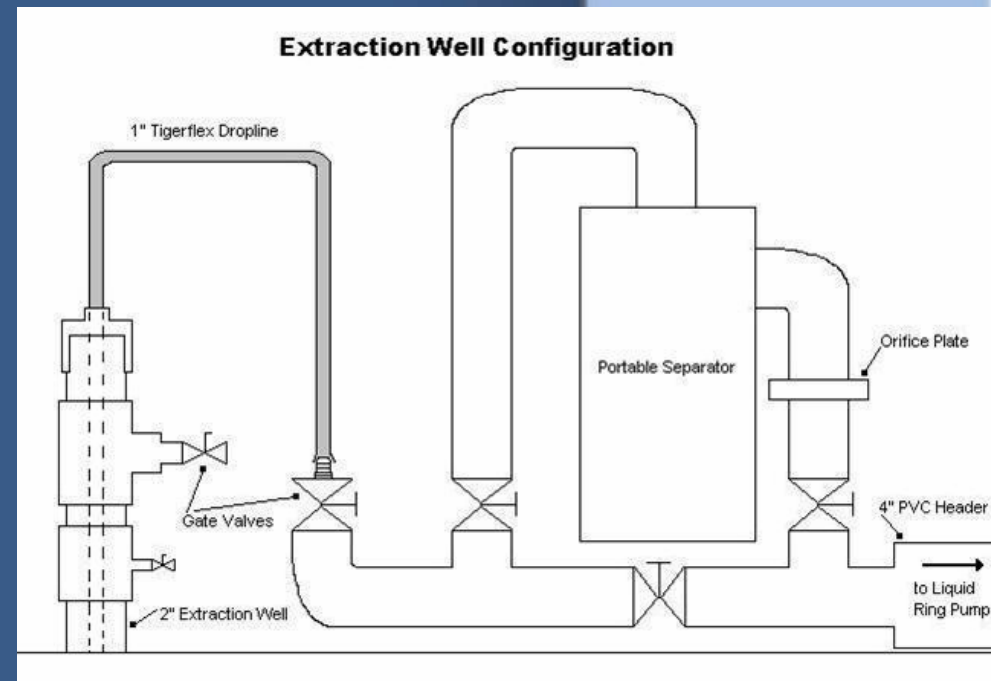
The Extraction Well:

- Modular well head coupled via 2" Cam-locks and could be moved to each test location
- Portable separator to measure air and water flow at well

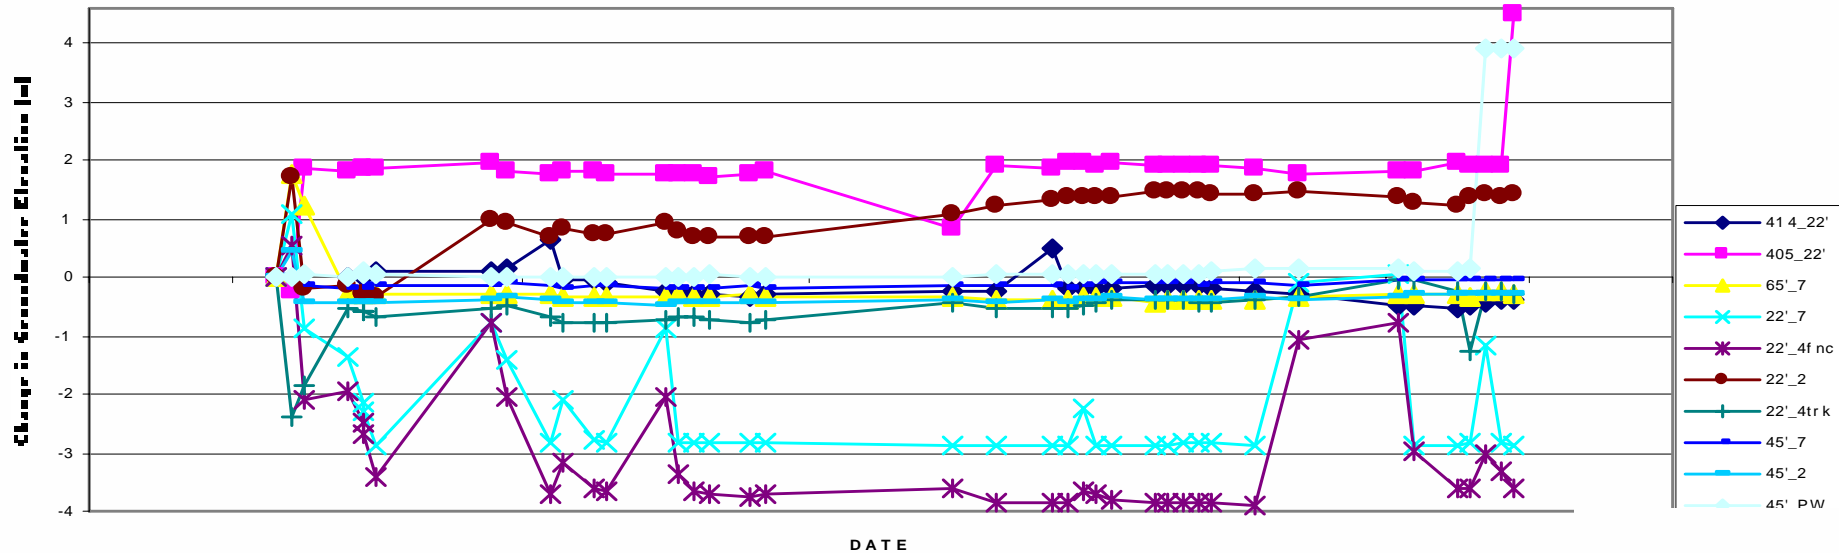
CHANGE IN GROUNDWATER ELEVATION - 22' Zone

- Overall drawdown and vacuum response was erratic due to shutdowns and a 'utility trench' nearby

- High, Medium and Low vacuum (17, 12 and 8" Hg) were run at this depth with extreme cold and shut down delays
- Excellent PCE removal (product observed in drop lines during start-up)
- 2.4 kg of PCE removed in 7300 l groundwater (5 l/day average pump rate)
- 350 kg of PCE removed in the vapour stream (290 g/hour average PCE removal rate)

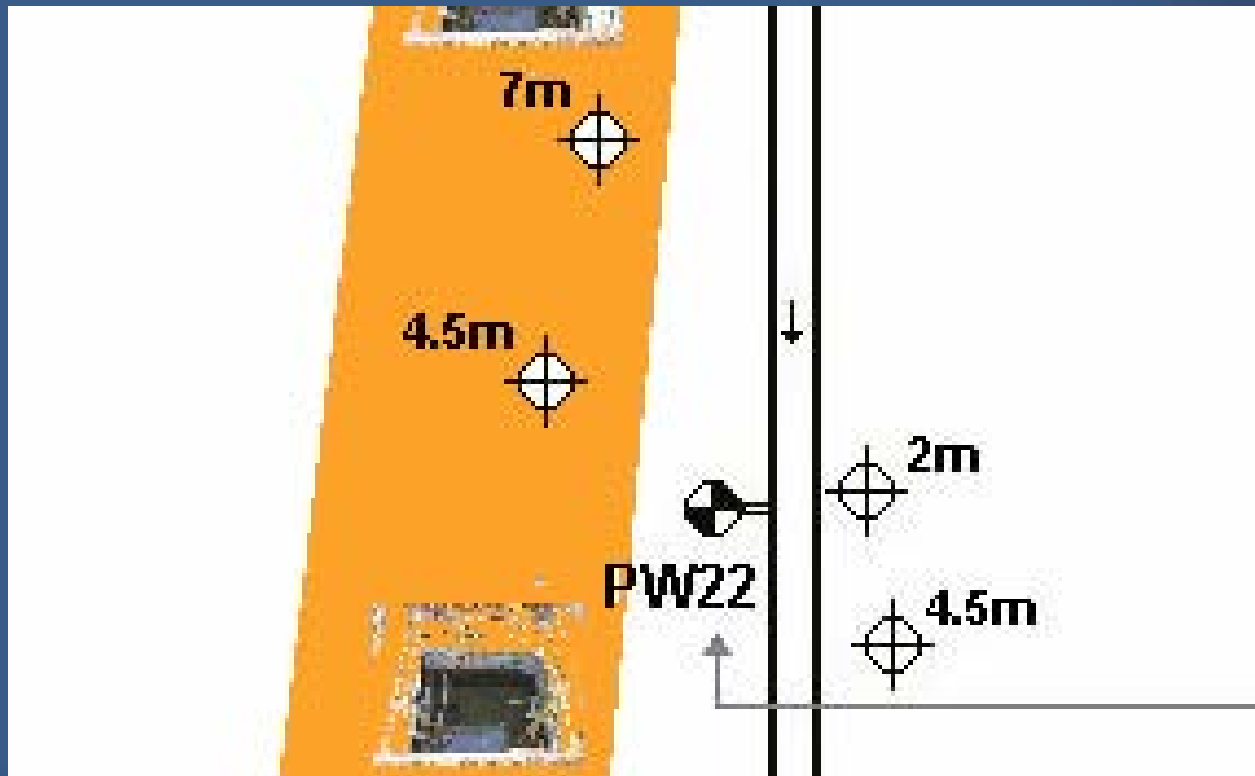
- Initially, all local monitor wells responded
- Once vacuum reached the trench, only drawdown and vacuum were observed in 22'_4.5F and 22'_7

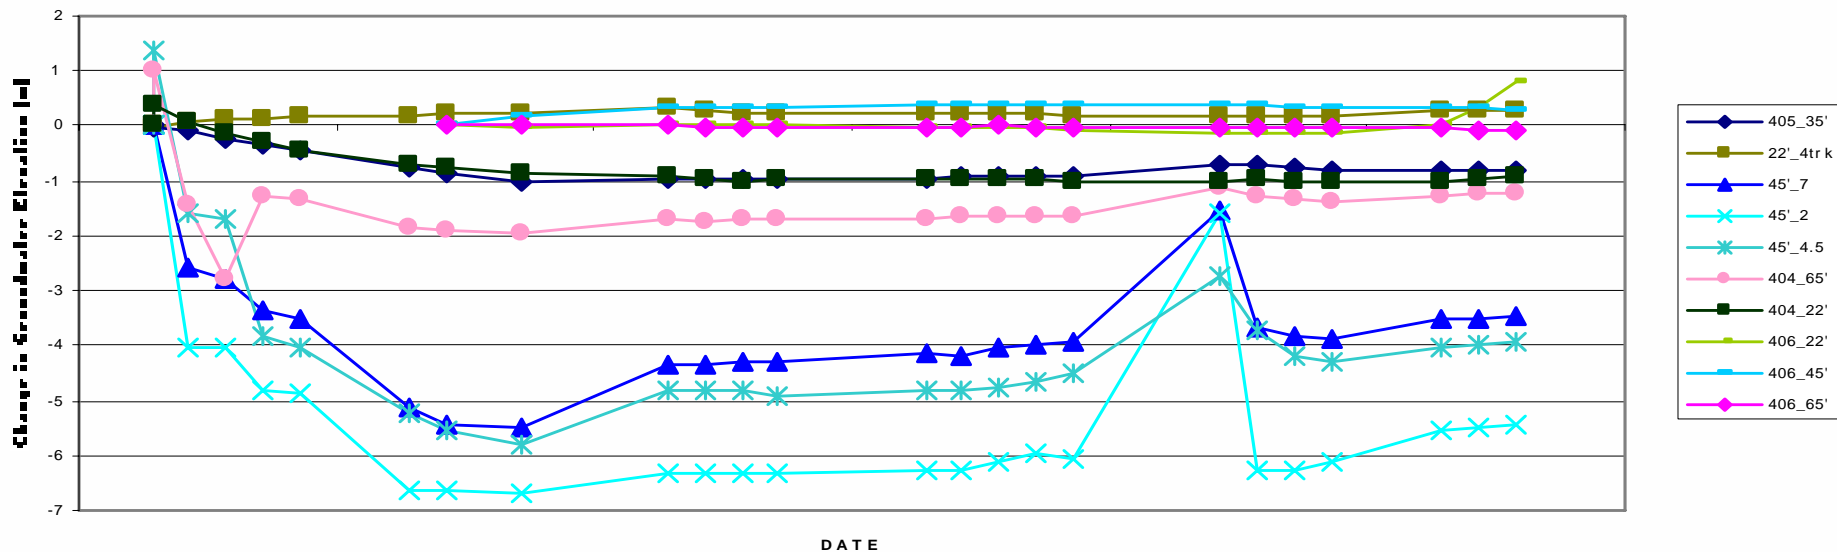
CHANGE IN GROUNDWATER ELEVATION - BRENNTAG PILOT TEST 30-45' ZONE

- Drawdown response very good (over 25m)
- Vacuum response noted between 2 and 4.5m

- High, Medium and Passive (no vacuum) were run at this depth (19, 12 and 0" Hg)
- Minor PCE removal but smoother operation
- 1.3 g of PCE removed in 2819 l groundwater (80 l/day average pump rate)
- 57 g of PCE removed in the vapour stream (0.07 g/hour average PCE removal rate)

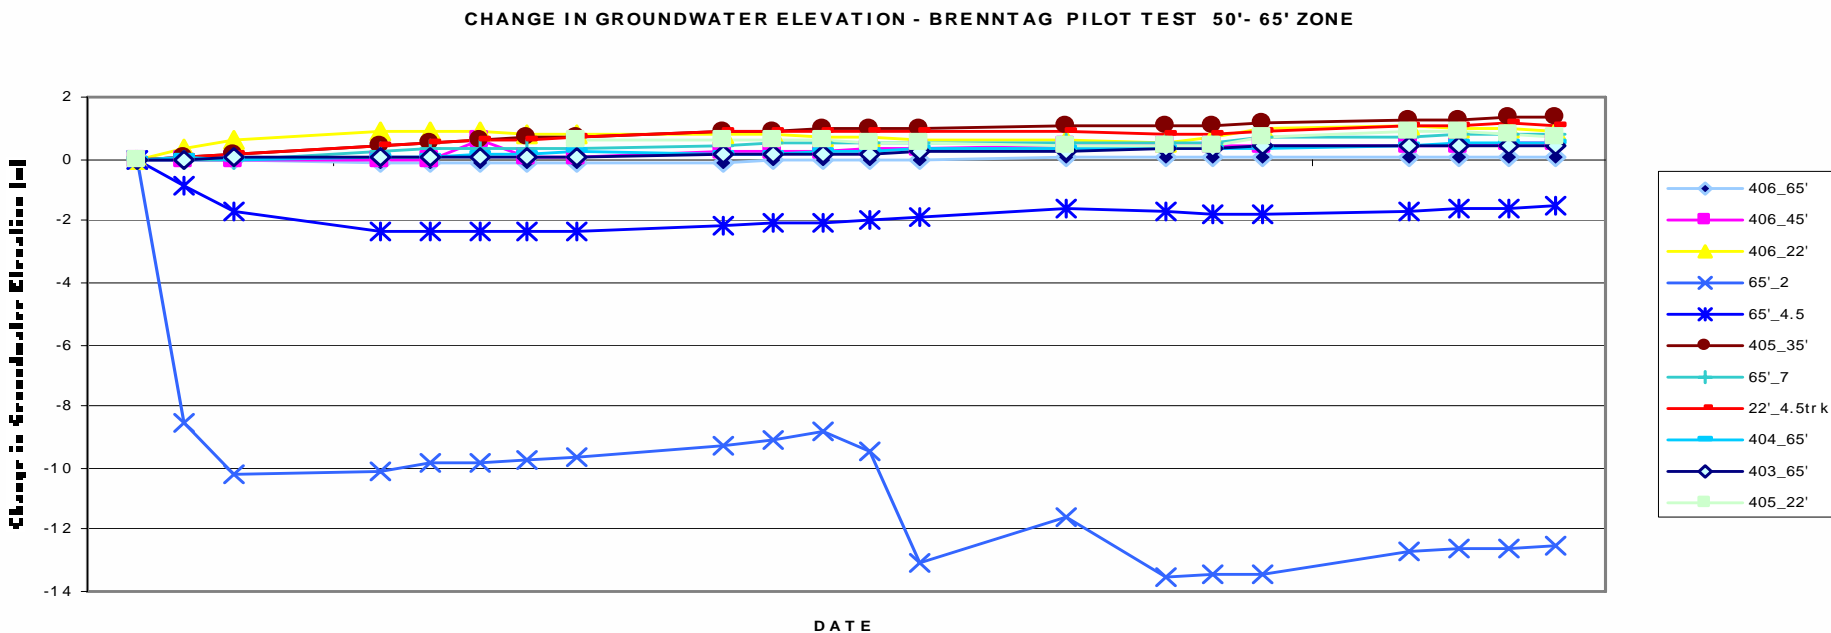
- Drawdown response between 4.5 and 7m
- Vacuum showed negligible response at 2m

- High, Medium and Passive (no vacuum) were run at this depth (17, 12 and 0" Hg)
- Fourteen locations drilled in nests of three
- Minor PCE removal (limited analytical confirmed)
- 0.8 g of PCE removed in 1016 l groundwater (36 l/day average pump rate)
- Low mass in vapour stream similar to Mid test

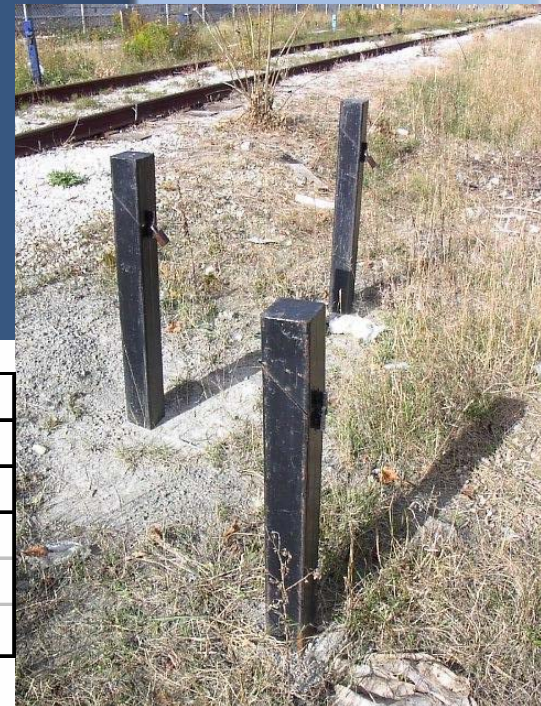
Average Hydraulic Conductivity Measured in Well Nests (k, m/s)

- k's averaged in the order of 10^{-7} m/s for Mid zone
- This appeared inconsistent with Pilot Test observations

Upper Zone	Mid Zone	Lower Zone
Soil Unit:	Clayey Silt	Sandy Silt	Sandy Silt/Clay Silt
Aprx. Screen Interval:	3.5 - 6.5 m	7.5 - 10.5 m	16 - 19 m
Average k (Hvorslev):	2.08×10^{-8}	2.03×10^{-7}	2.51×10^{-7}

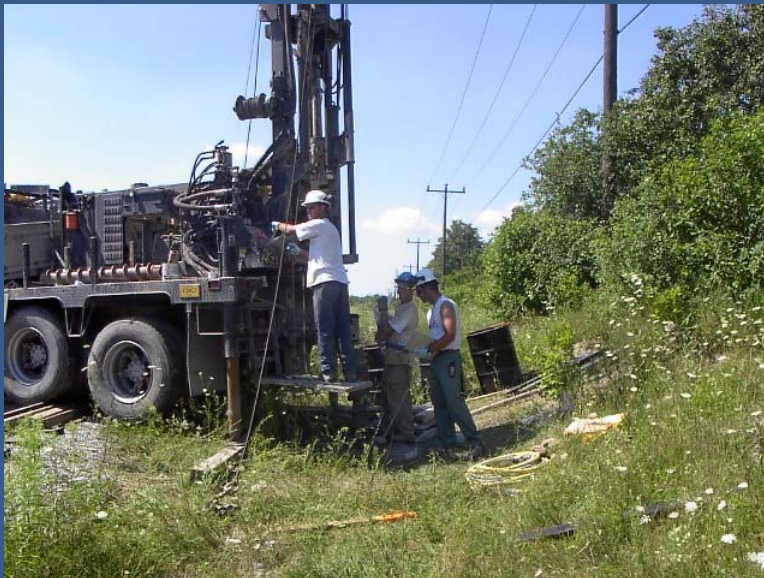
Hydraulic Control Well Pilot (H-well)

- Two 4" PVC H-wells were installed at the property line (H-1 and H-2)
- Pumping tests revealed low k values again, but more evidence of drawdown influence

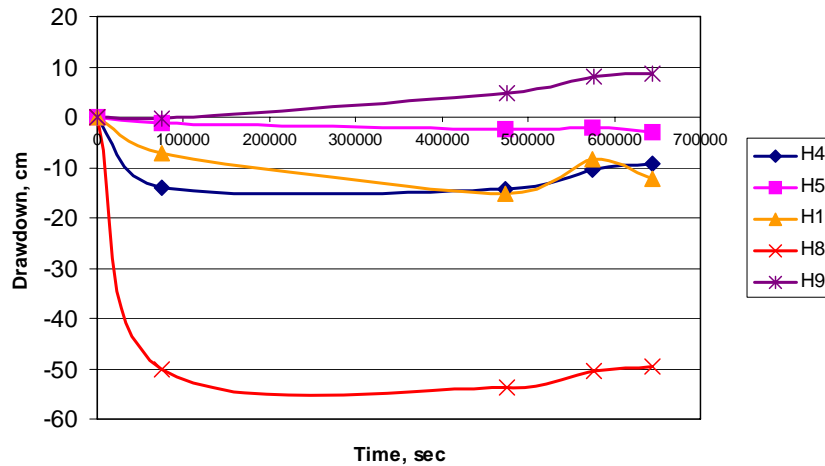
Chart 2: Head Drawdown in Neighboring H-Wells, June 2005

- The Consultant requested the testing of each individual H-well for k
- Testing was performed in 2 stages, every other well and then the alternate set
- Results again showed low k values, but observed evidence of influence in H-well midpoints and well nests
