# Hydrocarbon Impacts and Remedial Action at an Active Service Station

Jeff Linke, Chevron Canada Limited, Vancouver, BC  
Saleh A. Haidar, Keystone Environmental, Burnaby, BC  
Remediation Technologies Symposium 2006  
Fairmont Banff Springs Hotel  
October 11, 2006

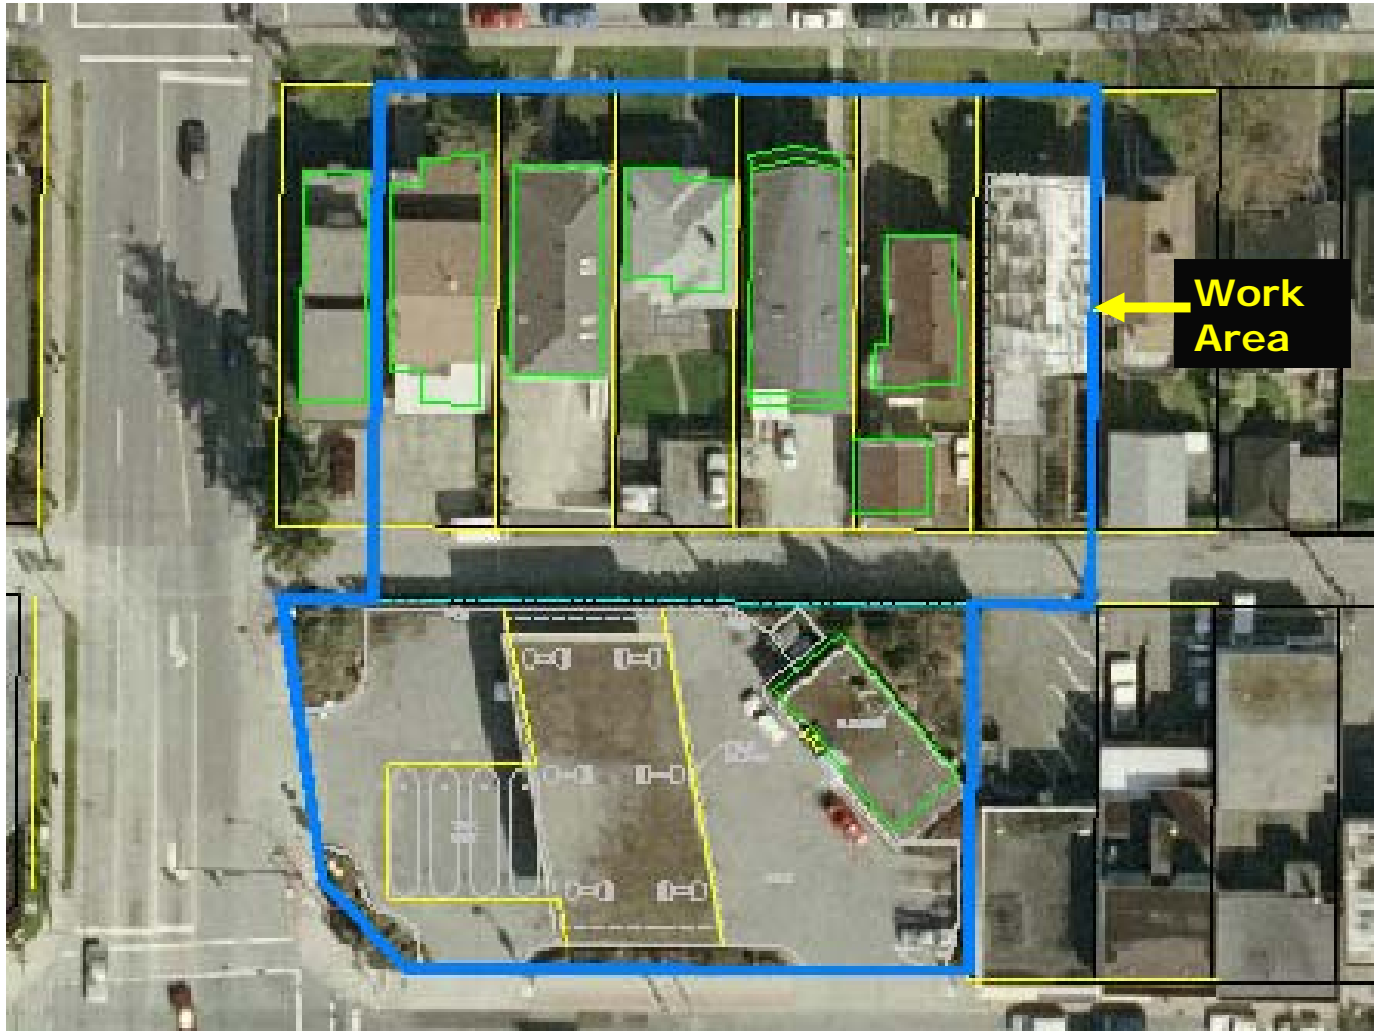
# SITE LAYOUT

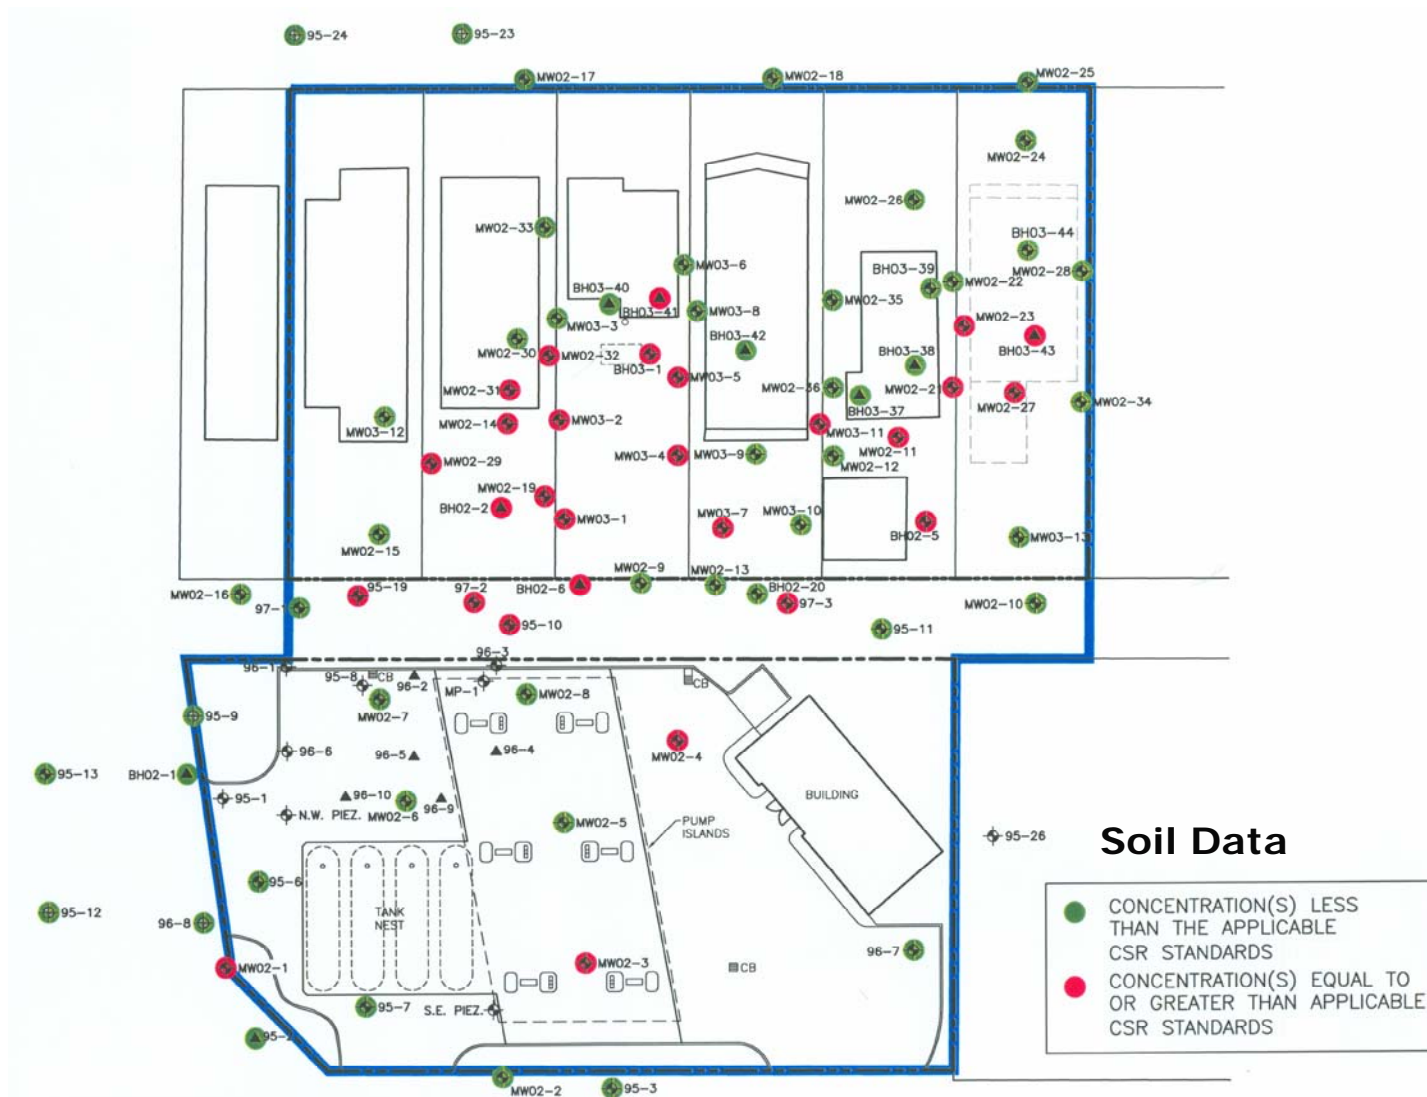
## INVESTIGATED AREAS

- Keystone Environmental Conducts Detailed Site Investigation
  - 62 Boreholes Advanced On and Off-Site
  - Analyzed > 400 Soil samples for Hydrocarbon Indicators
  - Analyzed > 500 Ground Water Samples for Hydrocarbon Indicators
  - Developed Detailed Conceptual Site Model
- Conducted Indoor Air Quality Monitoring
- Regular Liaison with Stakeholders (i.e. Residents, Local and Provincial Governments)

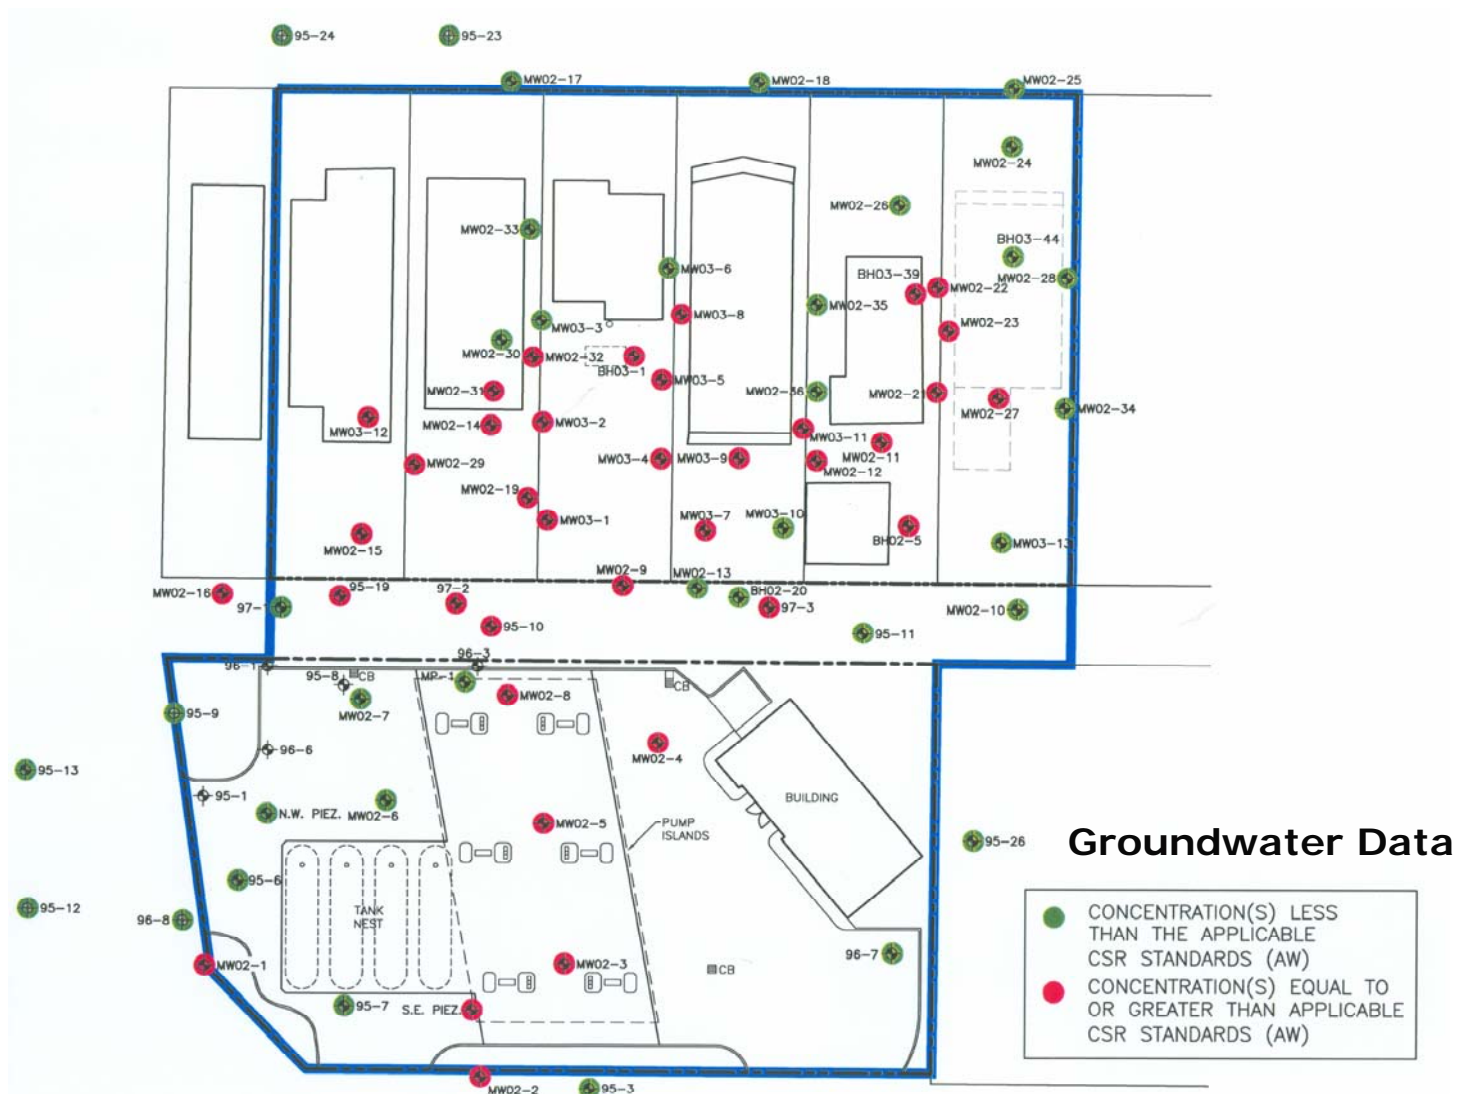
# INVESTIGATED AREAS

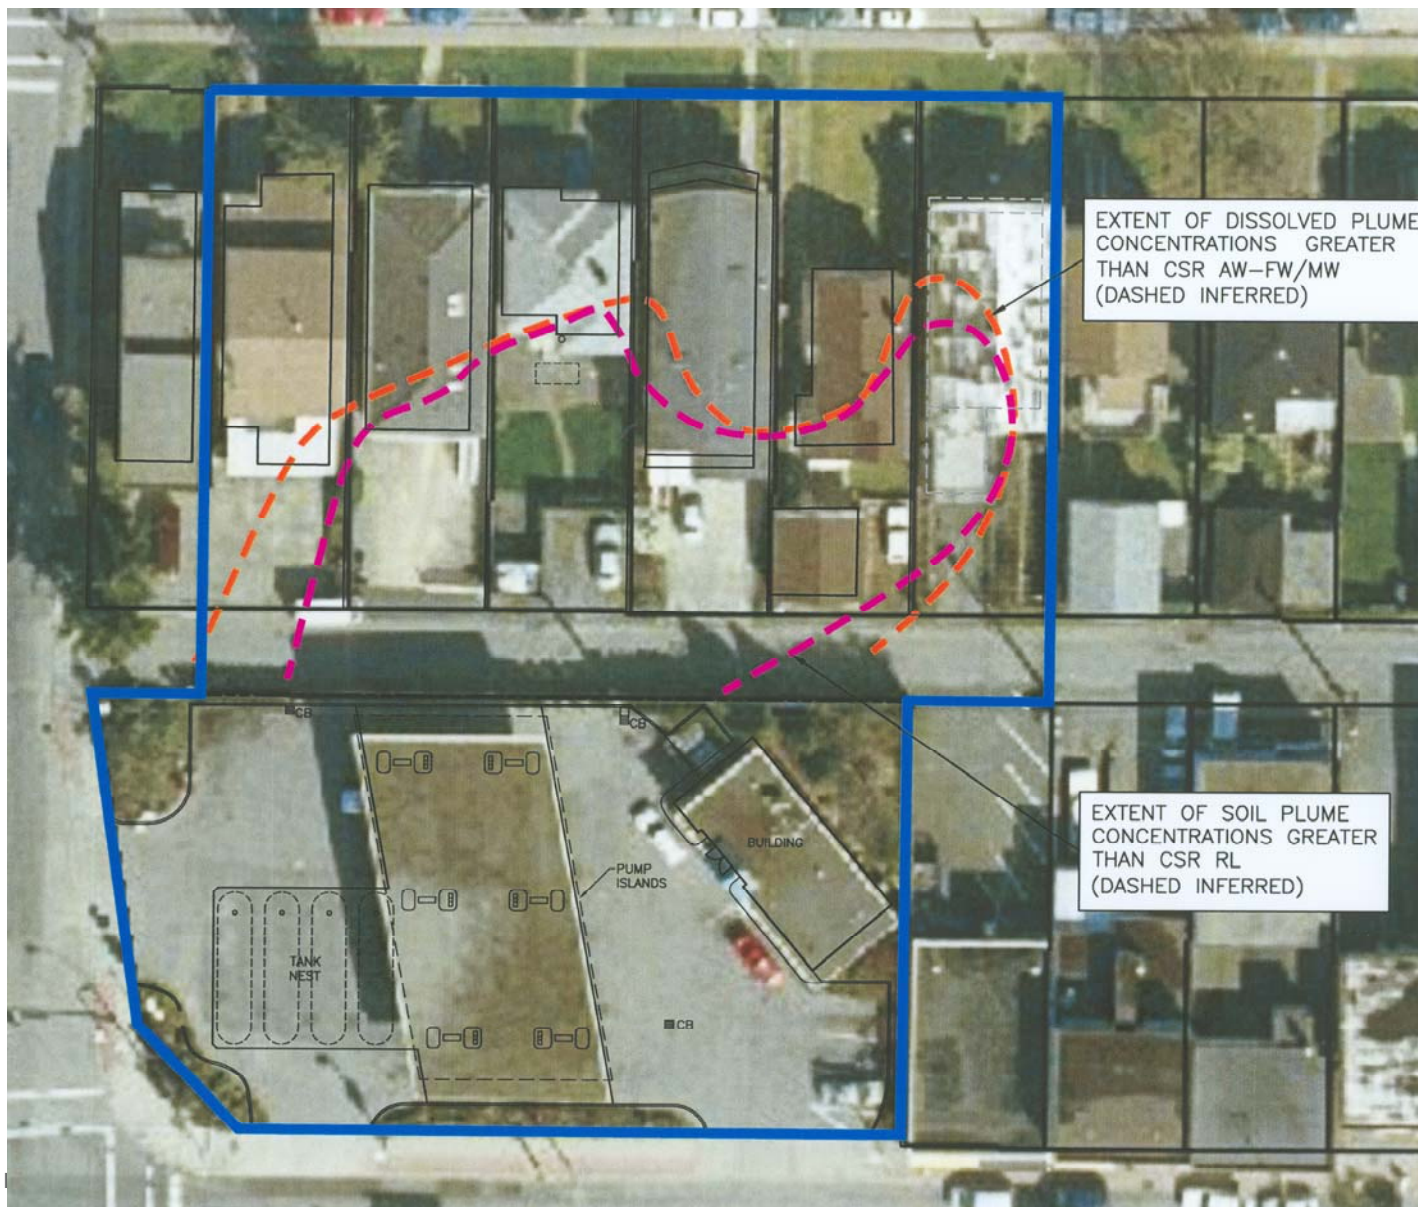
# SOIL AND GROUNDWATER PLUME

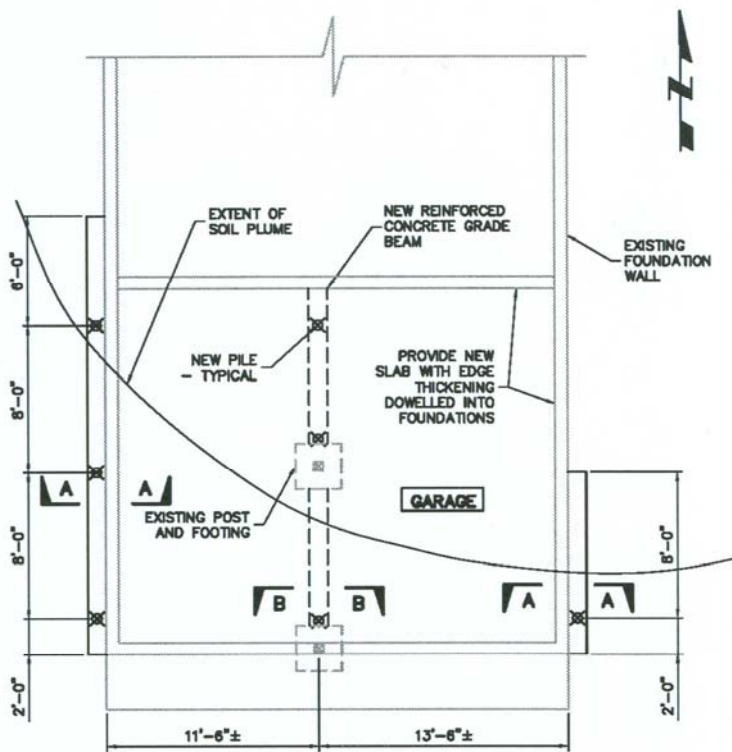
**FOUNDATION PLAN**

- Piles and grade beams installed on 4 homes
- One home demolished

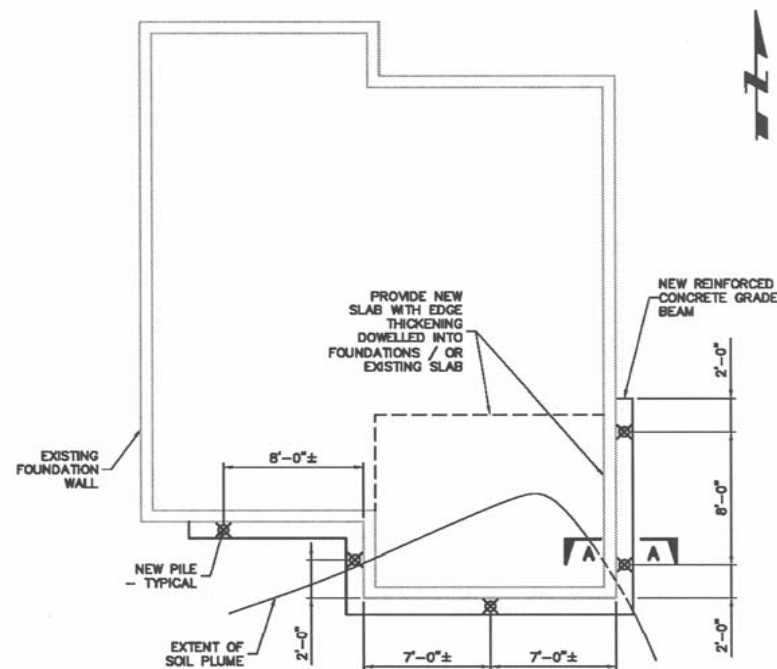
**FOUNDATION PLAN**

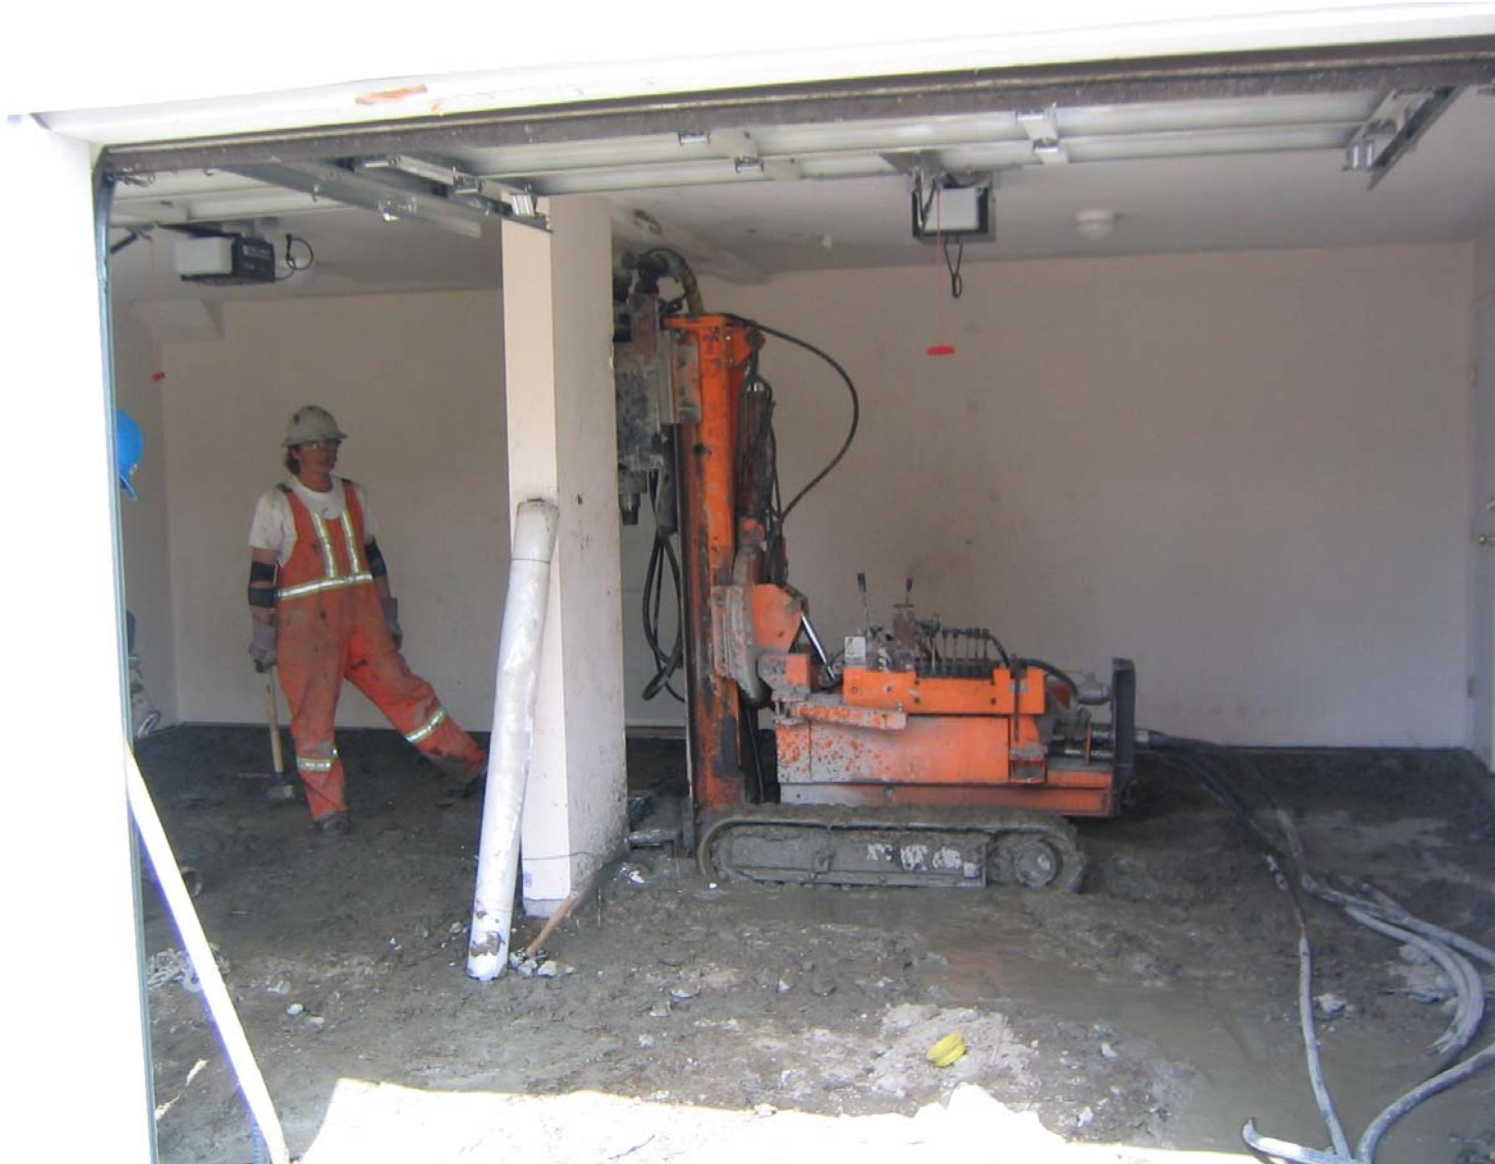
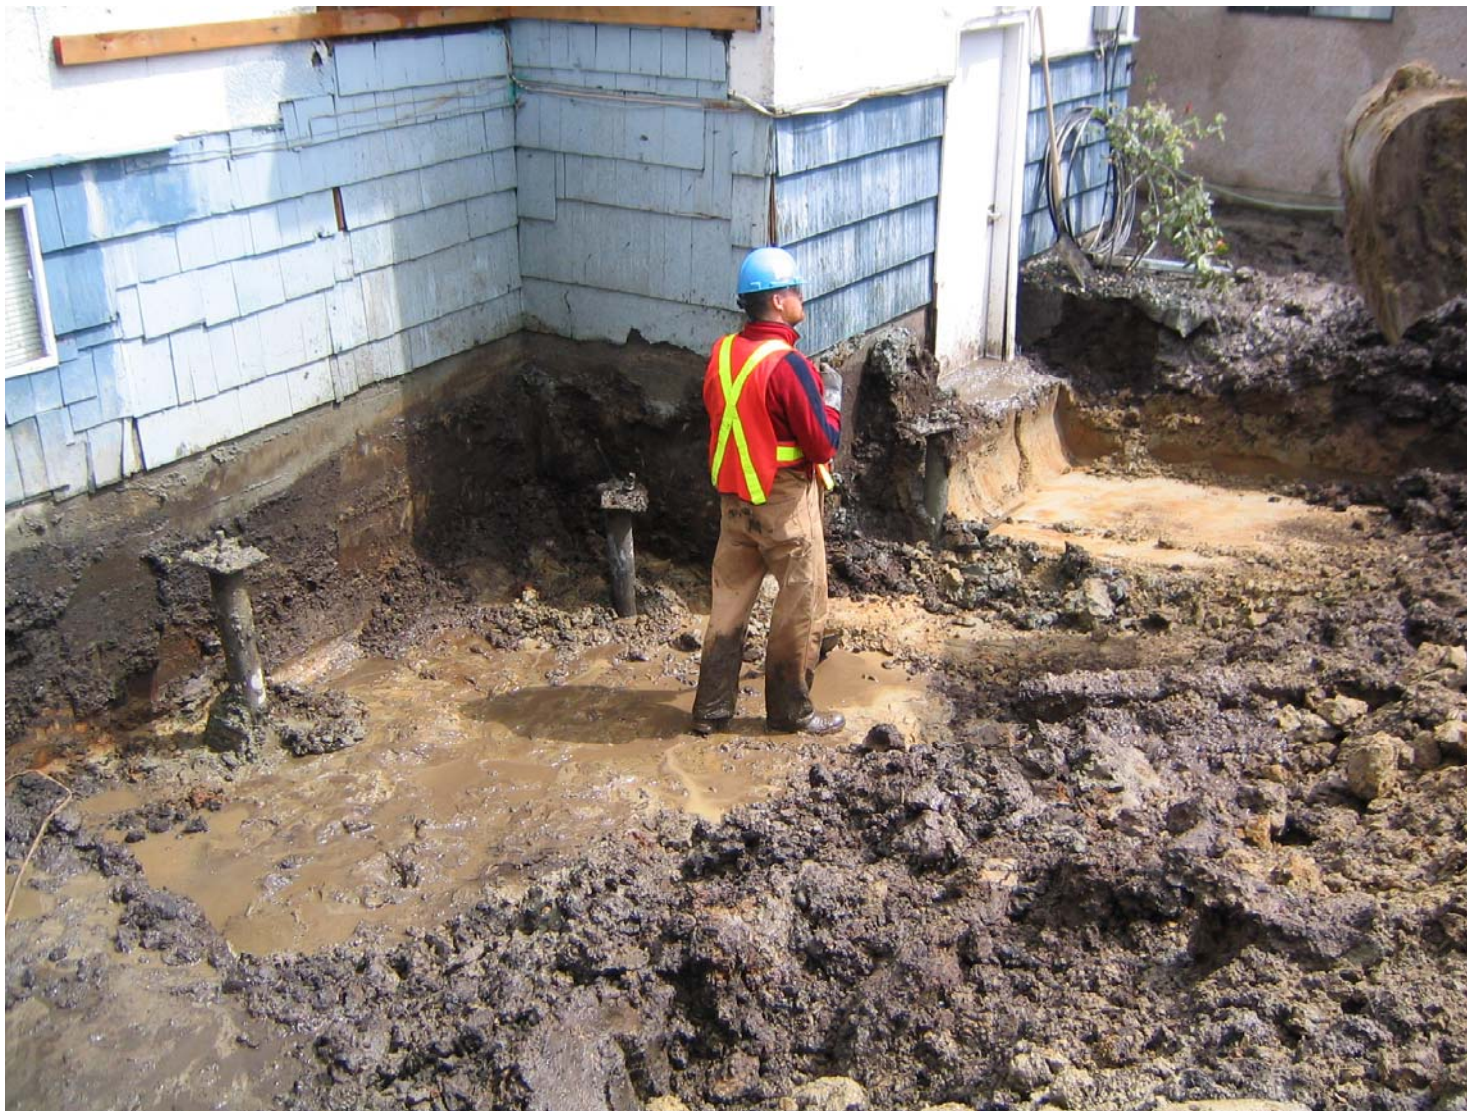
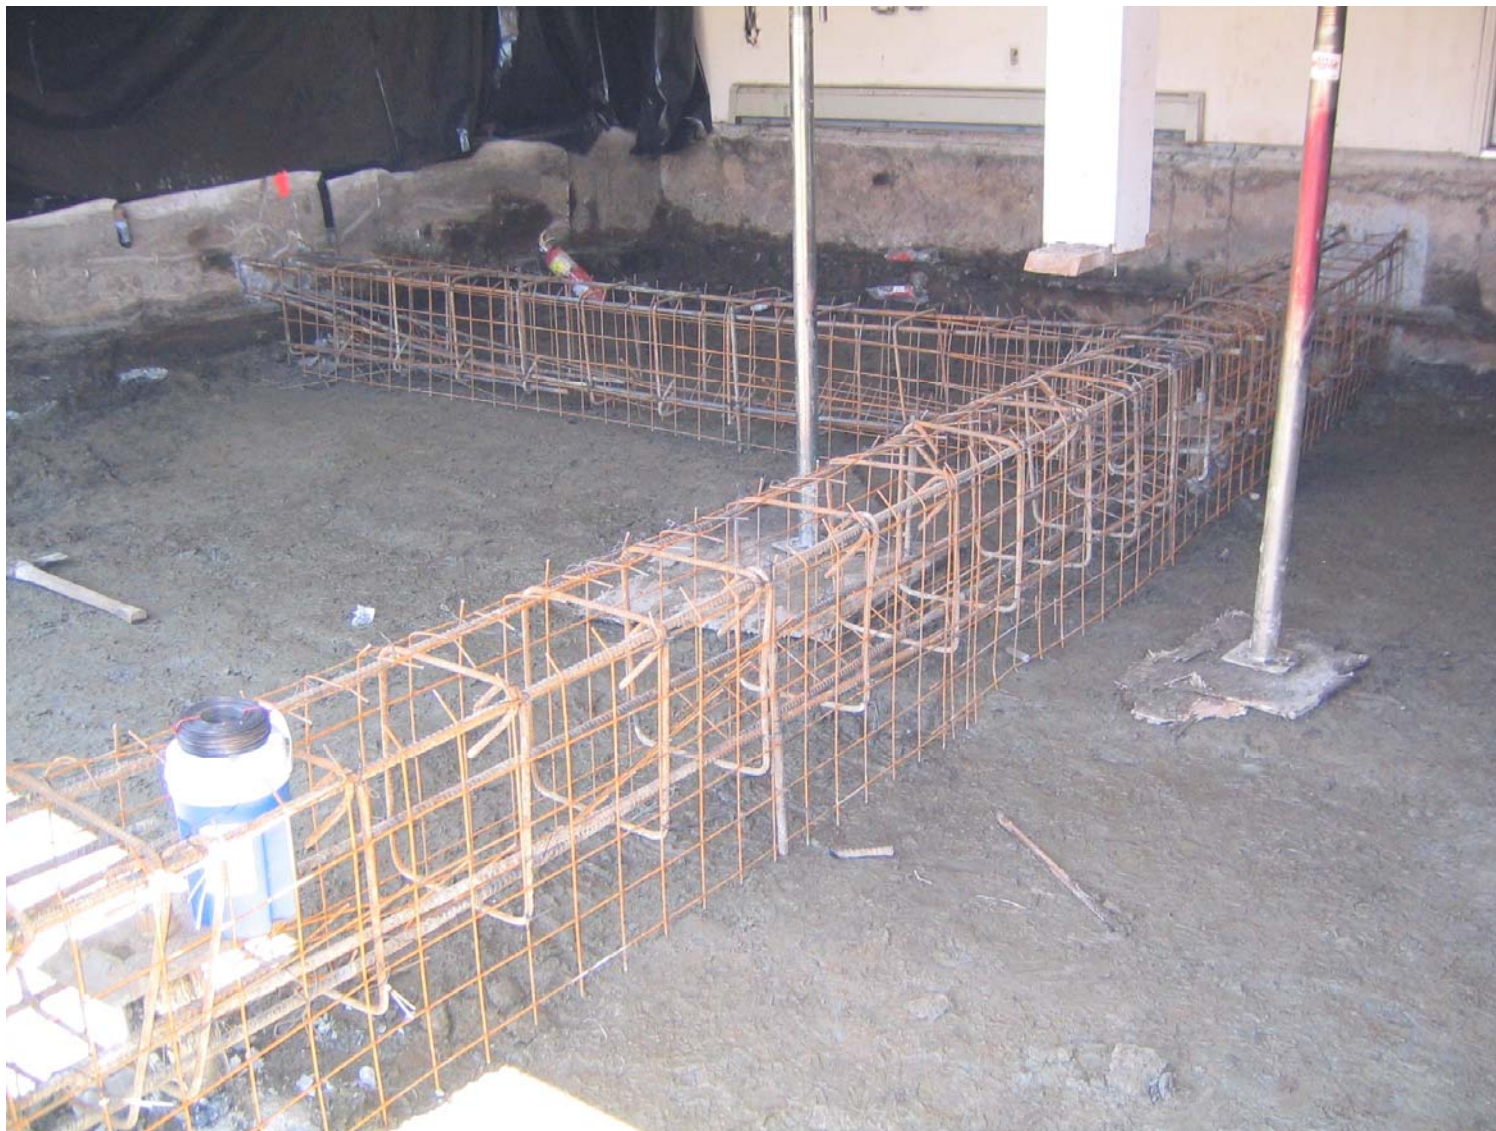
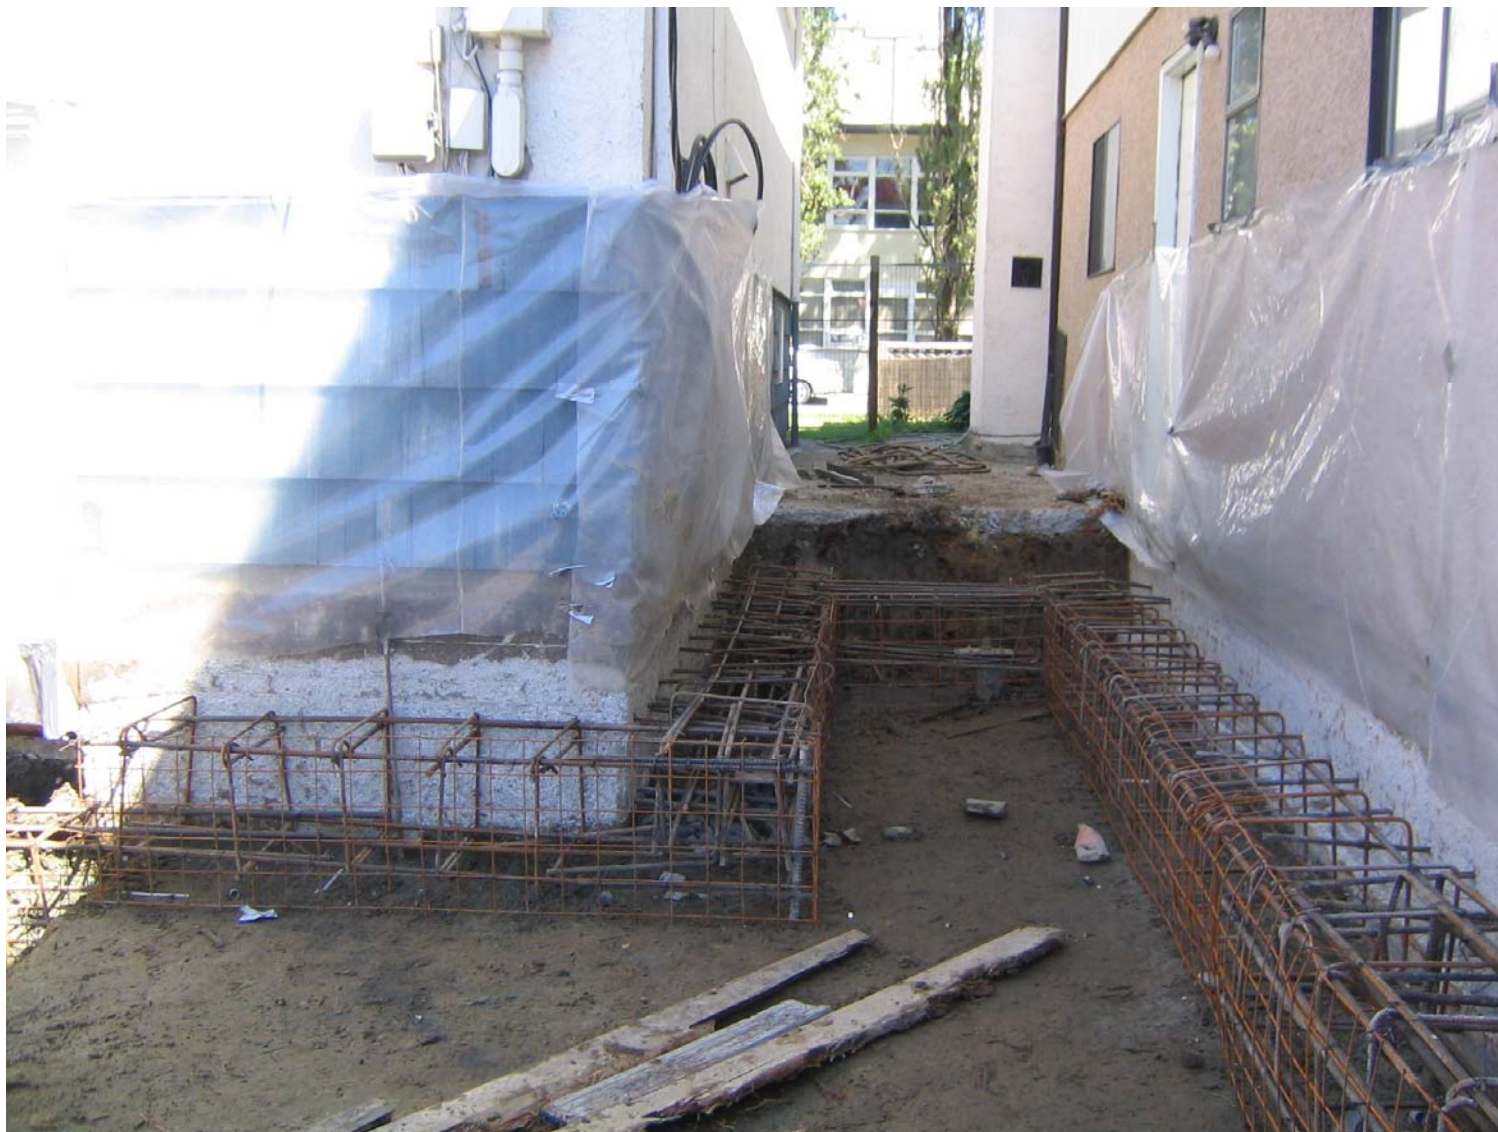
# UNDERPINNING AND SHORING

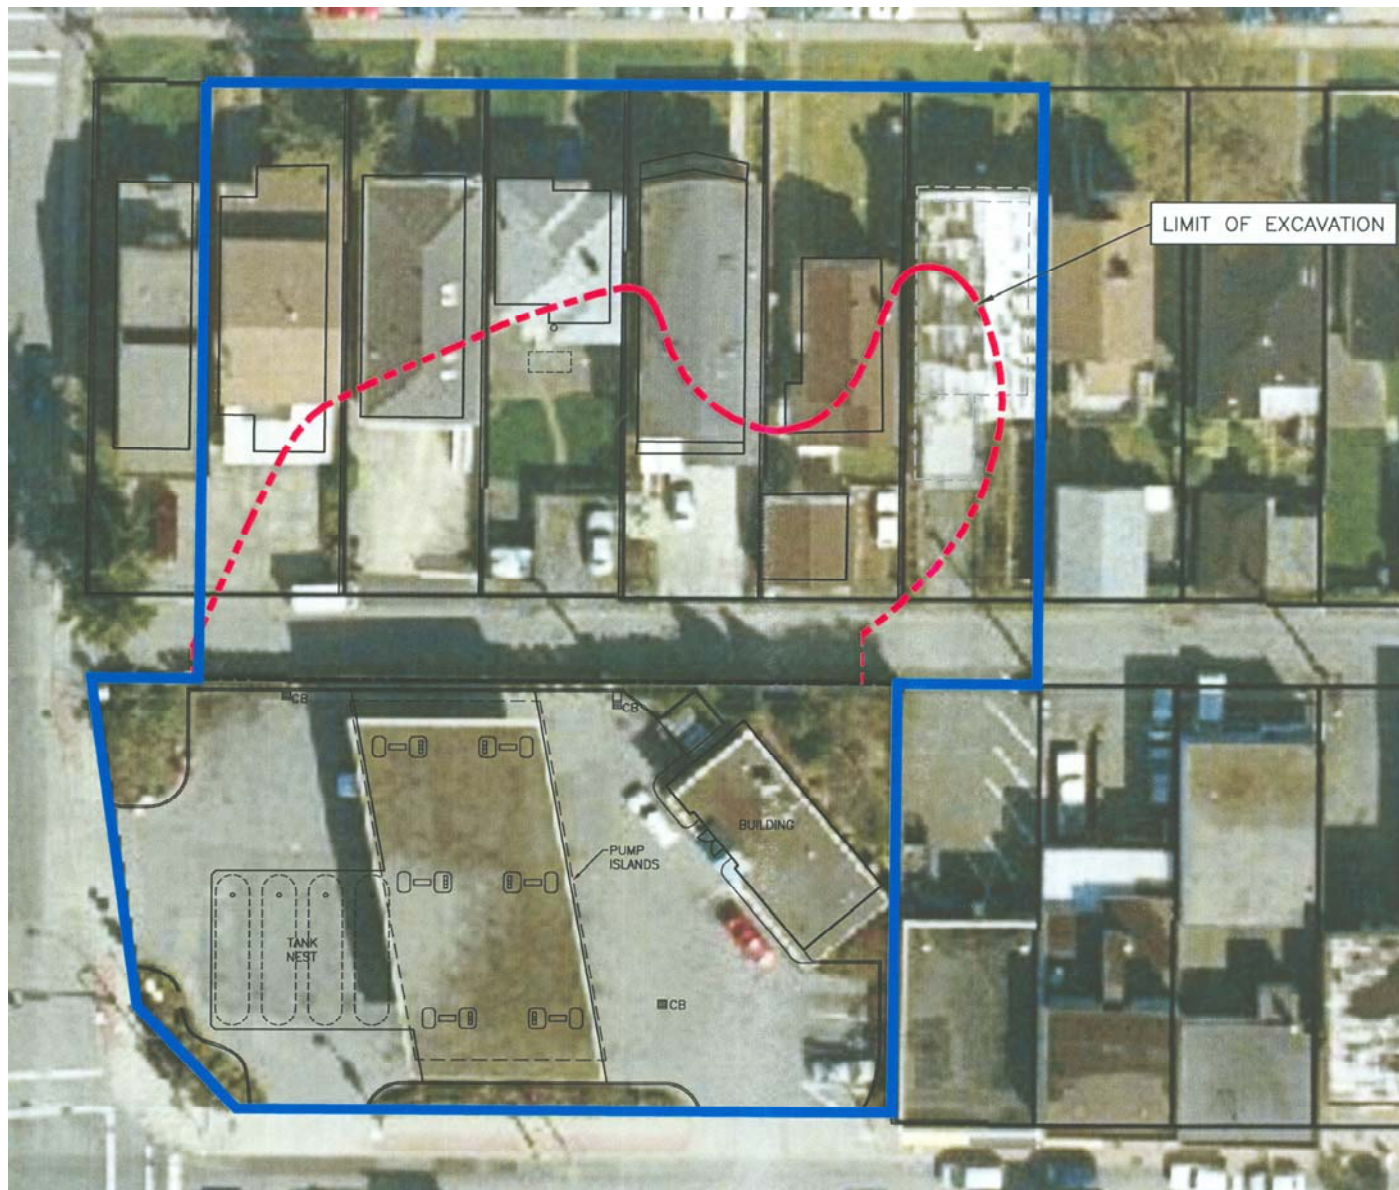
# EXCAVATION LIMITS

- Removed all backyard improvements
- Removed soil from backyards and under homes
