# Hydrocarbon Impacts and Remedial Action at an Active Service Station

Jeff Linke, Chevron Canada Limited, Vancouver, BC  
Saleh A. Haidar, Keystone Environmental, Burnaby, BC  
Remediation Technologies Symposium 2006  
Fairmont Banff Springs Hotel  
October 11, 2006

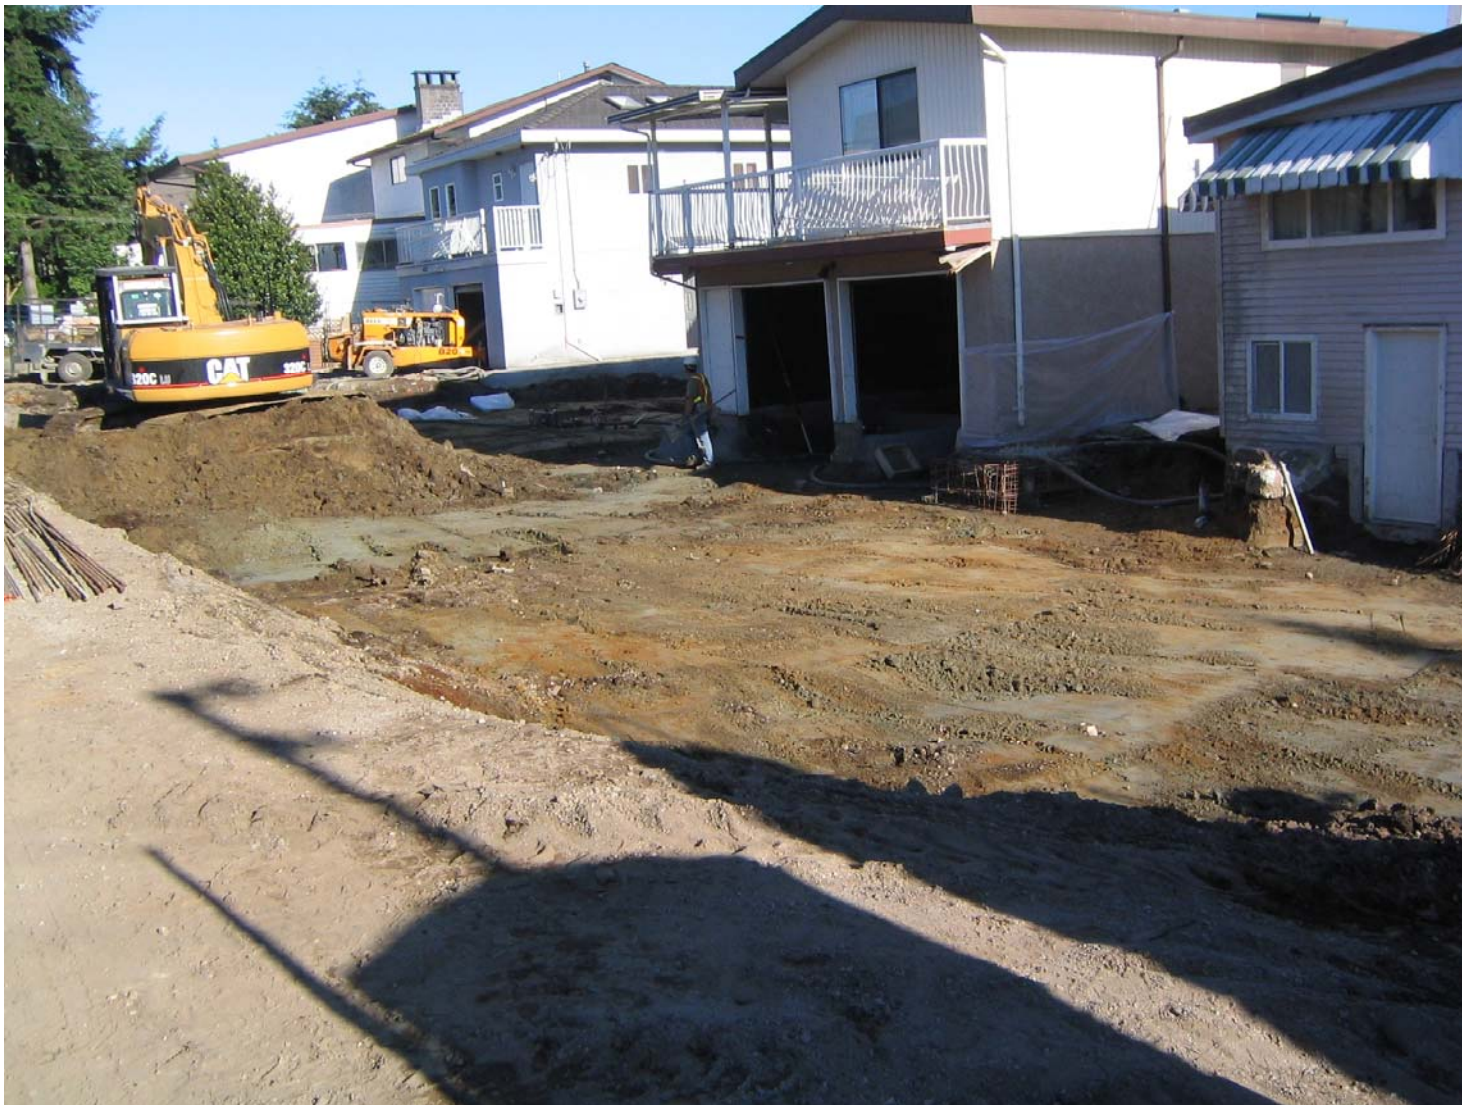
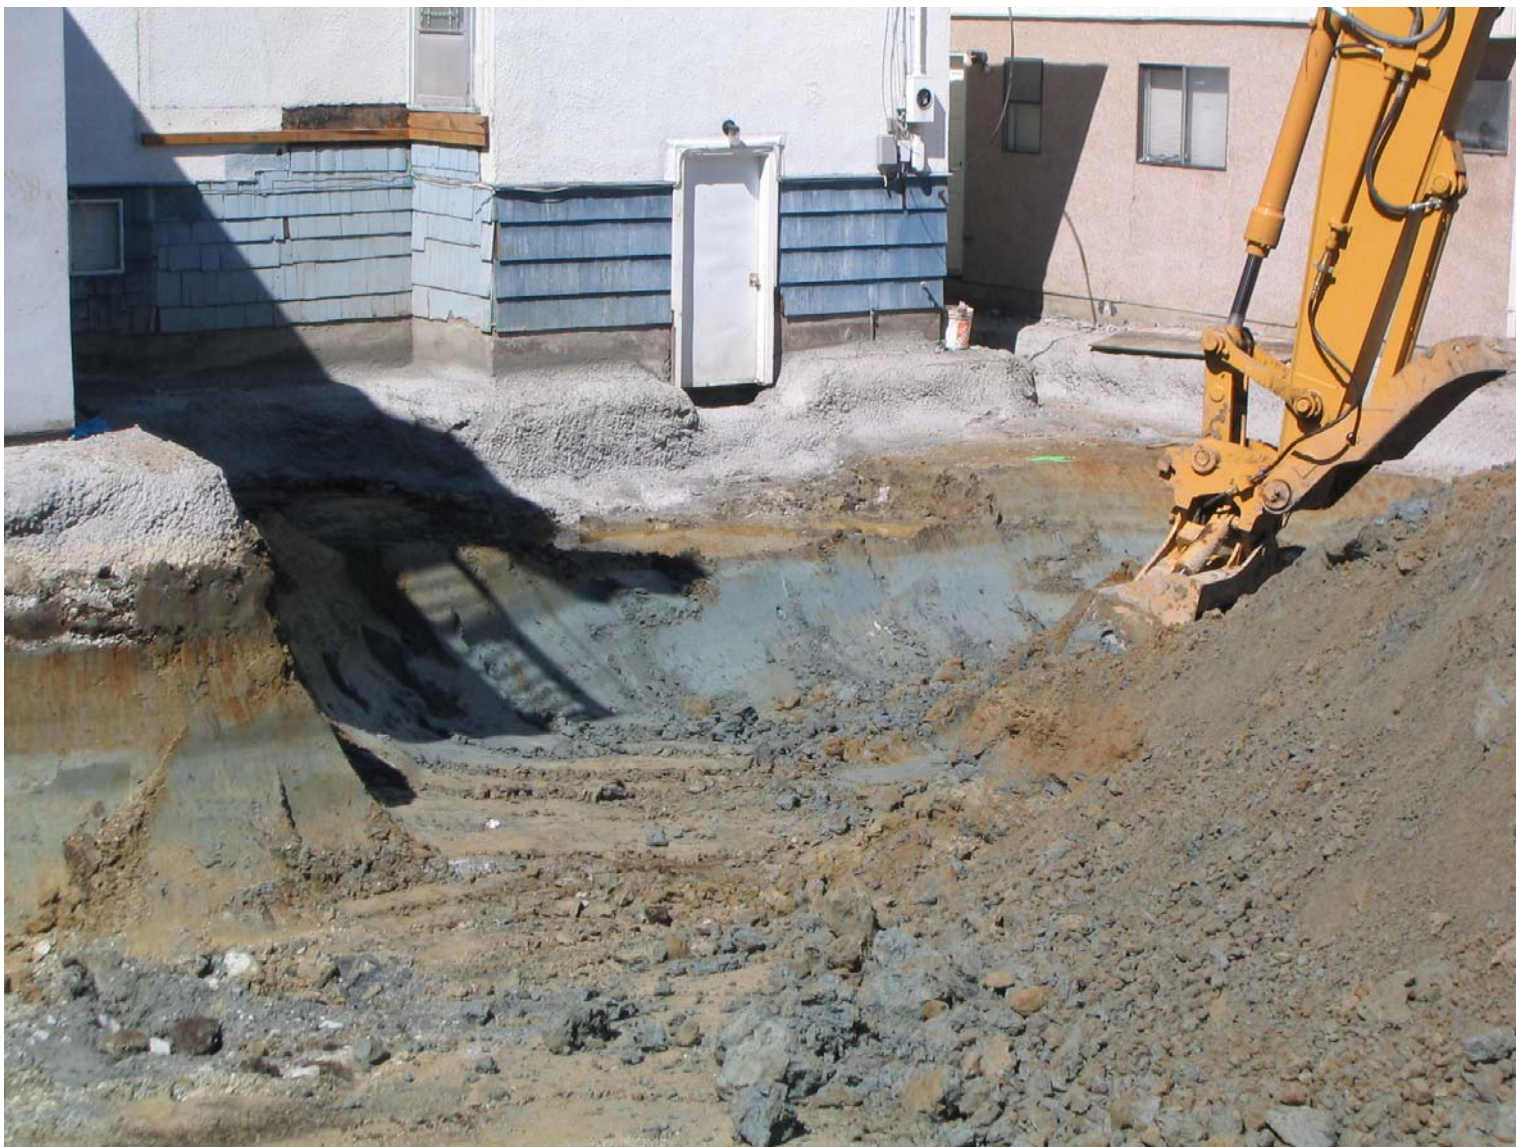
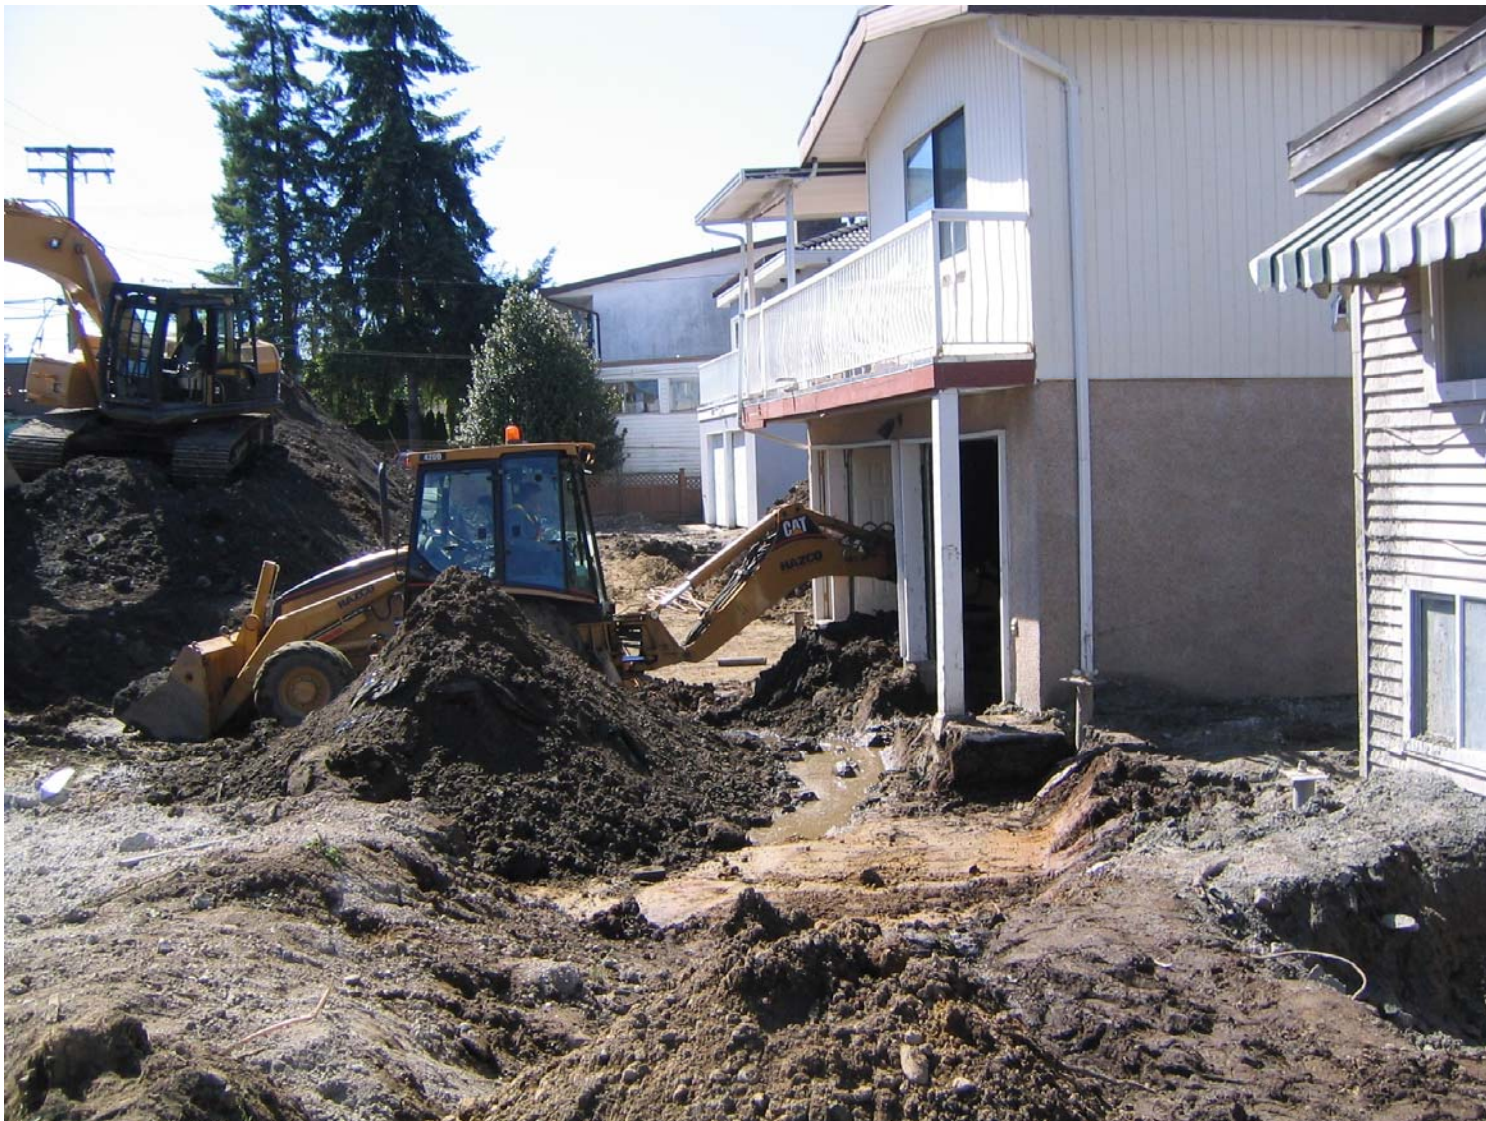
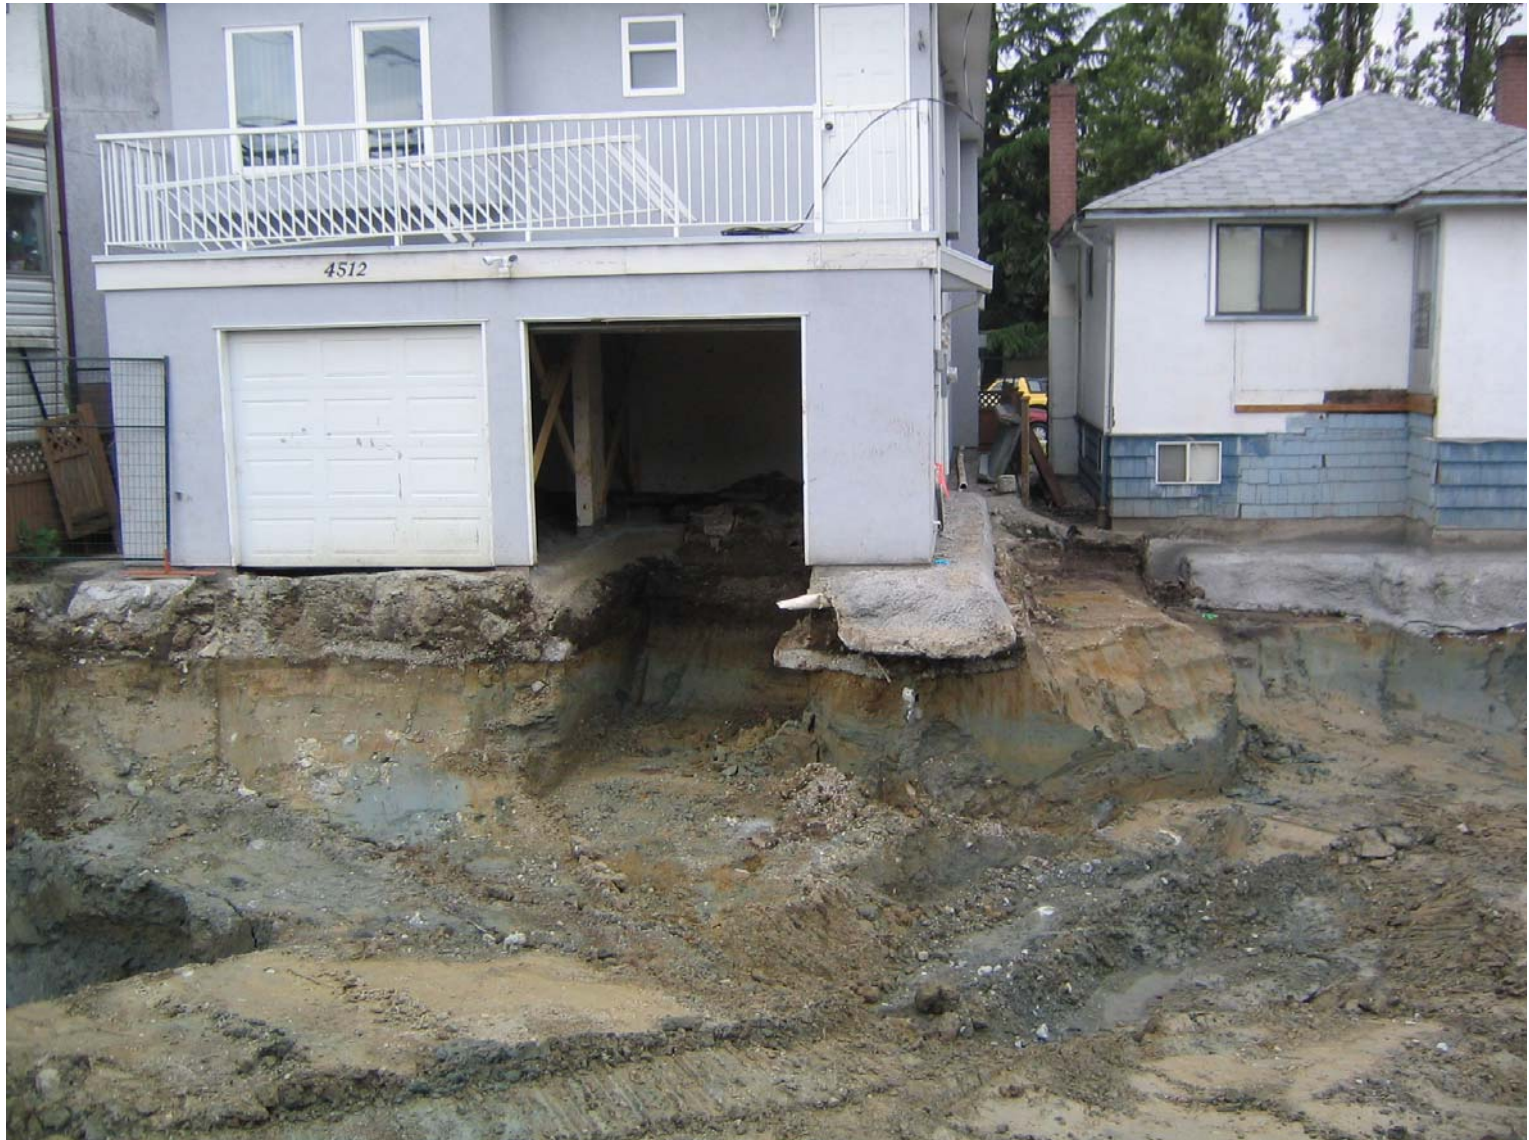
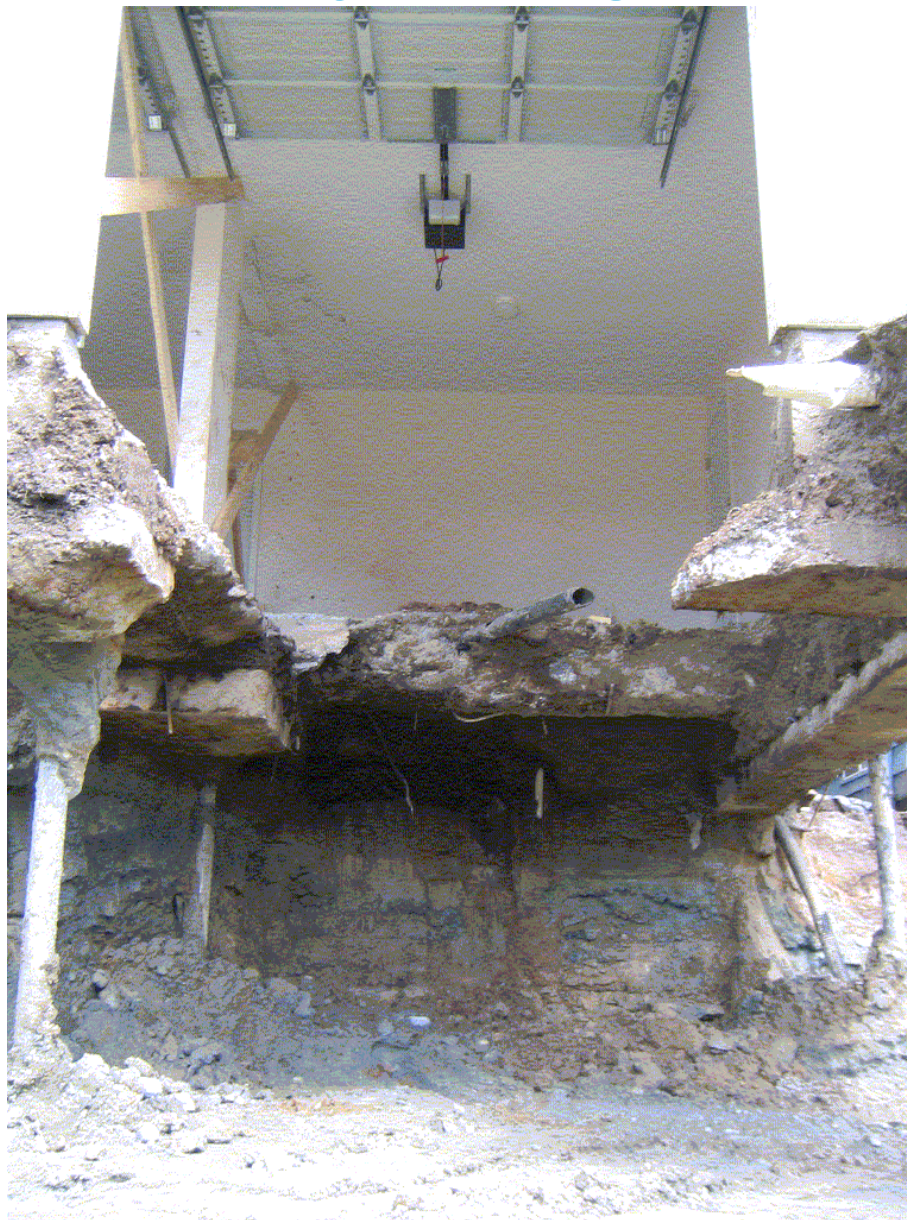
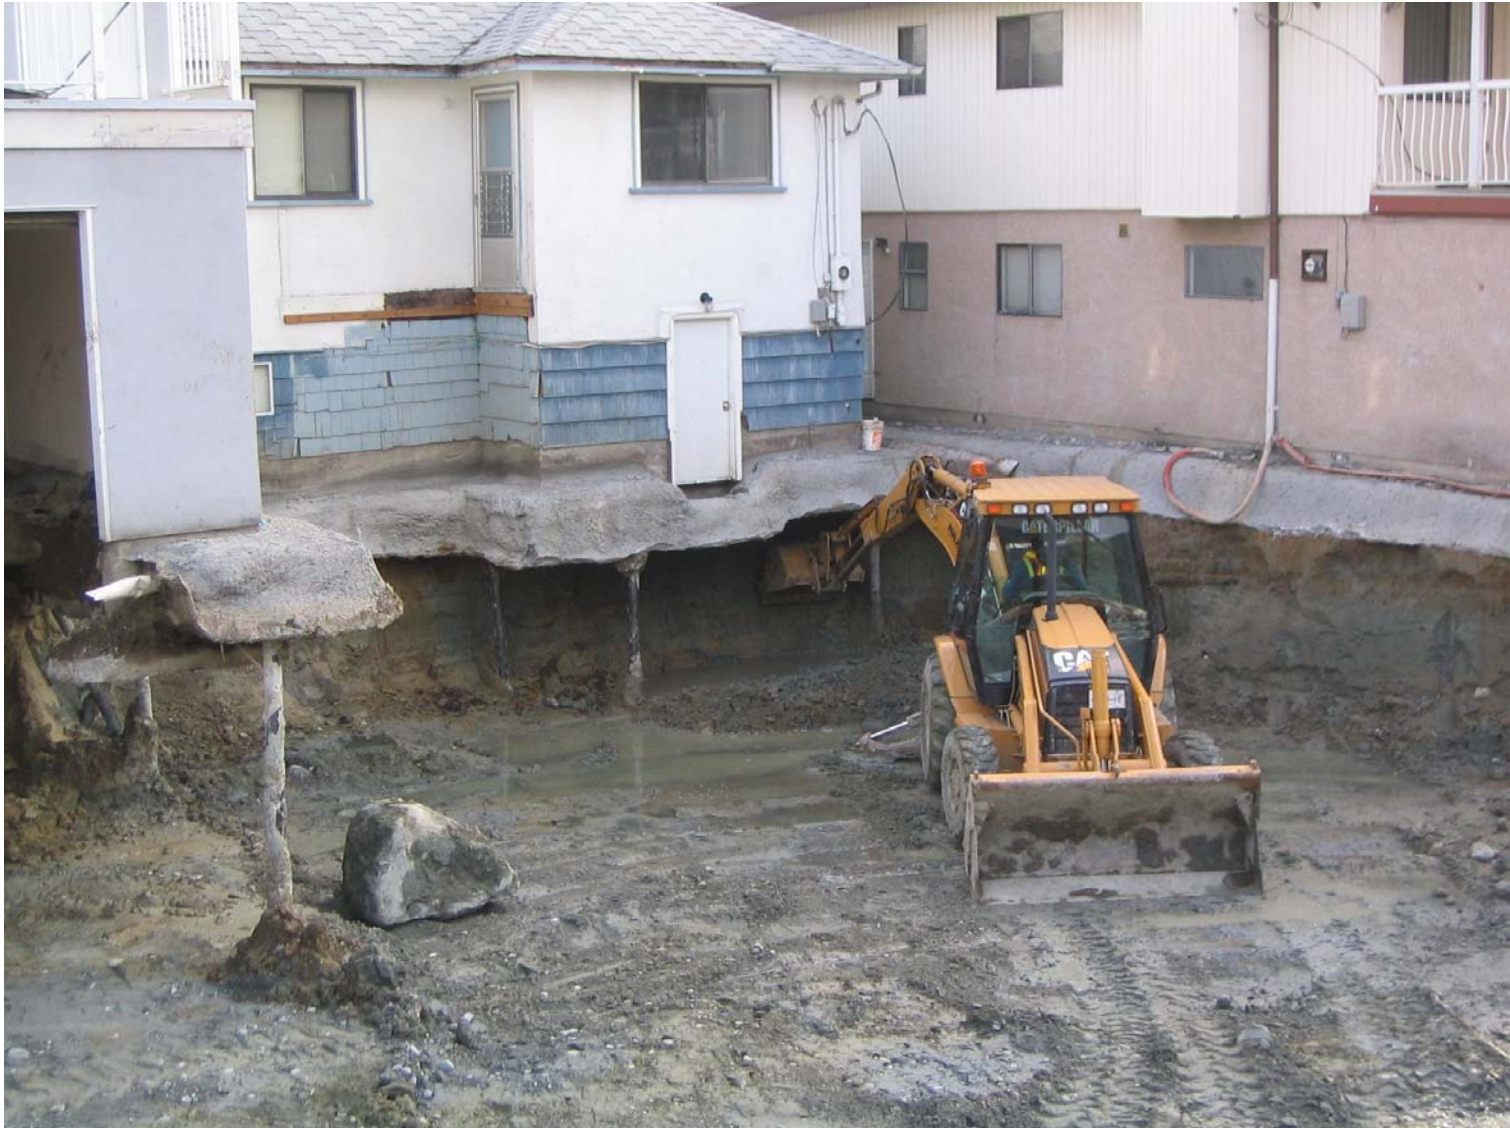
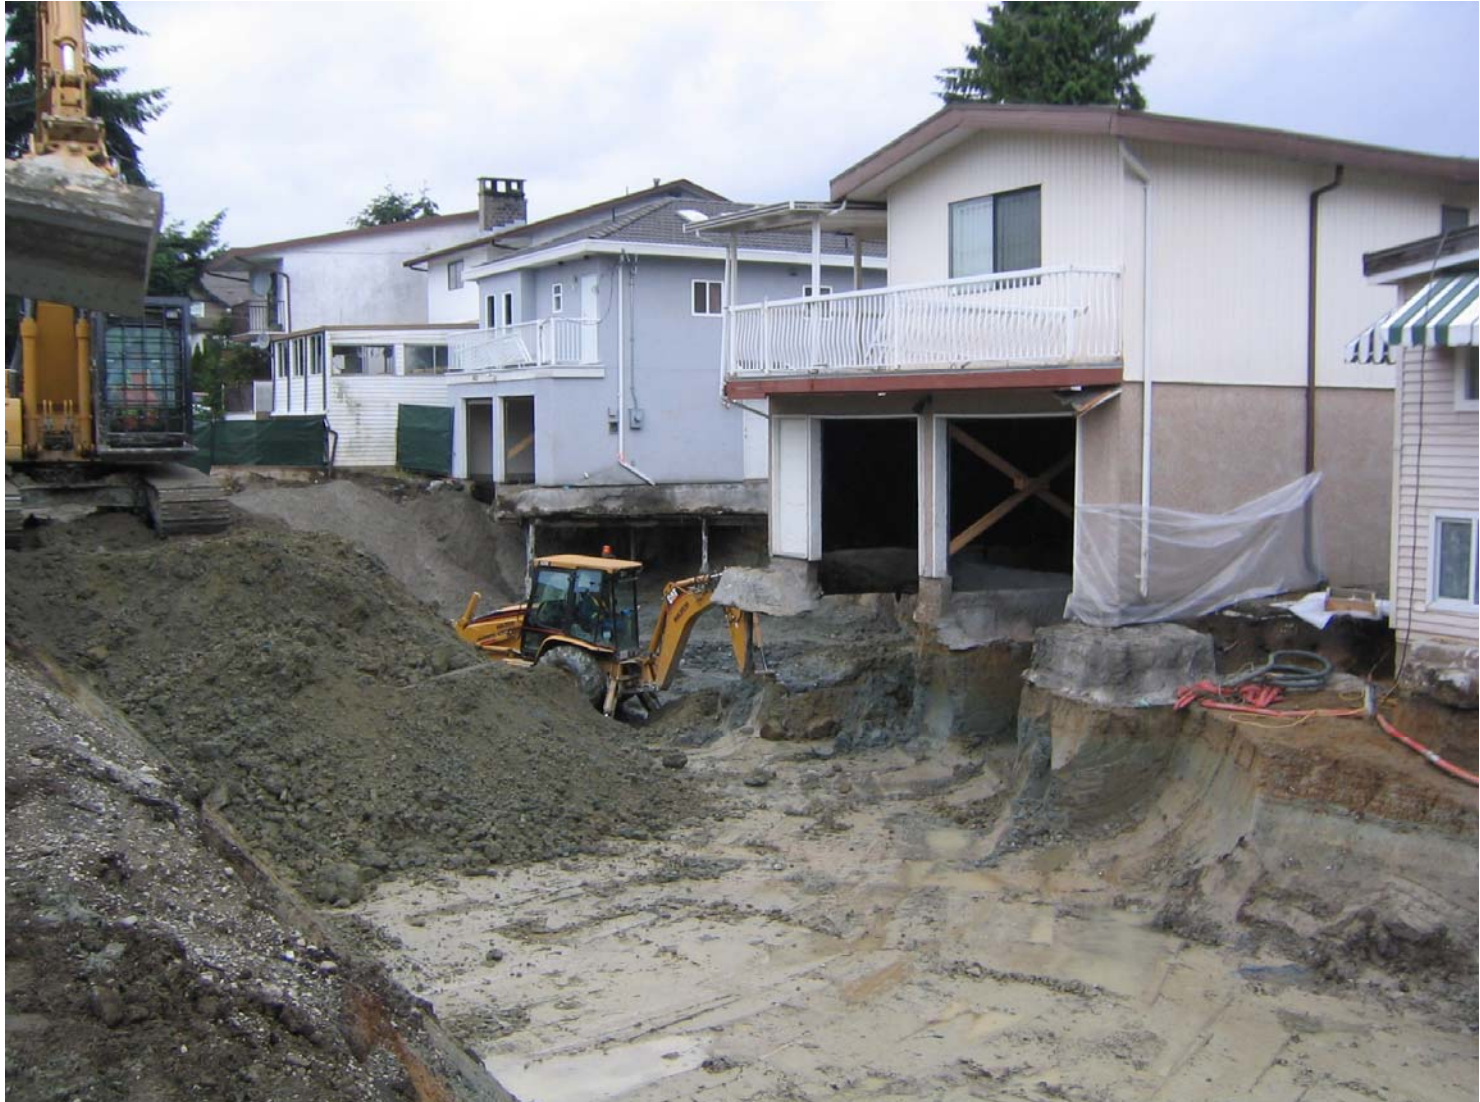
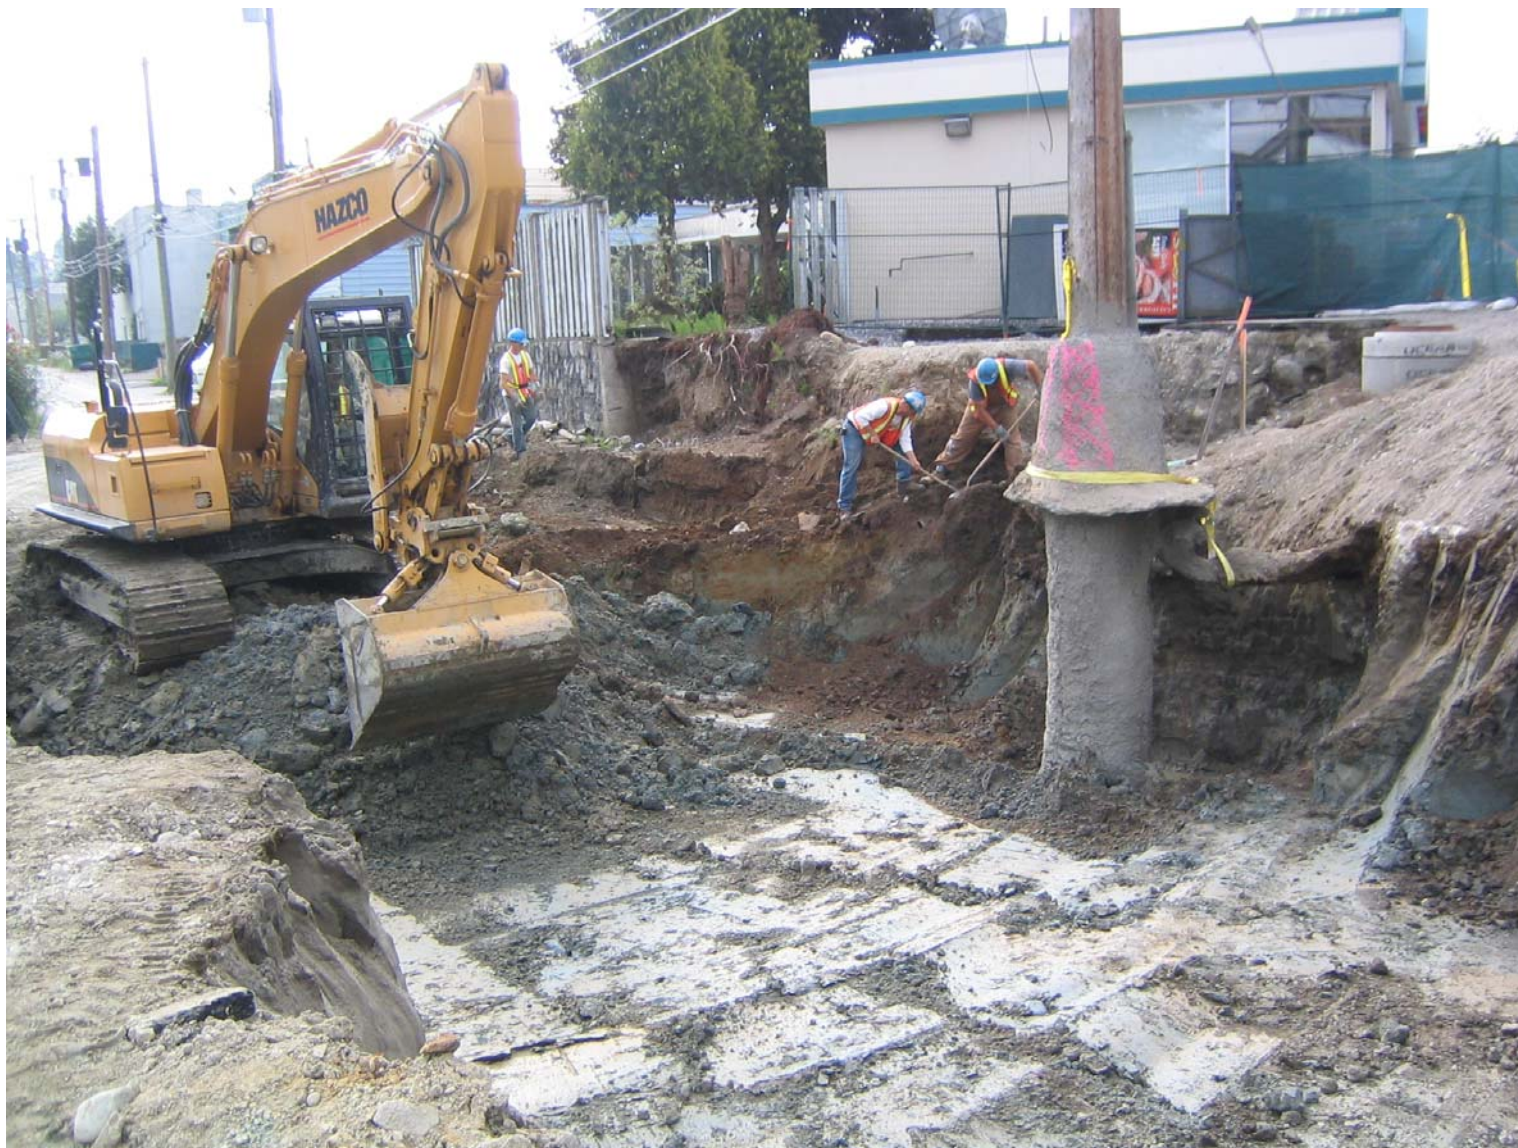
# EXCAVATION

- Removed all backyard improvements
- Removed soil from backyards and under homes

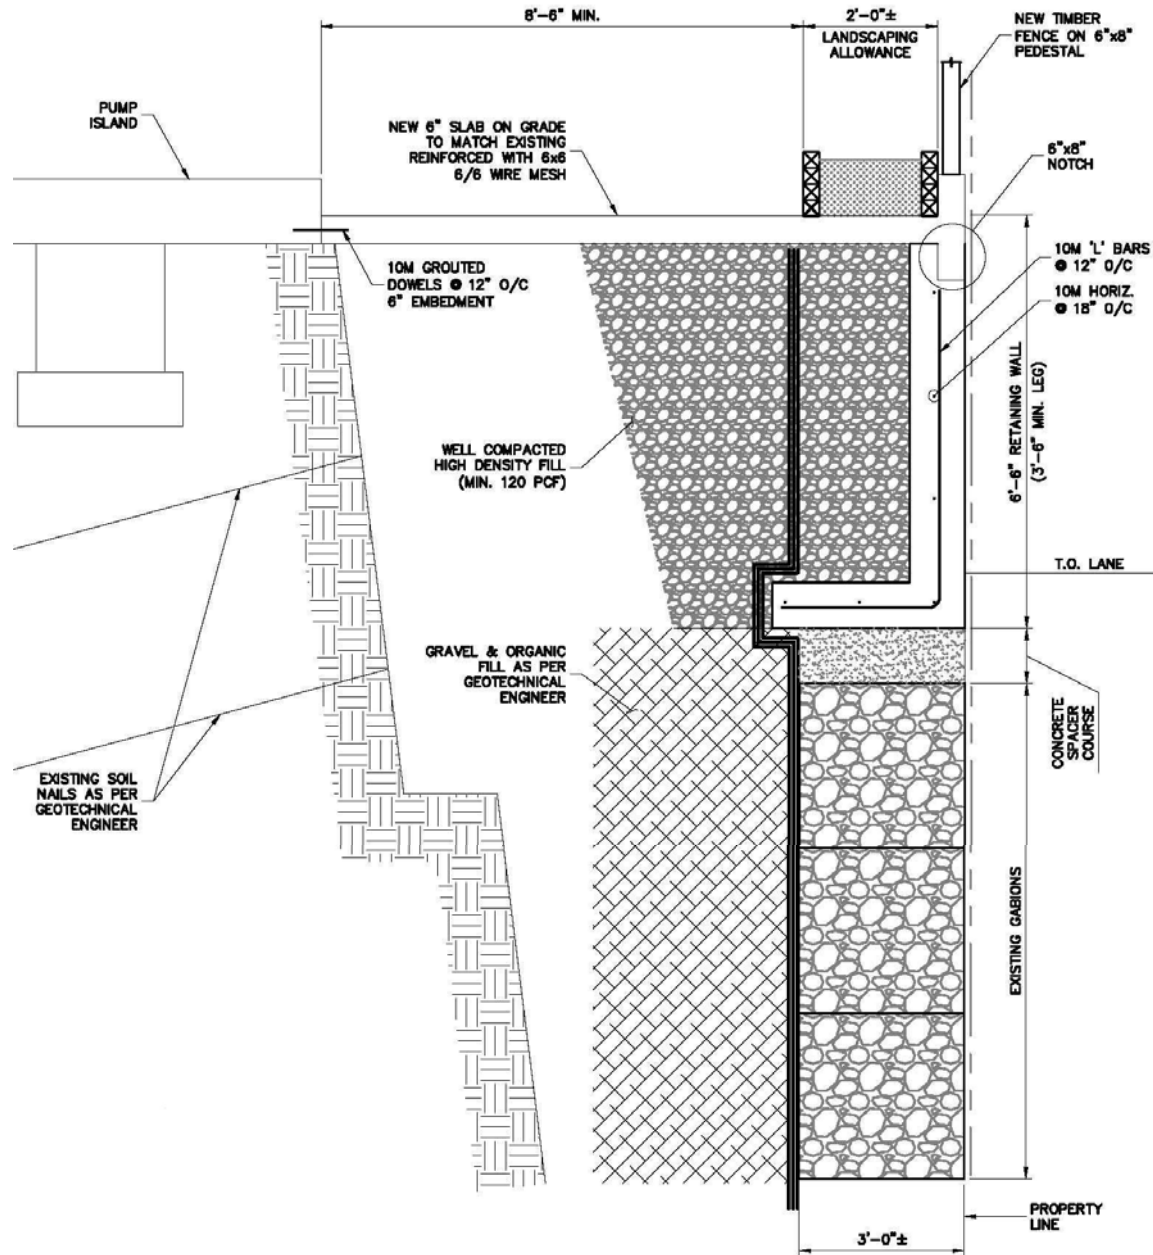
# BARRIER WALL DESIGN

- 45m by 5.5m organic reactive barrier wall installed on retail station property line

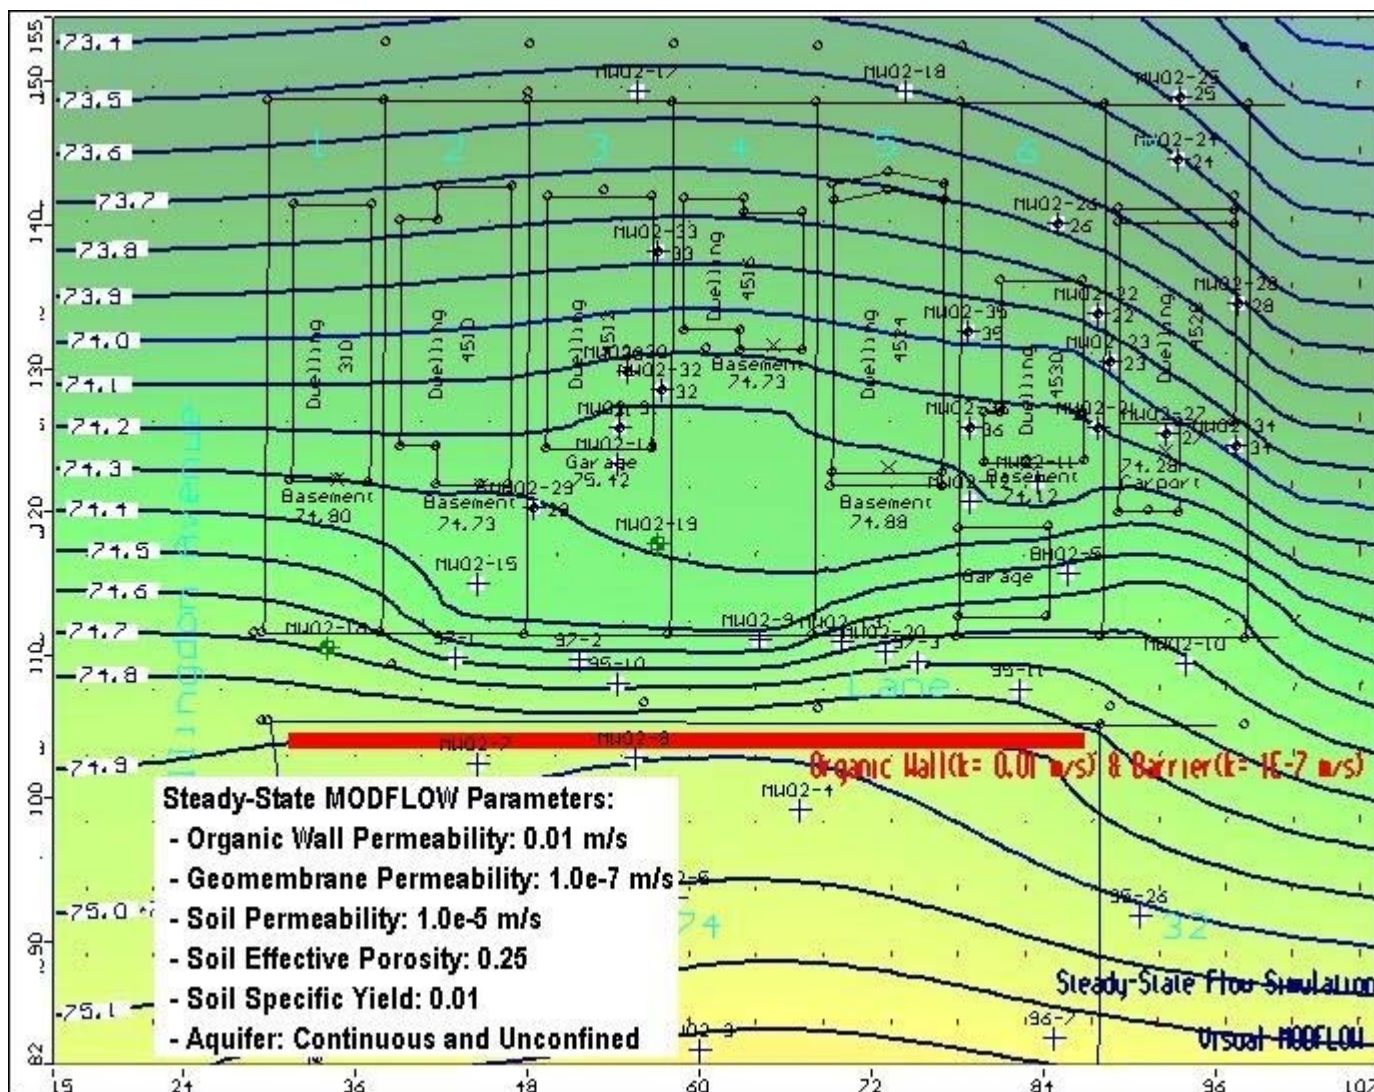
# BARRIER WALL MODEL
