# Hydrocarbon Impacts and Remedial Action at an Active Service Station

Jeff Linke, Chevron Canada Limited, Vancouver, BC  
Saleh A. Haidar, Keystone Environmental, Burnaby, BC  
Remediation Technologies Symposium 2006  
Fairmont Banff Springs Hotel  
October 11, 2006

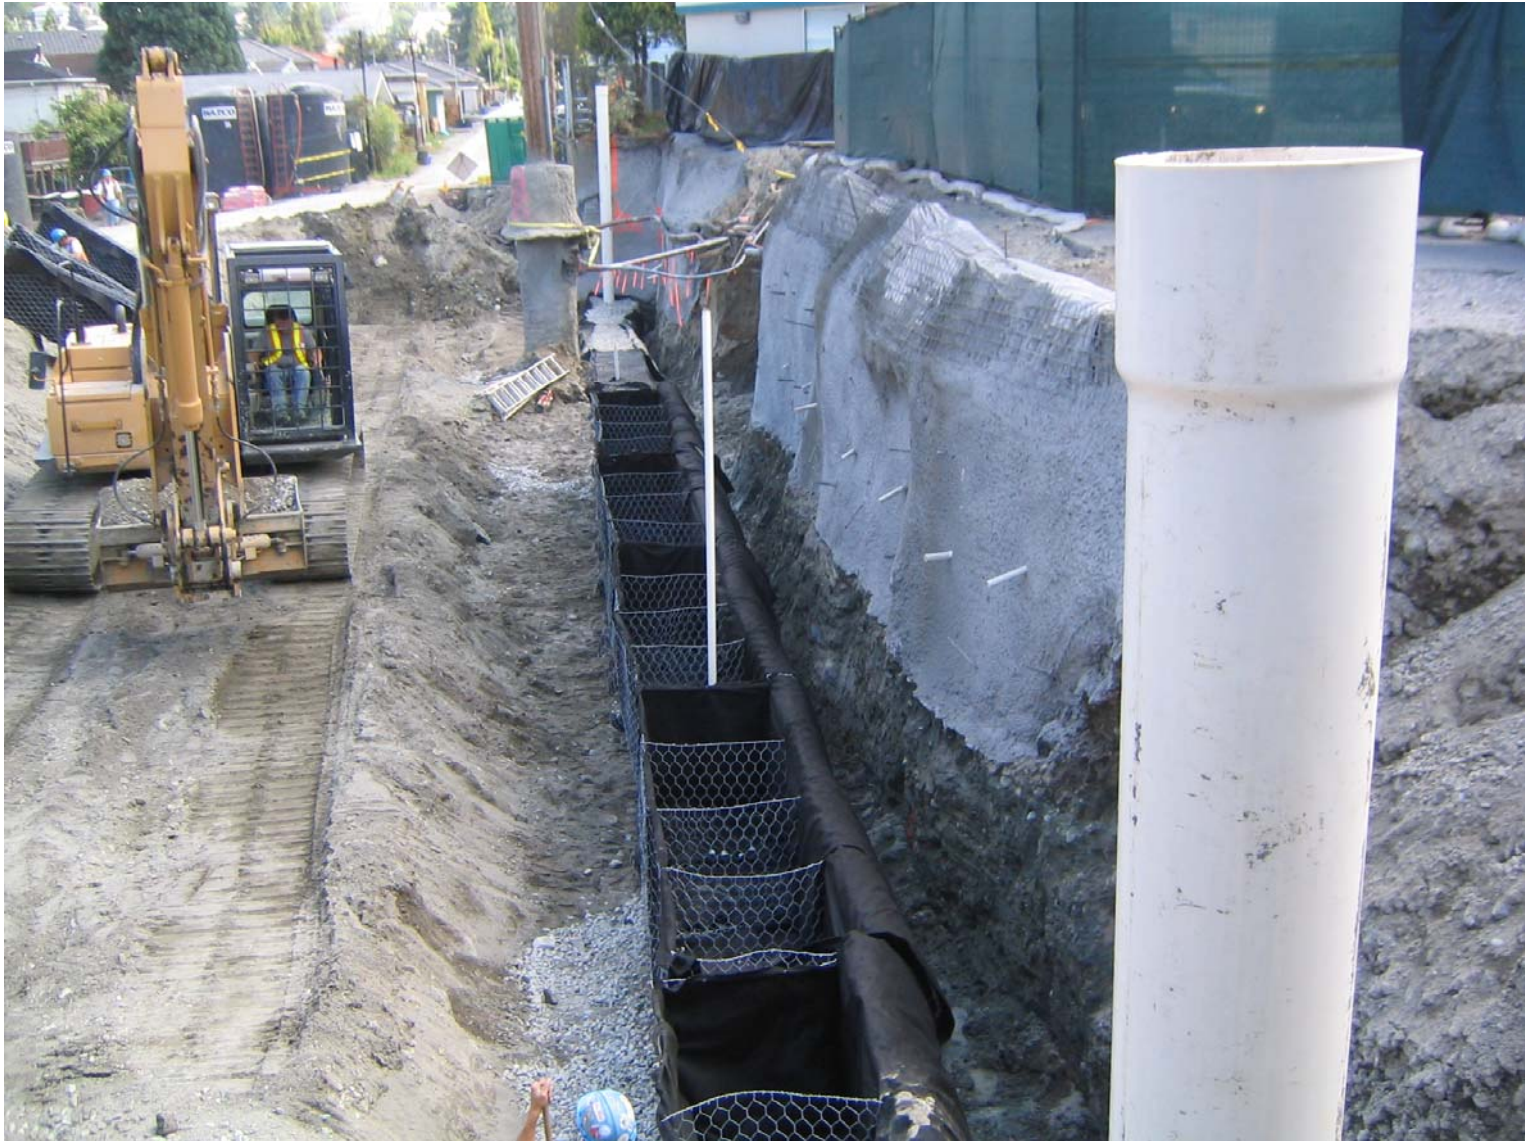
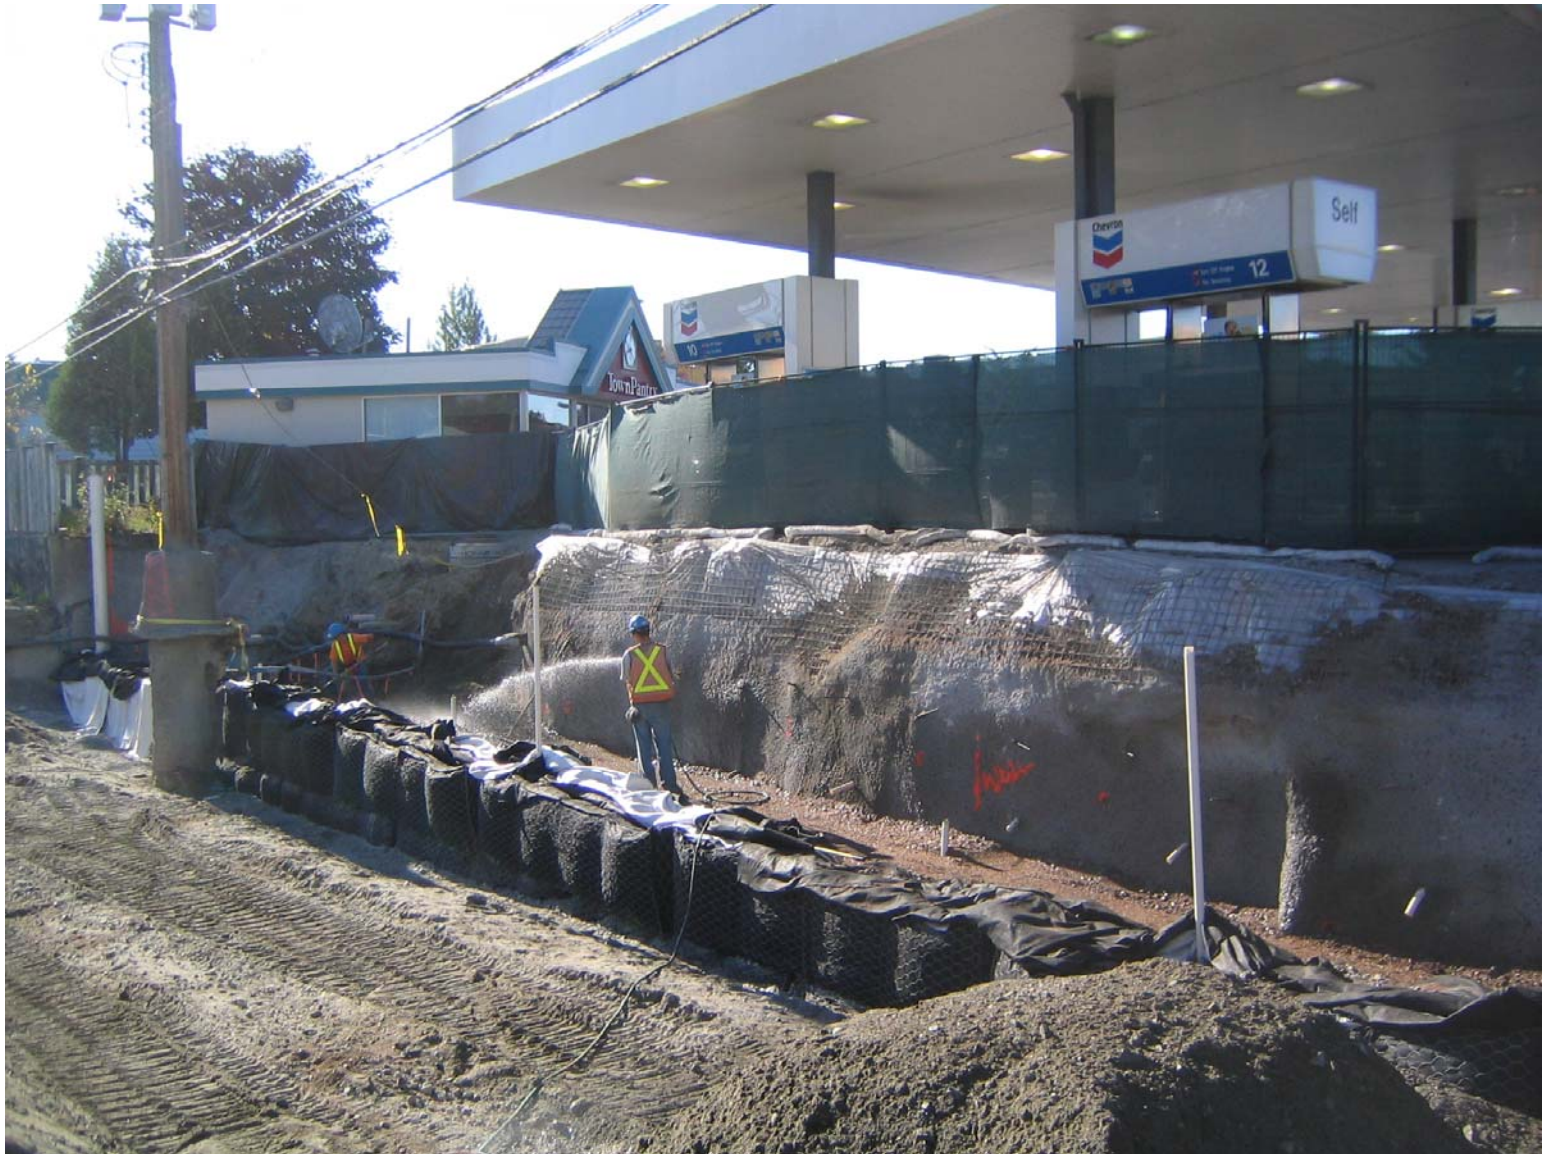
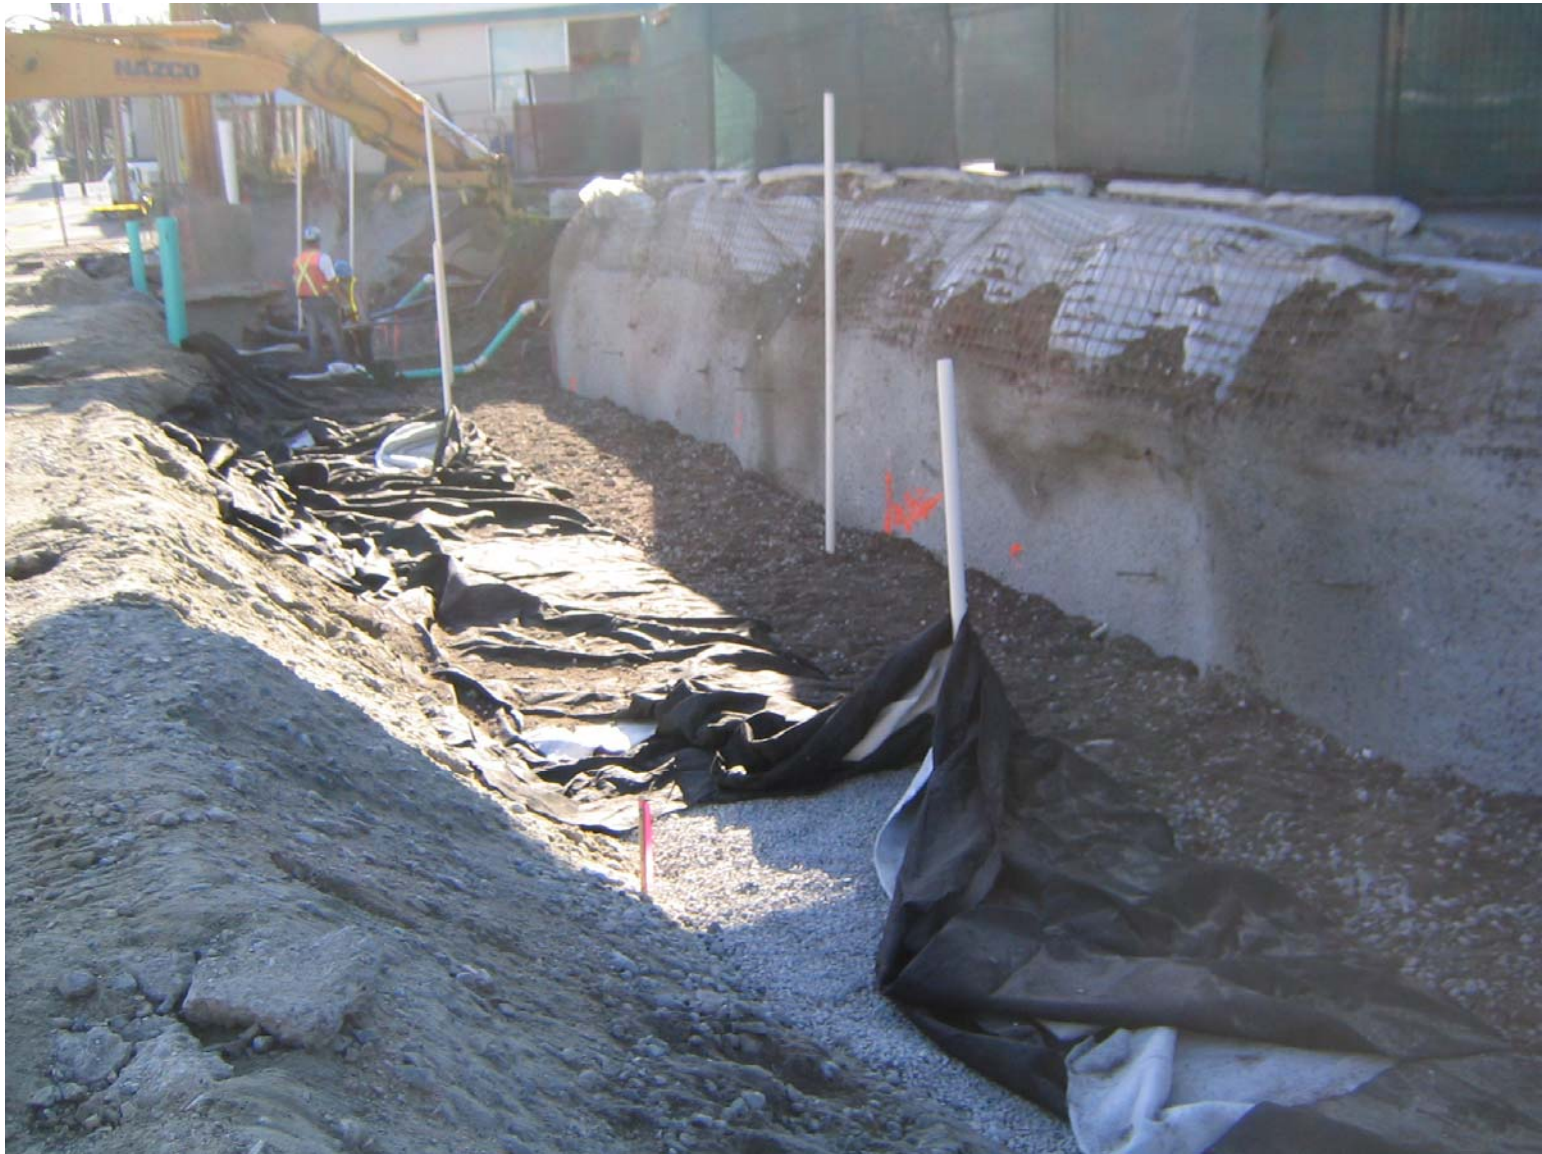
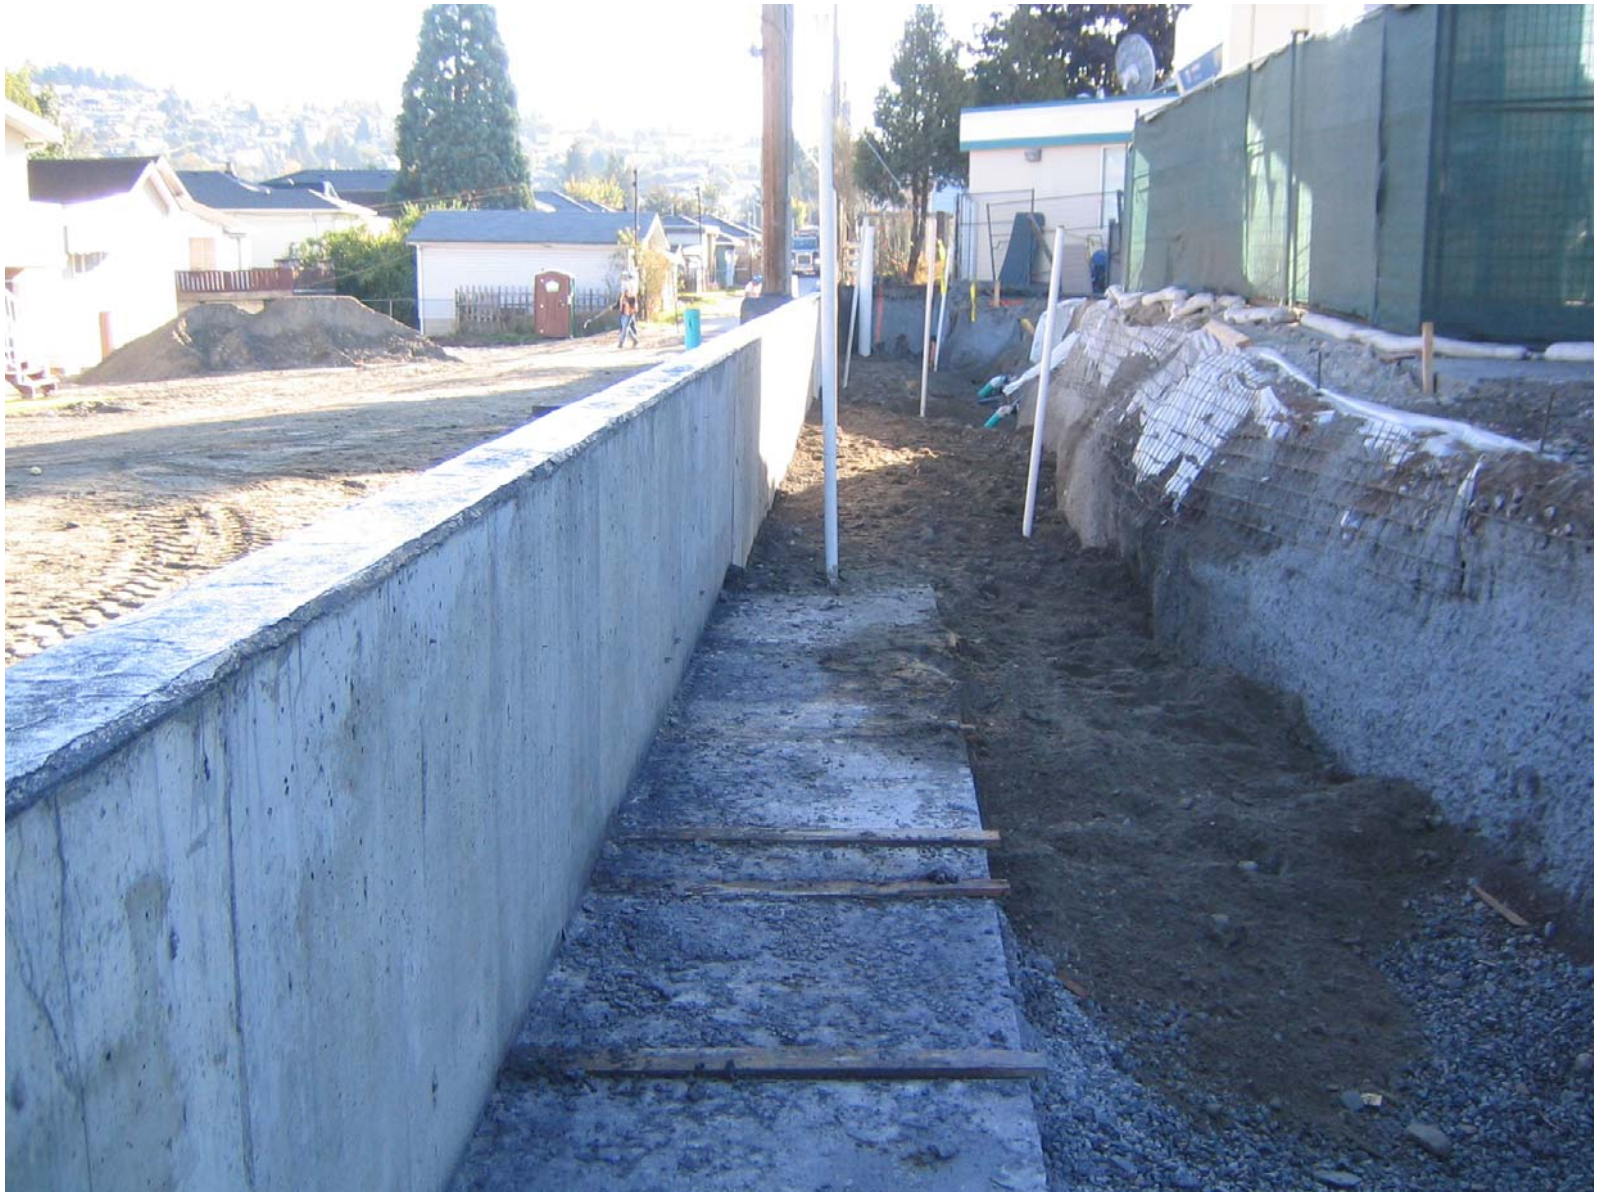
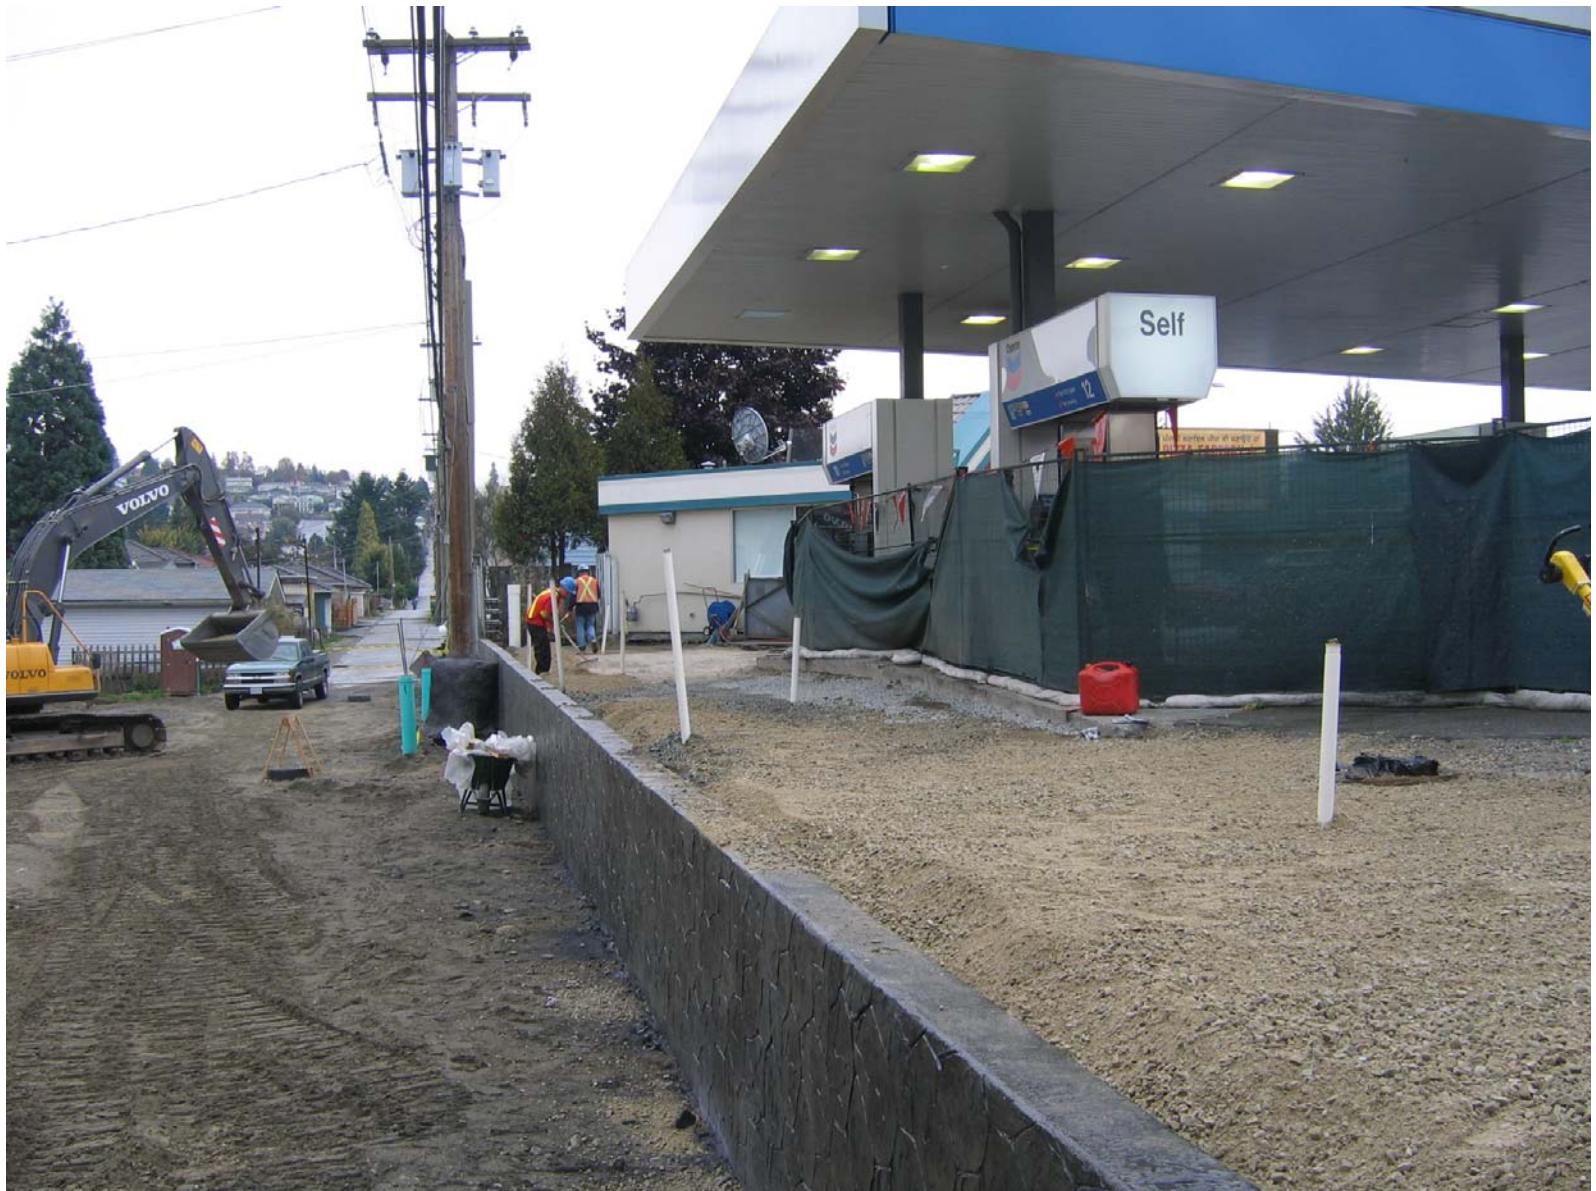
# BARRIER WALL INSTALLATION

- 45m by 5.5m organic reactive barrier wall installed on retail station property line
