# RemTech 2006

## **The Application of In-Situ Chemical Oxidation to Remediate Chlorinated Ethenes at Former Dry Cleaning Facilities in Alberta**

2006 Remediation Technologies Symposium  
Banff, October 12, 2006

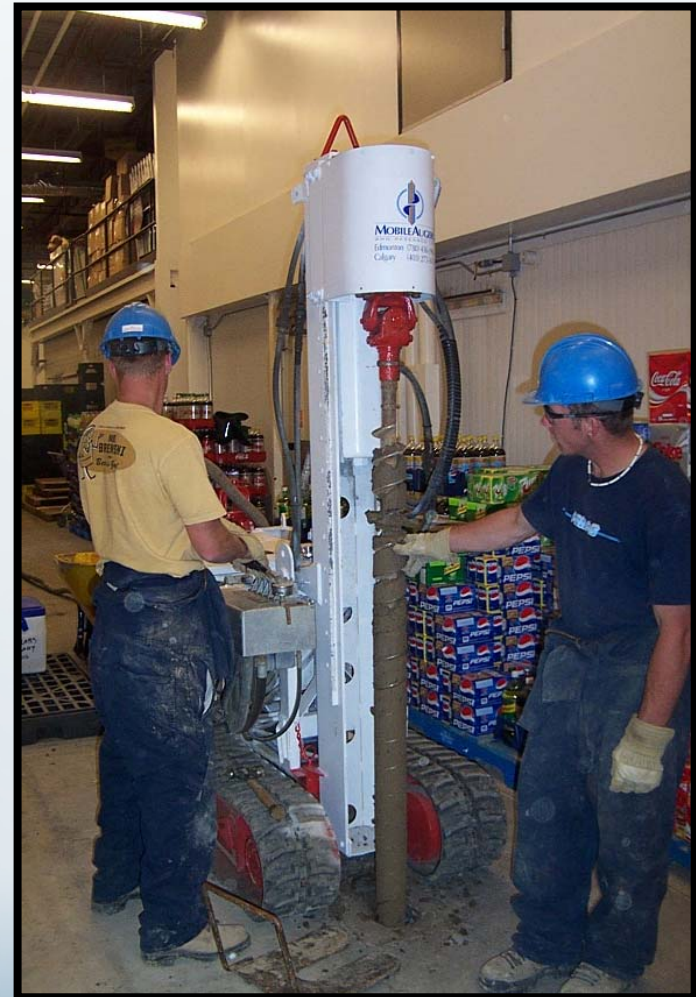
# Project 2 – Additional Site Assessments

- Supplemental Phase II ESA (February 2006)
- Remedial Action Plan
- Supplemental Phase II ESA (July 2006)

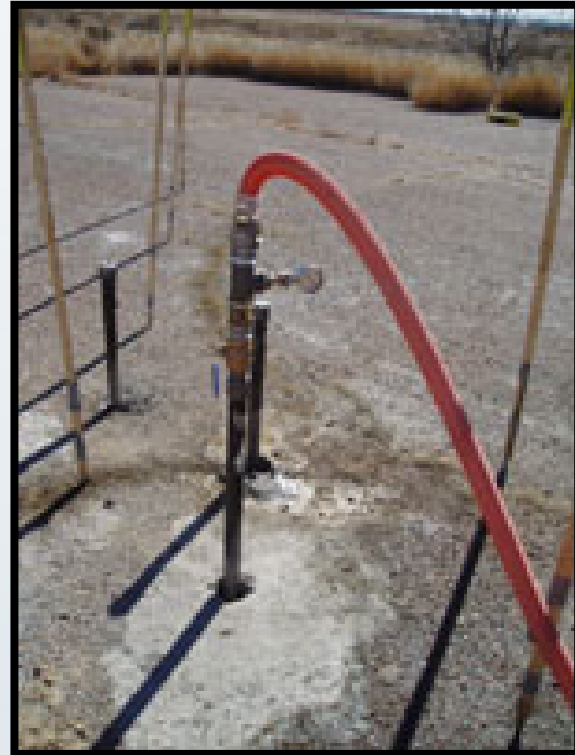
# Project 2 – Remedial Action Plan

- Soil Fracturing to increase clay permeability
- Creation of Injection Wells through the specifically placed screens
