M. Jillian Mitton, P.Eng  
Brian Pimblett, P.Eng

## Delineation and Remediation of Wabamun Derailment Site

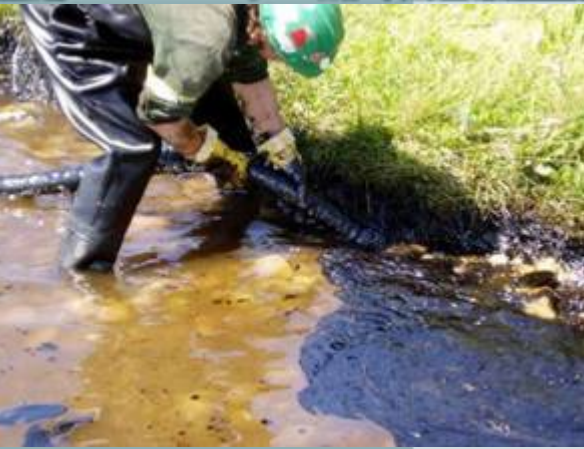
# Derailment Area - Initial Remediation

- 712,500 litres of Bunker C and 88,000 litres of Imperial Pole oil were released
- Initial response activities included recovering fluids, cutting and removing cars, repairing track starting August 3, 2005
- August 5<sup>th</sup> PTO observed seep from spring near lake
- Damaged water well where Bunker C flowed, discovered on August 16<sup>th</sup>

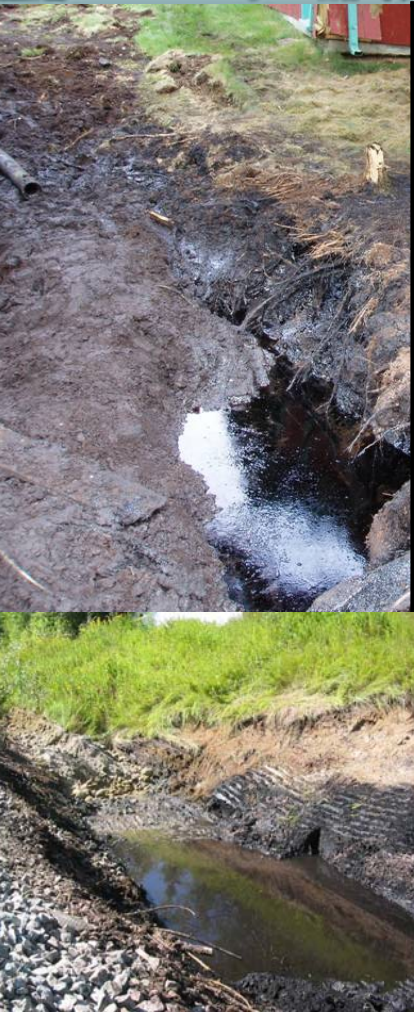
Property	Bunker C	PTO
Density (kg/m <sup>3</sup> @ 15 °C)	986.4	939.6
API Gravity (15.6 °C)	11.9	19.0
Viscosity (cSt @ 20 ° C)	6756	5.411
Description	Aliphatic, olefinic, naphtenic and aromatic hydrocarbon	Aliphatic and aromatic hydrocarbons (diesel like fuel)

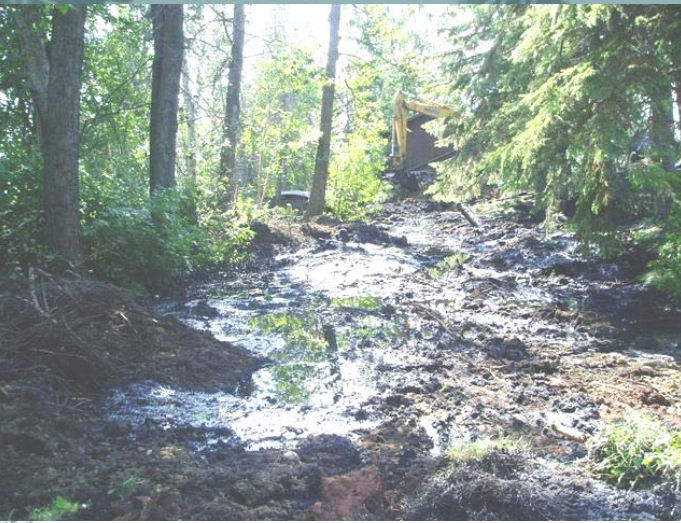
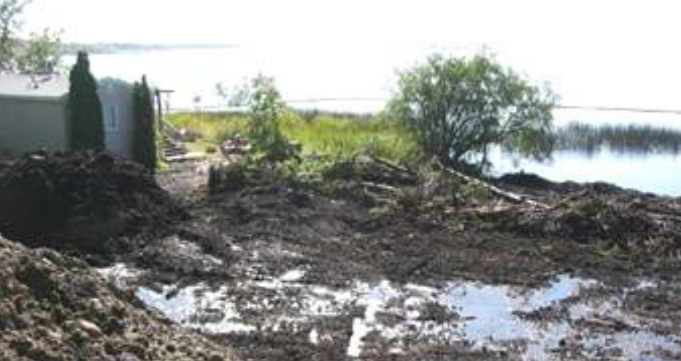
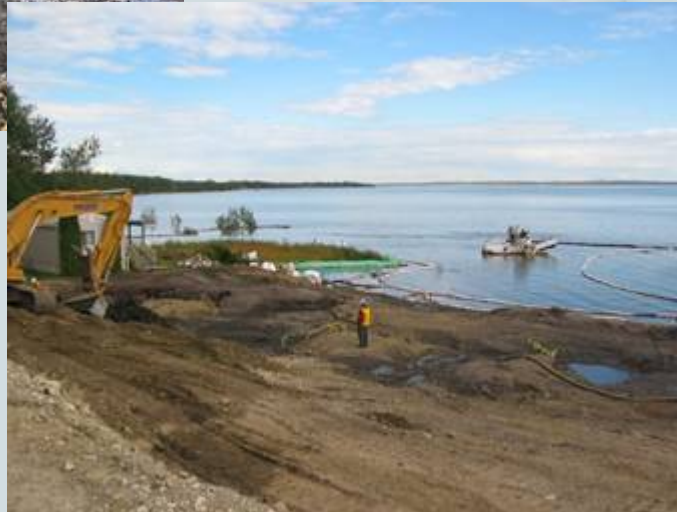
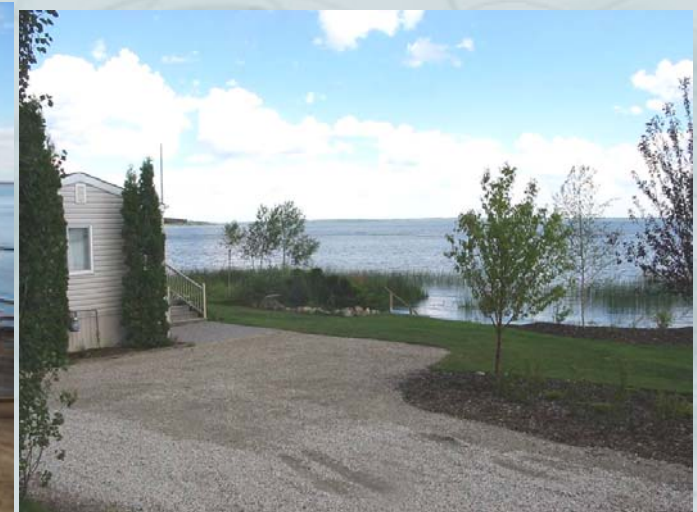
- Bunker C oil recovery using vacuum trucks from rail cars, pools of oil within ditches and bell holes.
- Removal and offsite disposal of impacted soil was stage due to restricted access
- All impacted soil disposed of at Hazco Tower Road Class II Industrial land fill
- 5059 tonnes of PTO impacted soil (11,000 litres of PTO)
- 17,472 tonnes of Bunker C impacted soil (231,000 litres of Bunker C)

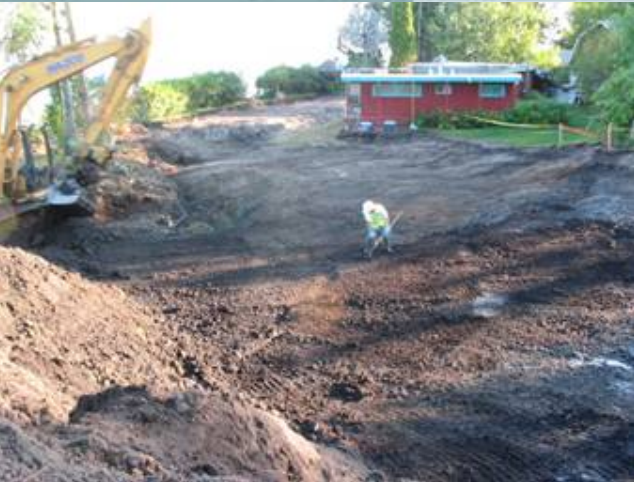
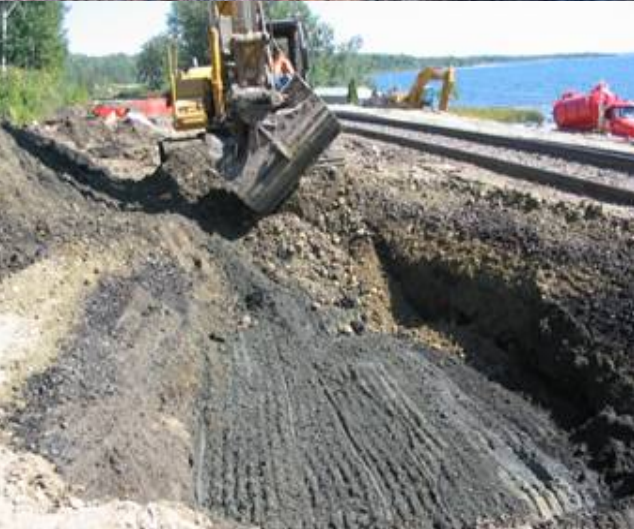
- The plan required soil sampling every 5 linear metres for every 3 m depth
- Collected over 500 soil samples
- Soil samples were analyzed for BTEX, PHC fractions F1-F4, and PAHs
- GIS and Information Management were essential for Sampling Plans
- Winter sampling program conducted for further validation
- Guidelines were the CCME Soil Quality Guidelines for Residential Land Use

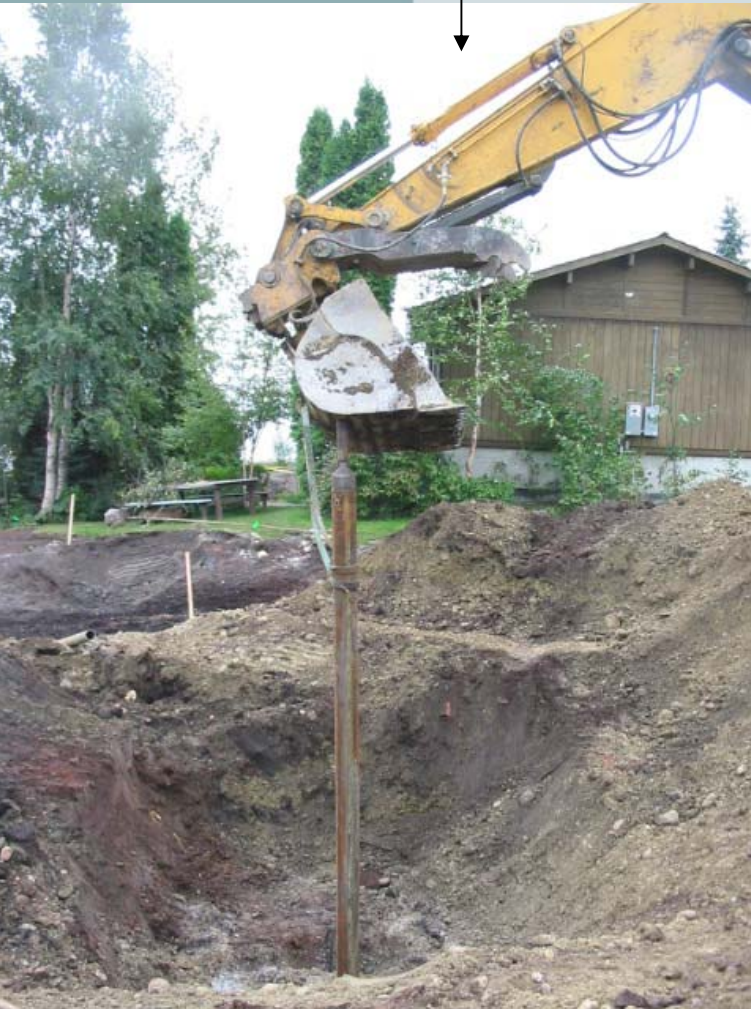
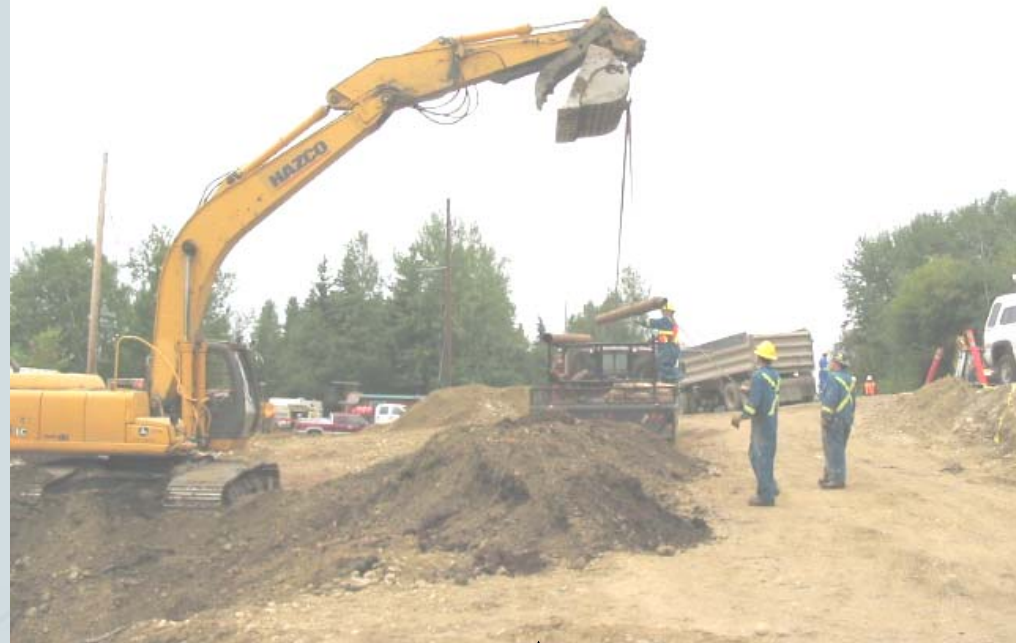
Casing Removal

Well Excavation

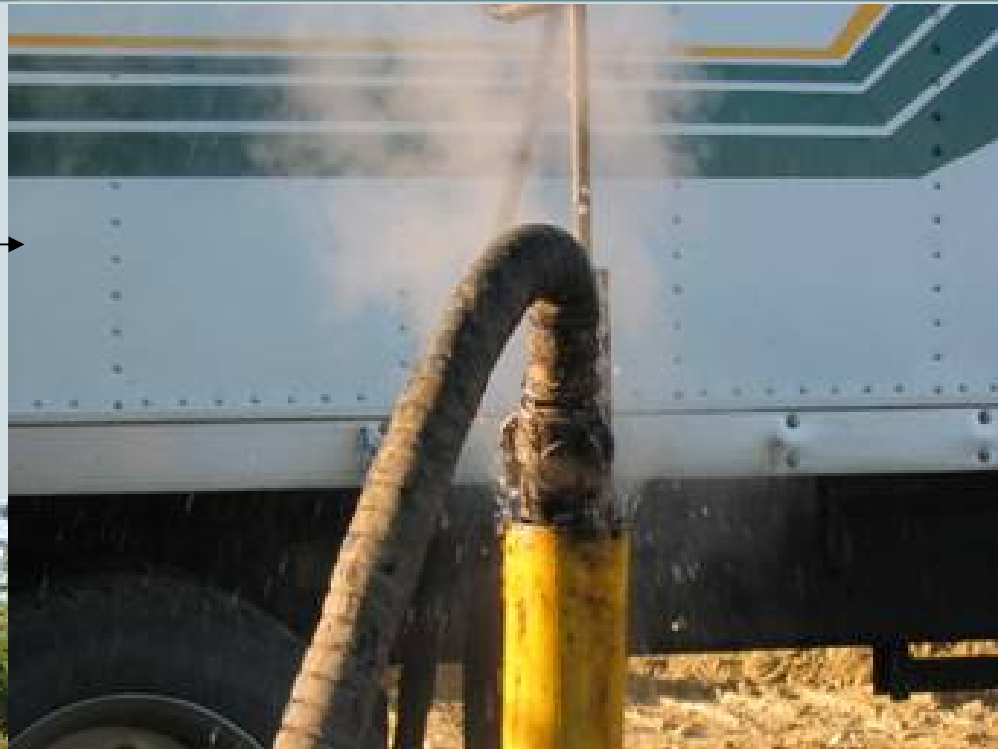
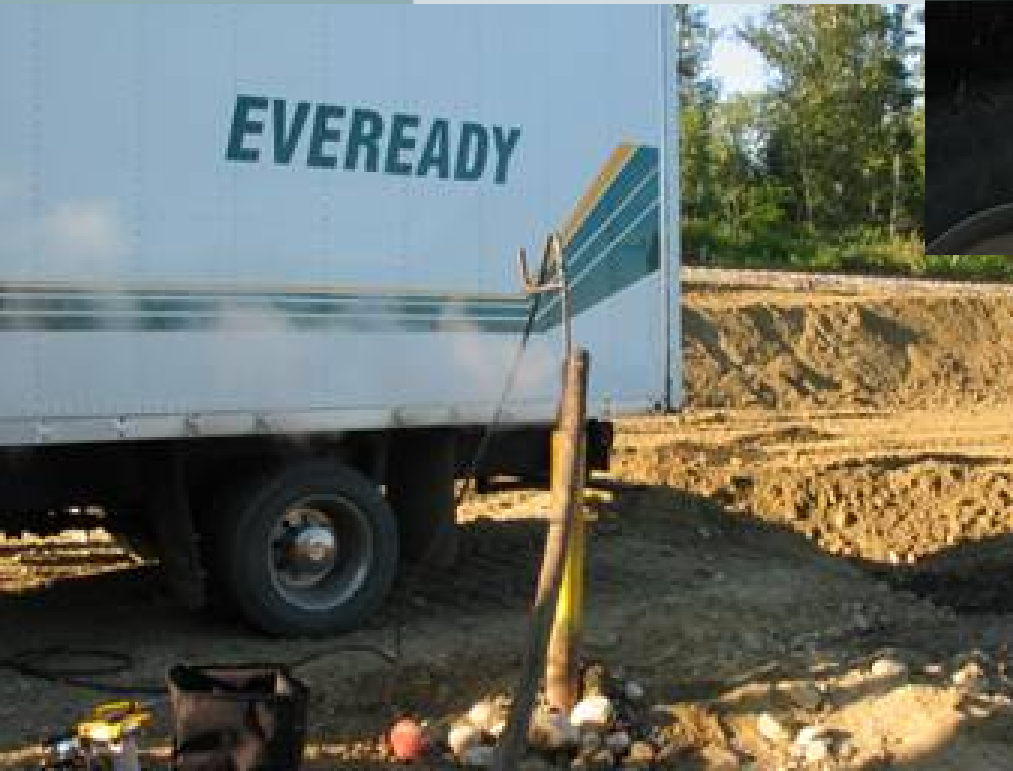
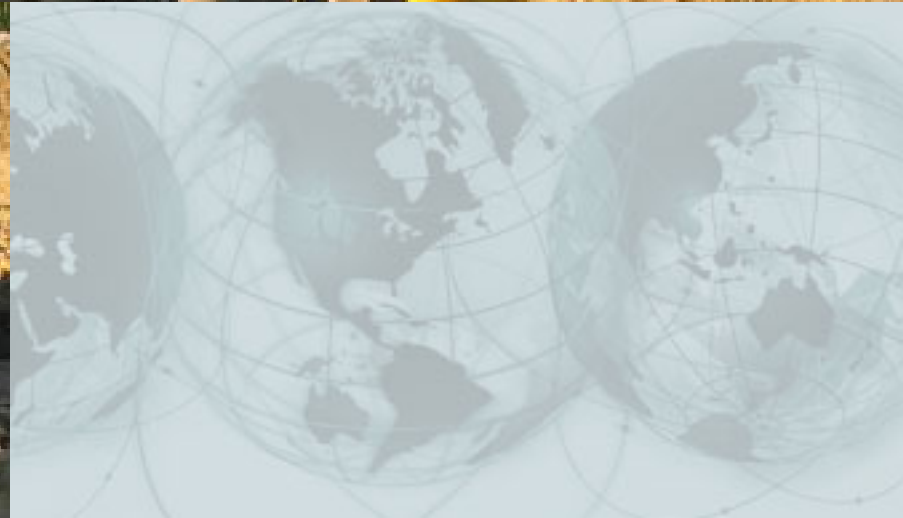
Steam Injection and  
Vacuum Extraction

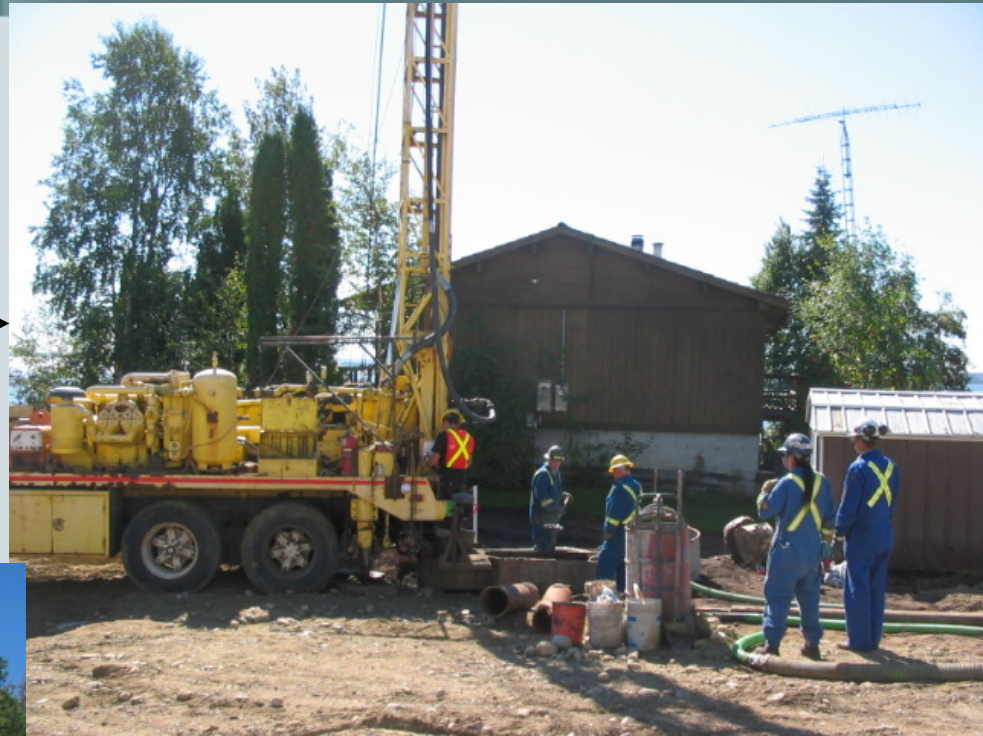
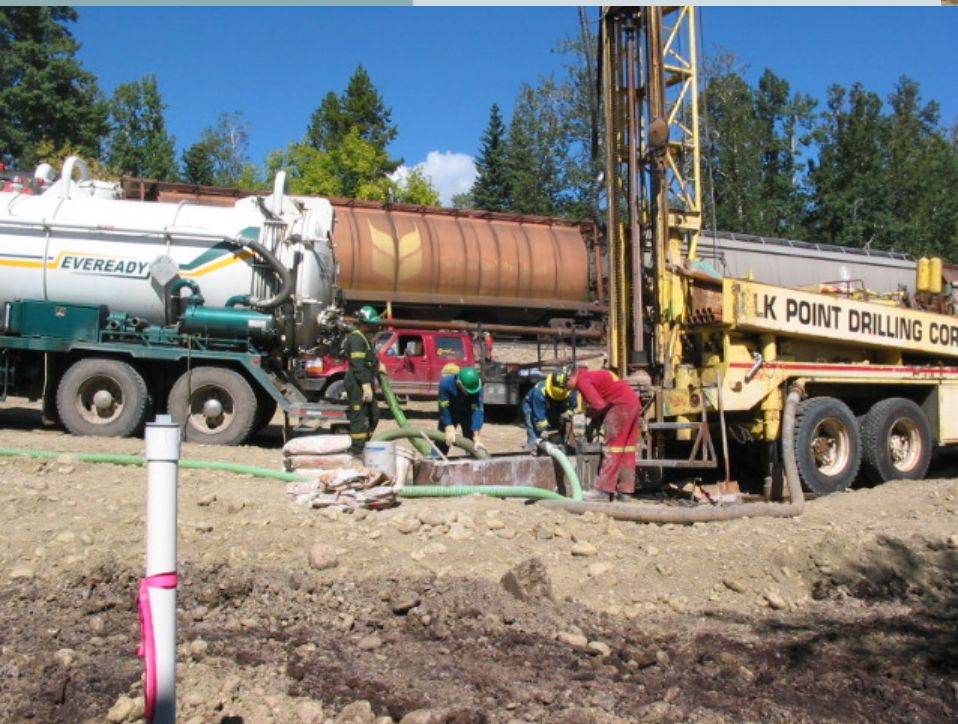
Well  
Decommissioning  
with Mud Rotary Rig

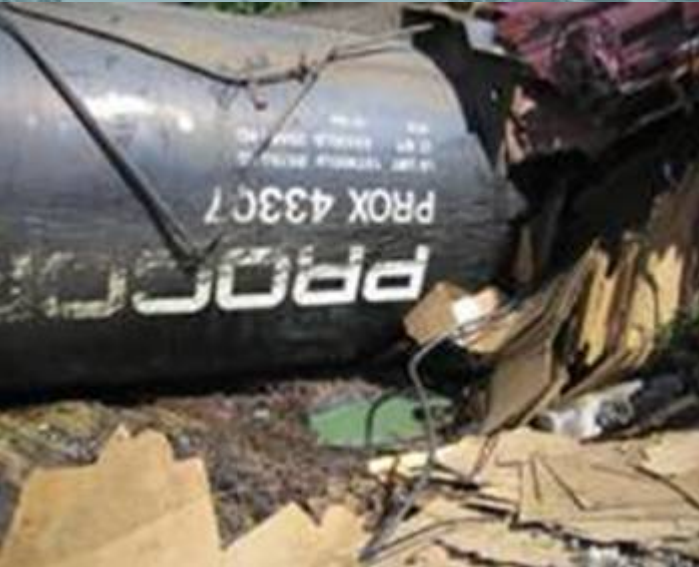
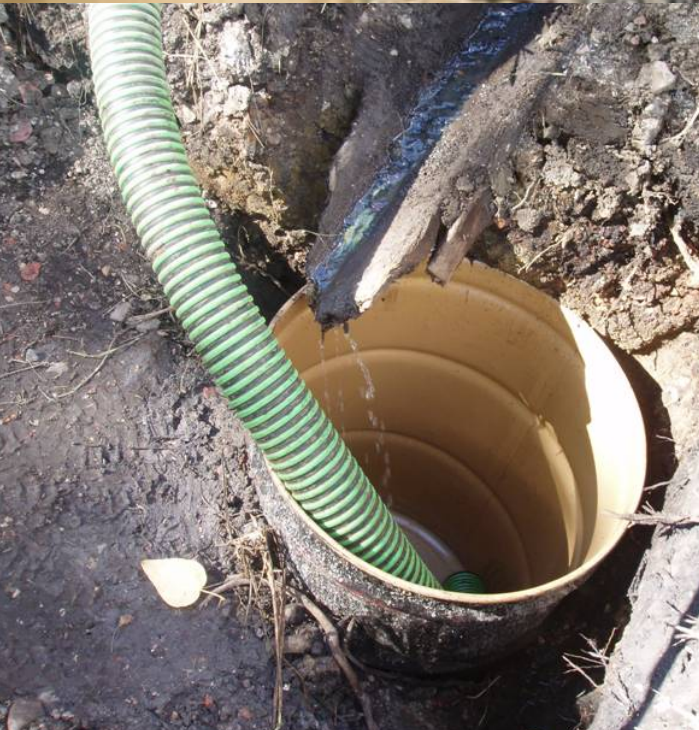
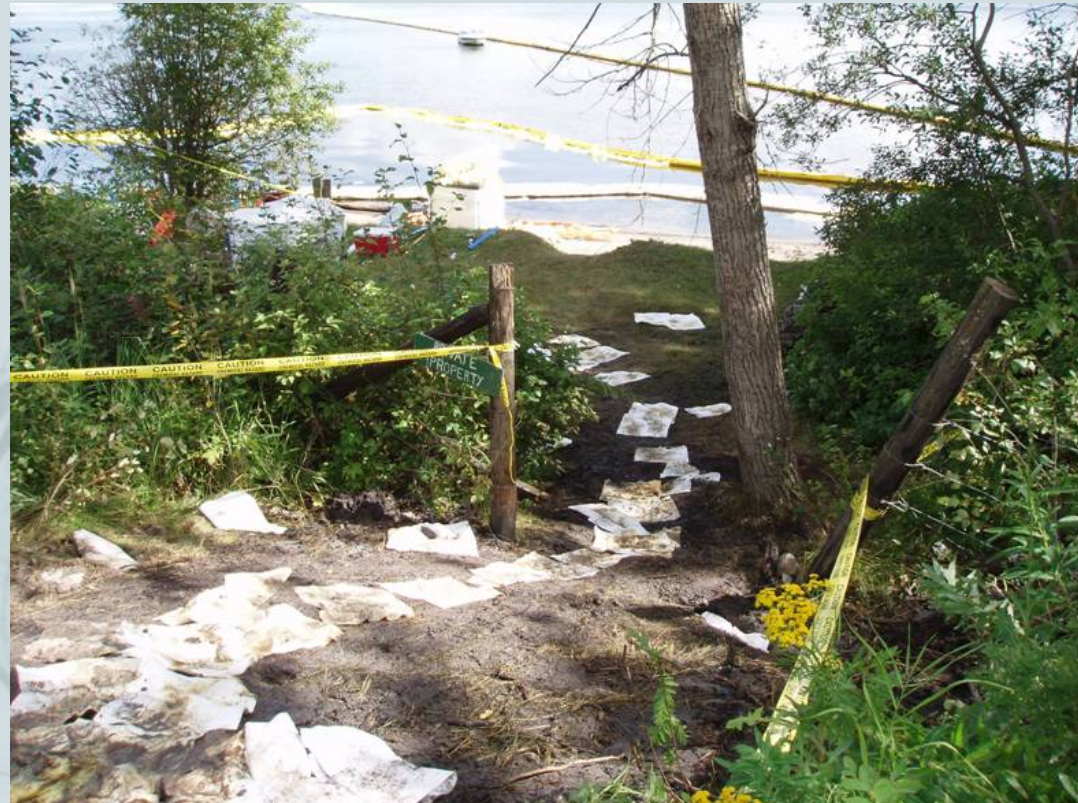
# PTO Initial Contaminant

- In addition to topography, underground culverts (wooden), natural spring and wood stave pipe promoted PTO migration

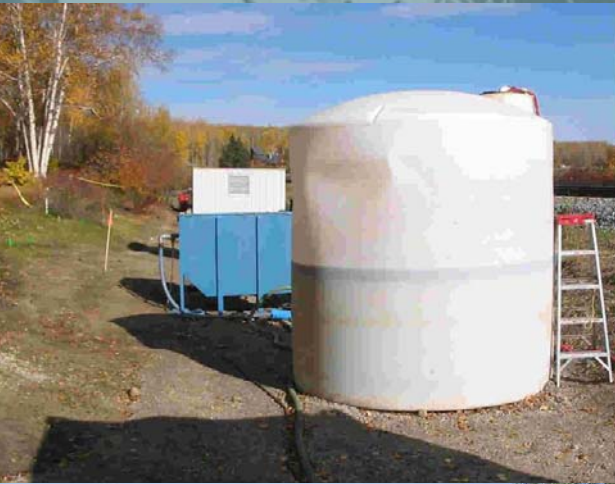
- Absorbent pads and booms initially used
- Shallow sump and vacuum truck
- Additional Bell Holes and Vacuum Trucks
- Temporary Dual Phase Vacuum System, storage tank, oil/water separator, clay/carbon filtration, clean water storage.
- Permanent Concrete Vault

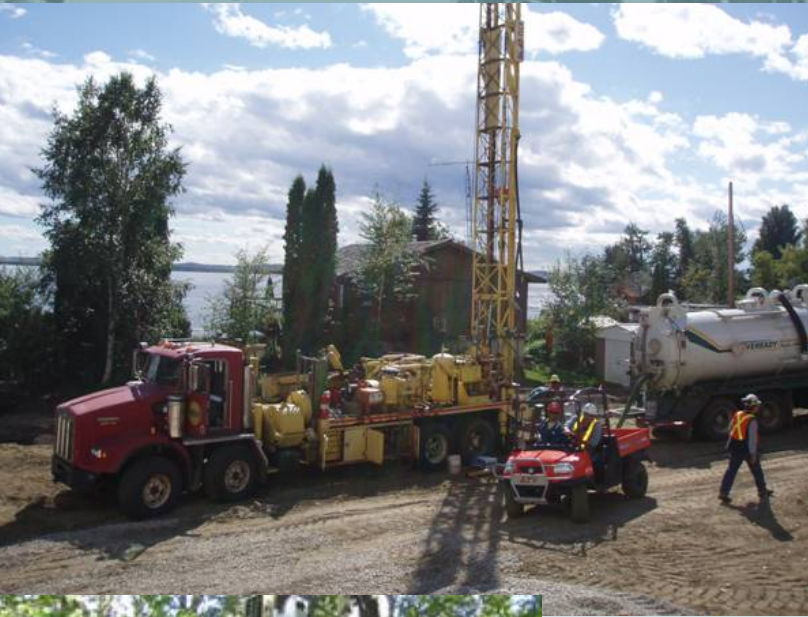
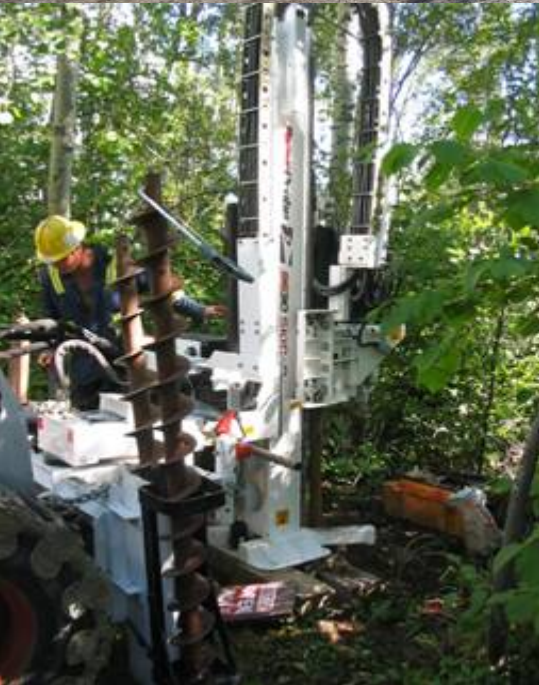
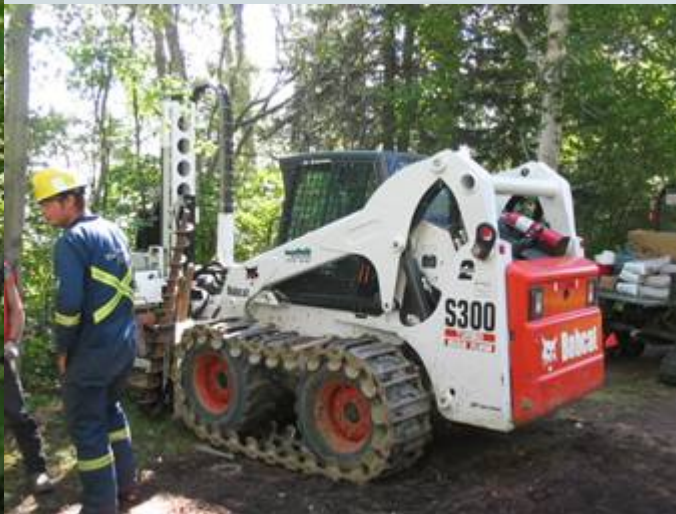
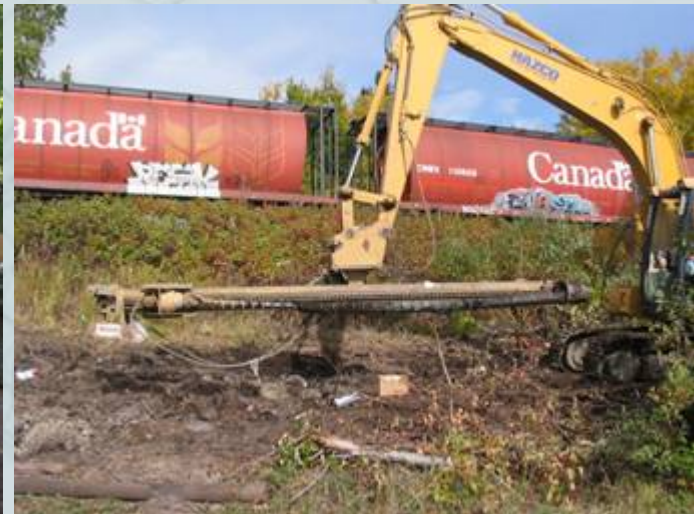
Drilling equipment selected based on:

- availability
- access restrictions
- depth
- drilling method

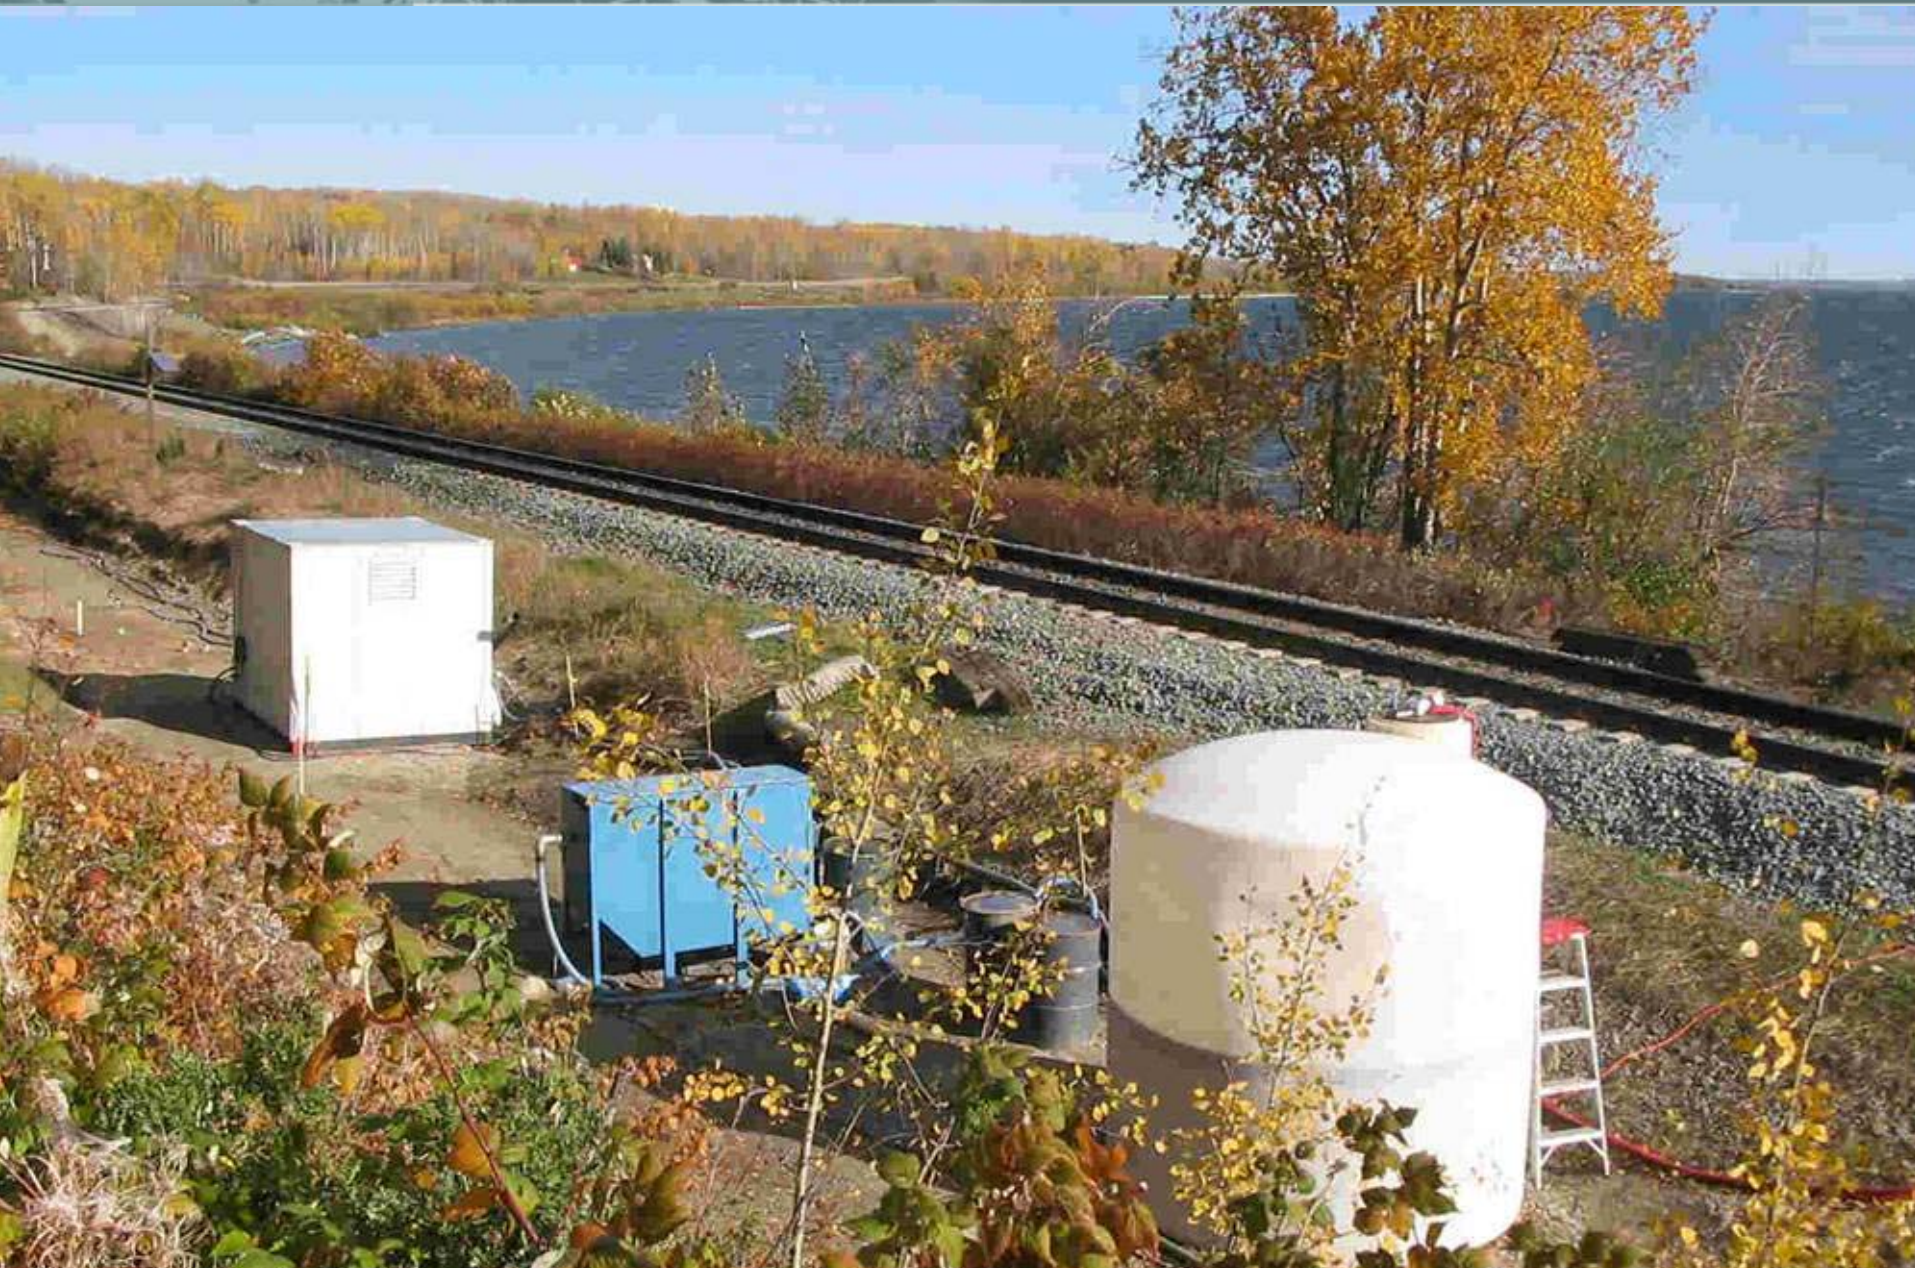
# Pilot Test

TEST DESCRIPTION	Hydraulic Conductivity (m/s)	Gas Conductivity (m/s)	Air Permeability (m <sup>2</sup> )	Air Permeability (Darcy)
VER Test I (using RW-001)	$2.13 \times 10^{-5}$	$1.83 \times 10^{-6}$	$3.29 \times 10^{-7}$	33.29
VER Test II (using RW-003)	$4.16 \times 10^{-5}$	$3.58 \times 10^{-6}$	$6.42 \times 10^{-7}$	65.03
Constant drawdown test I (using RW-001)	$1.34 \times 10^{-5}$	$1.16 \times 10^{-6}$	$2.07 \times 10^{-7}$	20.95

Well diameter	50 mm;
Length of screen	between 2 and 3 metres;
Drop tube diameter	1";
Vacuum at top of drop tube	between 5 and 13.5 inches of Hg;
Applied vacuum at annulus	20 to 40 inches of H <sub>2</sub> O;
Air extraction flow rate	between 20 and 35 cfm/well;
Water extraction flow rate	between 3 and 4 litres/minute/well;
Radius of pneumatic influence	4 metres; and
Liquid radius of influence	10 to 12 metres.

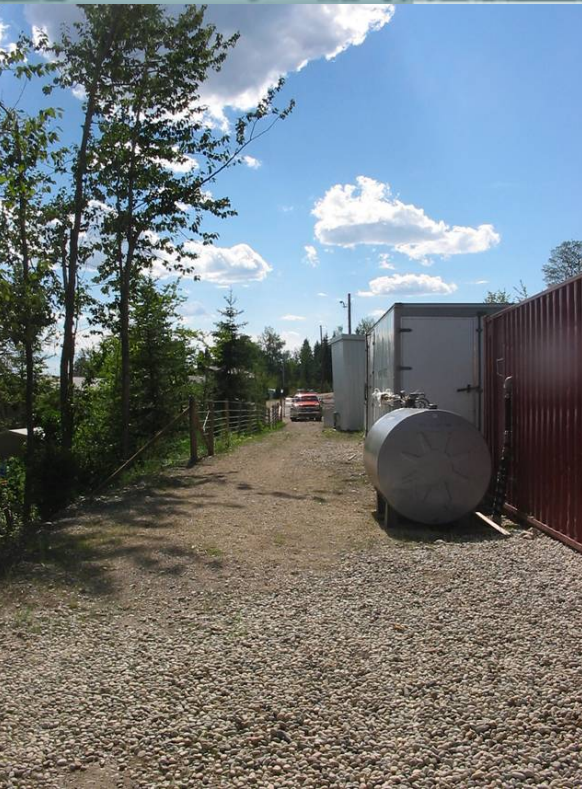
# PTO Recovery System

- 20 Recovery Well Network and PTO Recovery Sump
- Biological Percolating System (BPS)
- Water Treatment System (clay and carbon)
- Push Pipe
- Lake Discharge Basin
- Electrical

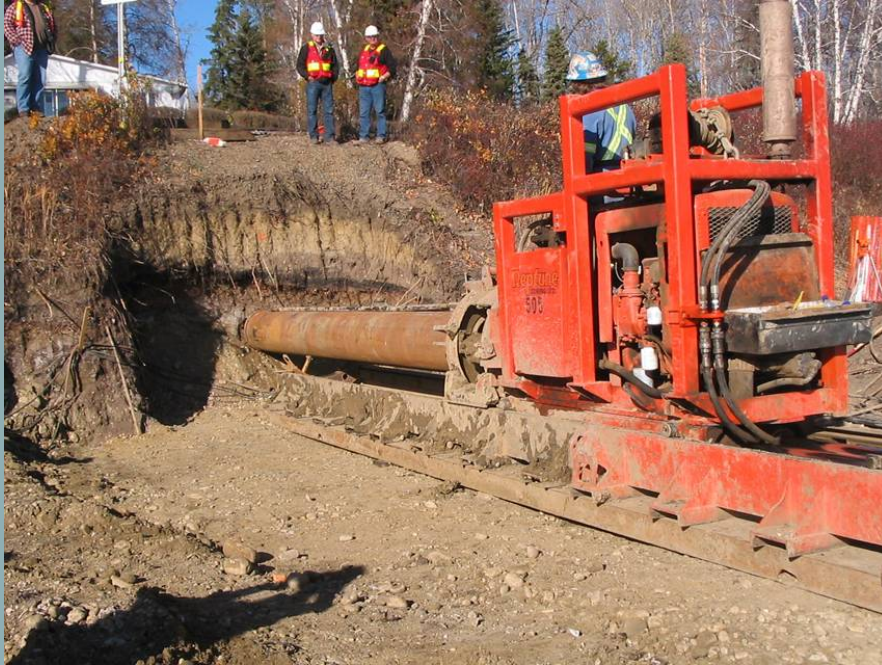
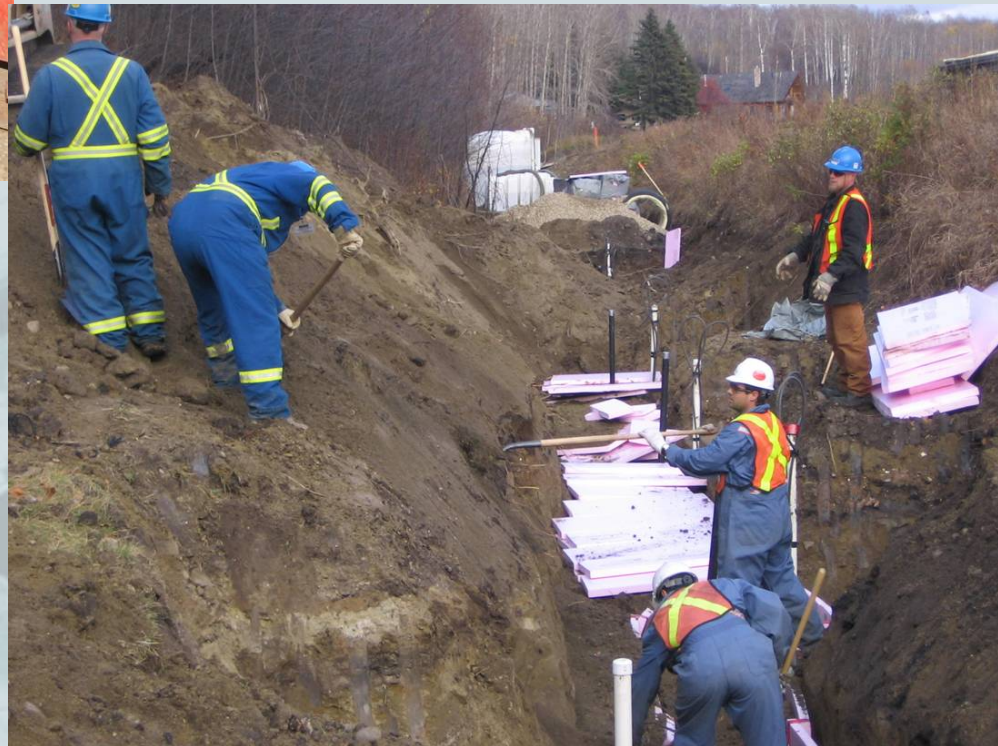
# PTO Recovery System Installation

Push Pipe

Well networks

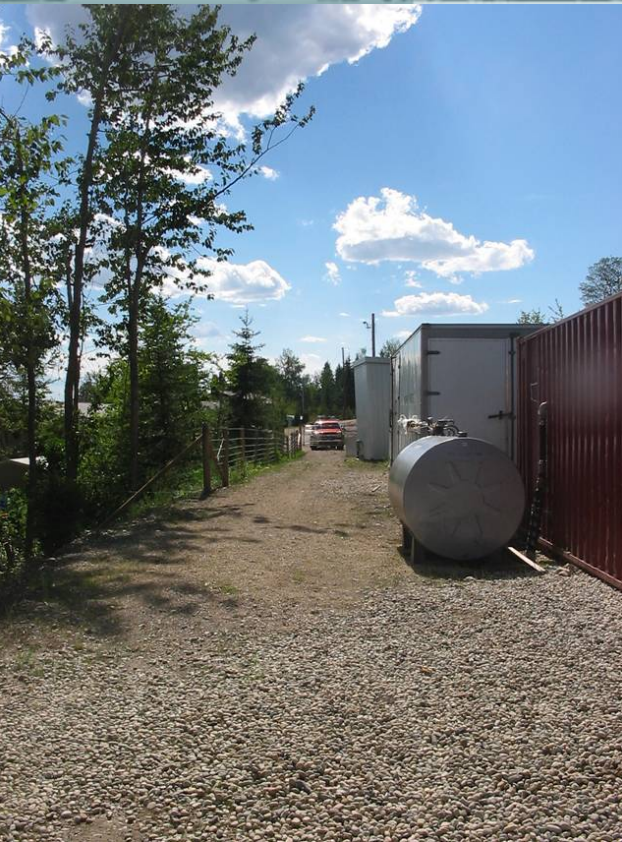
# PTO Performance

- VER recovery system has operated for a total of 5,550 hours.
- Groundwater recovery rates range from 3 L/min to 13 L/min.
- Total volume of groundwater recovered and treated during the period is 2,038,000 L.
- Total volume of PTO recovered in the dissolved phase (i.e., groundwater) is estimated to be 7,950 L.
- Removal efficiencies are generally greater than 95% BTEX, PHC and PAHs
- 48-h *Daphnia magna* (LC50) toxicity testing indicate greater than (>) 100 percent (%) survival for the test criteria
- Current apparent PTO thicknesses in recovery wells range from 0.010 to 0.050 m.
