Emergency Response Management

Wabamun Derailment

The Spill

0520 MDT August 3, 2005

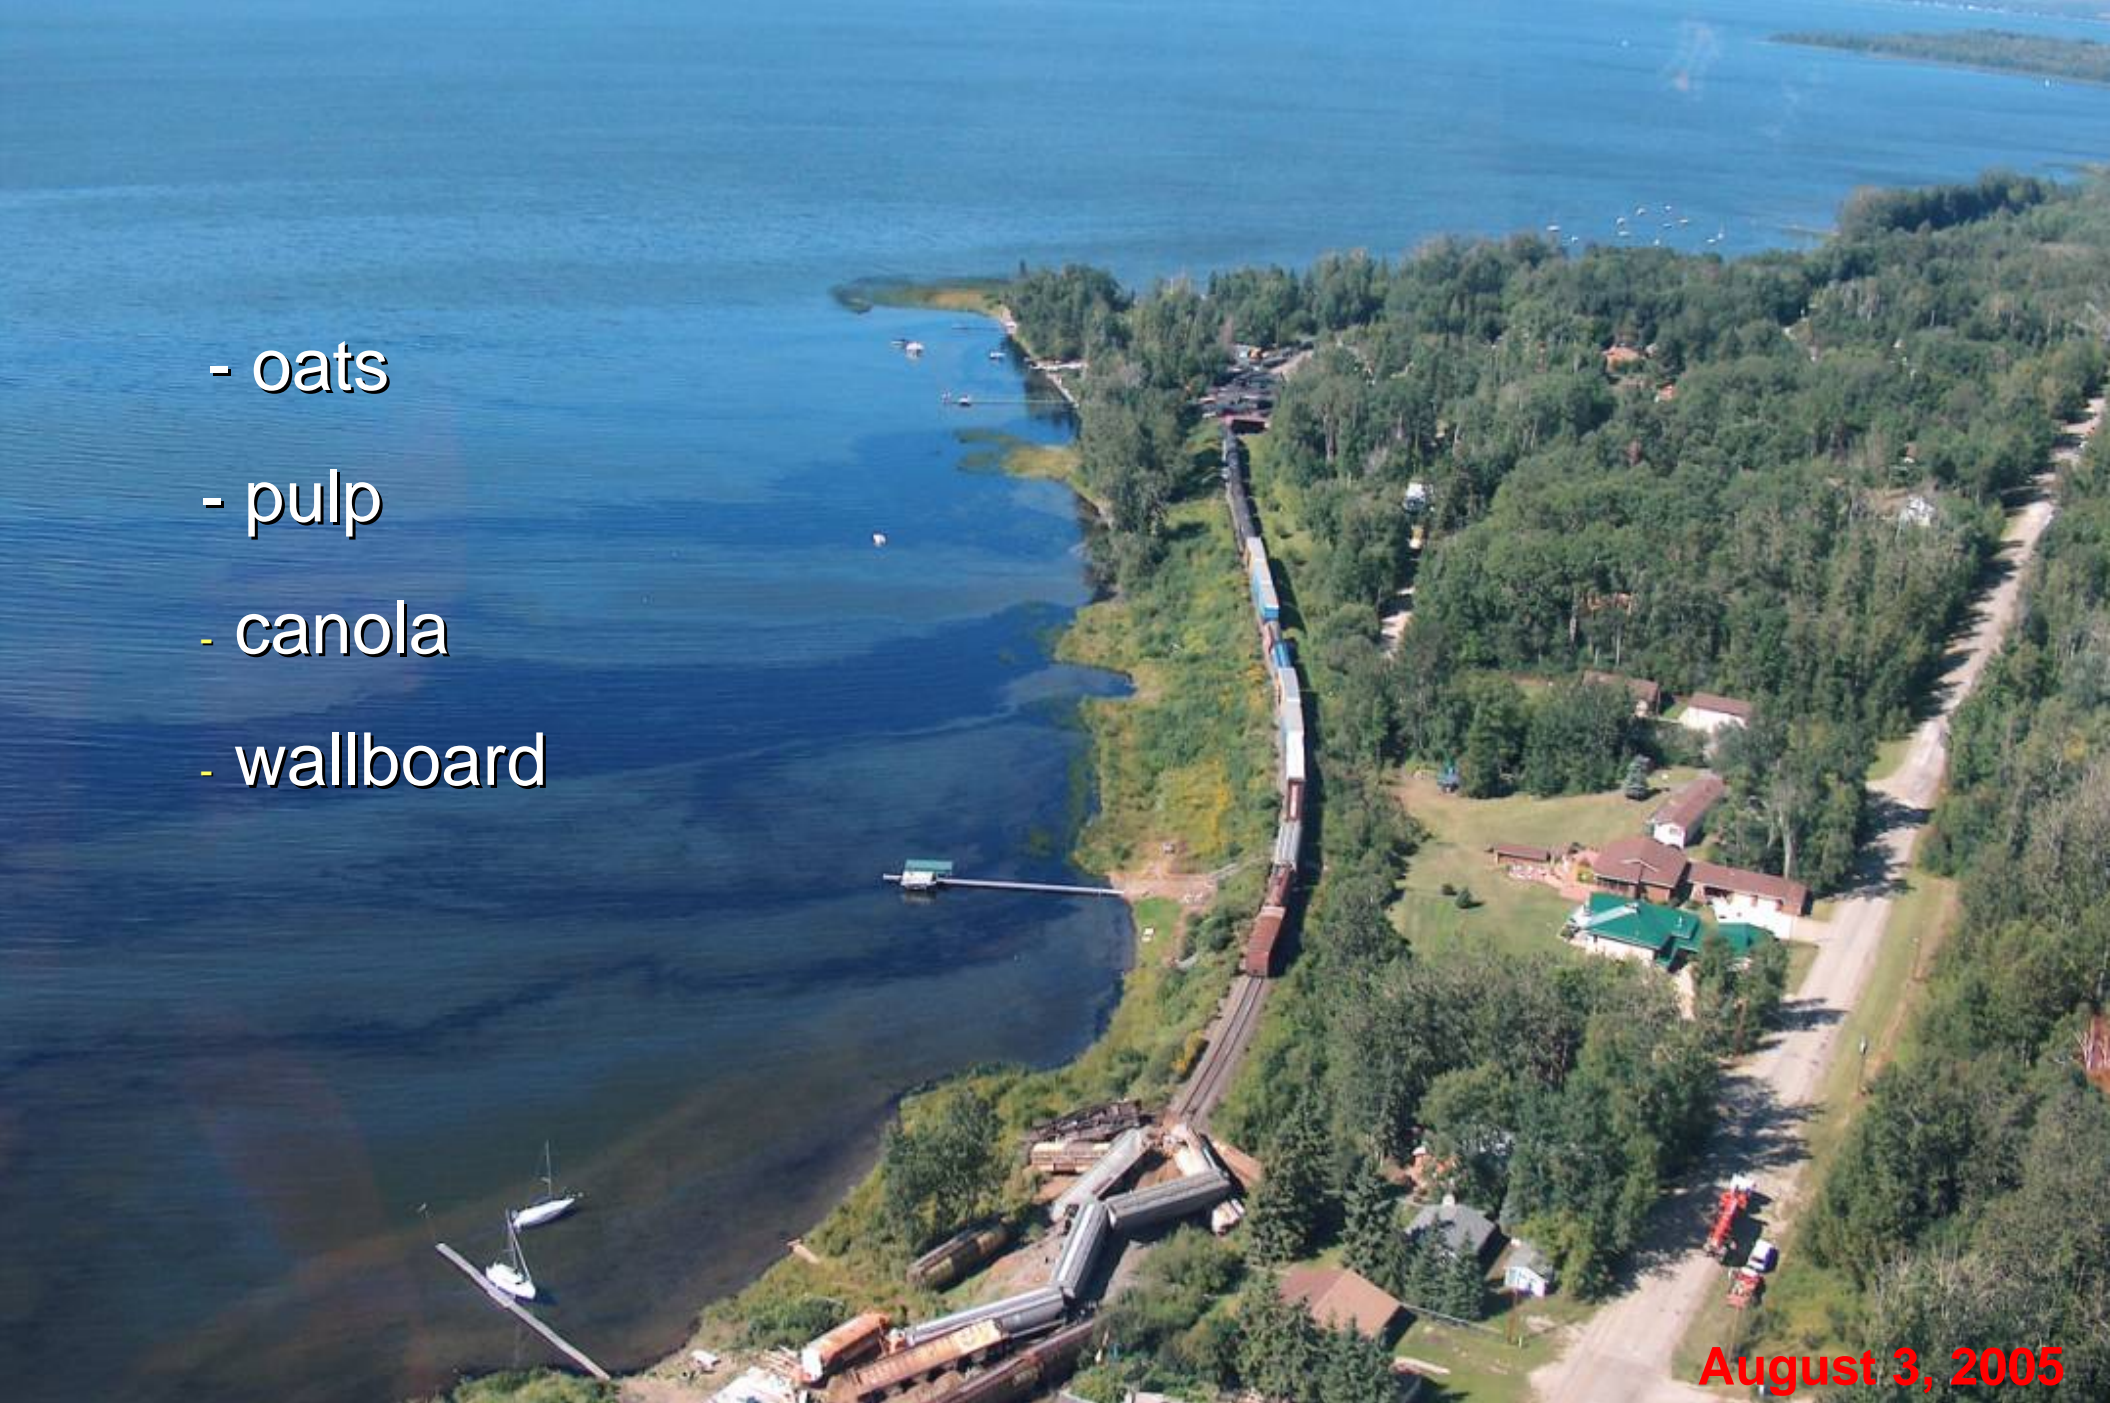
30351 03 derailed at mile 49.4,
Edson Subdivision

140 car train derailed 43 cars

- 25 bunker C (11 leaked)
- 1 pole treating oil
- 1 toluene

- An aerial photograph showing a large body of water on the left, a dense forest in the center, and a residential area on the right. A long train of freight cars is visible, running parallel to the shoreline and through the forest. In the foreground, there are several buildings, including a large one with a green roof, and a red crane. A small boat is docked at a pier in the water.
- oats
 - pulp
 - canola
 - wallboard

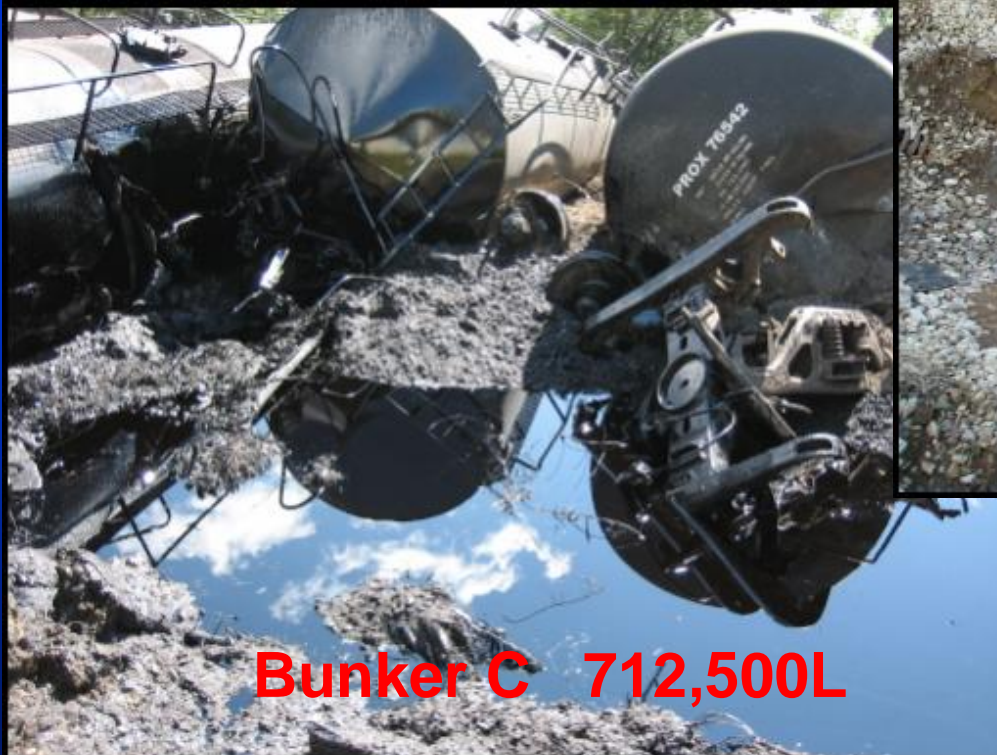
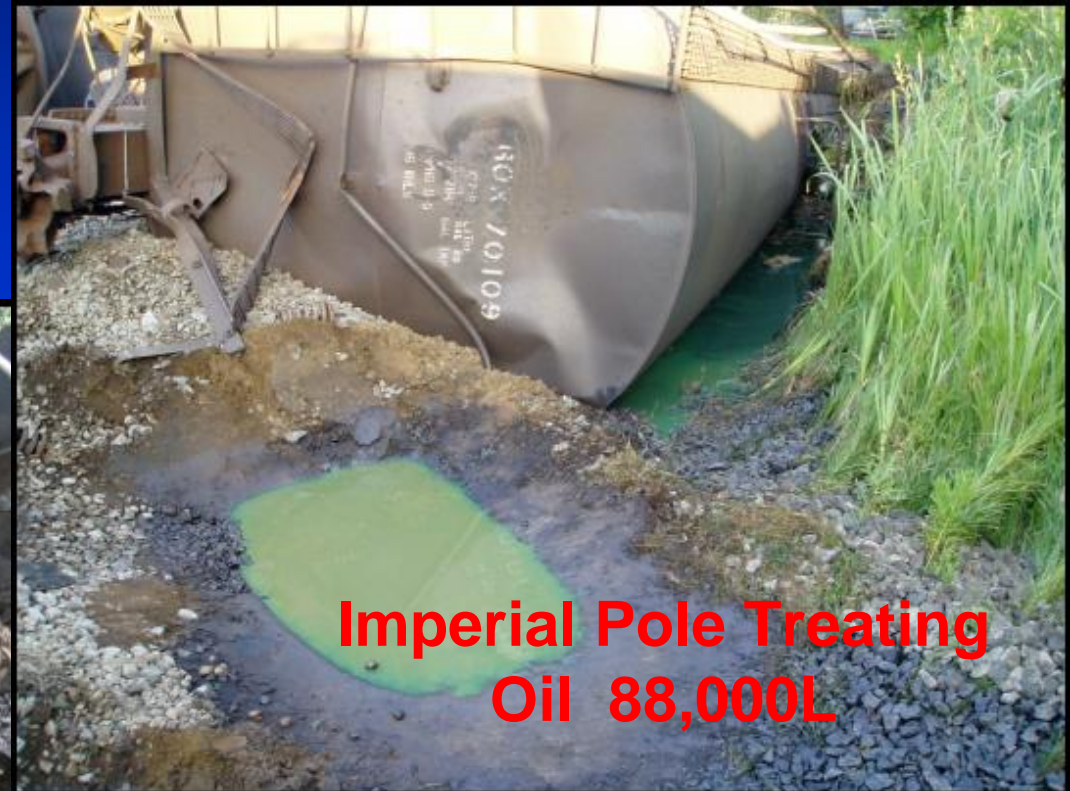
Spill Volumes

Total 800,500 L

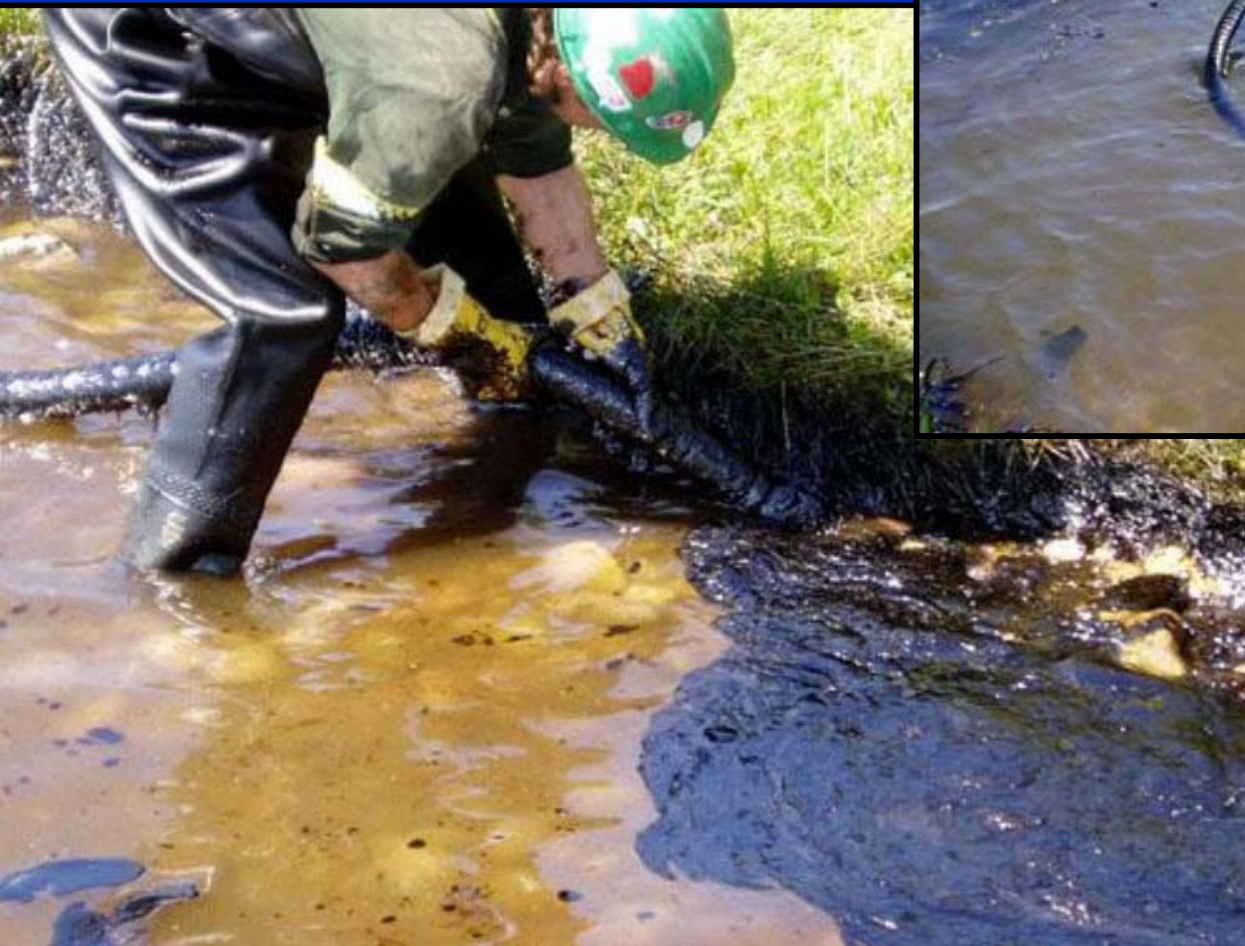
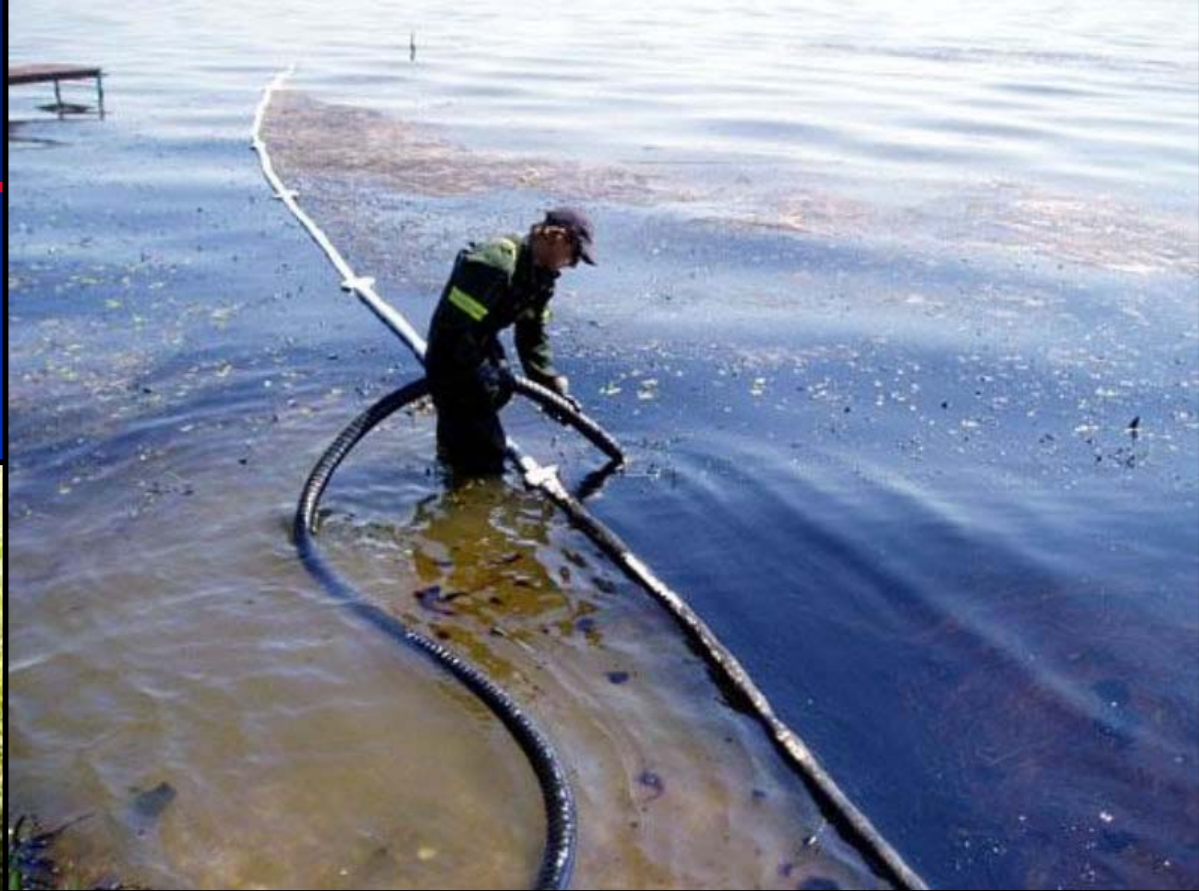
16 vacuum trucks
+ mini-vacs

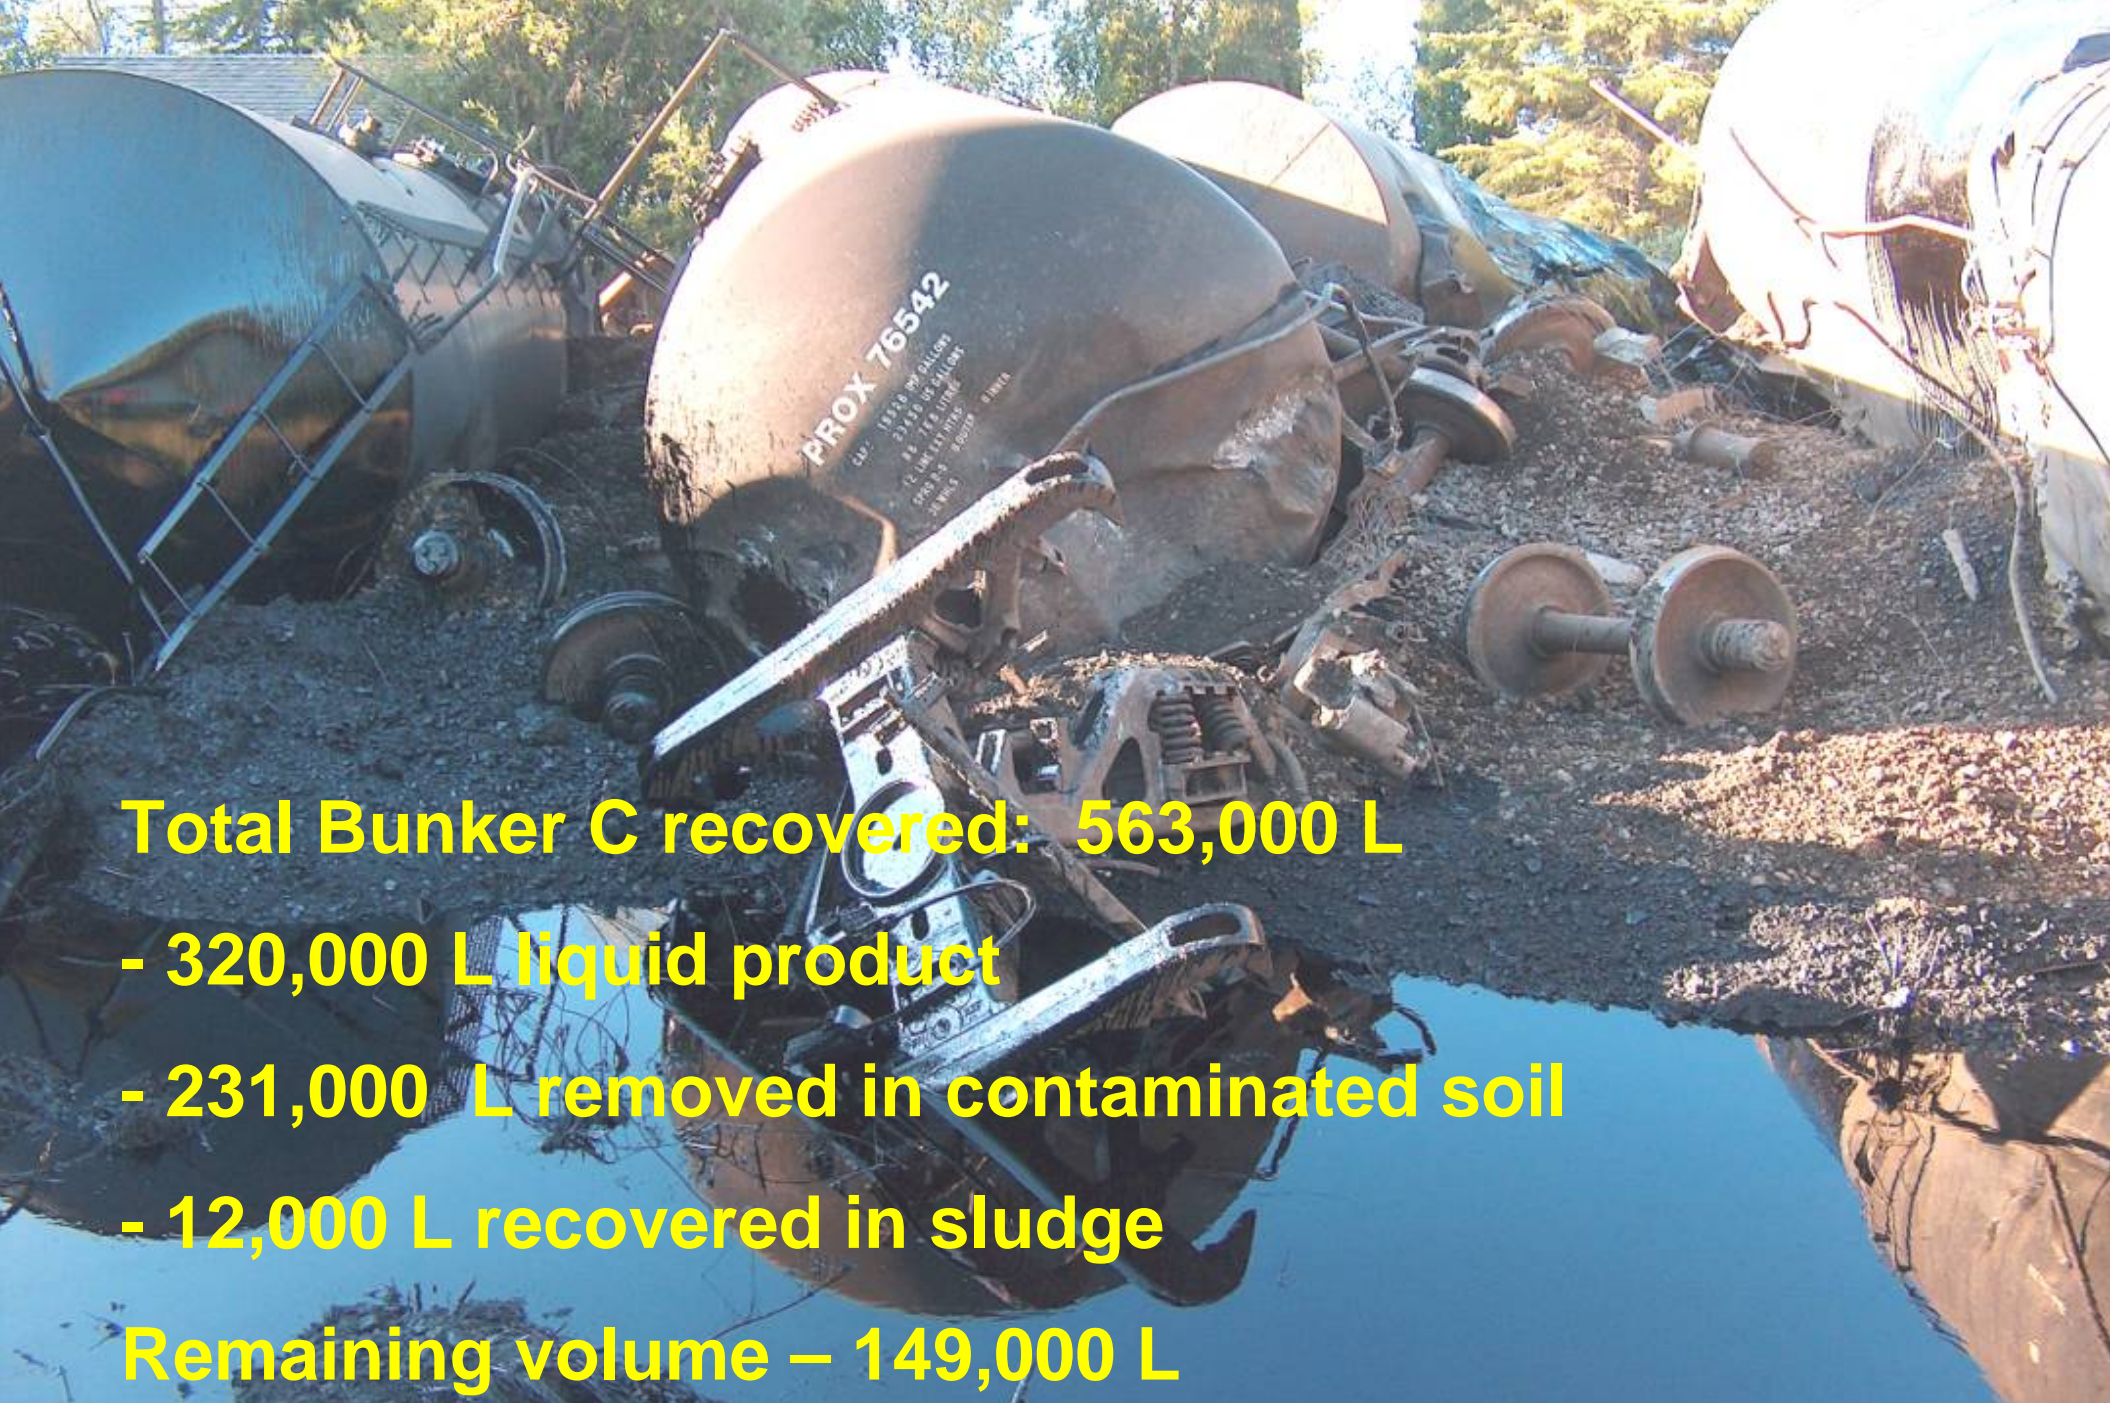
Total Bunker C recovered: 563,000 L

- 320,000 L liquid product

- 231,000 L removed in contaminated soil

- 12,000 L recovered in sludge

Remaining volume – 149,000 L

1.24 million litres transloaded
