REMEDIATING DIFFICULT SALT SPILL

SITES:

NO MAGIC WAND - BUT WE HAVE A
FEW TRICKS UP OUR SLEEVE

RemTech 2007

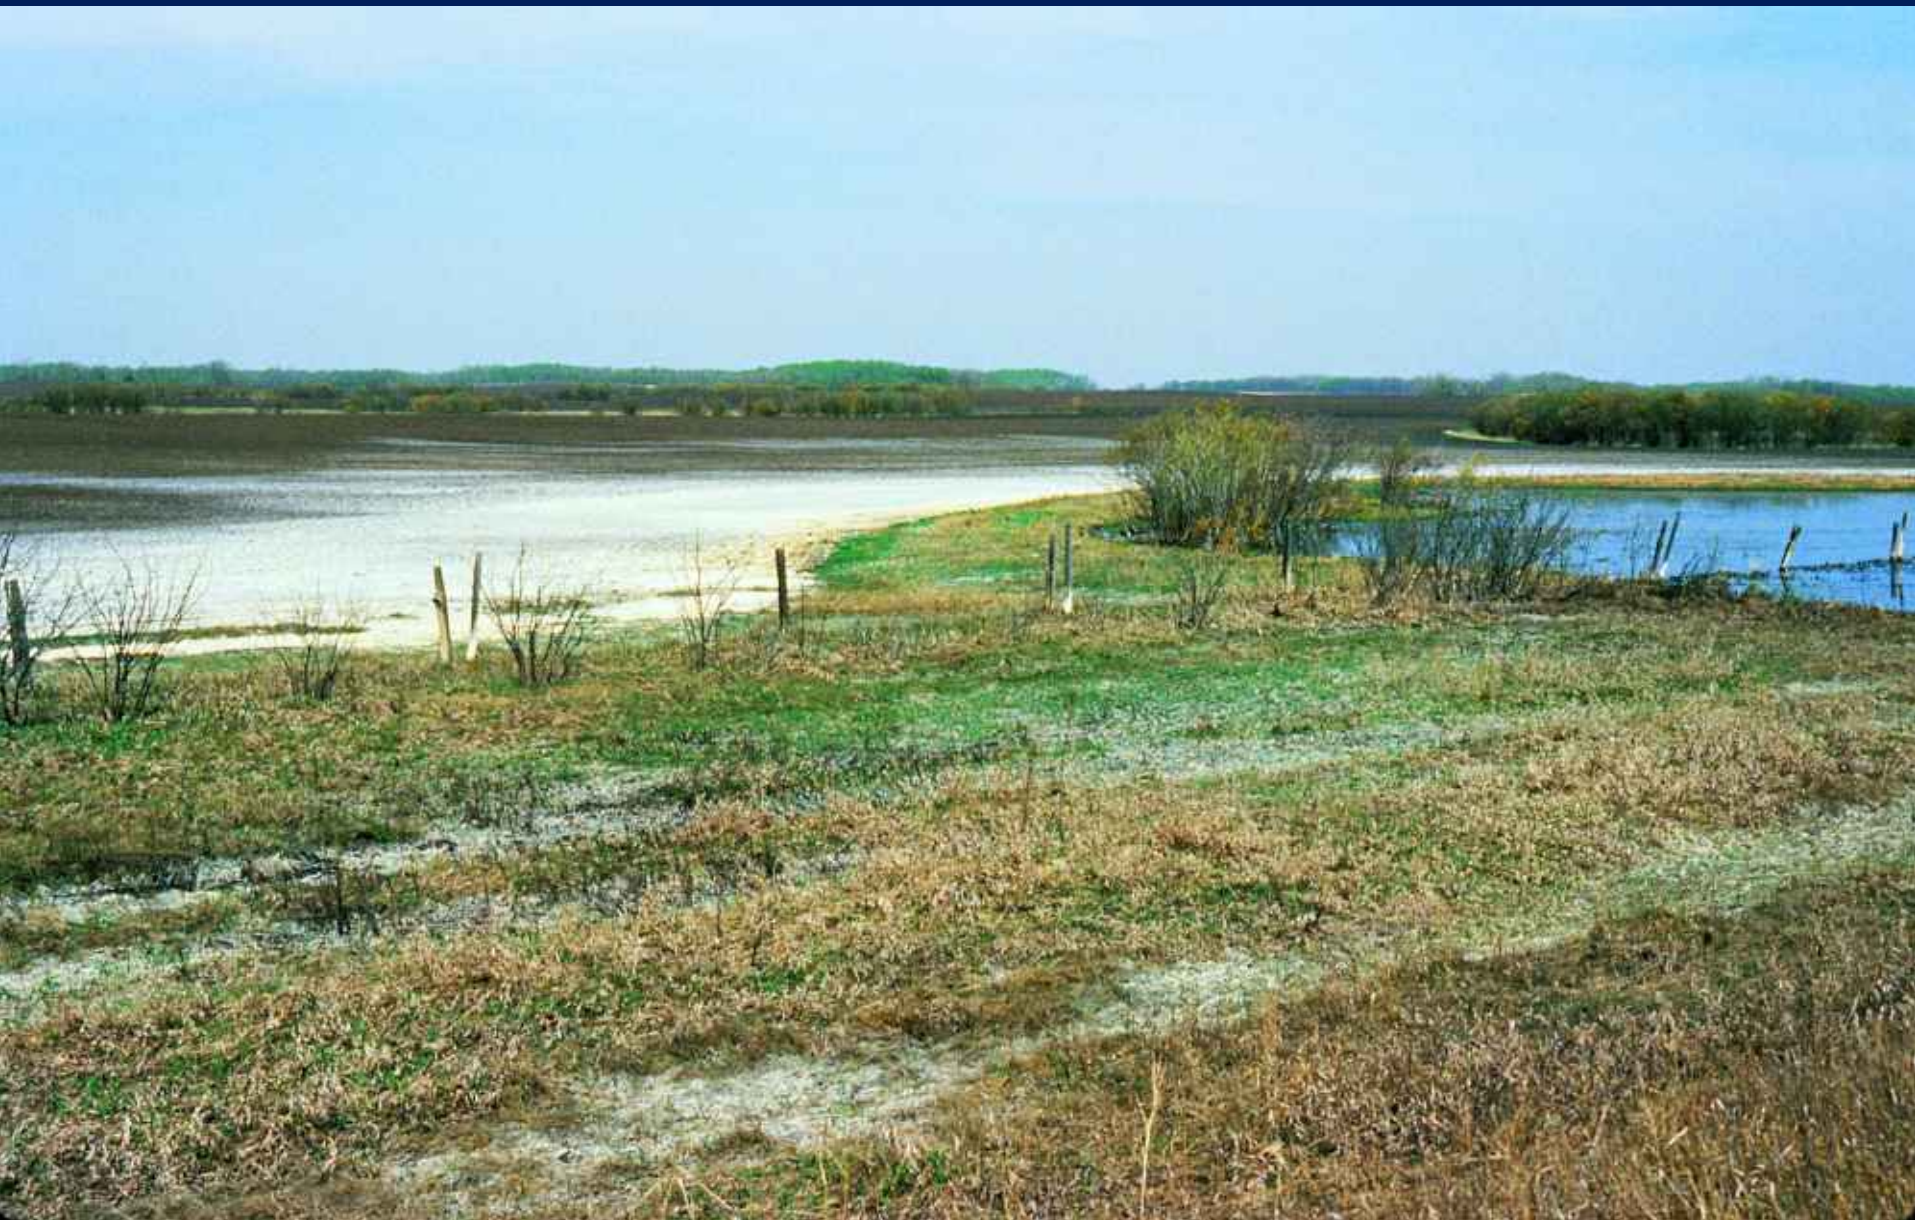
Naturally Saline Soils Around a Prairie Slough

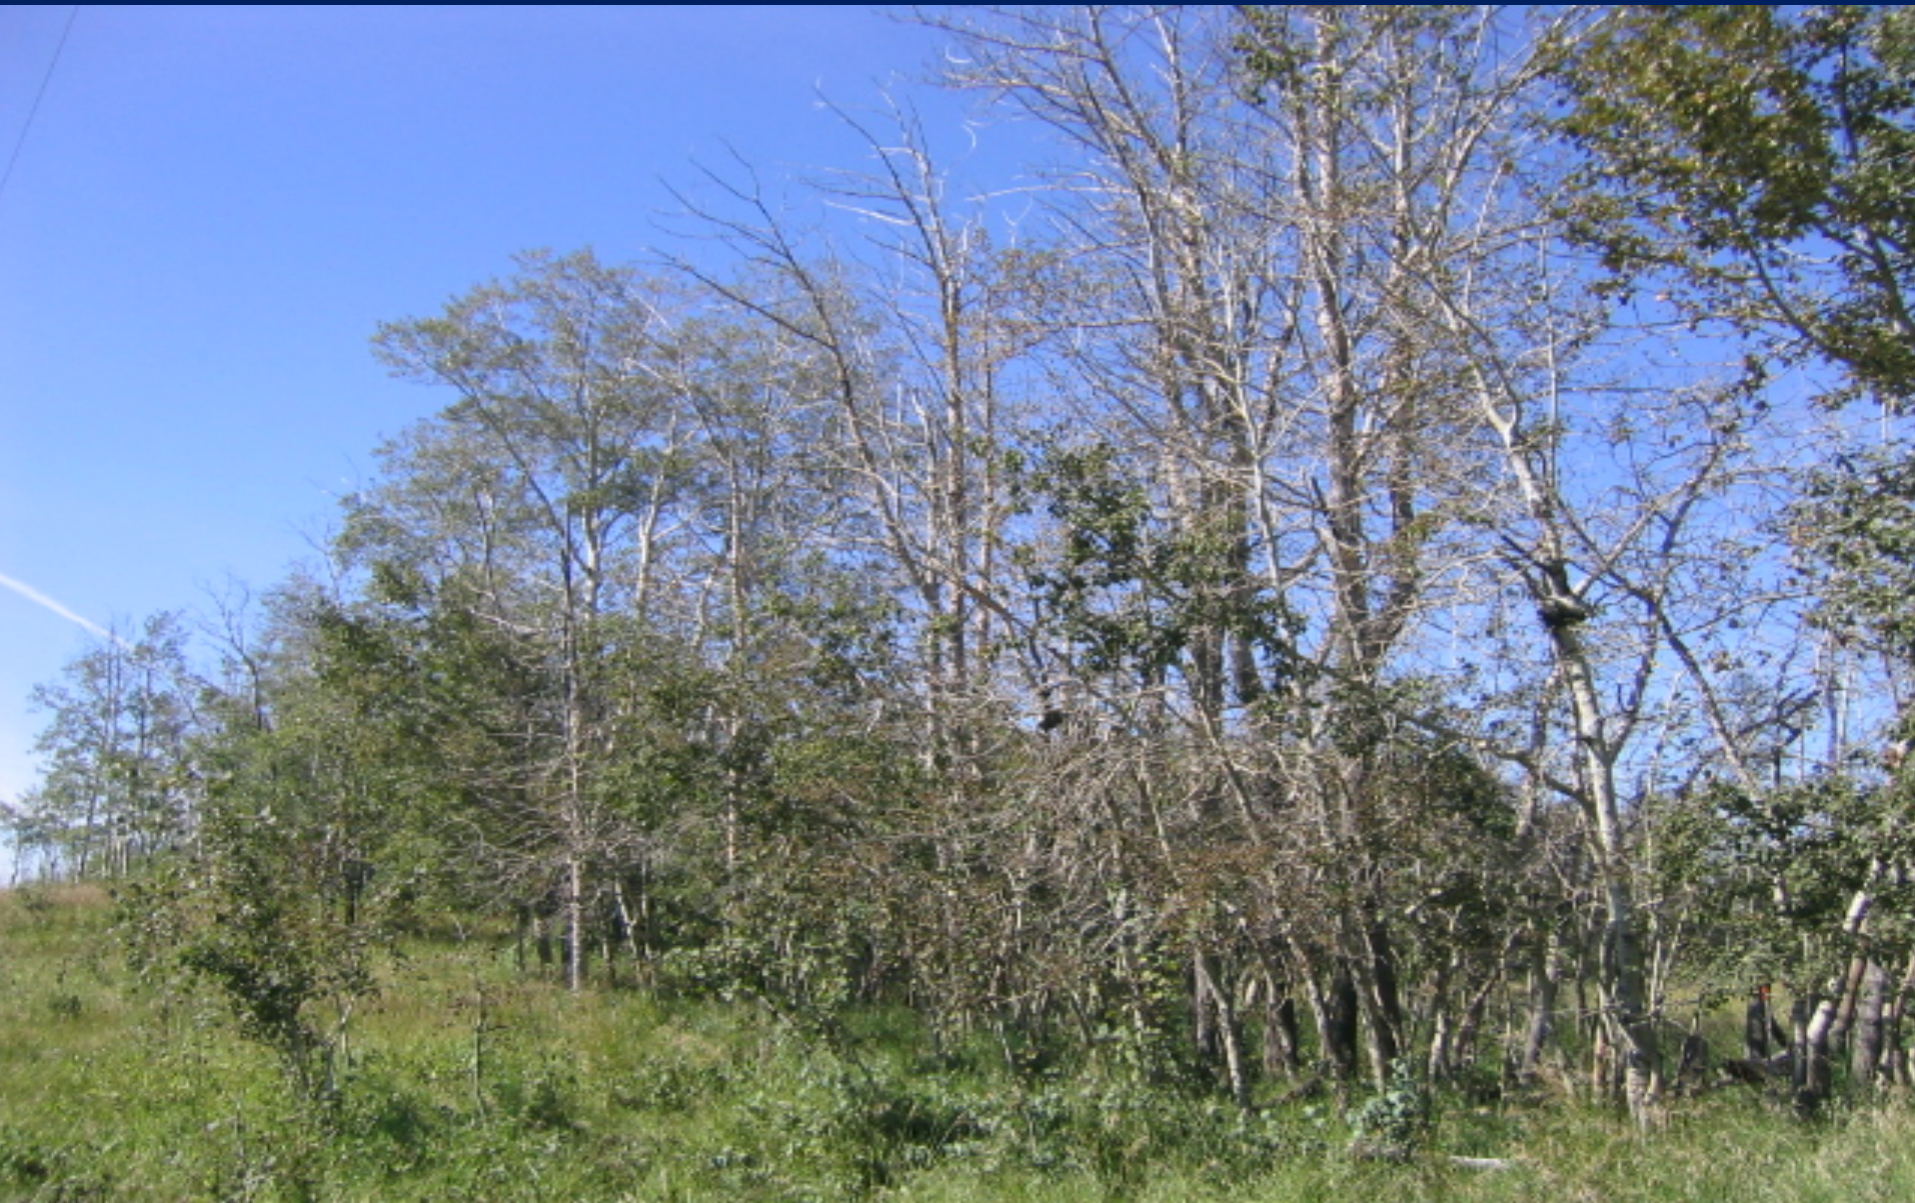
Dead and Stressed Aspen

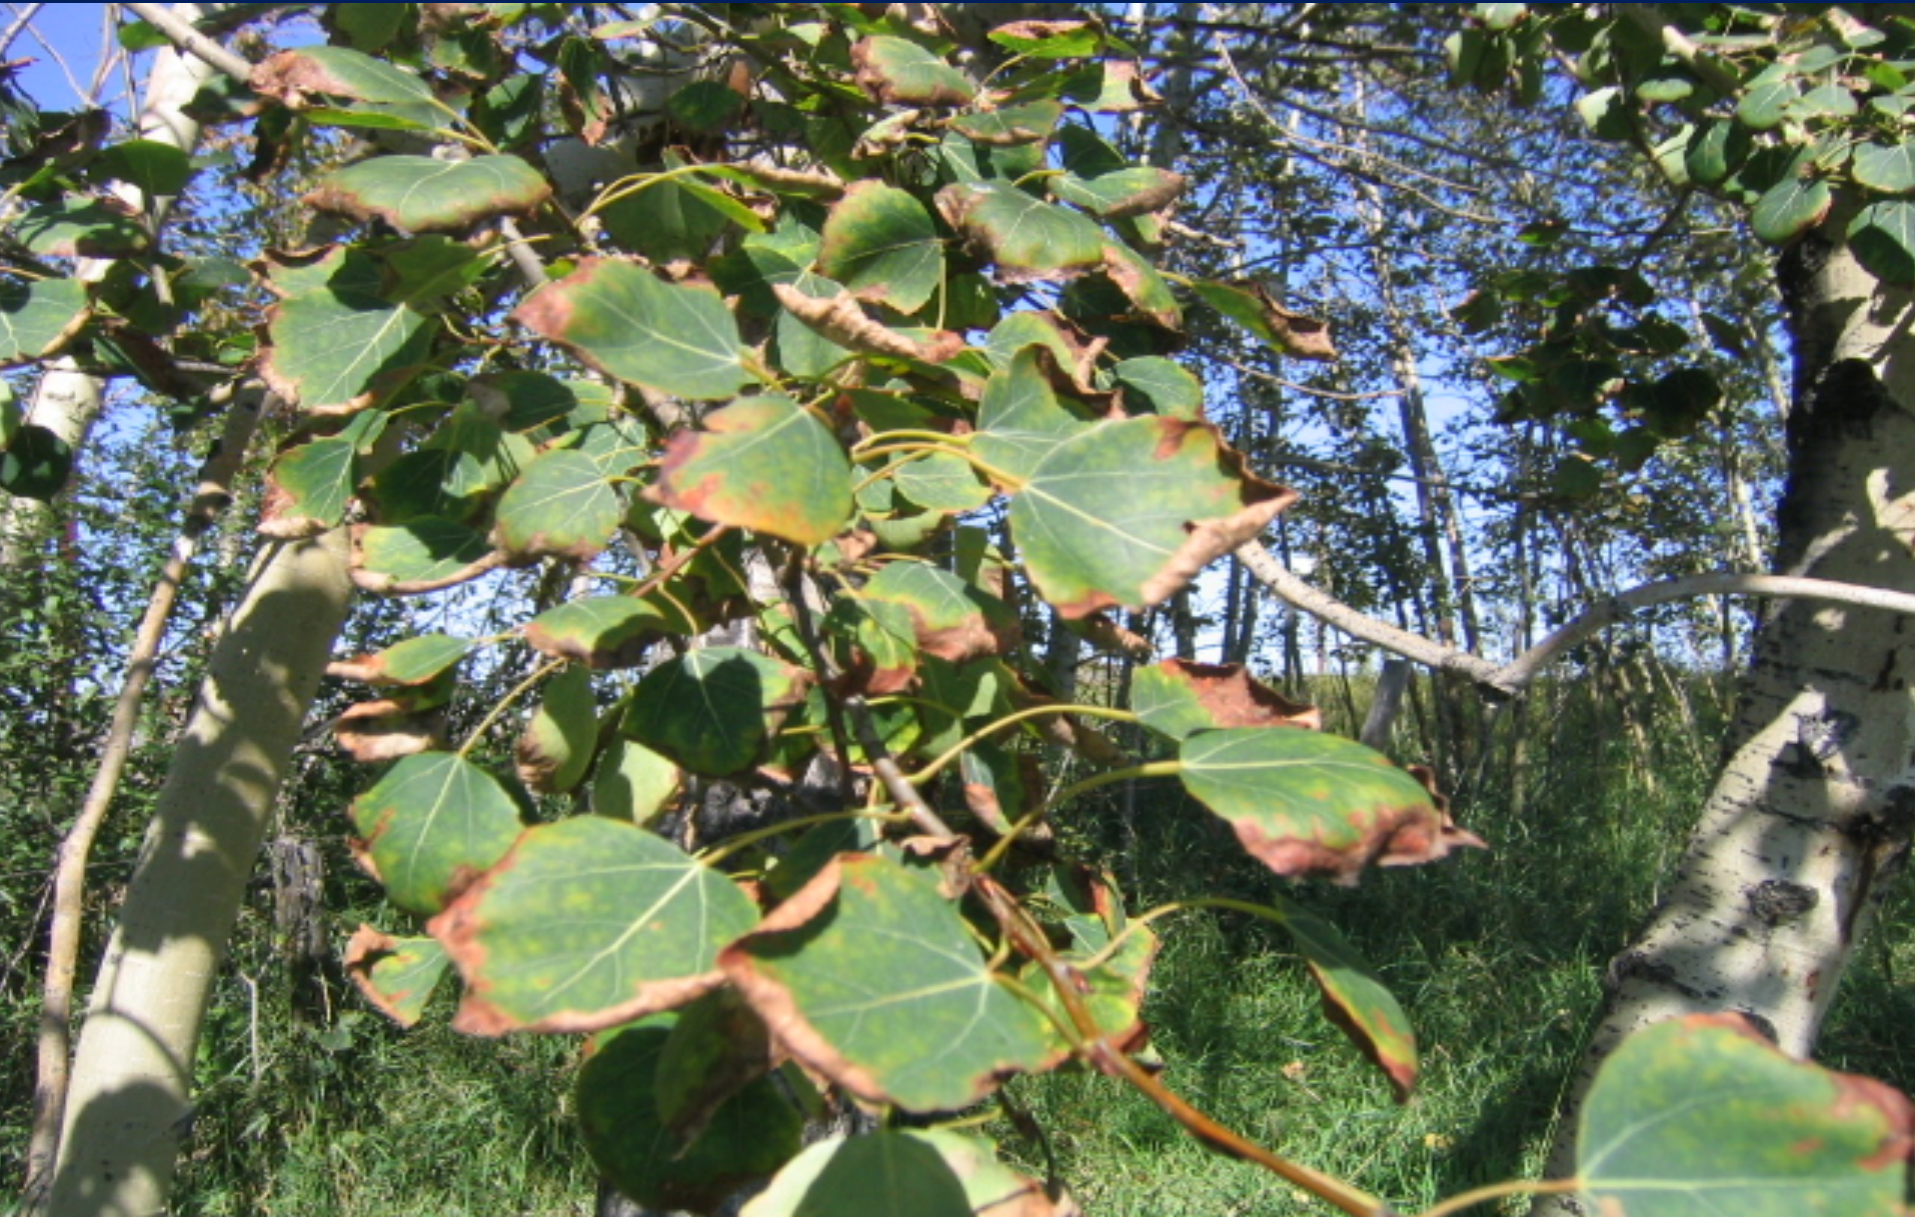
Leaf Stress – Brown Margins

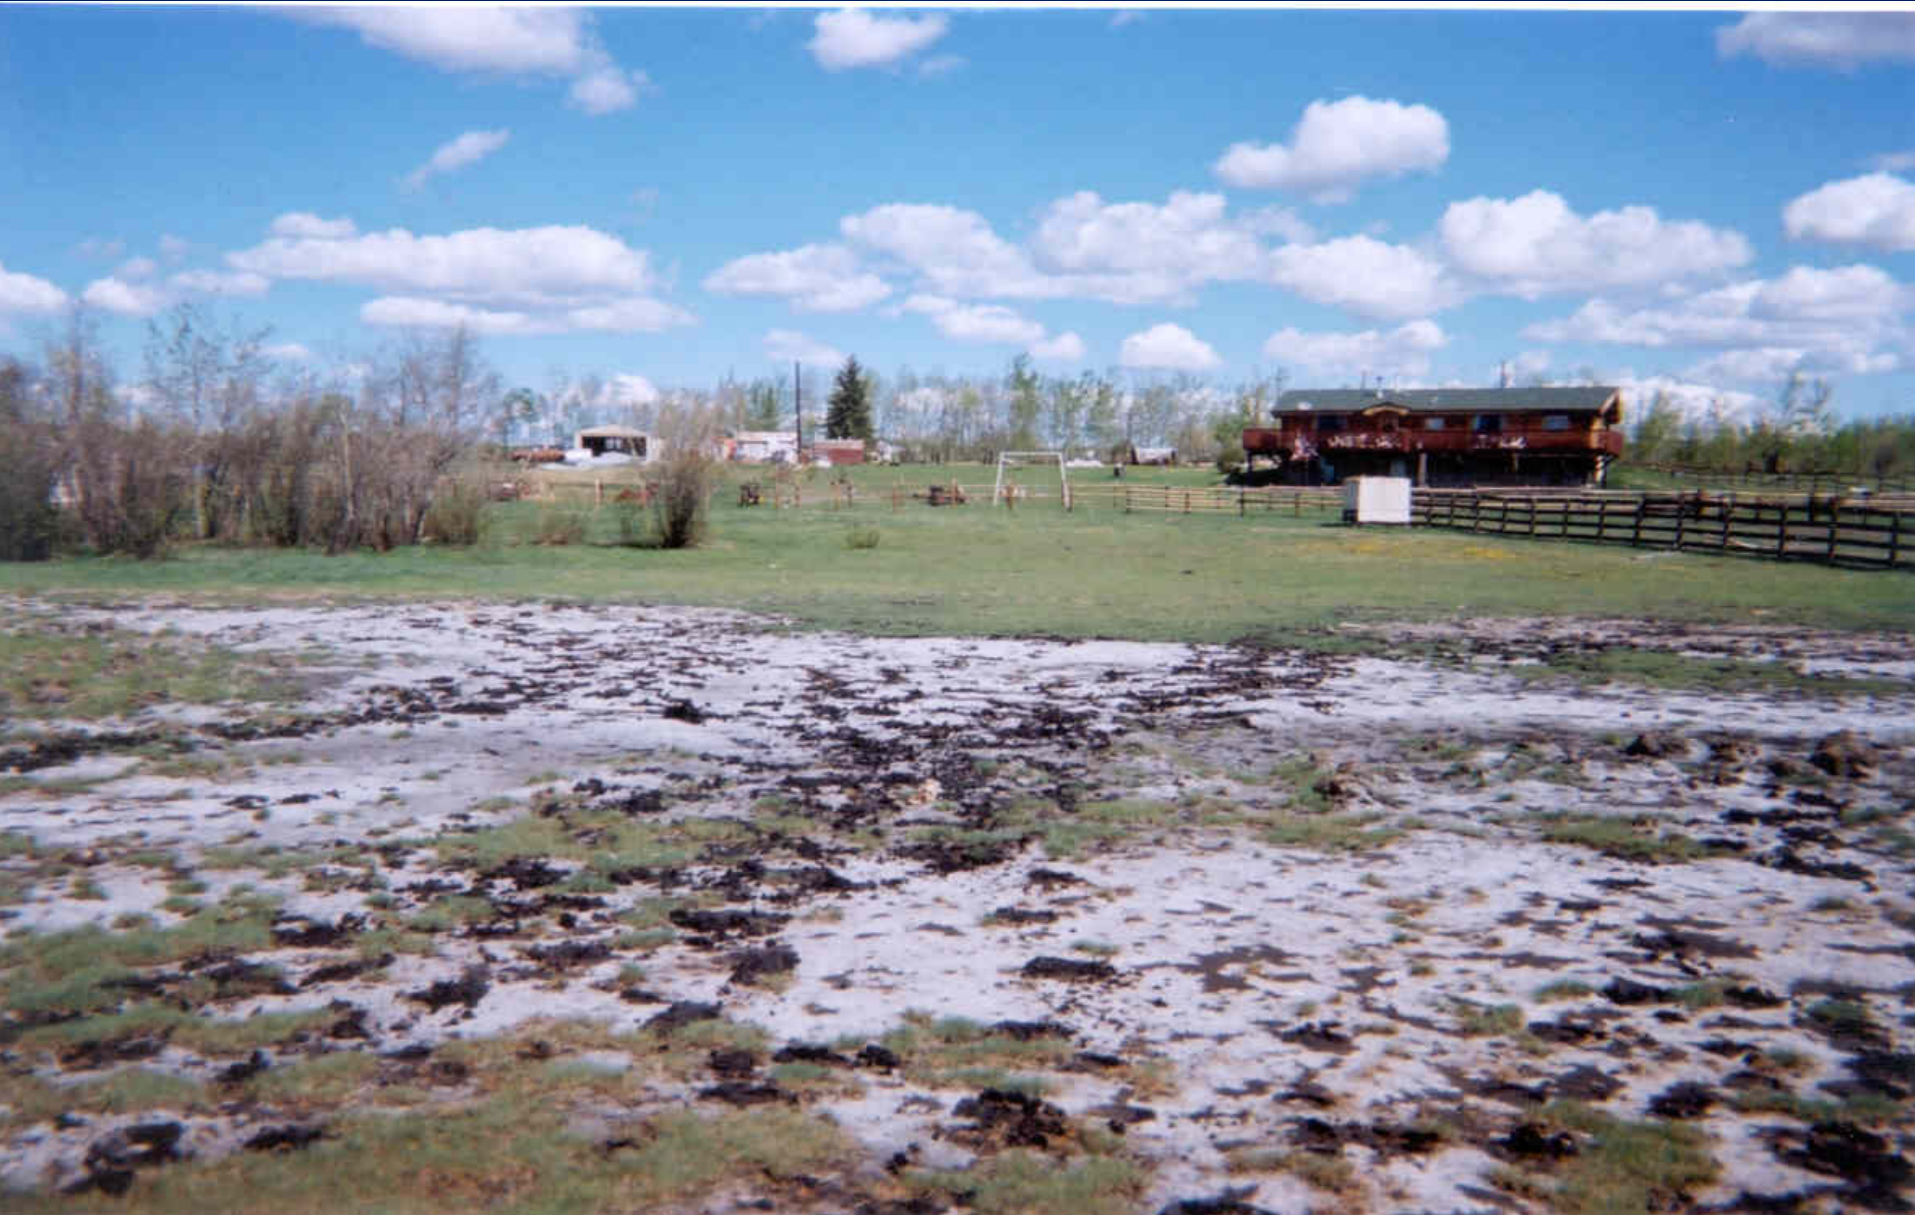
Surficial Salt Crust

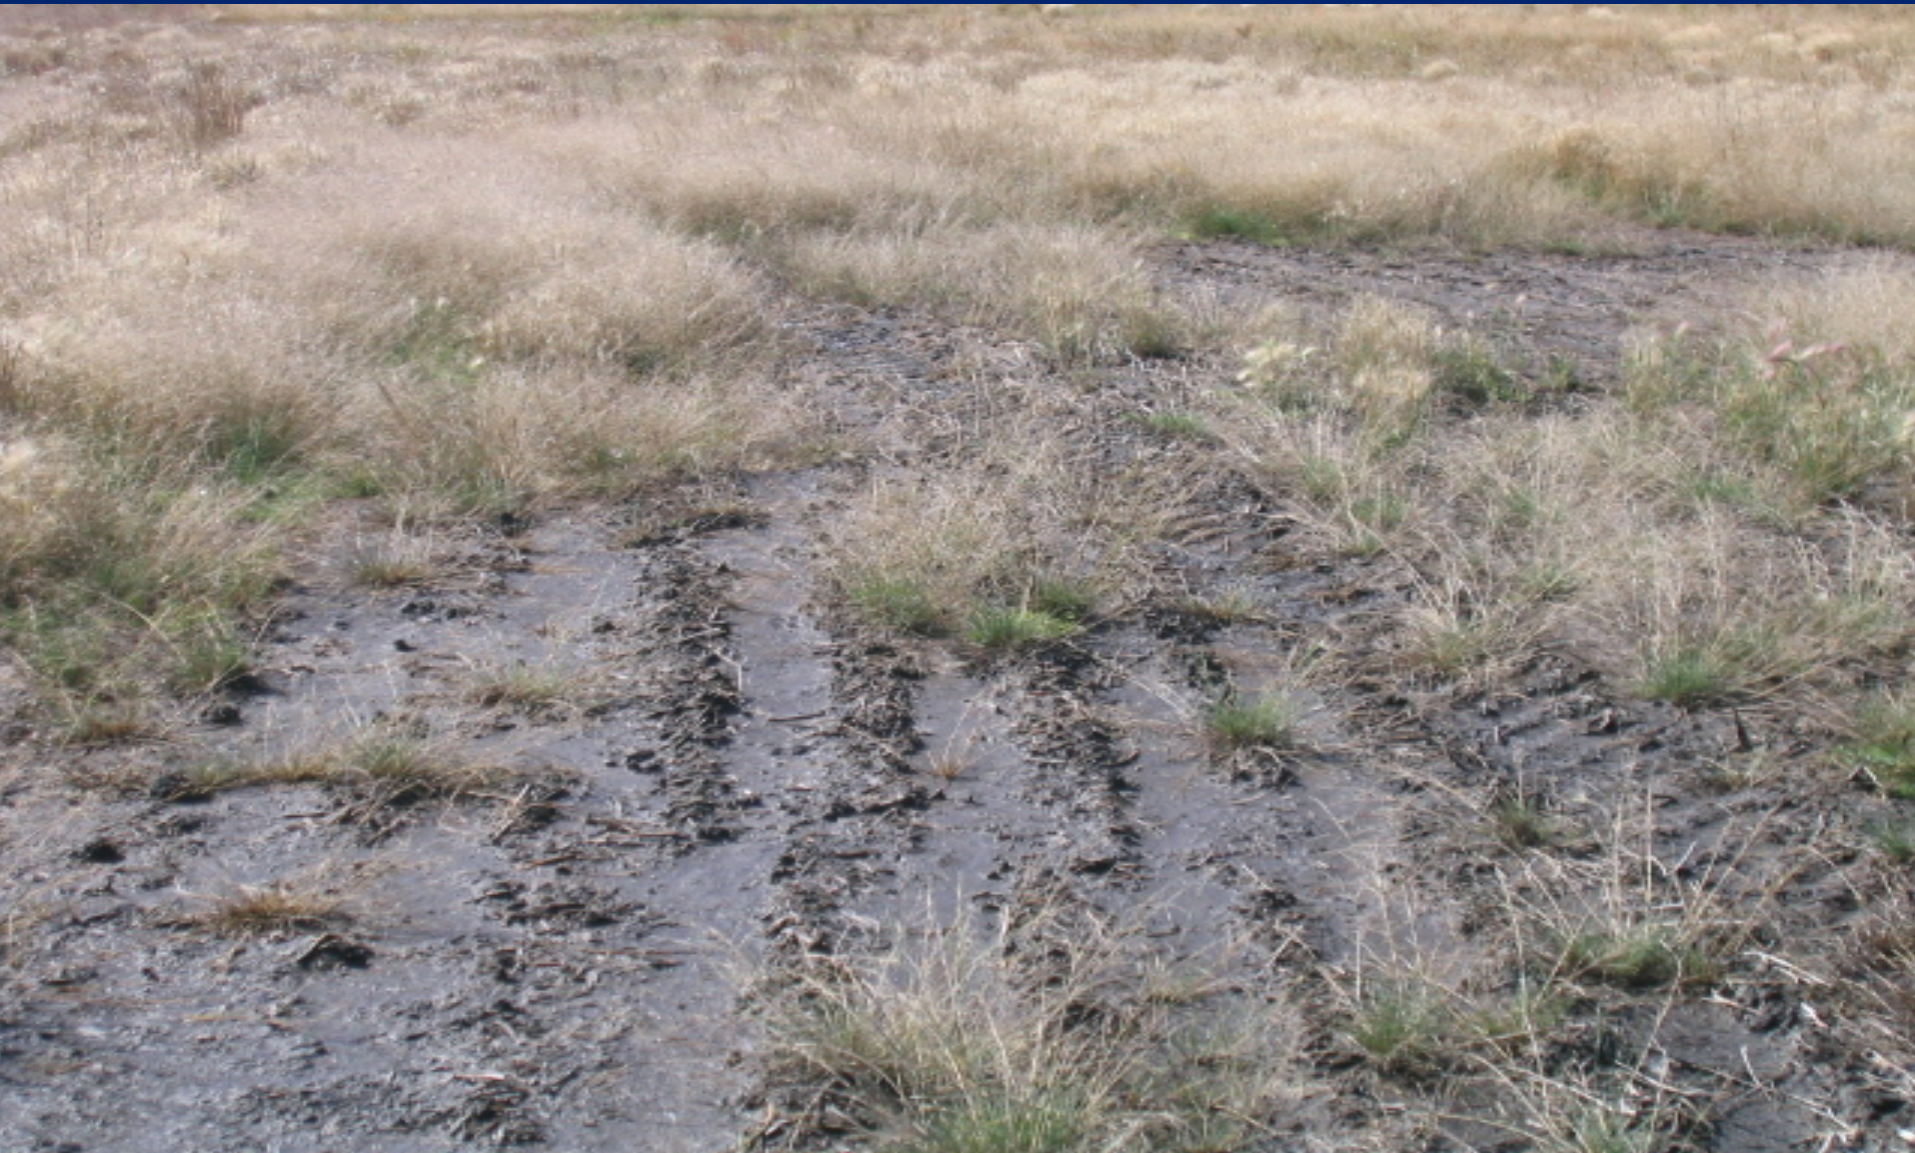
Bare Soil in Pasture

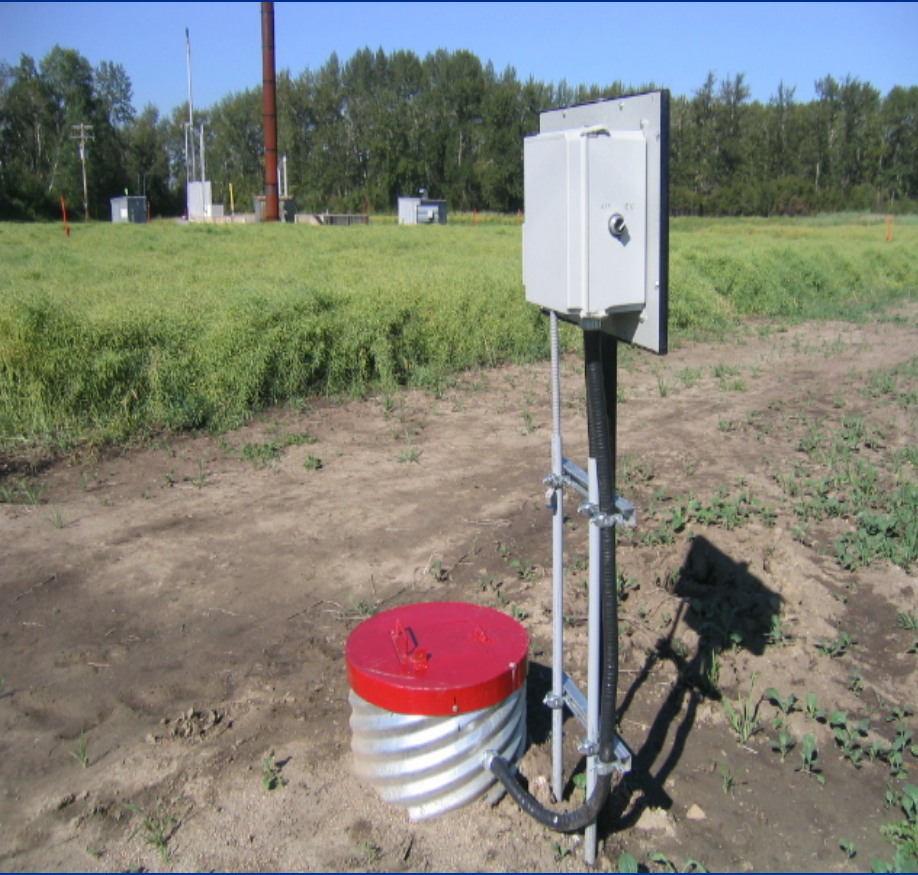
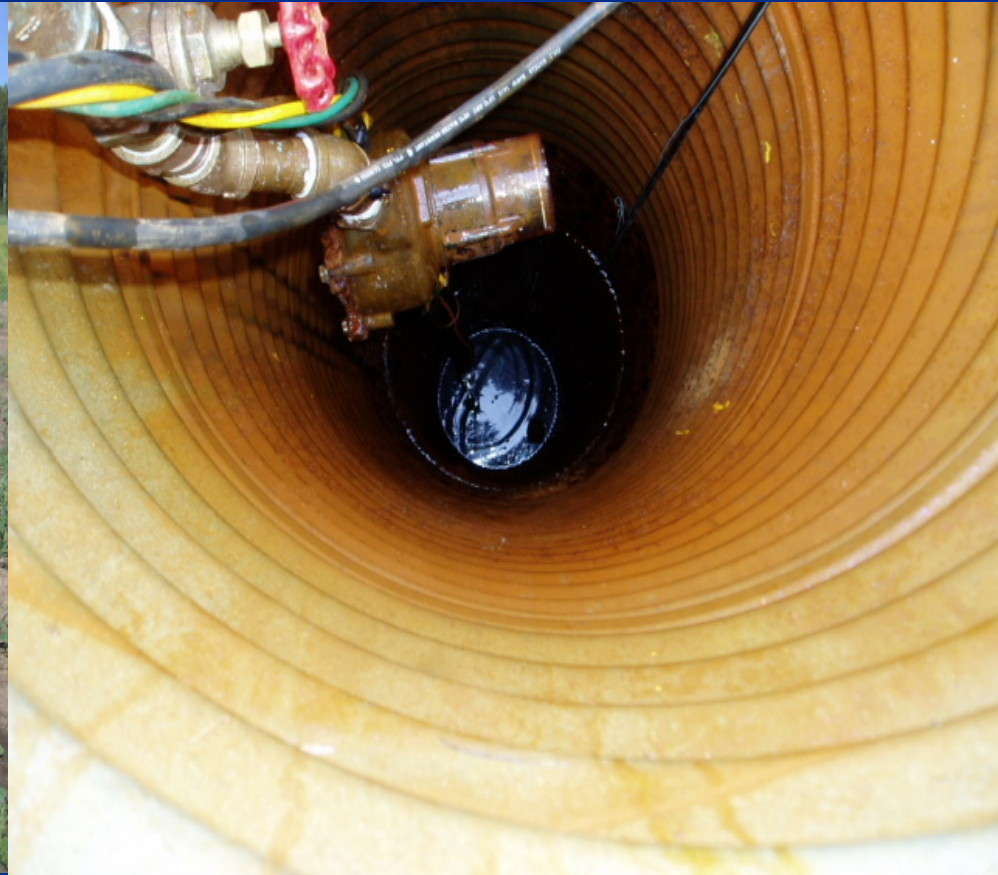
Bored Recovery Well

- Rapid response included:
 - installation of three groundwater recovery wells once access agreements were in place
 - commissioning of a pumping and water management system tied to disposal well
 - monitoring of operating system and groundwater

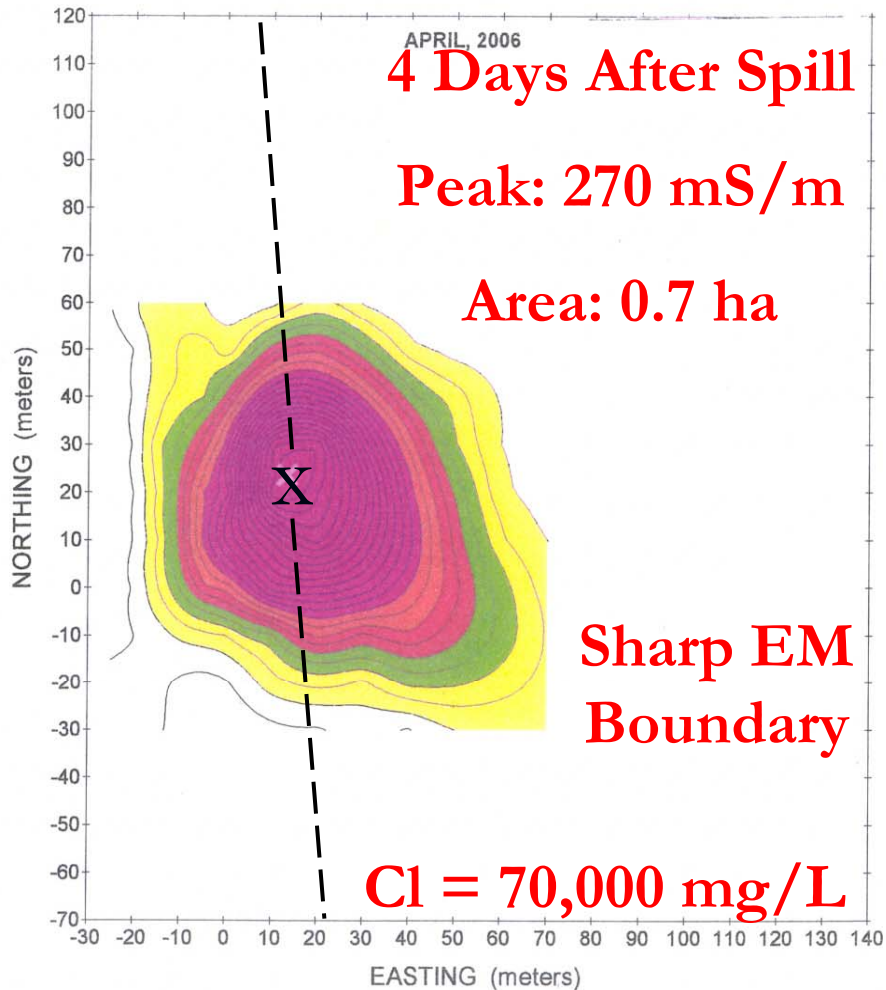
High Plume Migration Rate

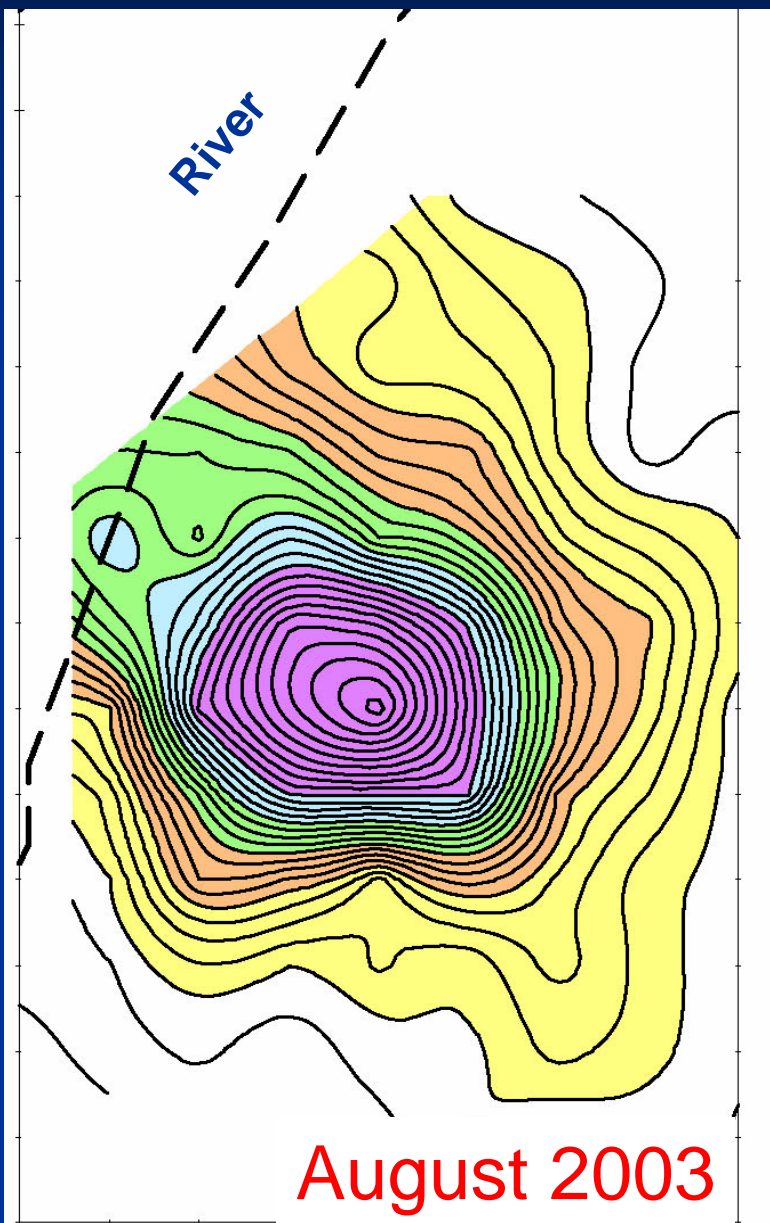
Decreasing EM Intensity Year 1

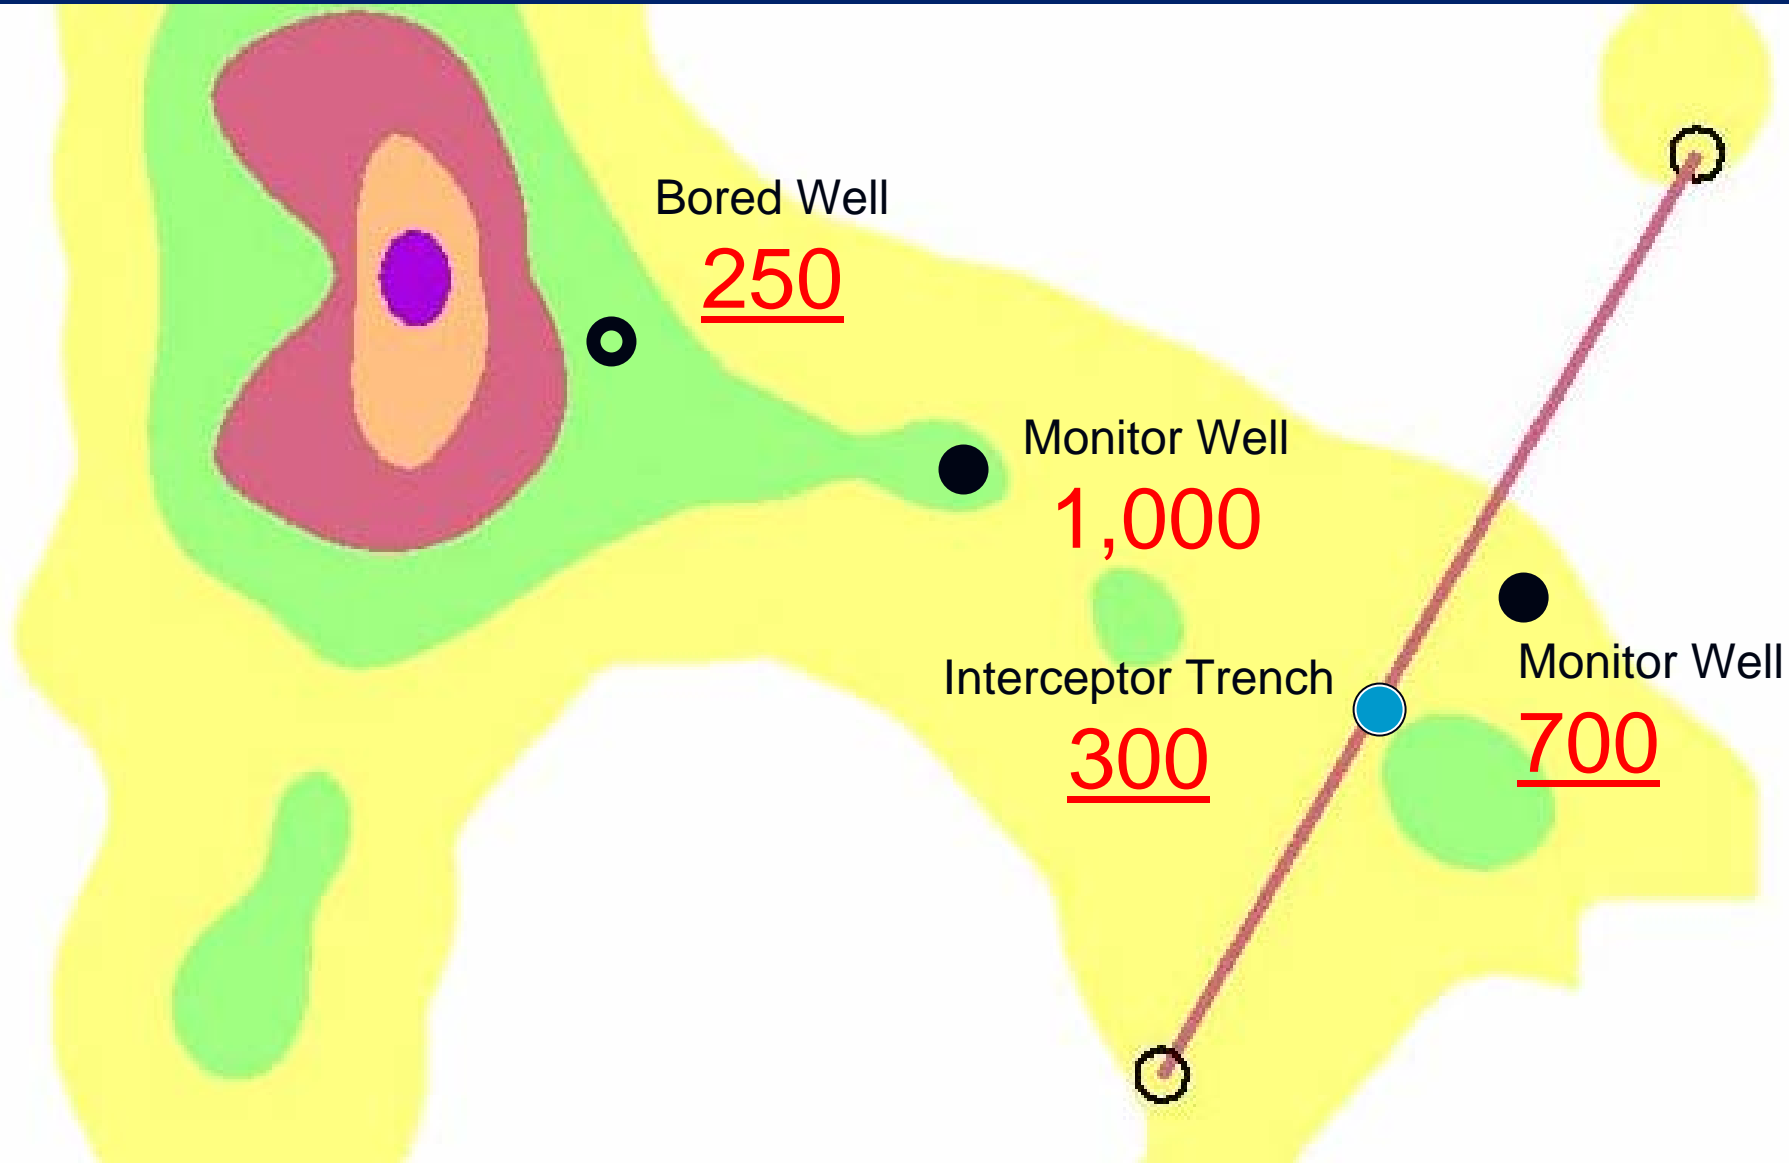
EM Survey and Cl (mg/L) - 6 Years Later

(150 m³ pw equivalents)

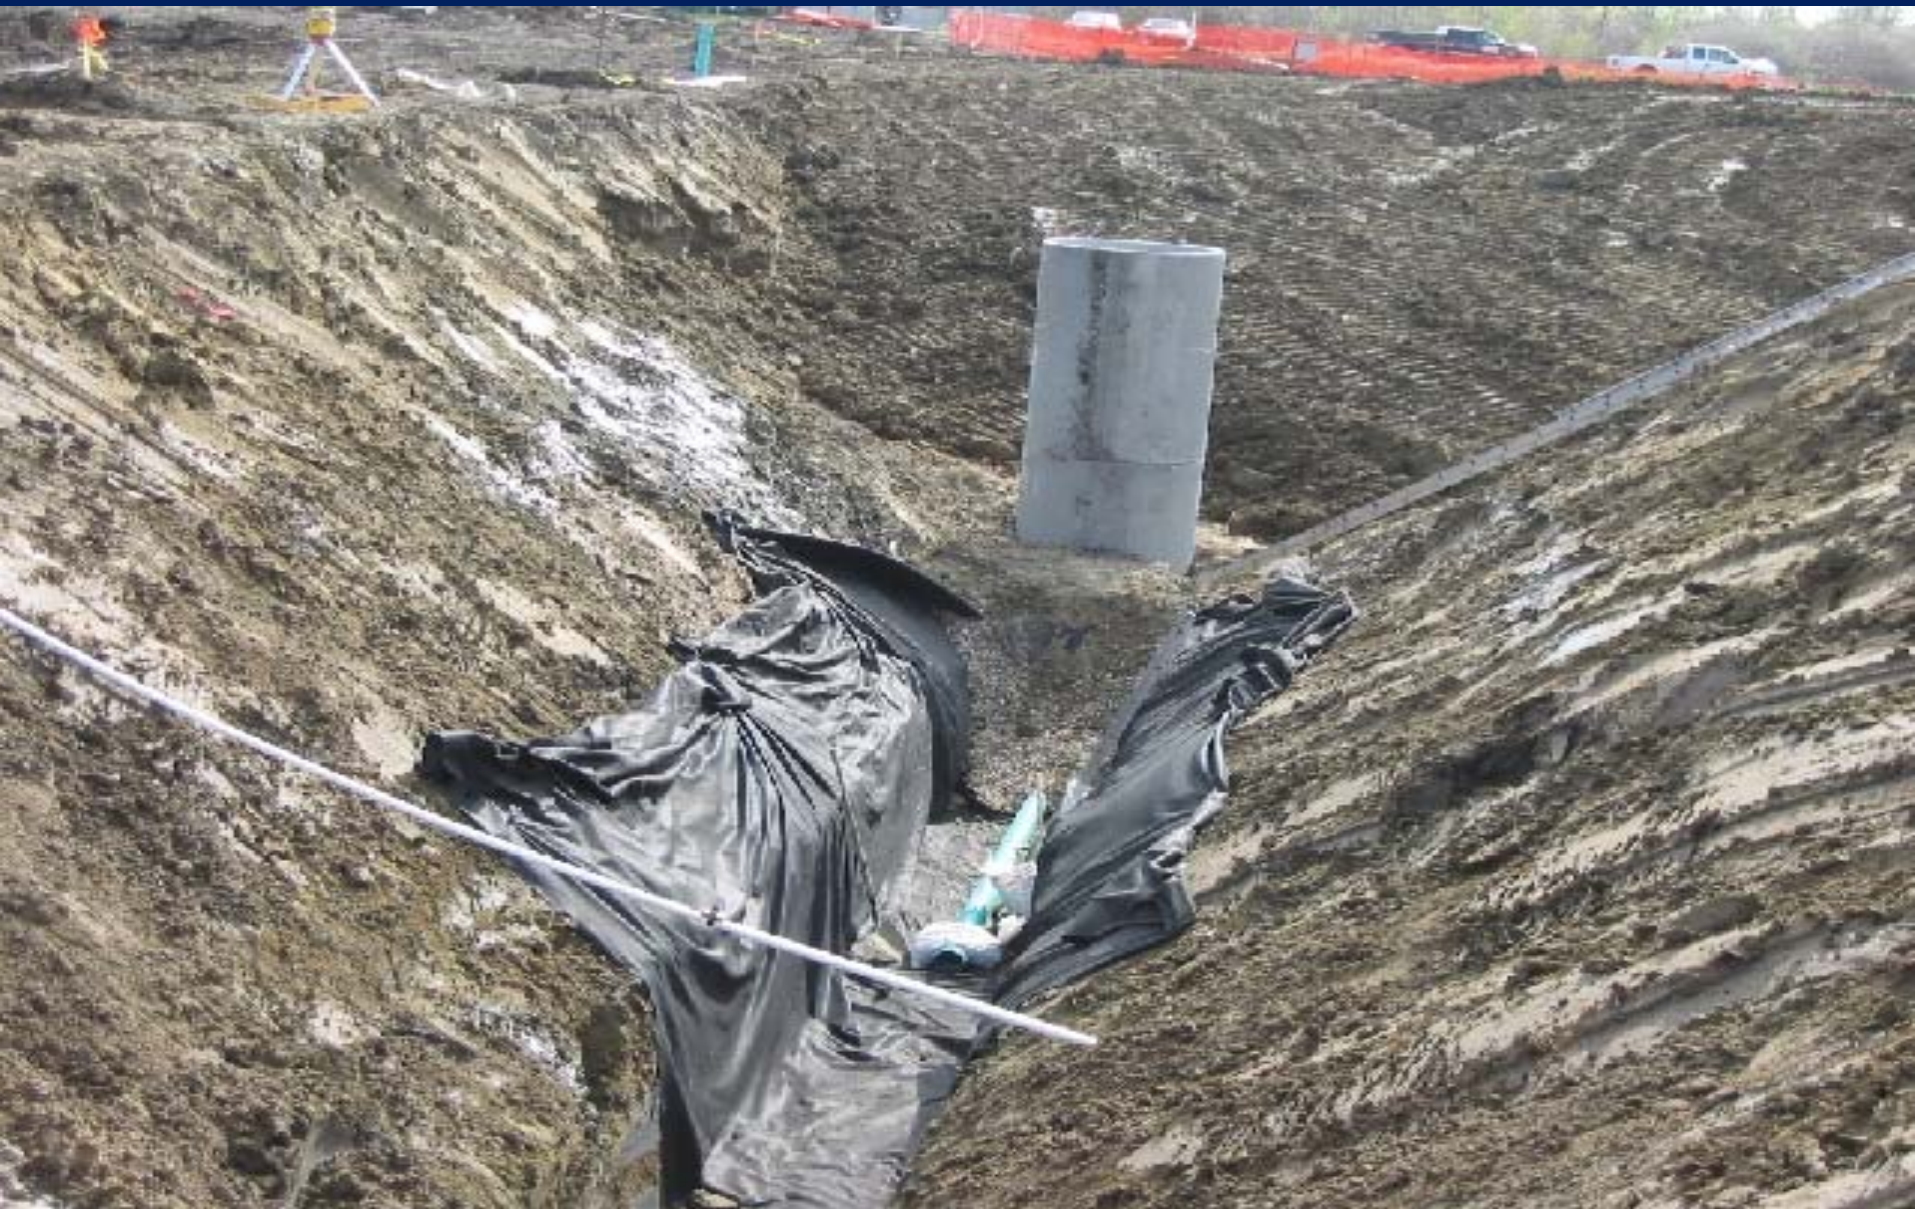
Linear Interceptor Trench

- Removed flarepit and portion of saline source soils
- Installed barrier groundwater interception trench to protect creek and adjacent farmland
- Installed groundwater recovery trench through source area
- Installed pumping system tied to remote disposal well via new pipeline, maintain and monitor

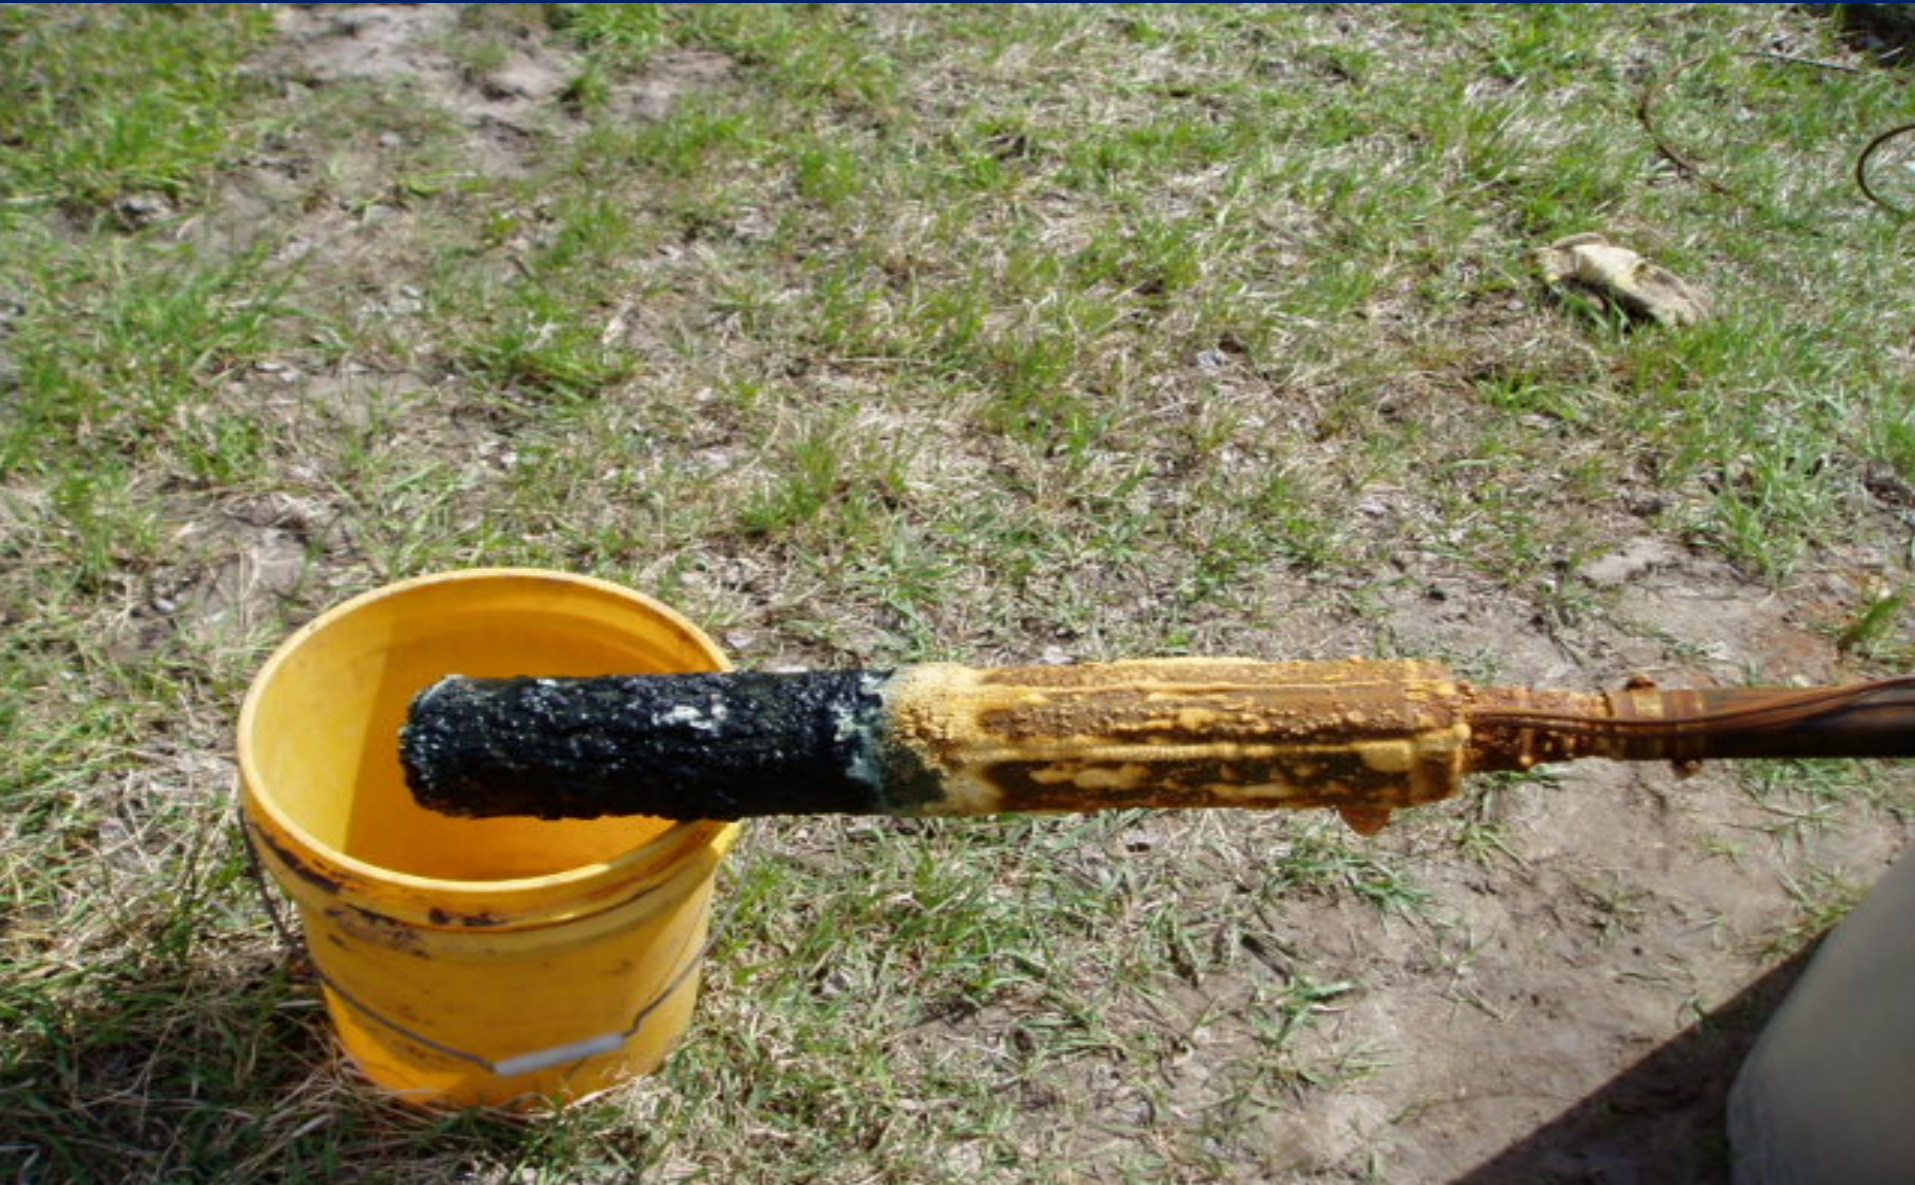
Scale Problems

- Declining salt recovery rates as concentrations drop – therefore the cost / m³ of produced water equivalents goes up
- Salt reservoir remaining in the soil above the water table
- Maintenance, corrosion, scaling
