# **An Integrated Approach to LNAPL Remediation in Support of a Large-Scale Brownfield Redevelopment**

**RemTech 2007  
October 24-26, 2007  
Banff, Alberta**

**Matthew C. Rousseau, Conestoga-Rovers & Associates Ltd.  
David J. Cushman, Conestoga-Rovers & Associates Ltd.**

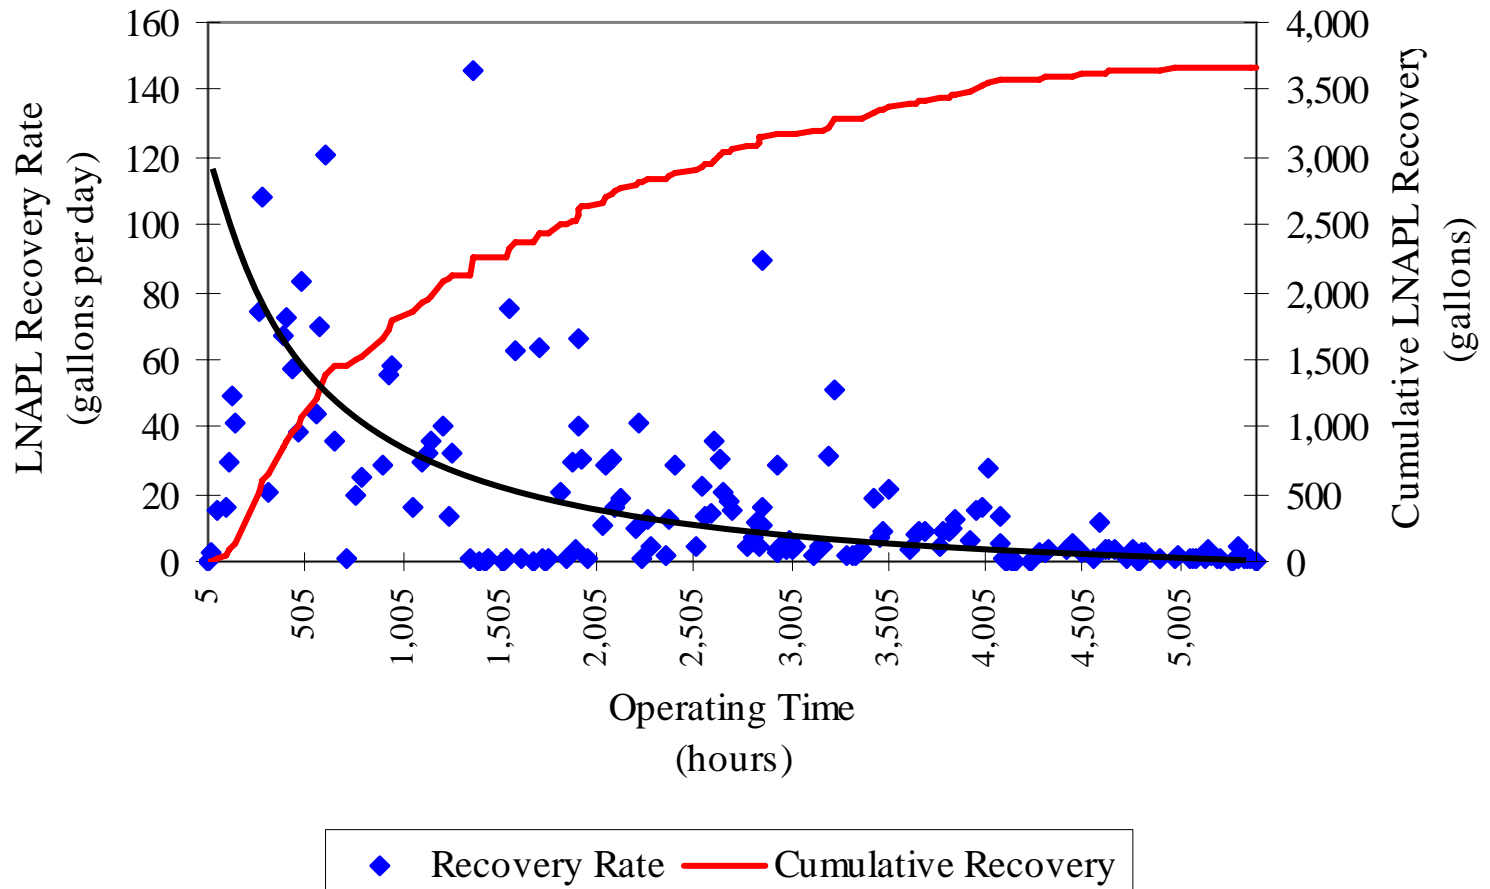
MPVE2750 Titan (System 1) LNAPL Recoveries

- Based on evaluation of remediation metrics, active recovery was terminated in February 2006;
- Some wells (in poor recovery areas) continued to exhibit up to 8 feet of LNAPL;
- Large in-well thicknesses despite low recovery suggest that LNAPL is present in various seams under confined conditions;
- U.S. Environmental Protection Agency (U.S. EPA) reviewed LNAPL performance and agreed that aggressive recovery using MPVE systems could be terminated.

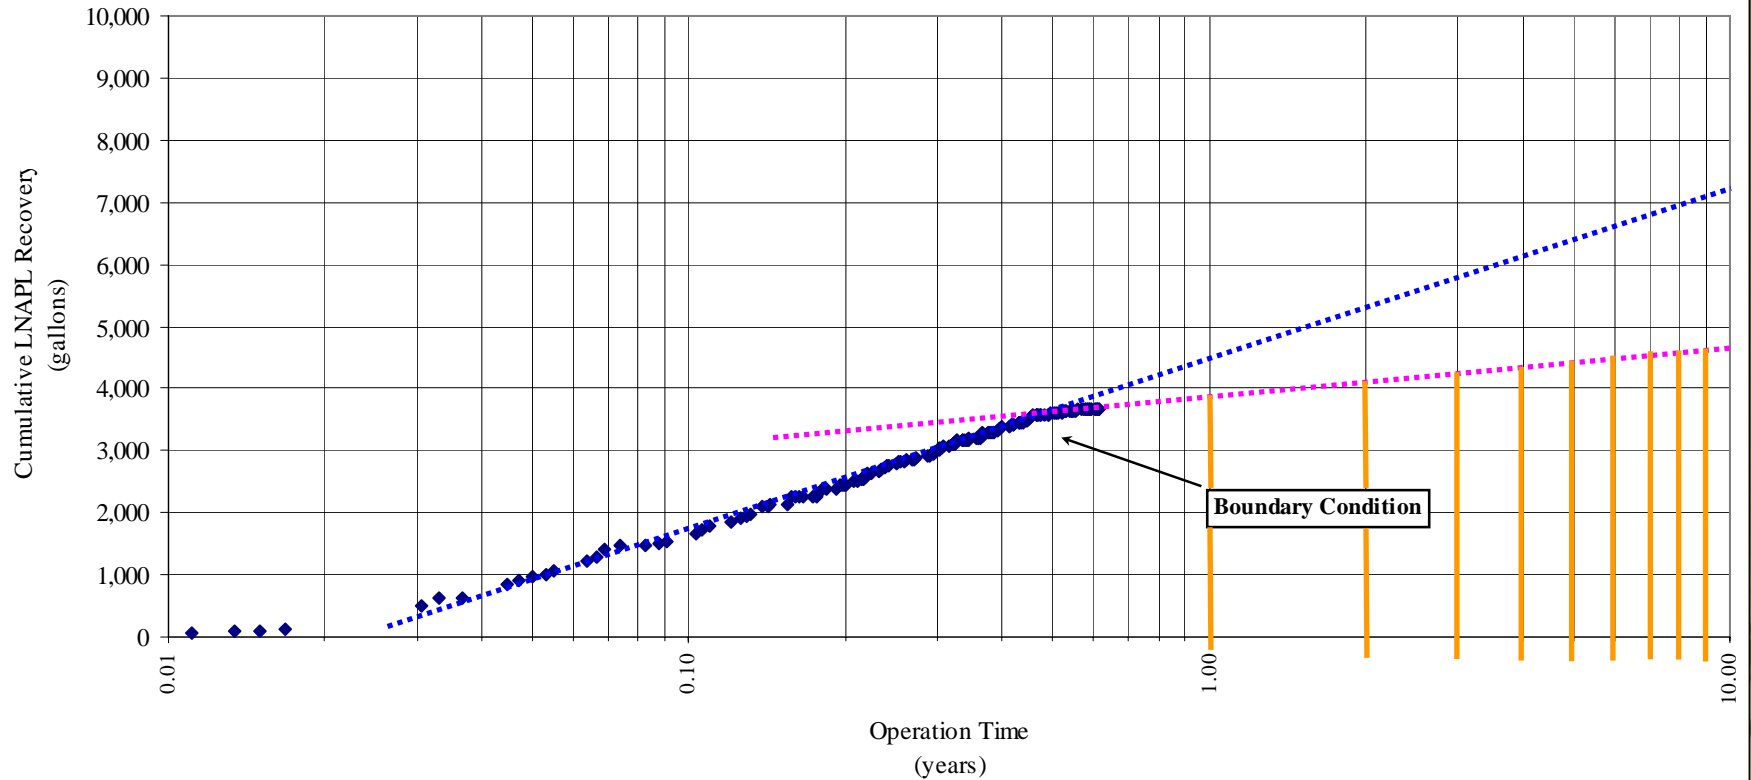
MPVE System 1 Semi-Log LNAPL Recovery Projection

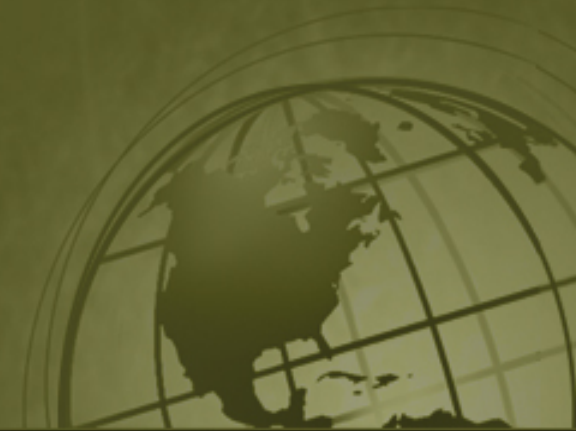
- Laboratory measured oil saturation and conductivity values were used to calculate LNAPL mobility and velocity values.

- Based on the Method 2 calculation results, 3 of 6 test locations exhibited an LNAPL velocity in excess of  $1 \times 10^{-6}$  cm/s, which represents the *de minimis* mobility threshold for LNAPL (ASTM, 2007);
- Based on the Method 3 calculation results, none of the 24 test locations exhibited an LNAPL velocity in excess of  $1 \times 10^{-6}$  cm/s.

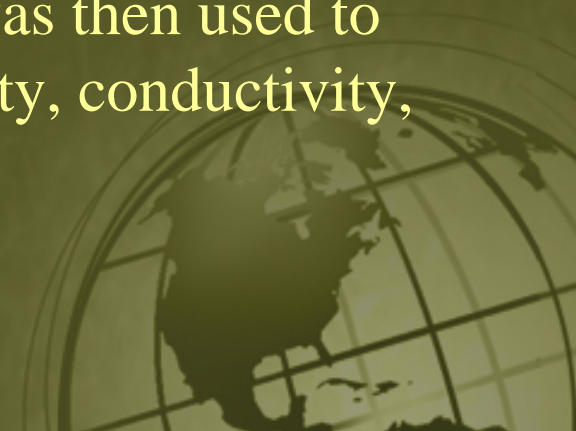
- The laboratory measured LNAPL saturation value was deemed to represent the maximum LNAPL saturation point at the sample location (based on ROST and UV photography);
- This measured maximum saturation was then used to determine LNAPL relative permeability, conductivity, mobility and velocity.
