Remediation in and Under Buildings

**David L. Isopo, B.Sc.
Project Manager**

**Quantum Remediation a Division of Quantum Murray LP
Prairies Division**

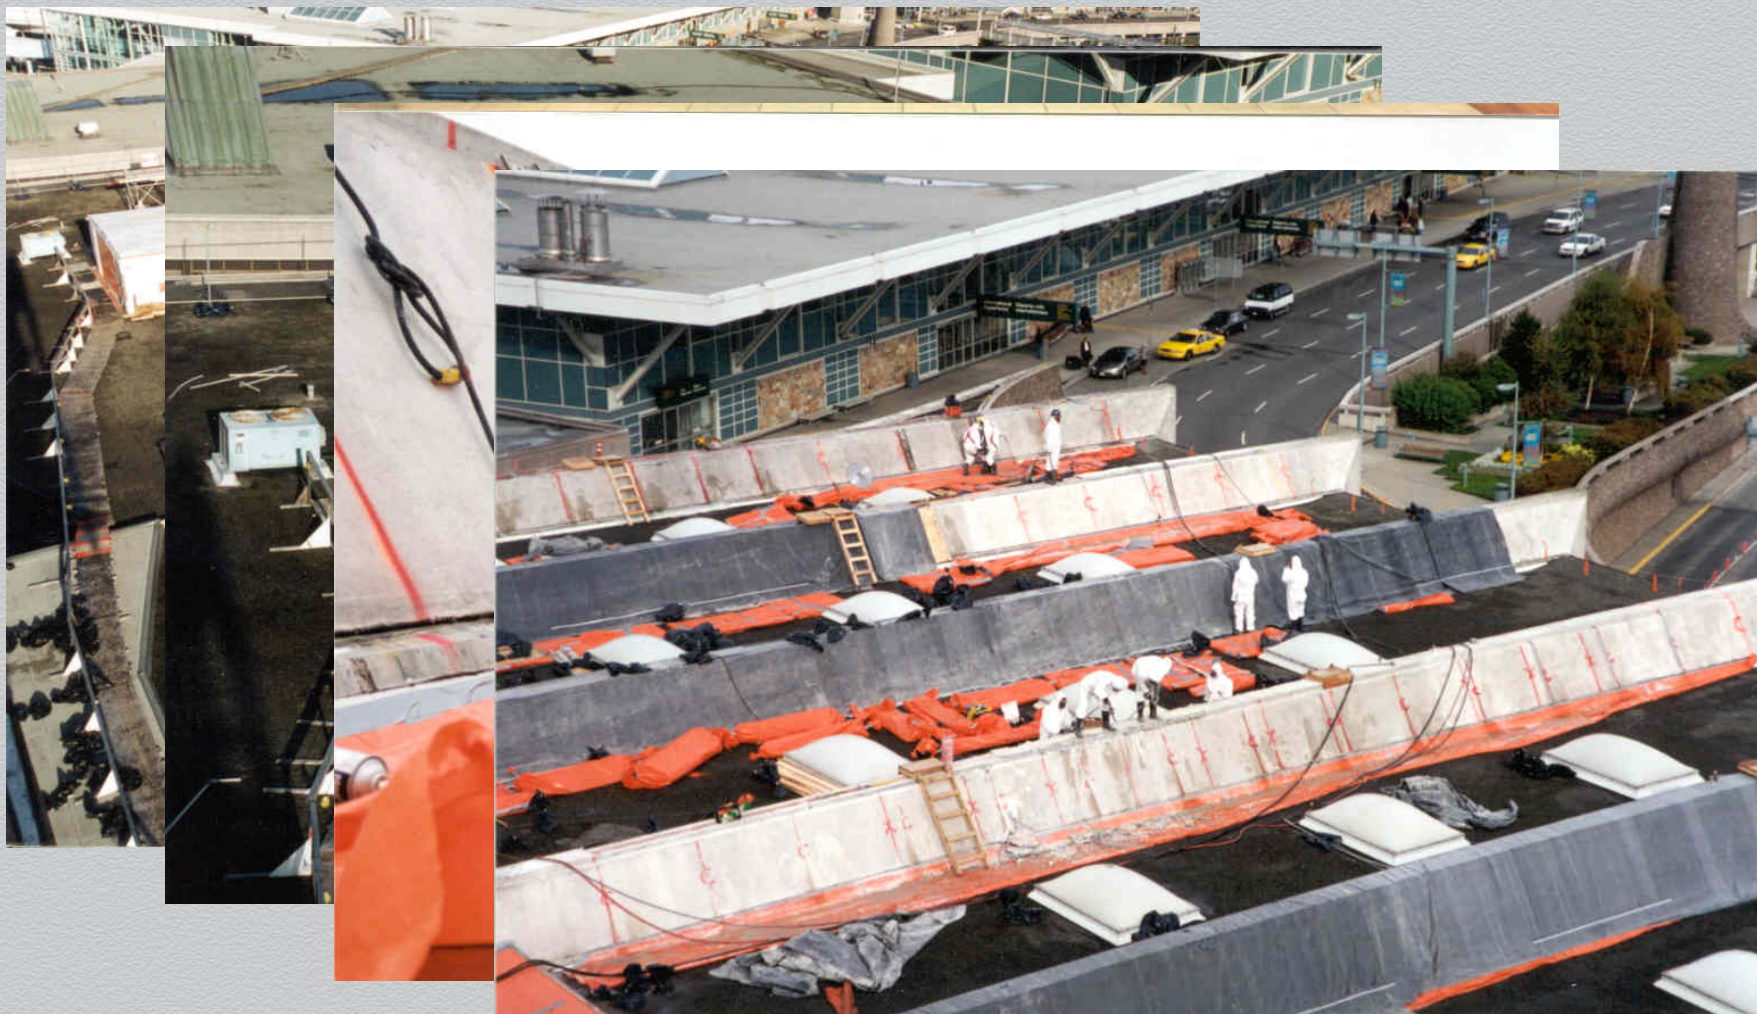
Roof Removal and Containment

- Demolish all interior fixtures, including removal of the roof system and exterior cladding
- Remove asbestos containing materials from domestic check-in gallery with a minimum disruption to the Airport Authority and its airlines.

- An extensive asbestos abatement and demolition program undertaken in the active Domestic Terminal Building (DTB) over a two year period involving over 100 site personnel

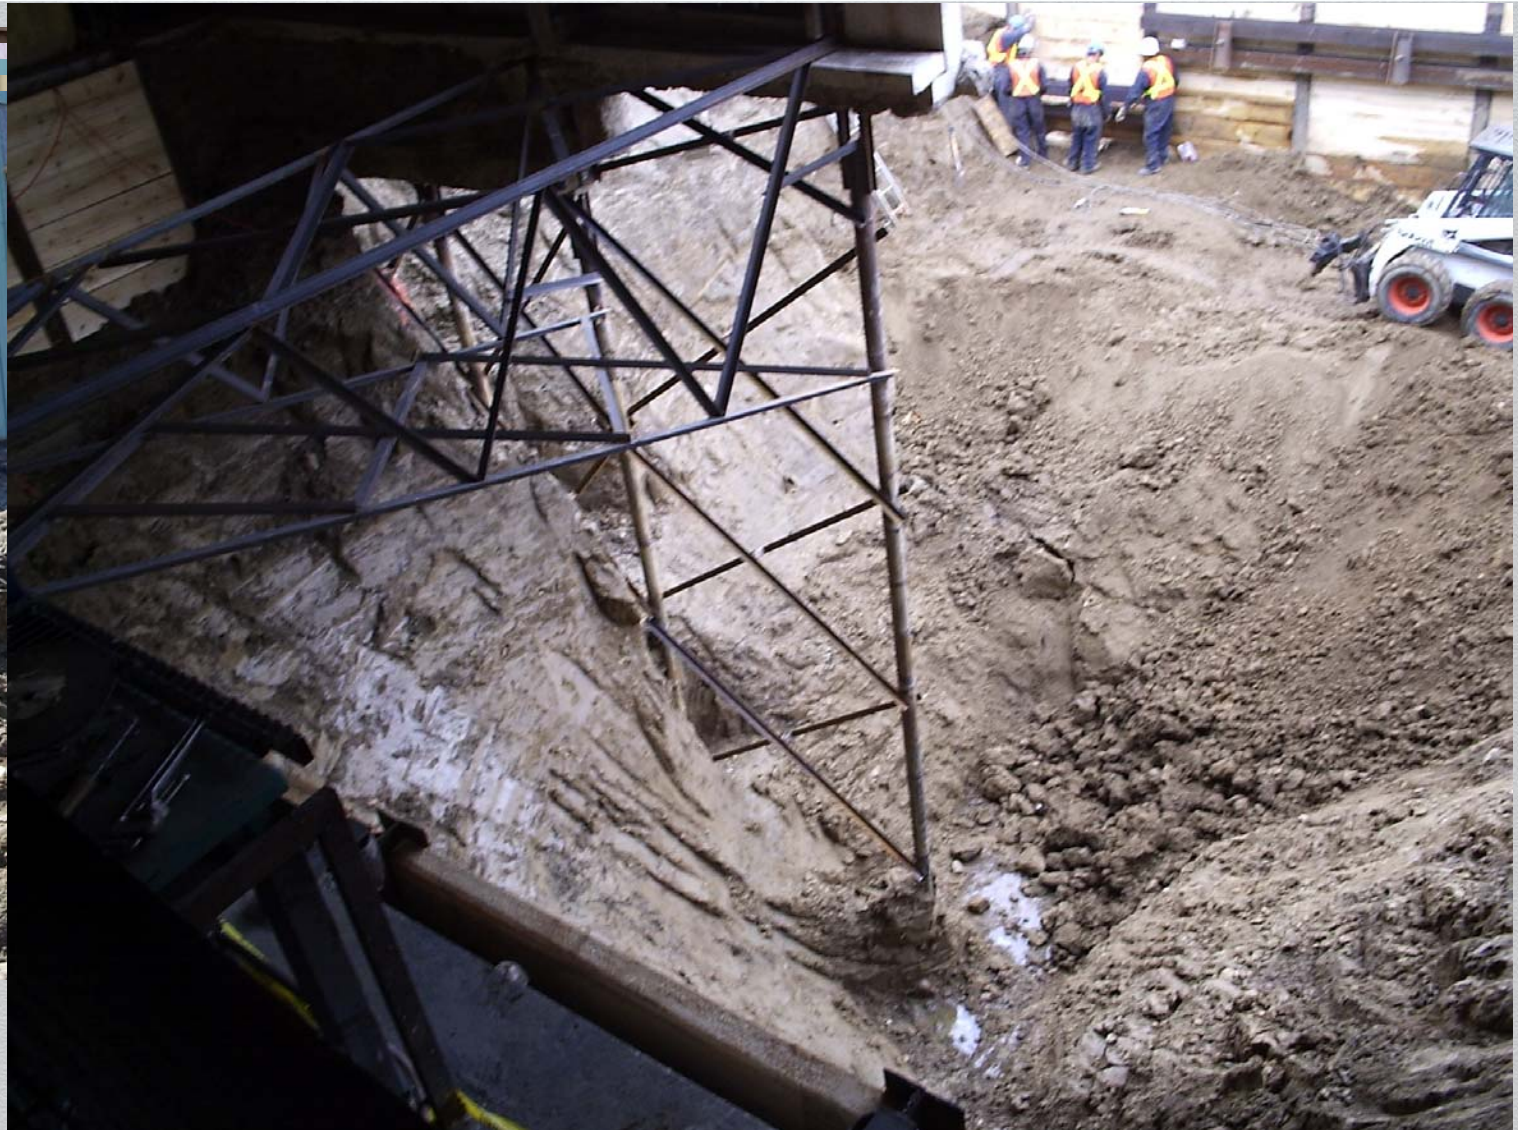
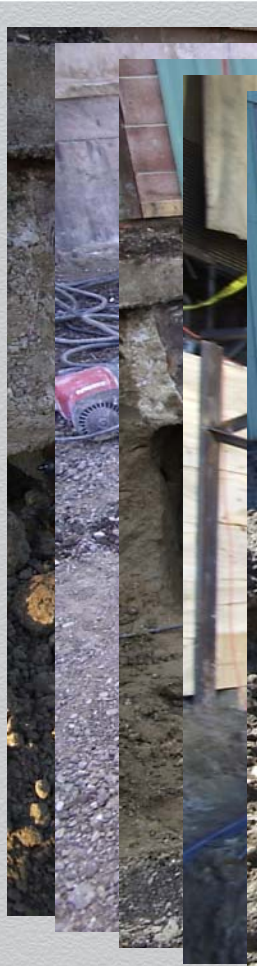
Underpinning

A design build project including underpinning one side of industrial building adjacent to the mechanical room. Shoring along roadway at opposite end using shoring caissons and timber lagging

To remove 1500 m³ of contaminated soil from beneath an industrial building to a depth of 10m. Ensure main floor slab is not undermined and stocked mechanical room is kept in tact

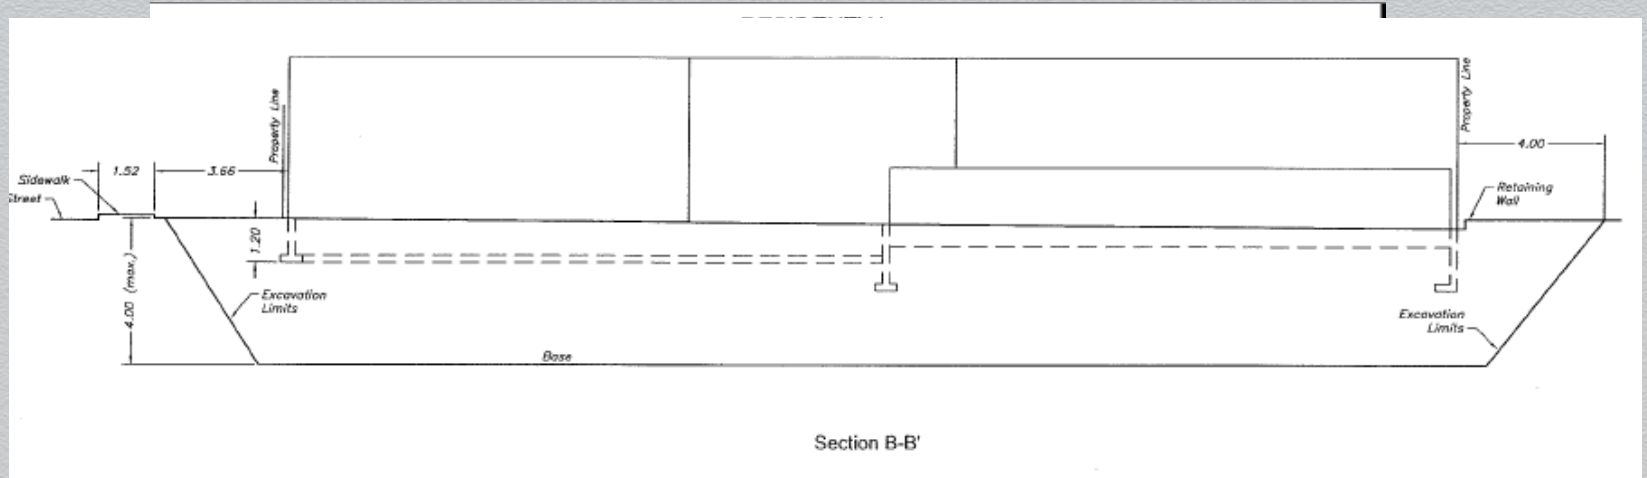
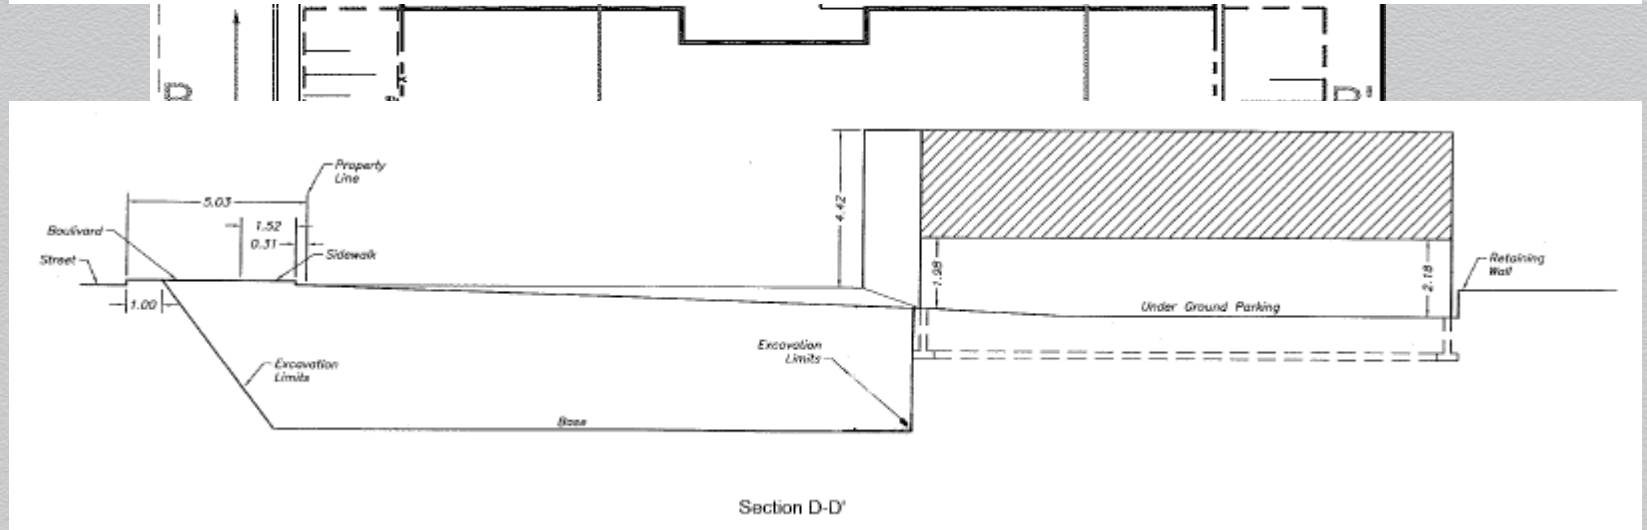
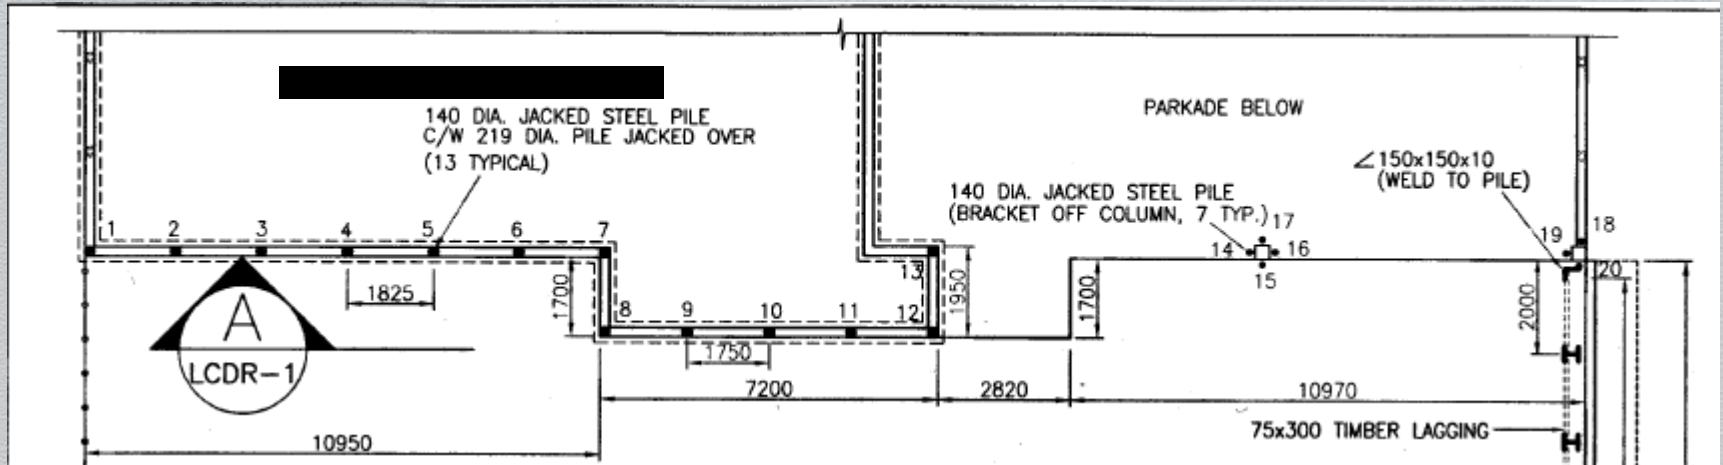
- 13 jacked steel piles installed along front of restaurant and parkade
- Property to the south at higher elevation therefore shoring required to reinforce retaining wall
- Bulk excavation between the building and Centre Street North to a depth of 4m
- Installation of impermeable liner along south and west side
- Excavation limit up to property line therefore reinstated boulevard and curb

Another design build project including underpinning frontage of restaurant and parkade. Shoring along adjacent retaining wall using shoring caissons and timber lagging

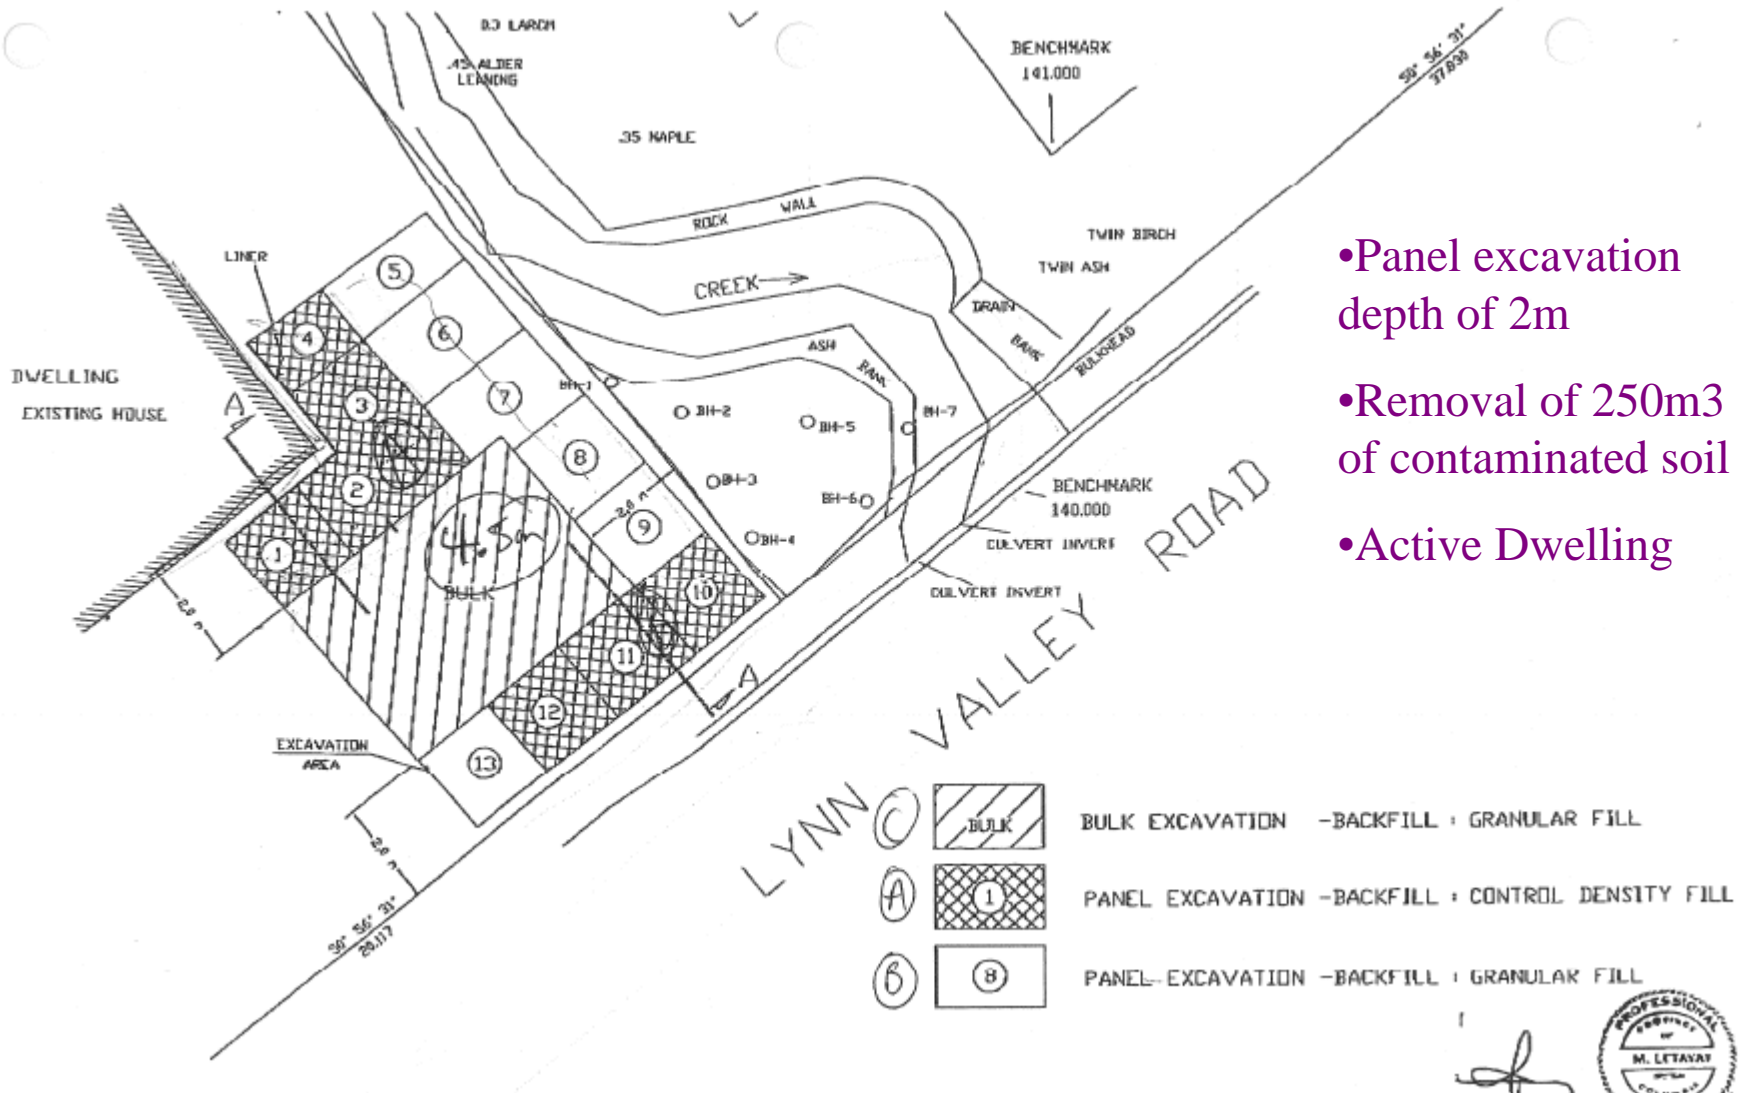
- Panel excavation depth of 2m
- Removal of 250m³ of contaminated soil
- Active Dwelling

- Conduct alternating panel excavations to required depth in order to completely remove contamination
- Backfill using Control Density Fill (CDF) which ensures 100% compaction and integrity of structure

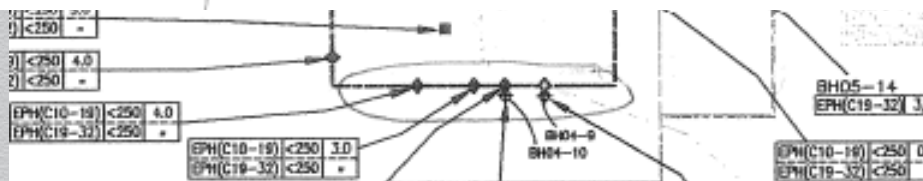
Panel Excavation and CDF Option

- Depth of excavation 6m
- Mechanical room above contaminated plume
- Series of utilities to south end of mechanics bay
- Confined work area
- Contaminated plume inside building adjacent to exterior wall and canopy footing (2'*2'*4')
