Case Study: Remediation of Lead Impacted Soils Former Strathcona Shooting Range, Edmonton

project
**Strathcona Shooting Range
Site Remediation**
location : 50th Street and Ellerslie Road

drawing title
**LIMIT OF
HAZARDOUS SOILS PLAN
SKREET and TRAP**

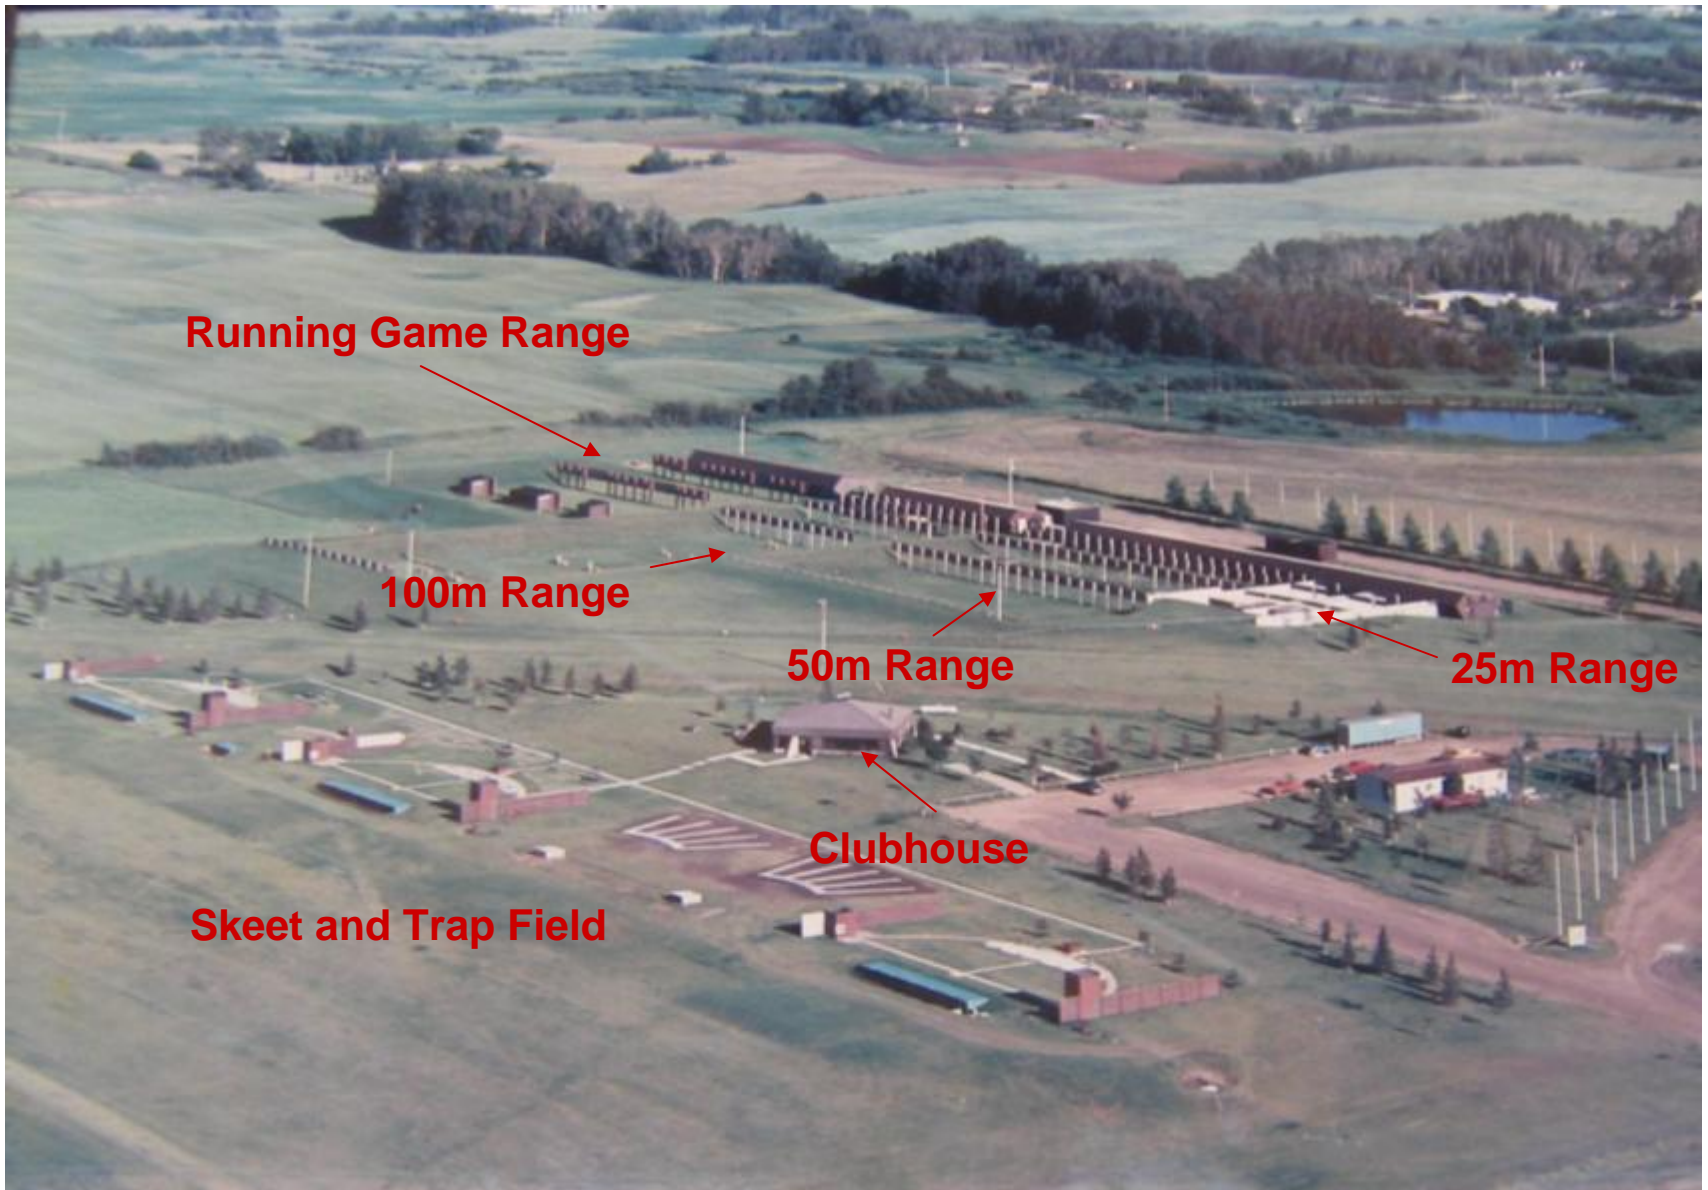
Photo 1: Overview of Strathcona Shooting Range (circa 1988)

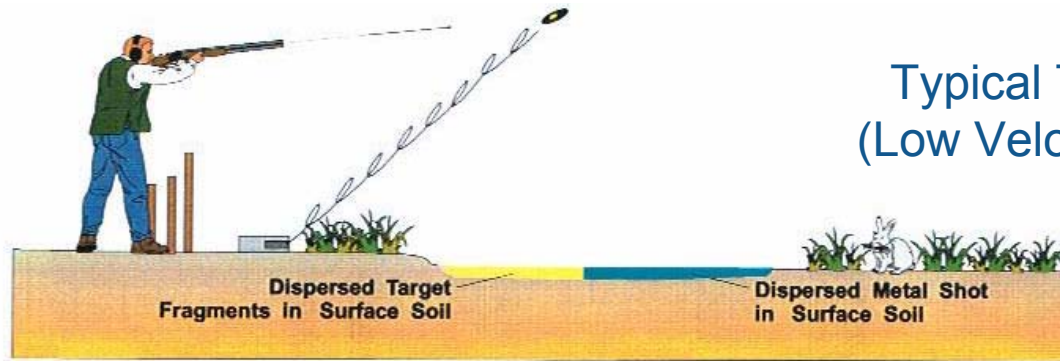
Typical Trap & Skeet (Low Velocity Projectile)

Schematic Cross Sectional View

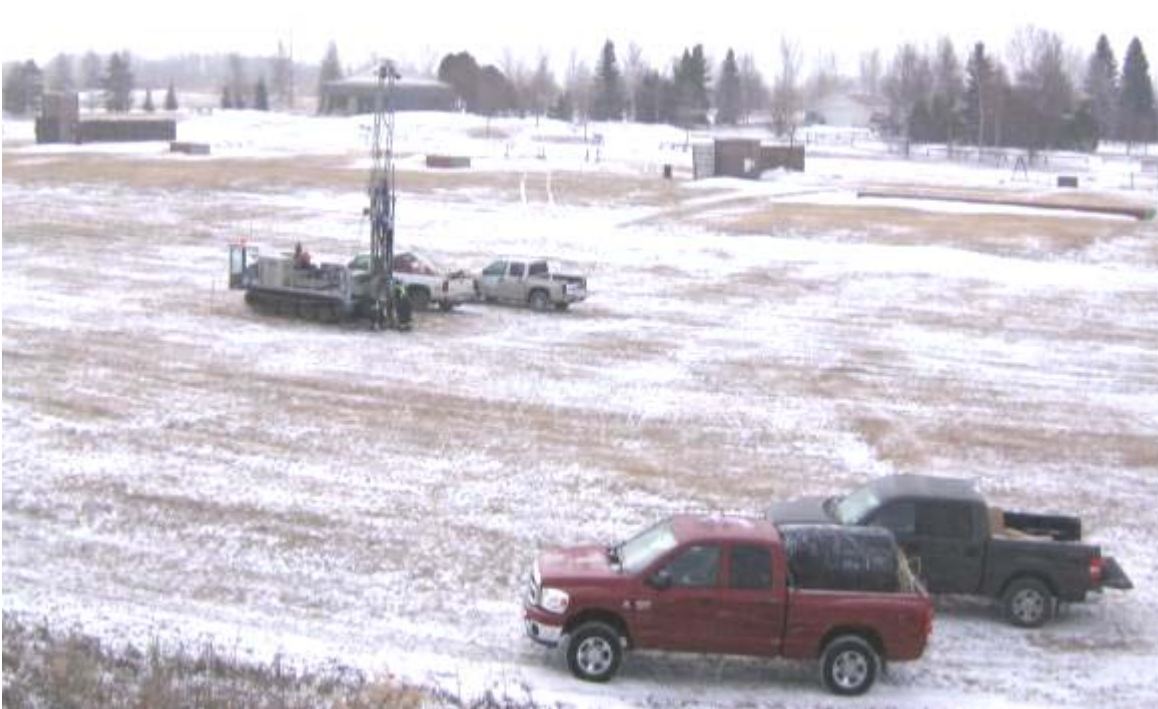
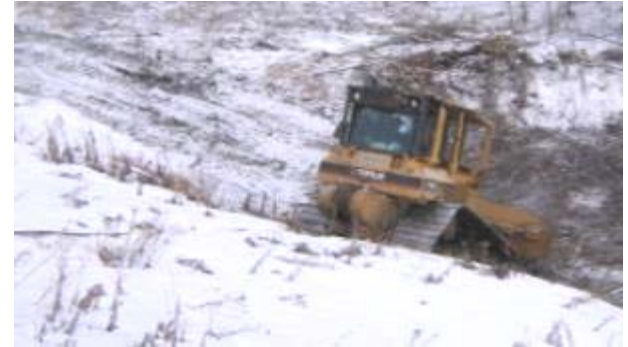
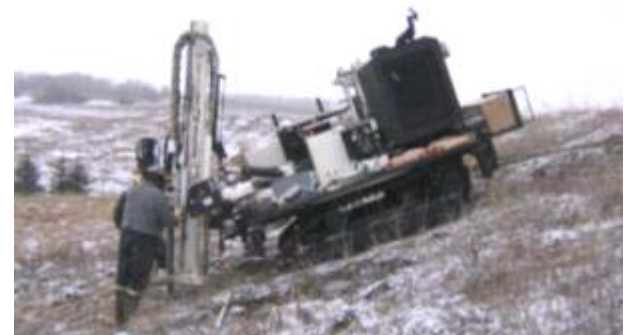
- Snow and frozen ground
- Uneven slippery terrain
- Slopes and worker safety
- Decontamination in cold weather

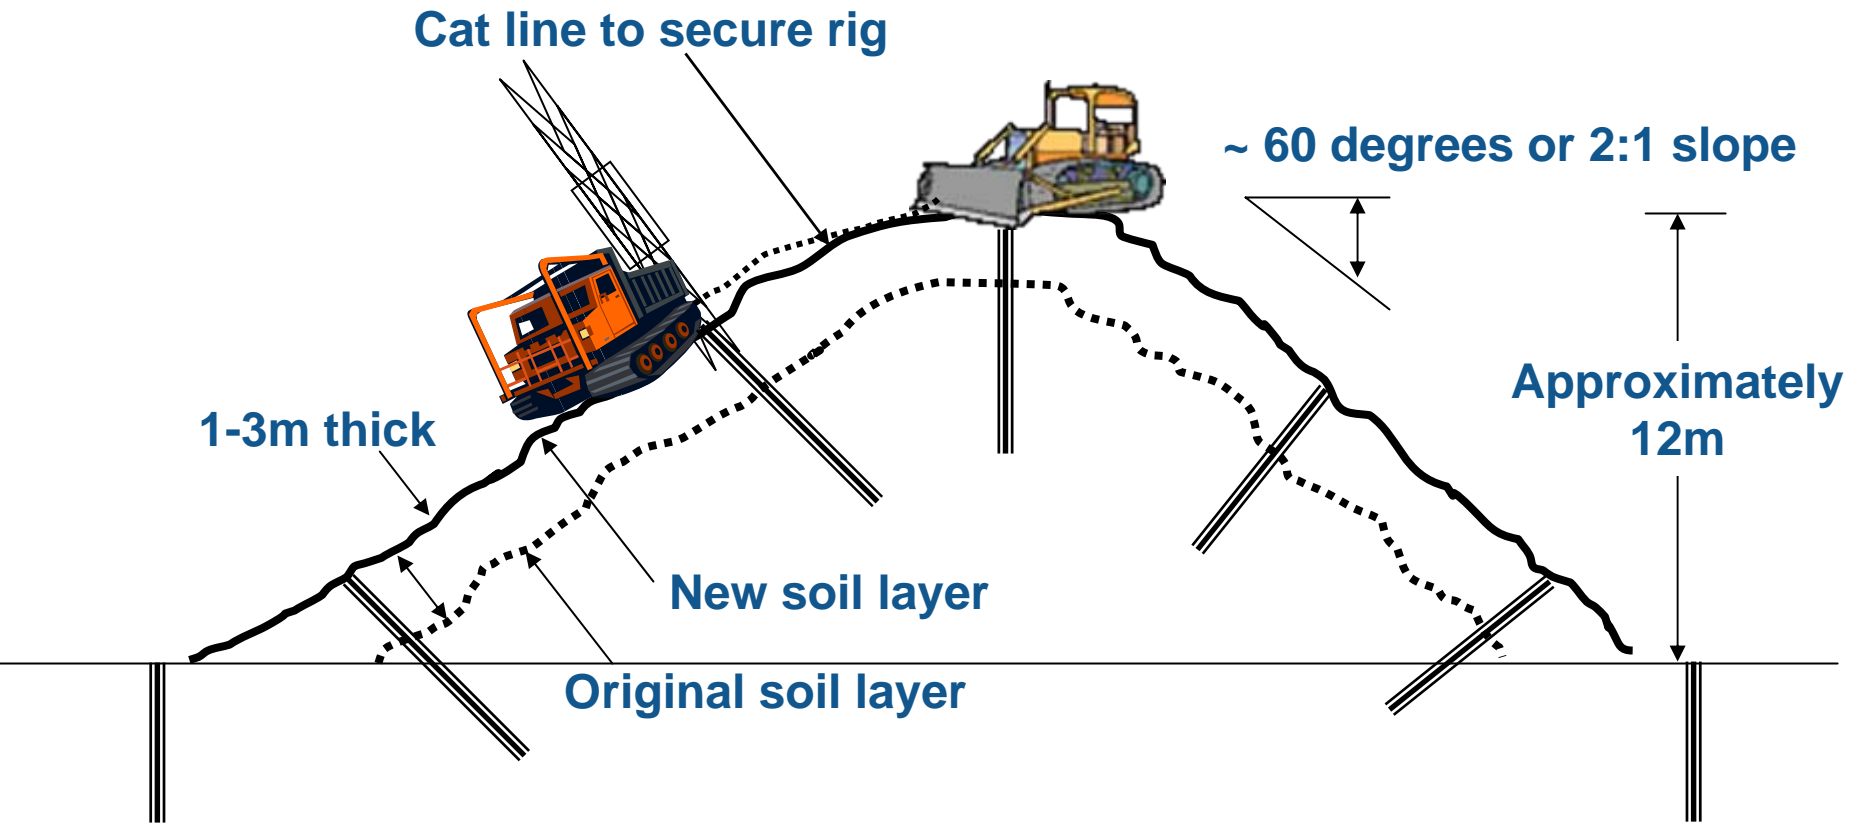
Proposed Schematic: How to Probe Skeet Shooting Berm N.T.S.

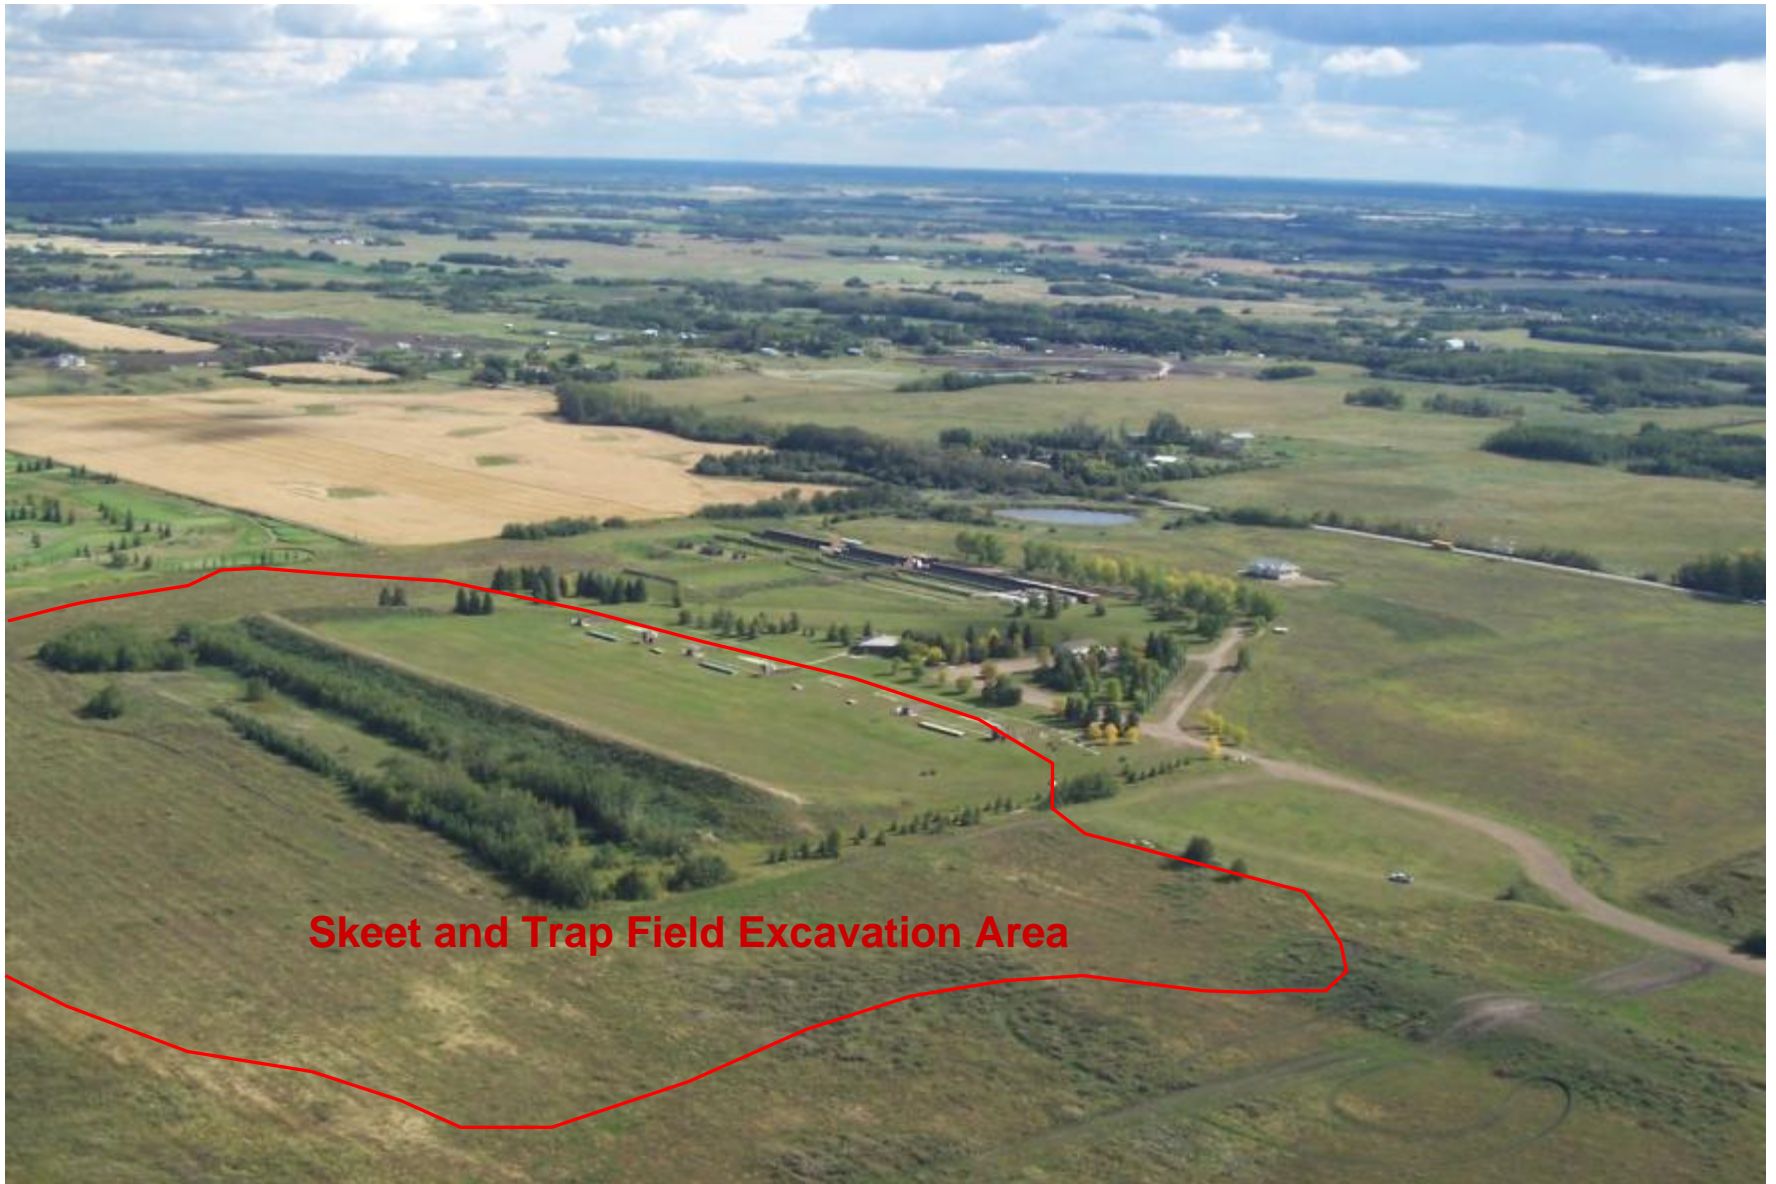
Skeet and Trap Field Excavation Area

Photo 10: Overall view of site showing skeet and trap field excavation area (Summer 2007)

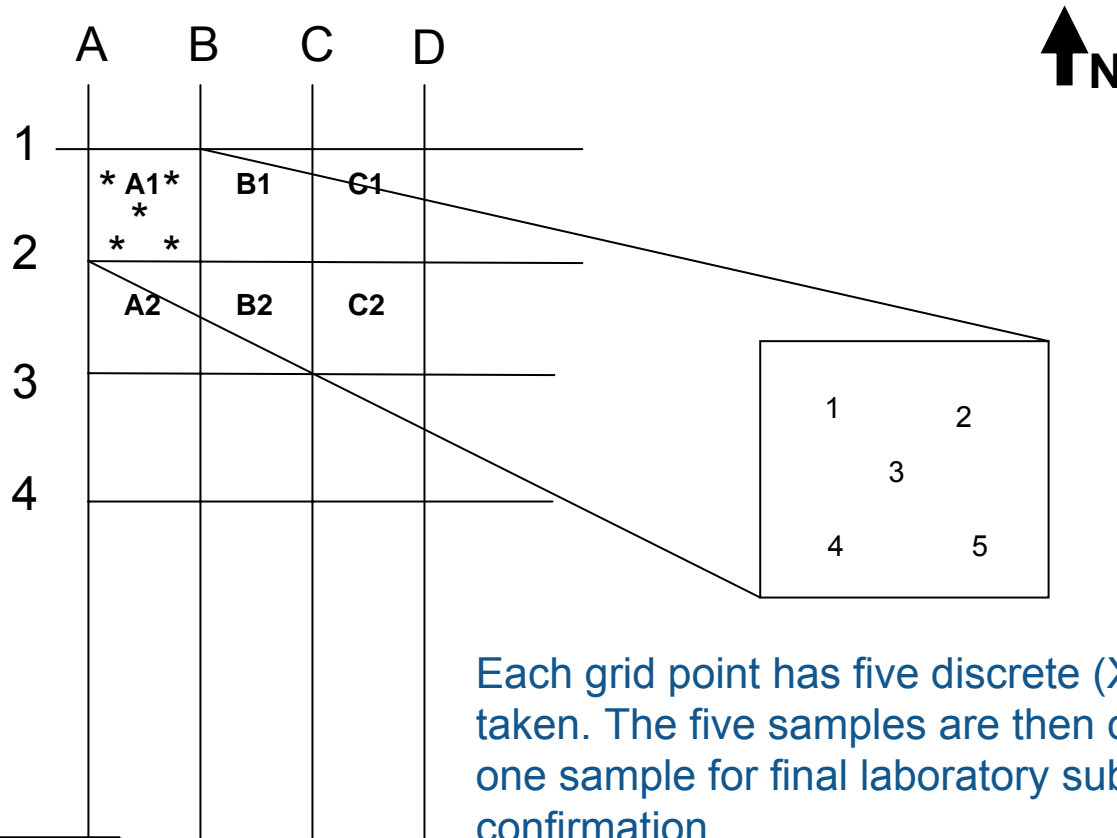
Each grid point has five discrete (XRF) reading taken. The five samples are then composited into one sample for final laboratory submission and confirmation.

12 ppm		39 ppm
	14 ppm	
63 ppm		41 ppm

Each grid point has a discrete (XRF) reading recorded. The reading and laboratory composite are then recorded in a reference table - referencing the grid location on a site plan.

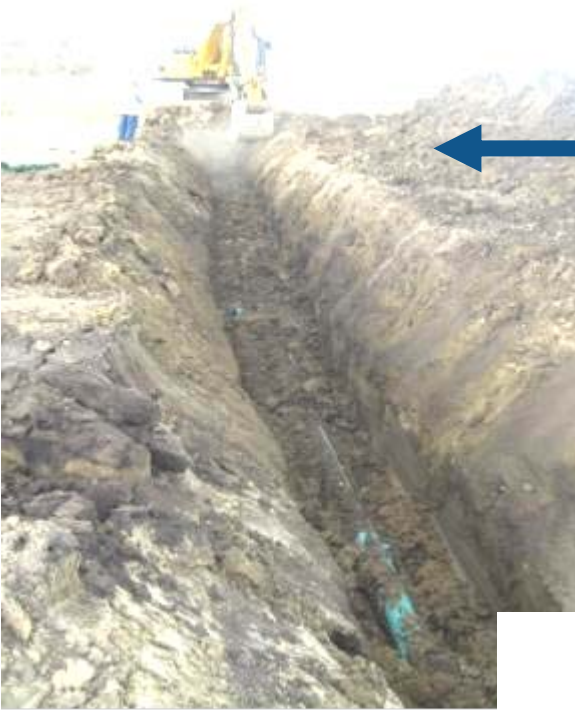
Uncovered Installation of Subgrade Drainage System

Backfilled With Lead and PAH-Impacted Soils

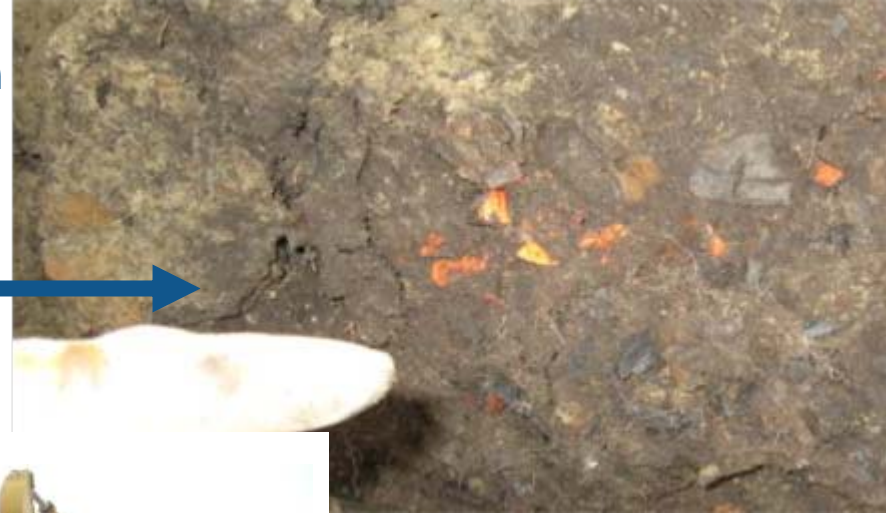
Uncovering of Several Unauthorized Disposal Pits

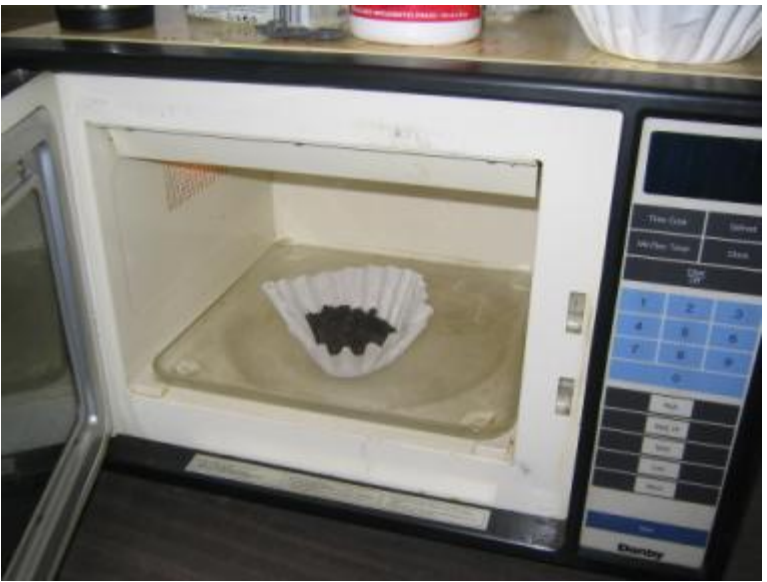
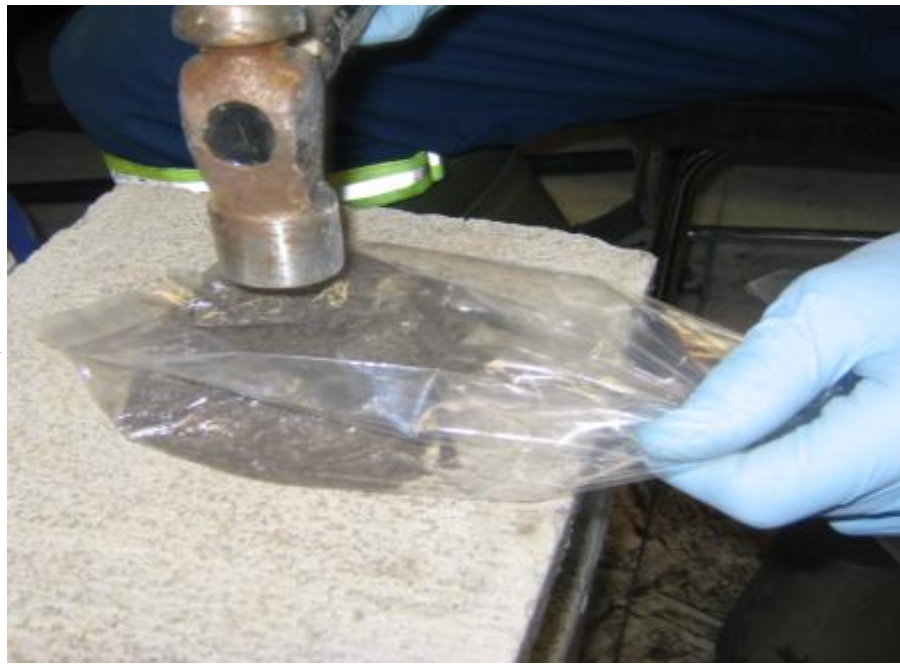
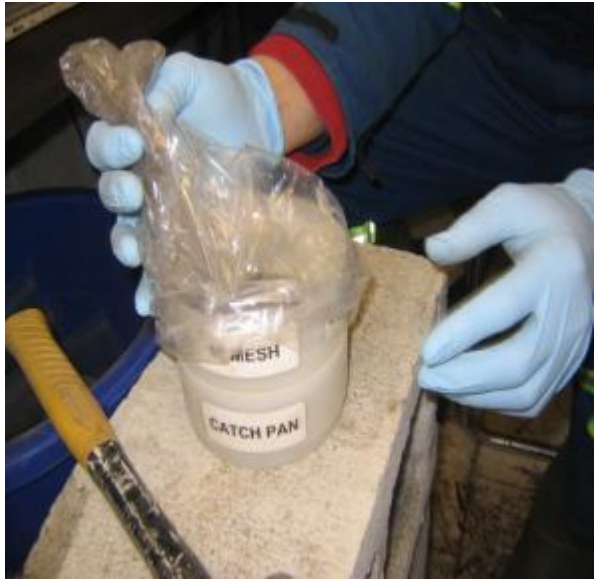
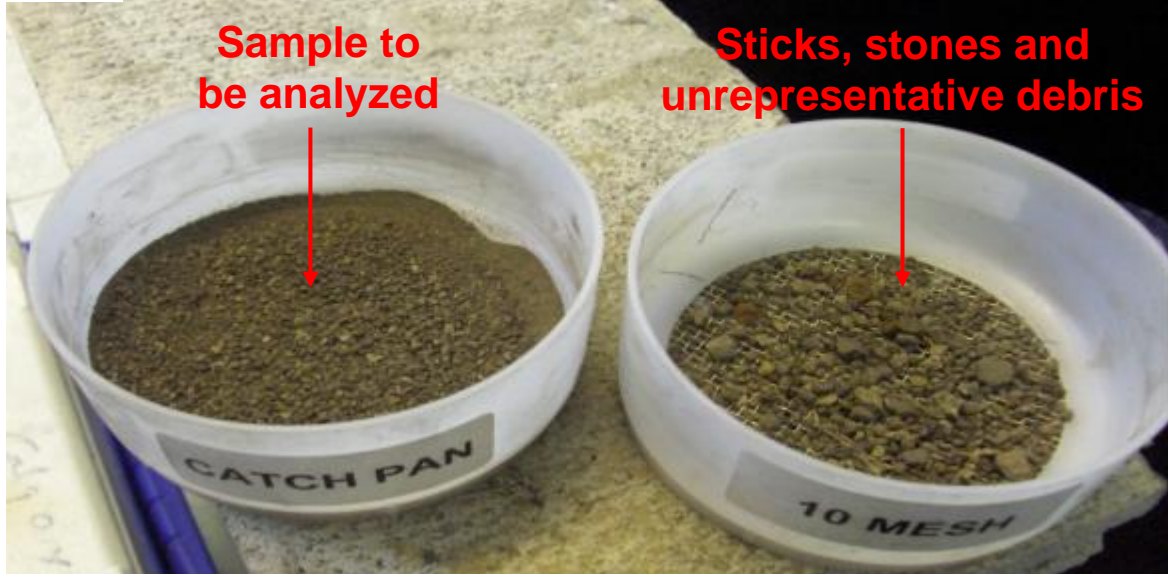
Dry
←

Crush
→

Sieve
←

Sample to be analyzed

Sticks, stones and unrepresentative debris

→
Prepared Sample
