Give Me Refuge

Transforming the
“most contaminated
square mile on earth”
into a premier urban
wildlife refuge

- Background of the Rocky Mountain Arsenal (RMA)
- Manufacturing and Disposal History
- Soil Remedy
- Operations and Maintenance
- Lessons Learned

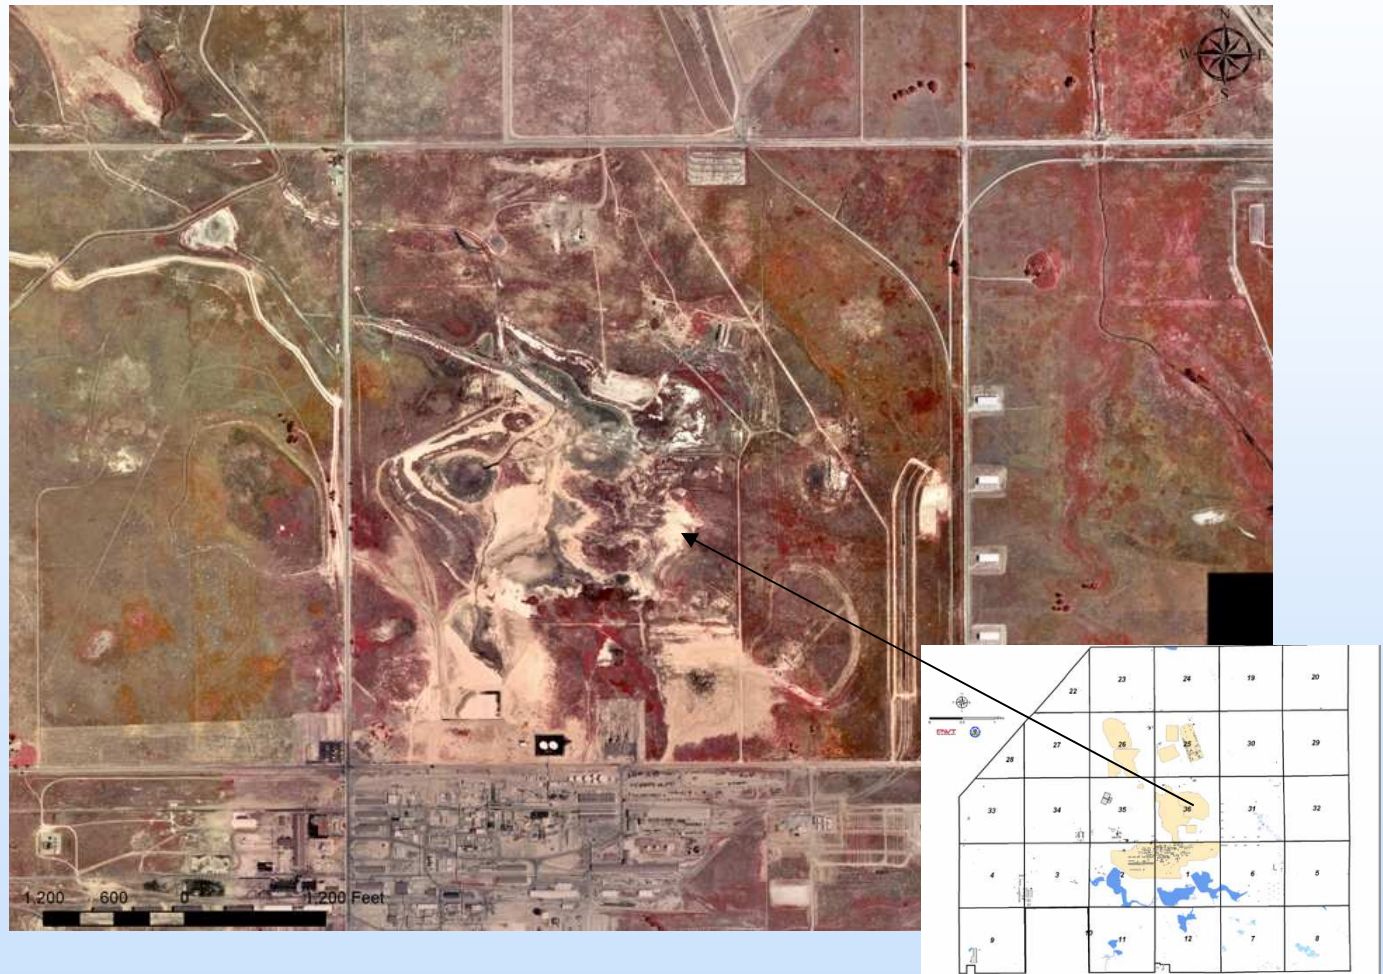
Section 36 as it appeared in 1976 (U.S. Army aerial photograph)

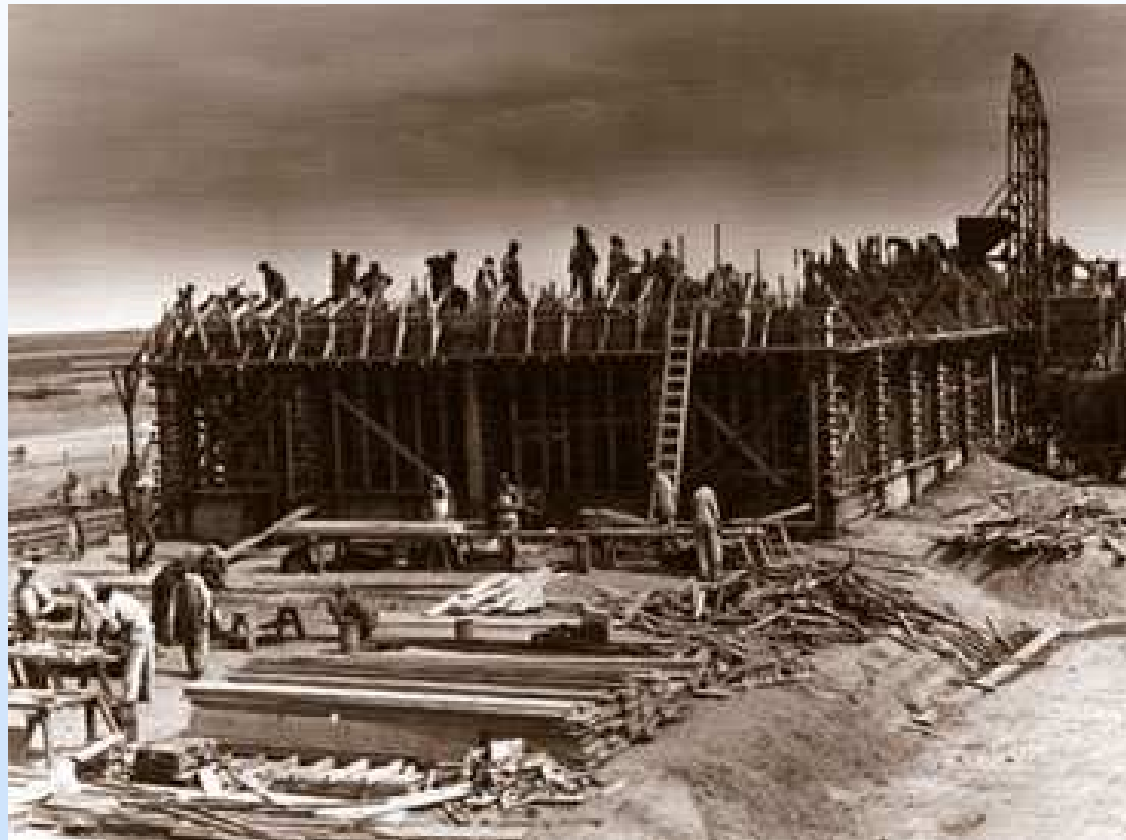
Construction of the first chemical weapons manufacturing facility at the Rocky Mountain Arsenal, 1942 (U.S. Army photograph)

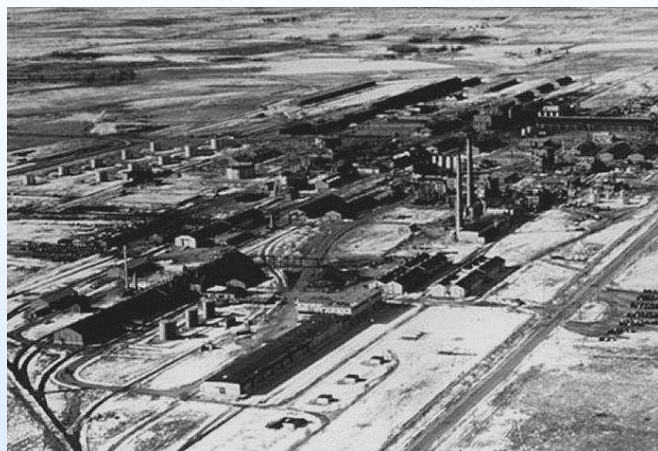
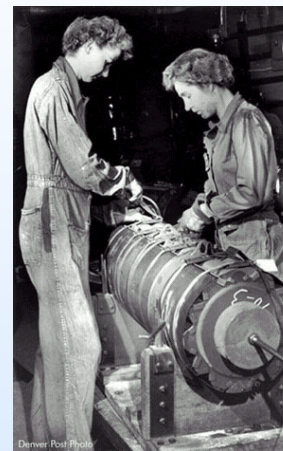
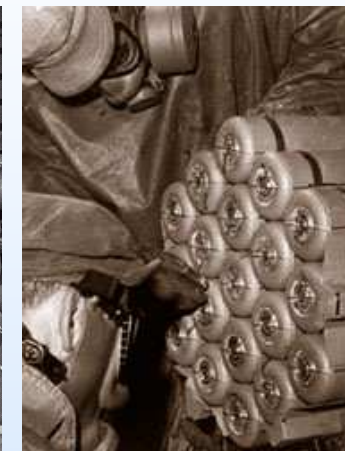
Clockwise from top left: aerial photograph of South Plants in 1964 (globalsecurity.org photograph); weapons assembly (Denver Post photograph); deactivating fuses from cluster bombs (U.S. Army photograph); and workers assembling a napalm bomb in 1957 (U.S. Army photograph).

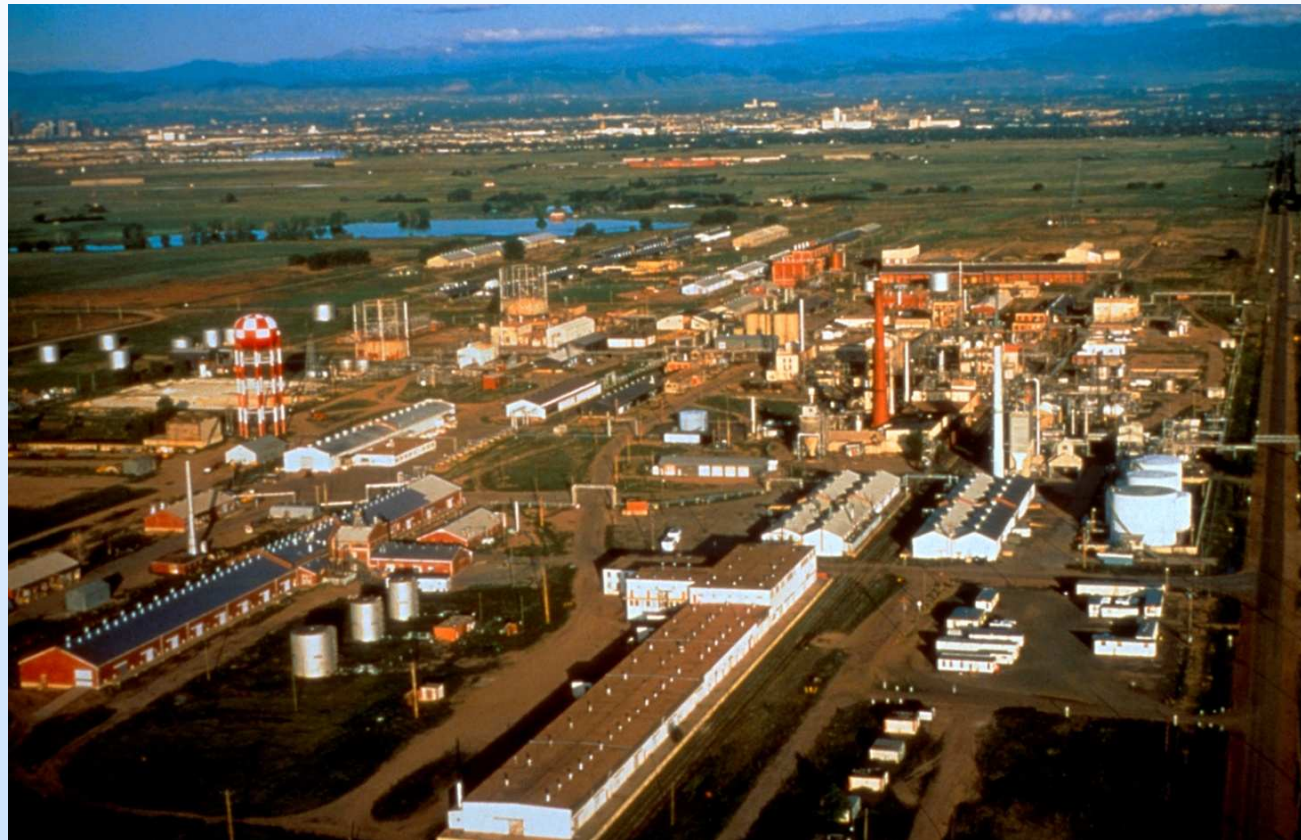
South Plants (U.S. Army photograph)

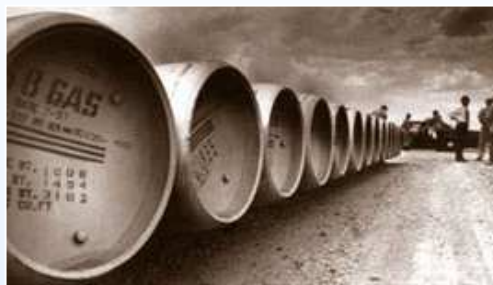
One ton containers of agent

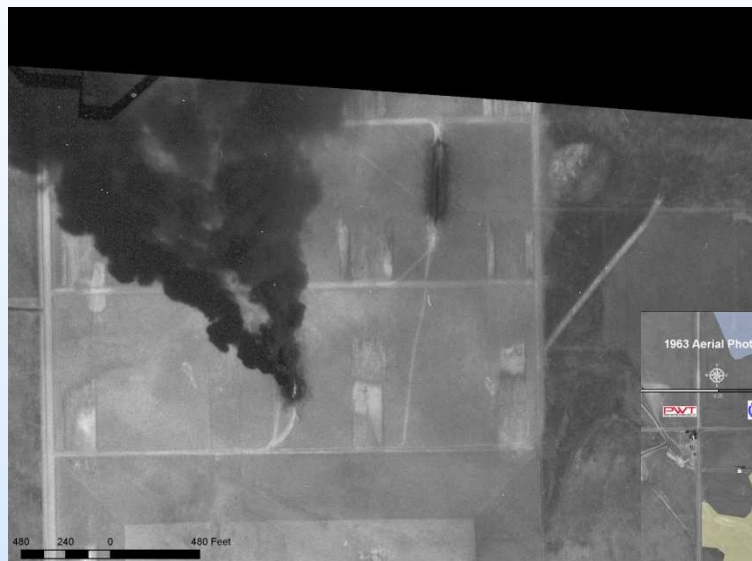
Active burn pit on the left and a recently used burn pit, center, in 1954 (left); munitions storage, testing, and disposal areas in 1963 (U.S. Army aerial photographs)

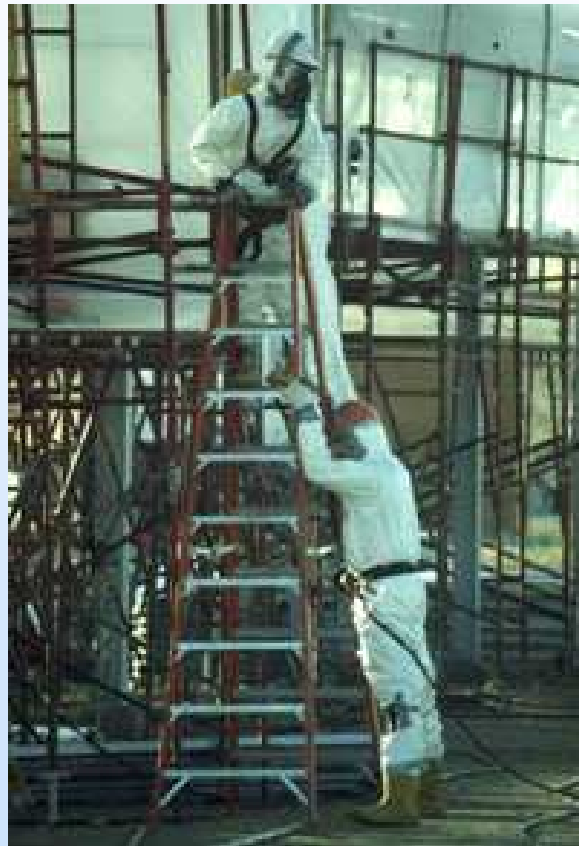
Asbestos abatement in South Plants (U.S. Army photograph)

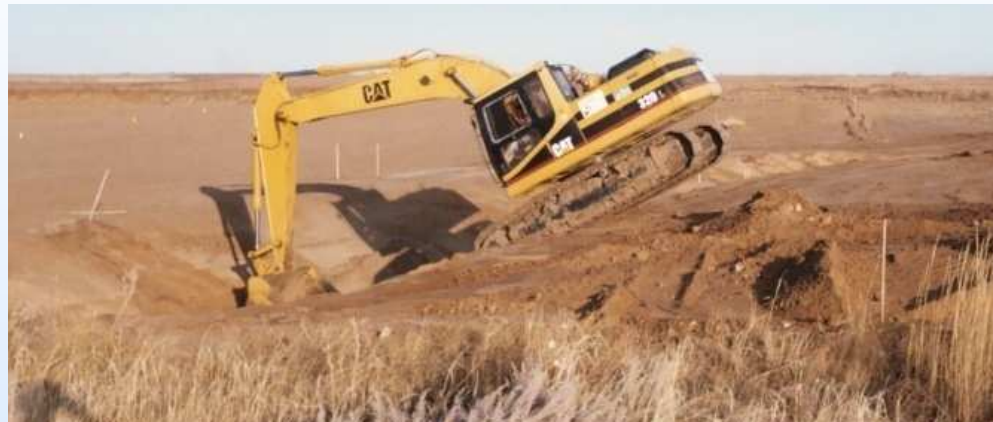
Soil remediation at the Rocky Mountain Arsenal (EPA field oversight photograph) and construction of the Hazardous Waste Landfill (Fiore and Sons photograph)

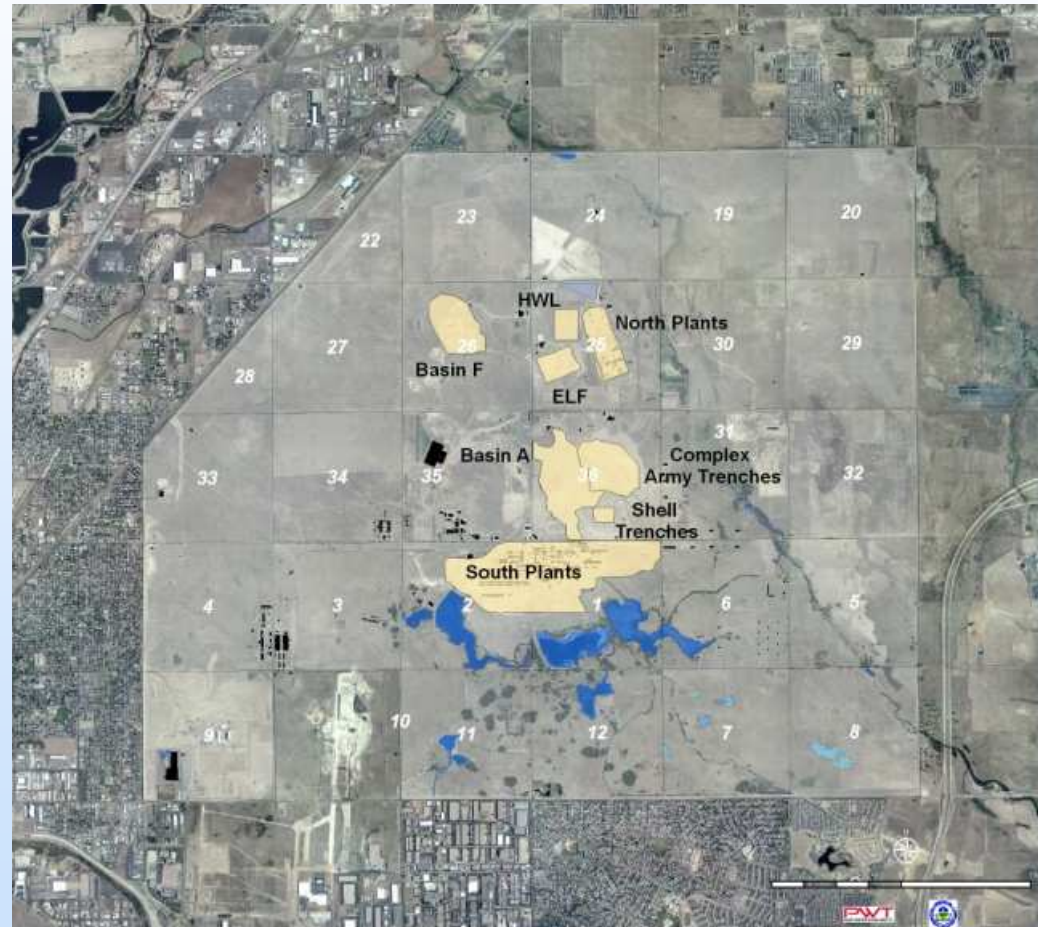
Buffer Area, unique habitat

(U.S. Army aerial photograph, EPA/PWT map overlay)

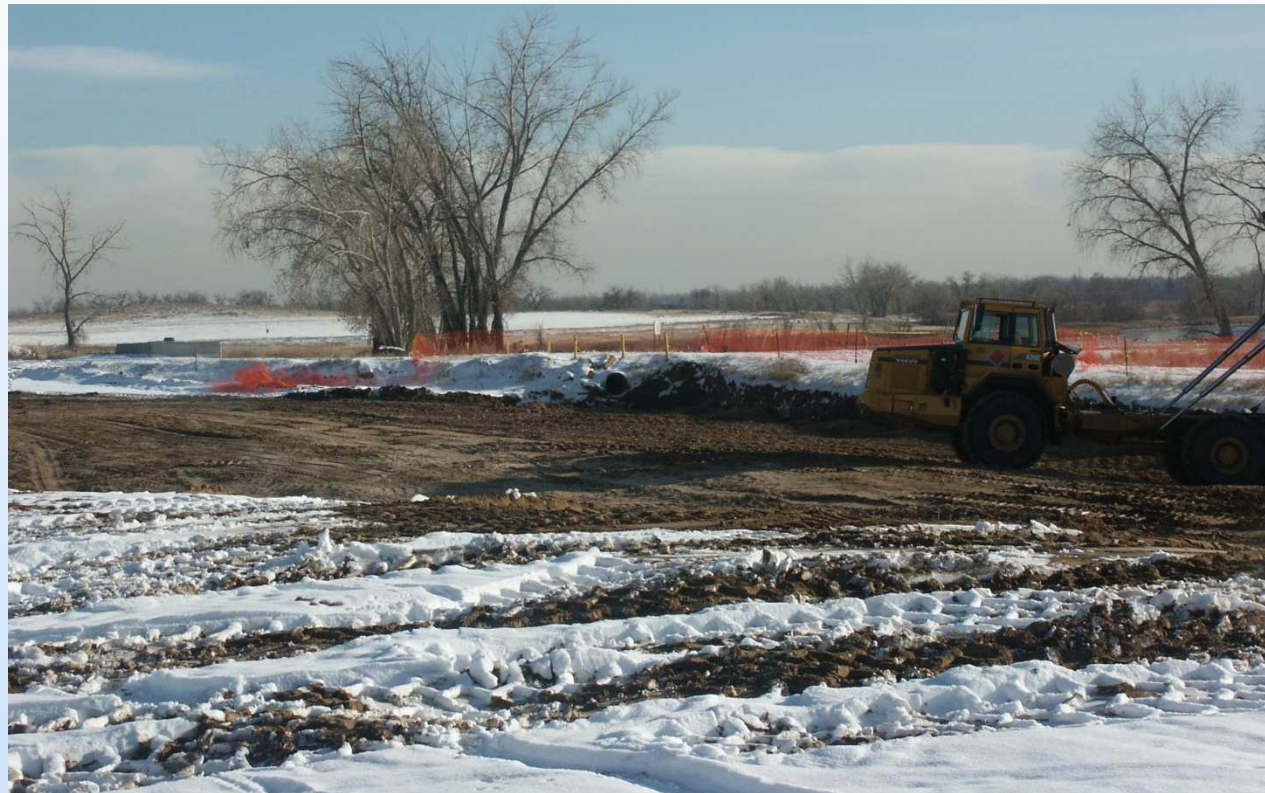
The remedy protects unique habitat when possible, including protecting large trees by not excavating around the dripline and leaving tree groves in place to preserve nesting habitat for raptors (U.S. Army photograph)

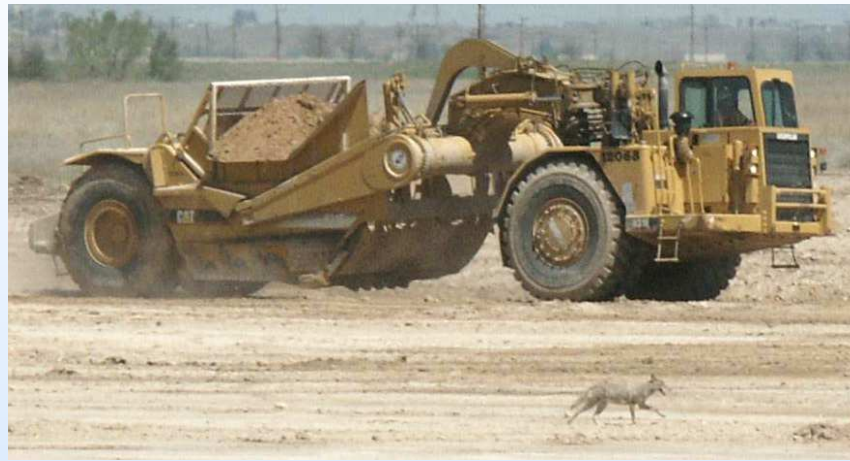
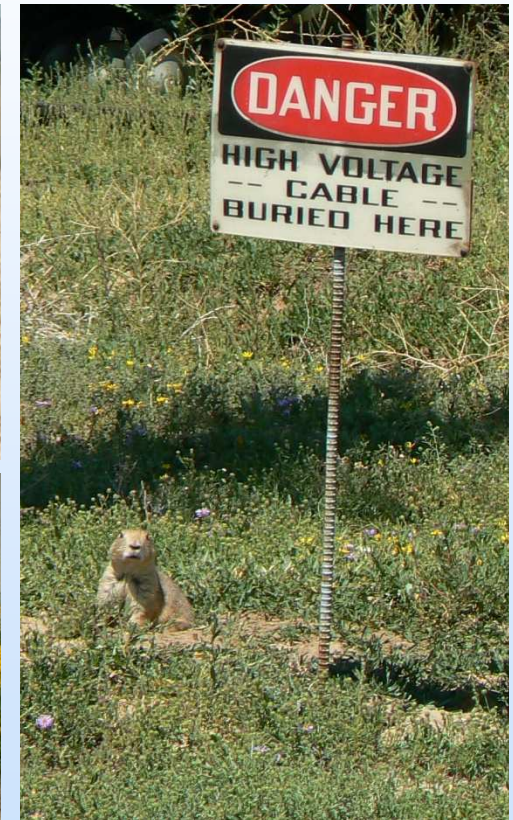
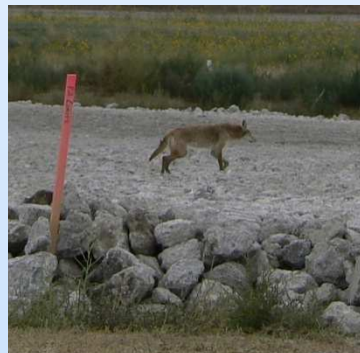
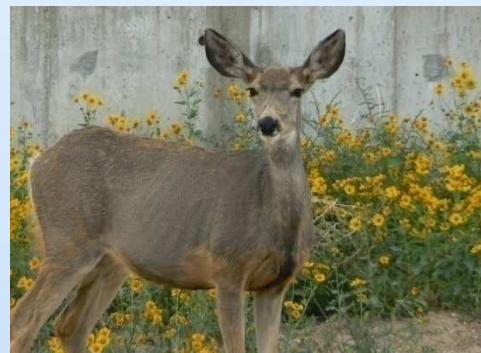
Clockwise from top: coyote running across biota barrier during construction of RCRA-Equivalent covers; prairie dog and high voltage cable; mule deer by a structure before demolition; coyote on biota barrier (EPA field oversight photographs)

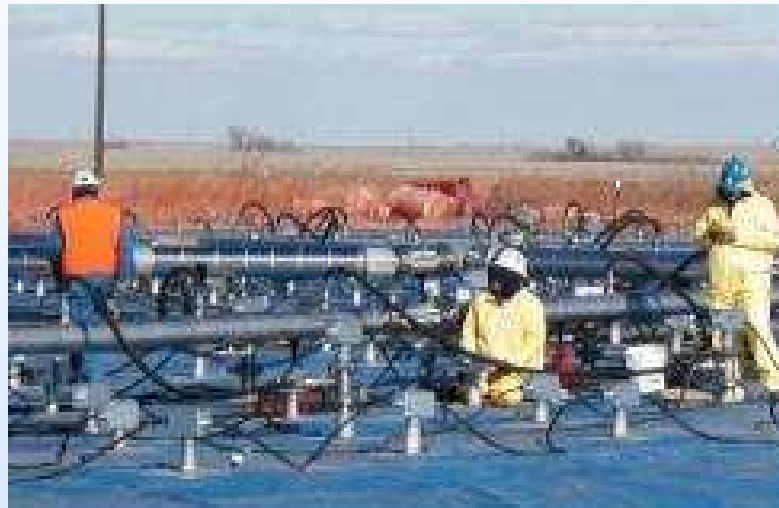
Plan view of the Hex Pits and array of heater and heater vacuum wells (diagram below)

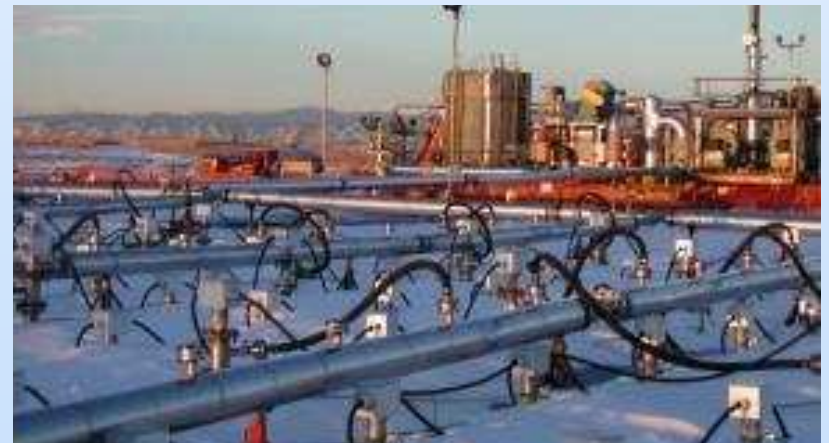
Installation of heater only (top photo) and heater-vacuum wells (right) for In Situ Thermal Destruction at the Hex Pits (U.S. Army photographs)

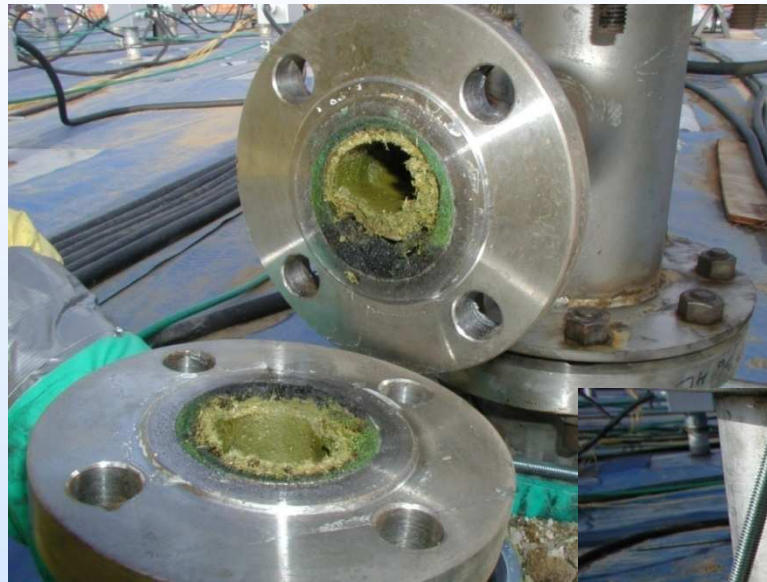
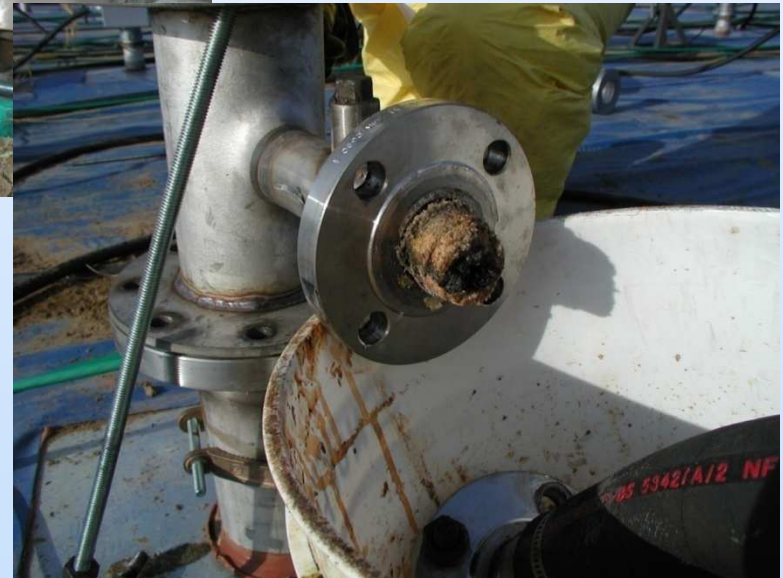
Corroded piping at the Hex Pit Remediation Project

U.S. Army photographs

- Do not assume that *in-situ* neutralization of acids will occur, especially in the case of highly chlorinated NAPL or situations in which the waste resides as a neat *solid* material that has not penetrated into a porous matrix
- Be conservative to ensure captured vapors remain in the vapor state

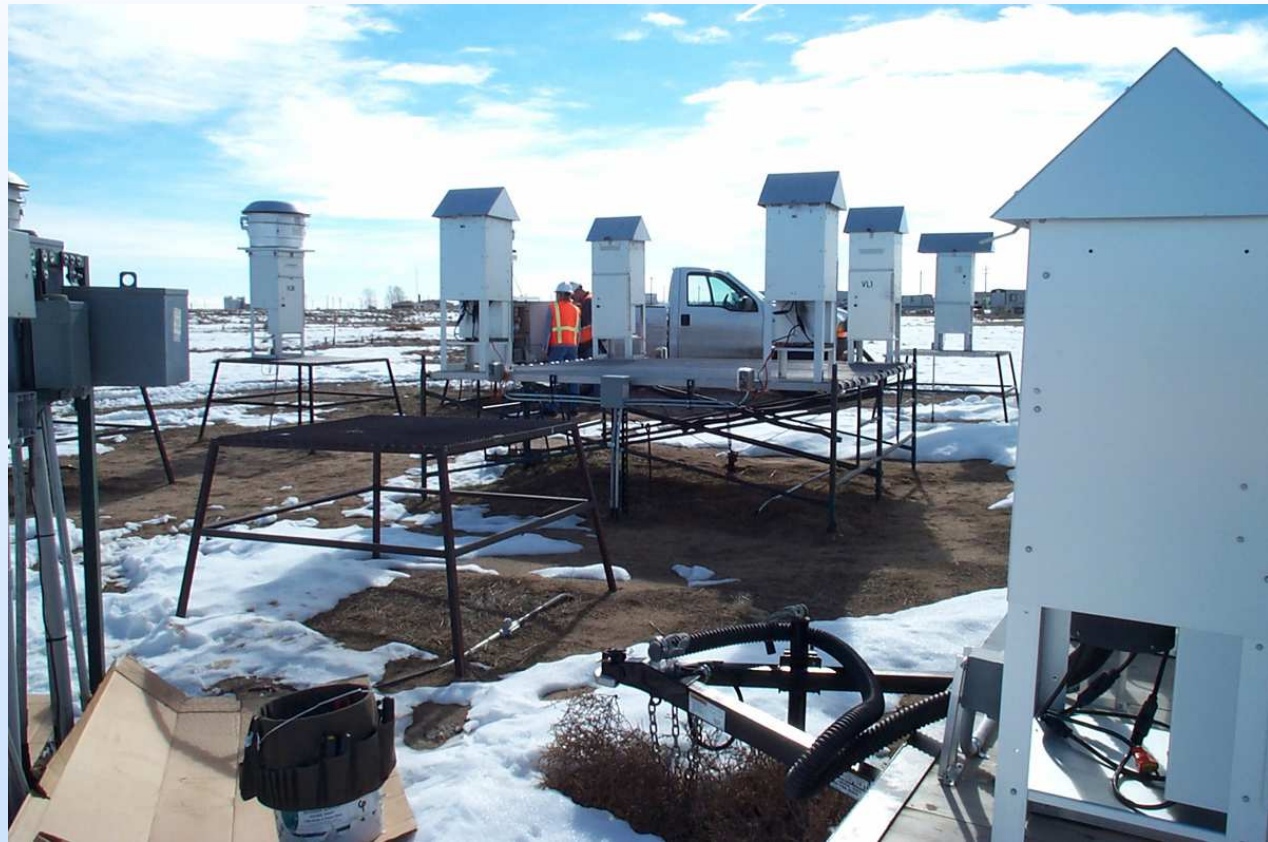
Air monitoring station for chemical emissions at RMA (EPA field oversight photograph)

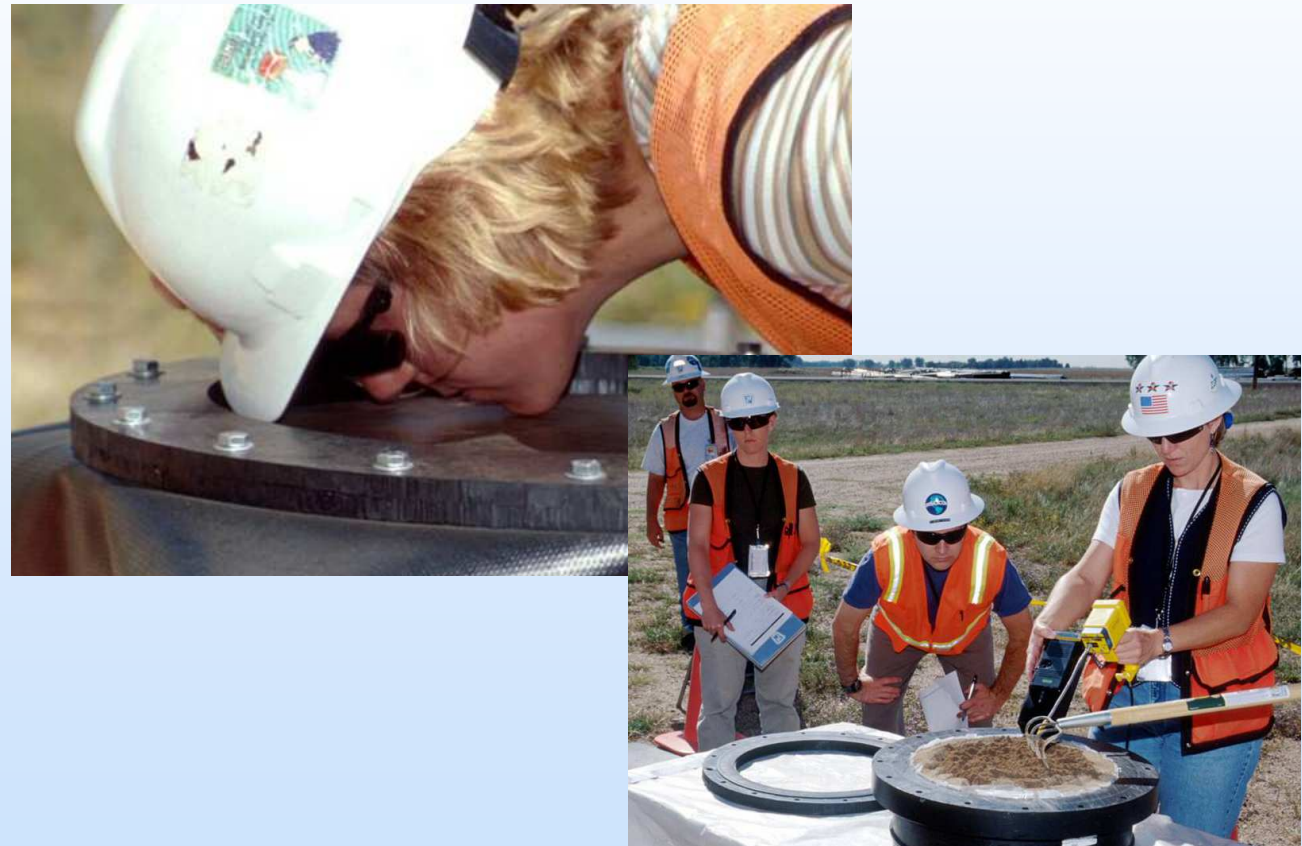
Geomembrane odor testing (EPA field oversight photographs)

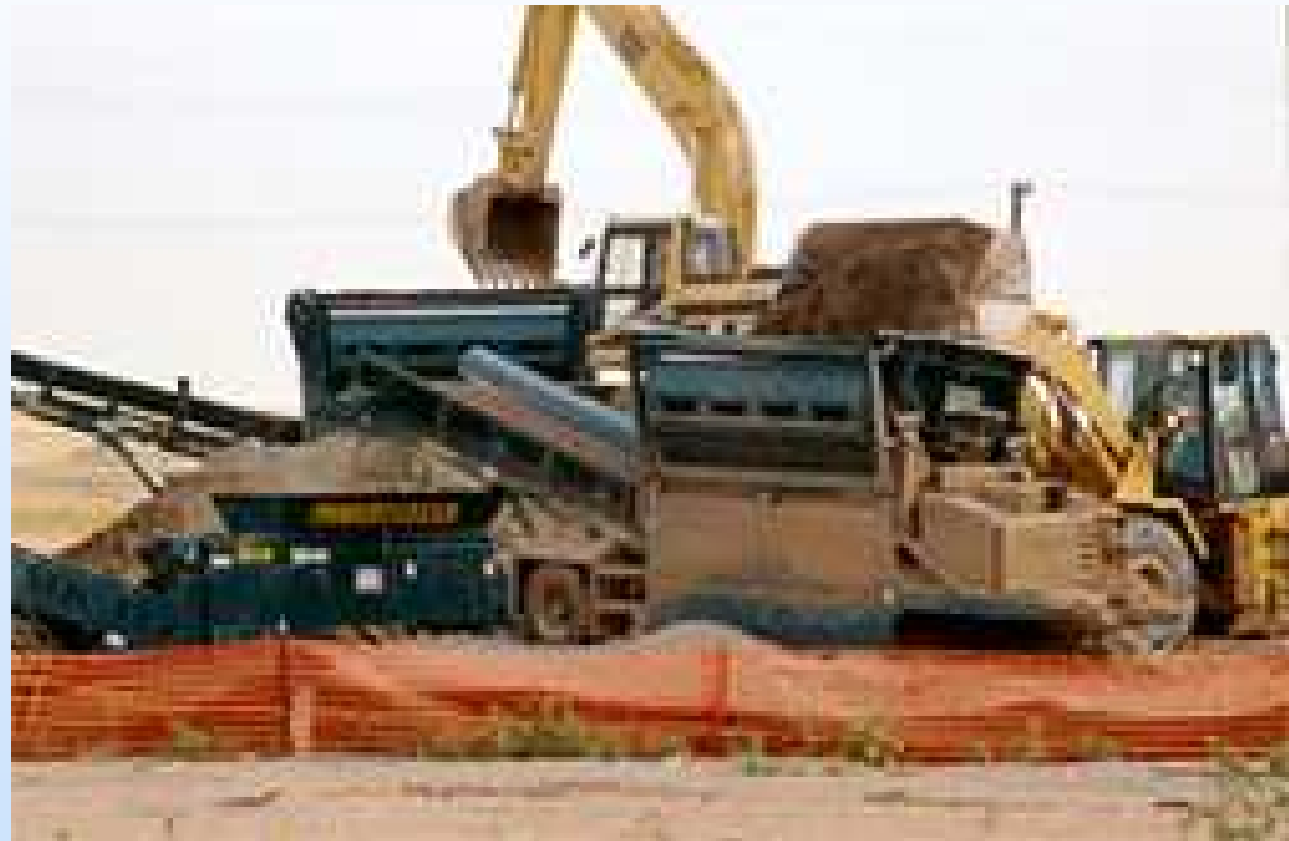
M-1 Pits – soil solidification and stabilization

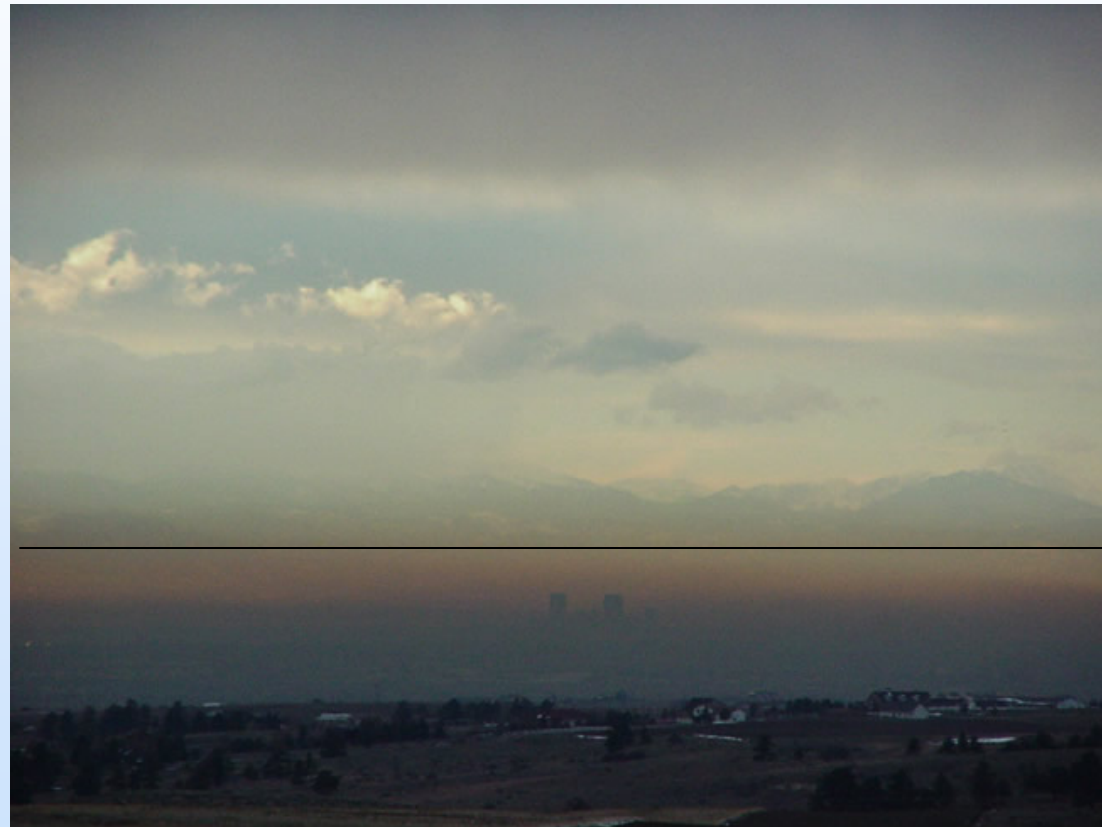
Poor air dispersion – still and stagnant air

Warm Air

Cold Air

November 2002 (Photograph by B. Burkhart)

- Favorable meteorological conditions were important for reducing odors. Set up a go/no-go decision based on atmospheric stability classifications
- Stockpiling odorous soil overnight was discontinued
- Minimizing disturbance/mixing of the soil greatly helped reduce odors
- Limiting the area of an open excavation helped reduce odors

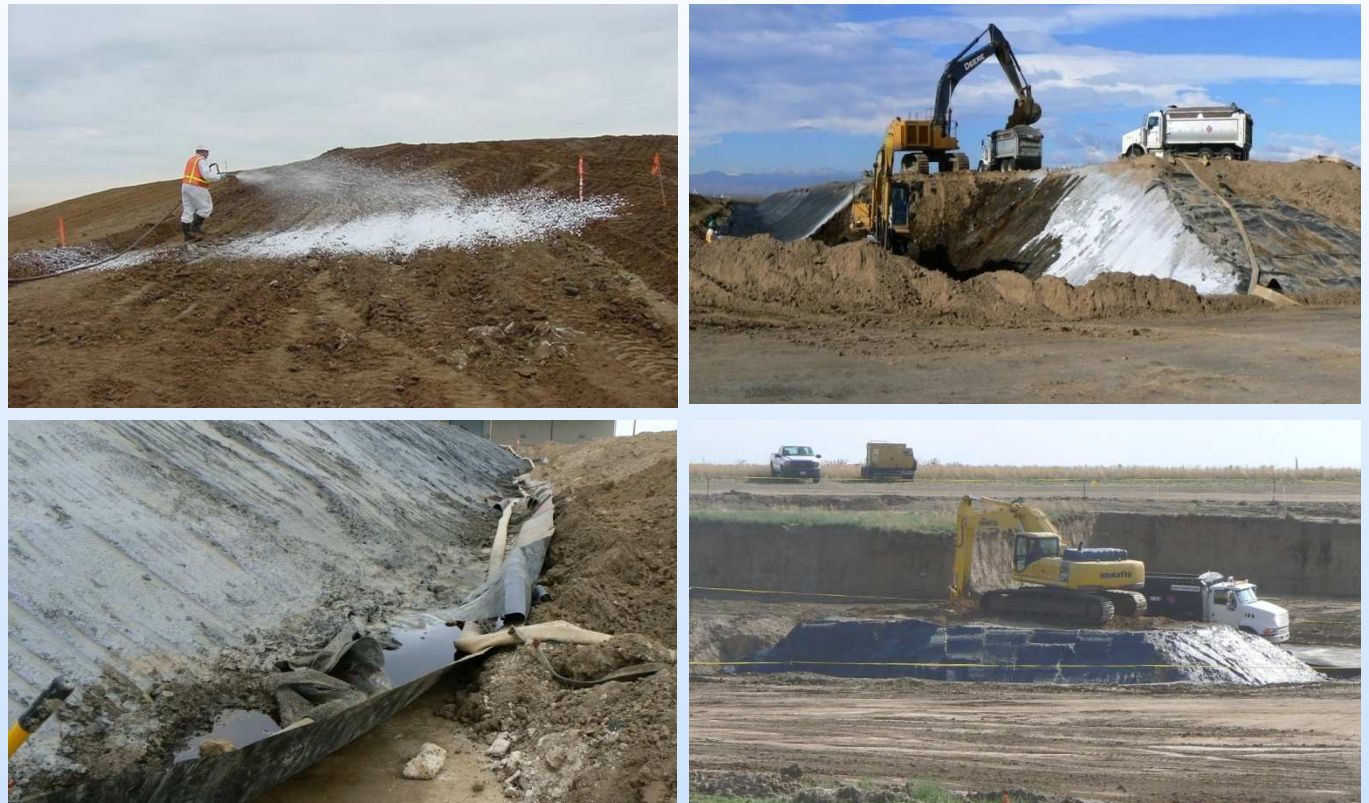
Clockwise from top left: placement of short-duration foam odor control; short-term odor control at Basin F HHE excavation; long-duration odor control foam; geomembrane used as odor control (EPA field oversight photographs)

- No complaints from the community were received
- Full-time odor monitoring to assess/confirm odors in the community was successful
- Slow start was successful
- It was possible to implement the project without a full enclosure
- Use of onsite meteorological towers and daily forecasting was successful in making go/no-go decisions
- Limiting the area of disturbance was successful
- Odor control using foam was not always effective because it breaks down in the rain, is difficult to apply in the wind, and won't adhere to steep slopes

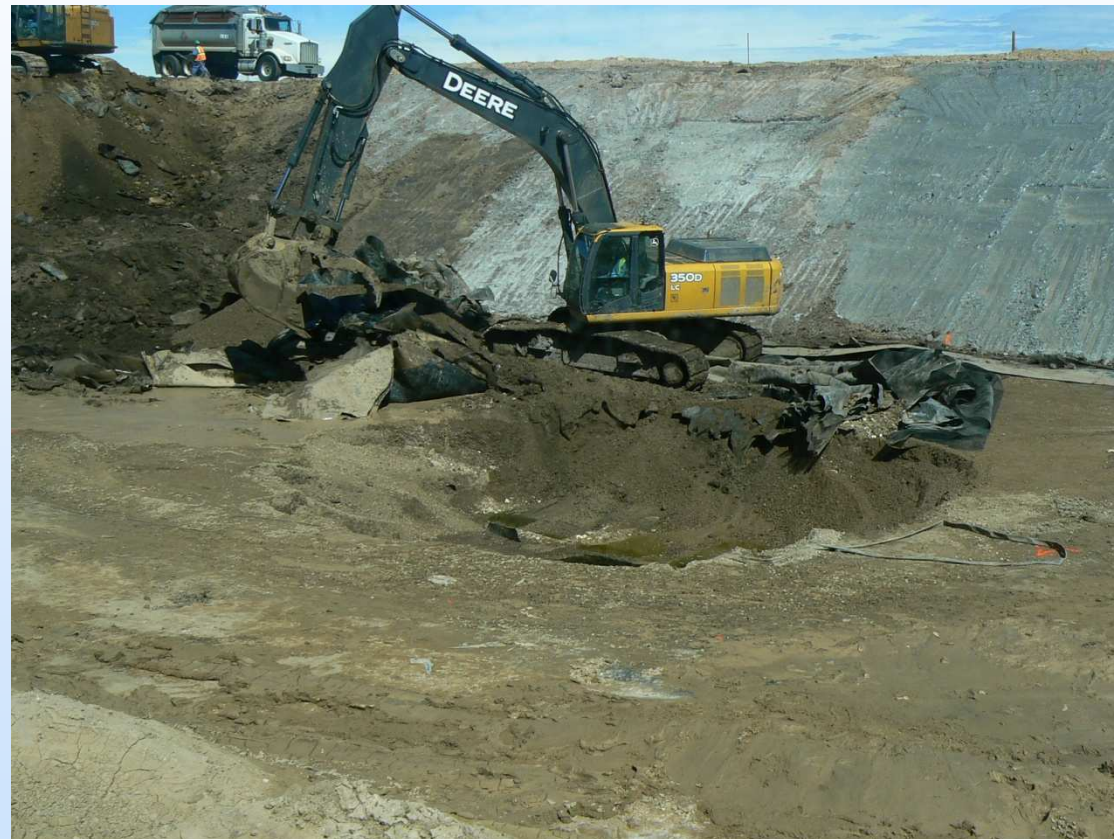
Removal of one of the Wastepile sumps and liner material (EPA field oversight photographs)

- Compacted soil subgrade
- 60-mil HDPE as a secondary liner
- 200-mil HDPE geonet (leak detection)
- 60-mil HDPE primary liner
- 200-mil HDPE geonet (leachate collection)
- 12-oz geotextile
- 36 inches of soil as a protective cushion layer

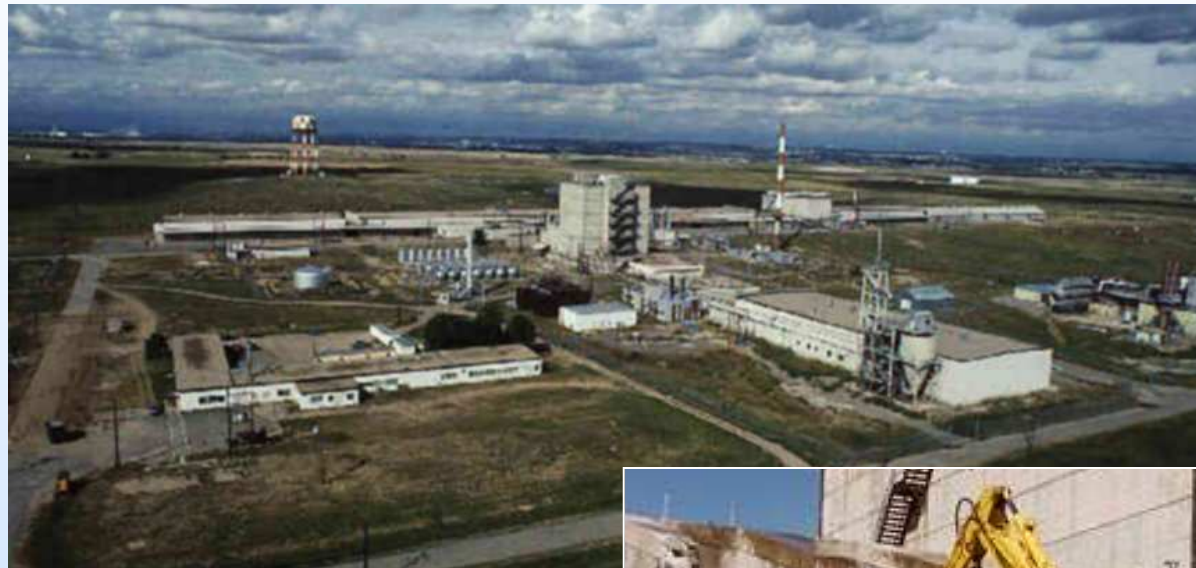
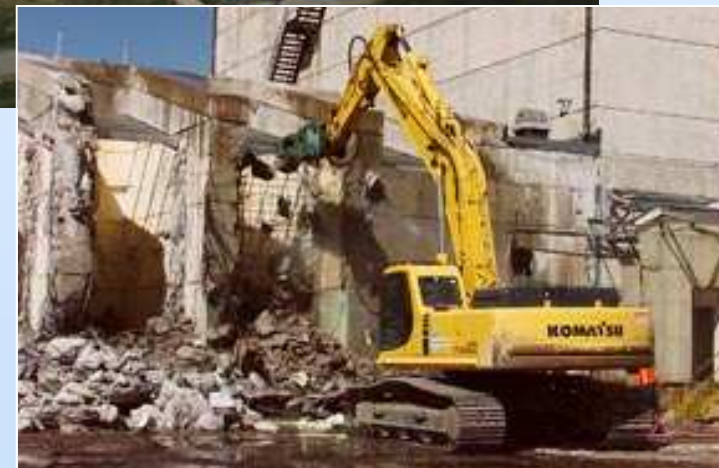
North Plants Weapons Manufacturing Facility, top (globalsecurity.org); building demolition of North Plants (EPA field oversight photograph)

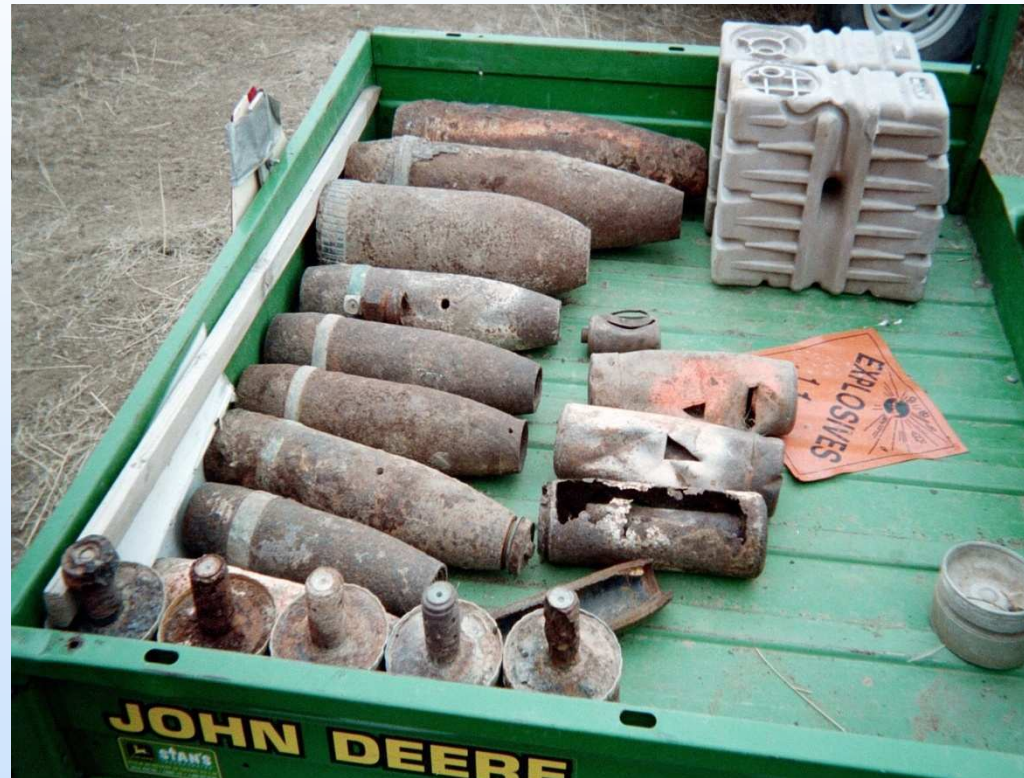
Recovered munitions debris from a former munitions testing area (EPA field oversight photograph)

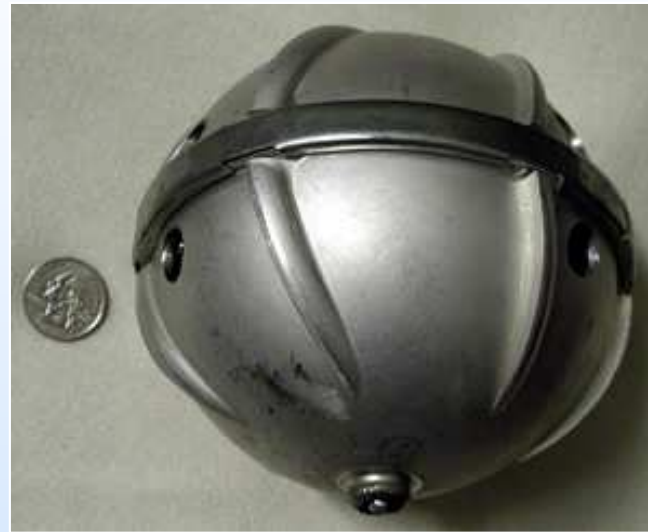
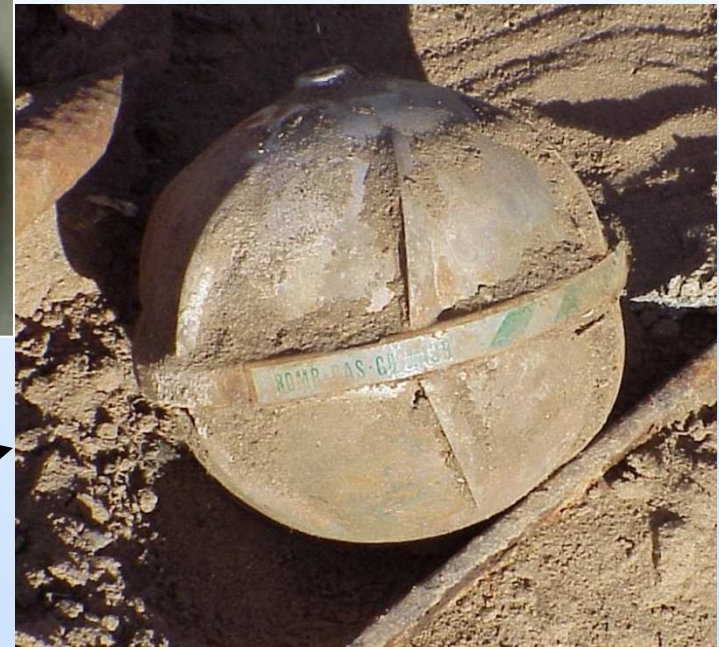
Left, a Sarin bomblet showing relative size (USFWS photograph). Below, Sarin bomblet recovered from a debris pile at the RMA (U.S. Army photograph)

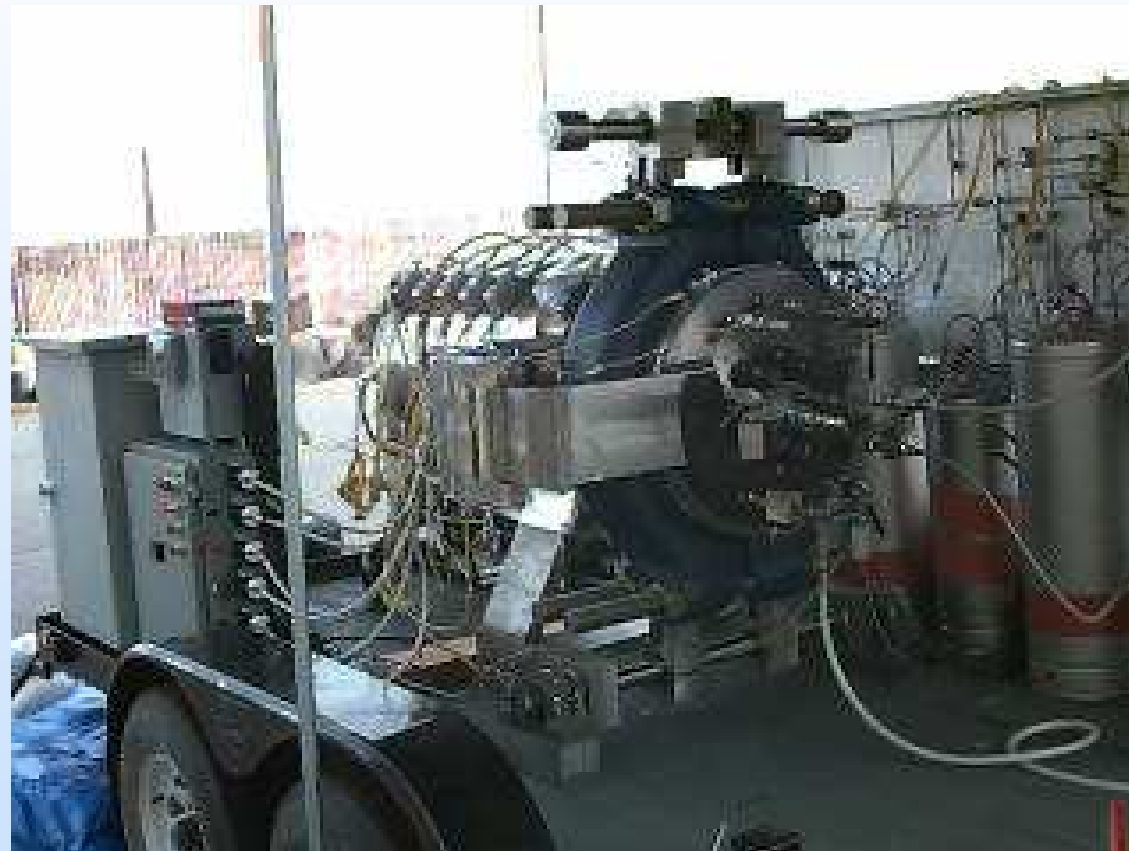
The Explosive Destruction System
(B.L. Haroldsen, J.H. Stofleth, and T.J. Shepodd)

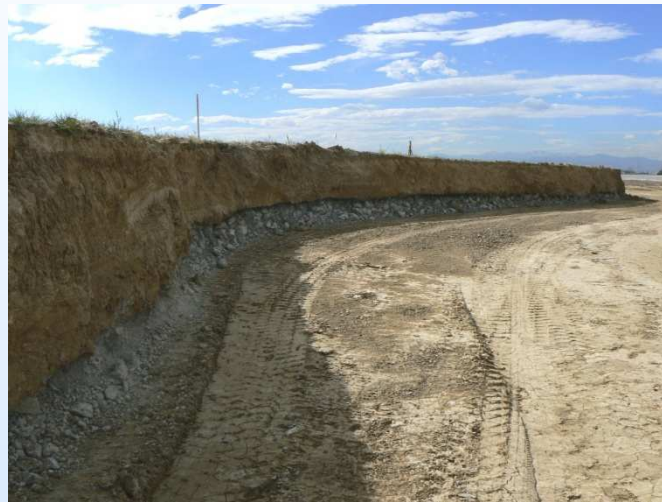
Cross section through the Shell RCRA-Equivalent Cover. 18 inches of BBM is overlain with a geotextile and 4 feet of soil (EPA field oversight photograph). Cross section of RCRA-E Covers (TetraTech EC 2008)

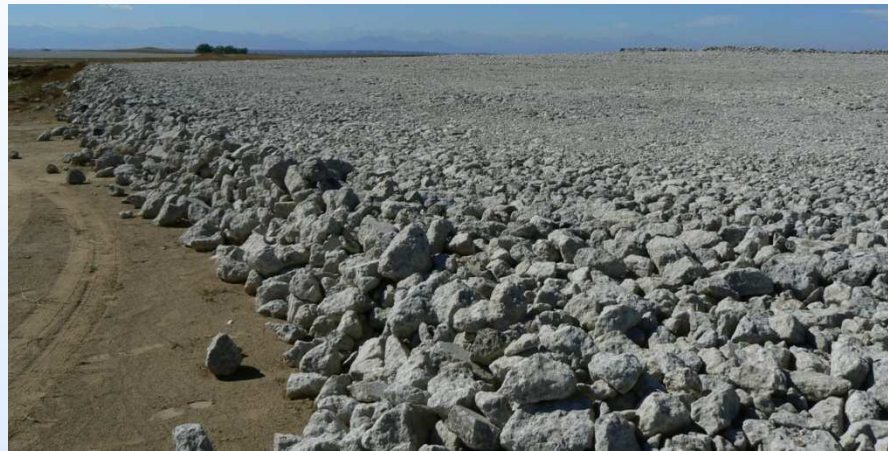
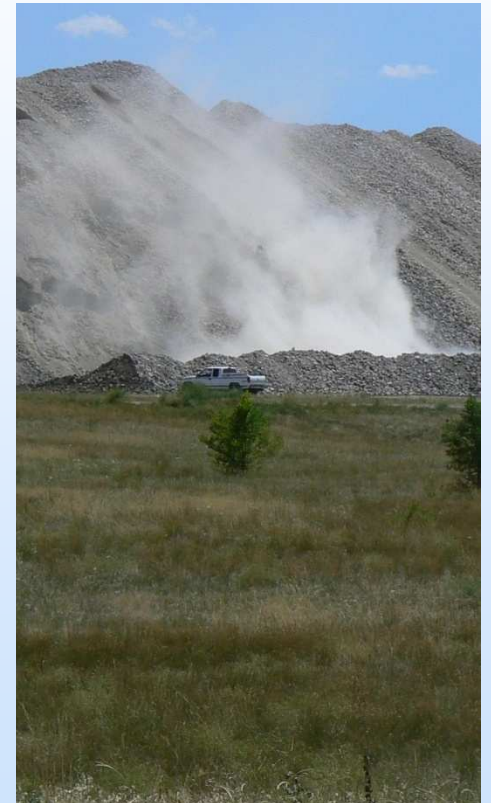
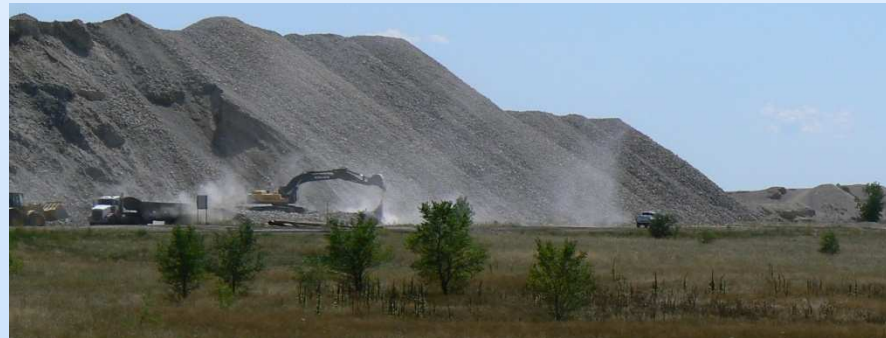
16 inches of biota barrier material. Stockpile of crushed concrete from the demolition of the old Stapleton International Airport, being loaded for cover construction (EPA field oversight photographs)
