Give Me Refuge

Transforming the
“most contaminated
square mile on earth”
into a premier urban
wildlife refuge

- Background of the Rocky Mountain Arsenal (RMA)
- Manufacturing and Disposal History
- Soil Remedy
- Operations and Maintenance
- Lessons Learned

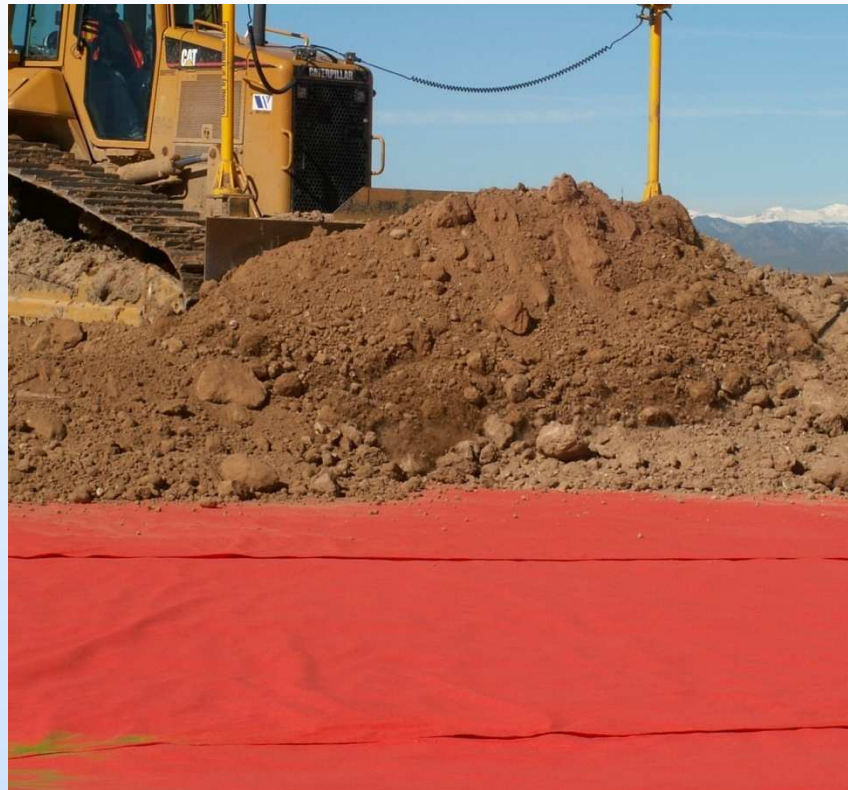
Capillary barrier layer (orange geotextile) on the Shell Cover. Placement of capillary barrier material (squeegee - a clean, washed gravel material) on the Integrated Cover System (EPA field oversight photographs)

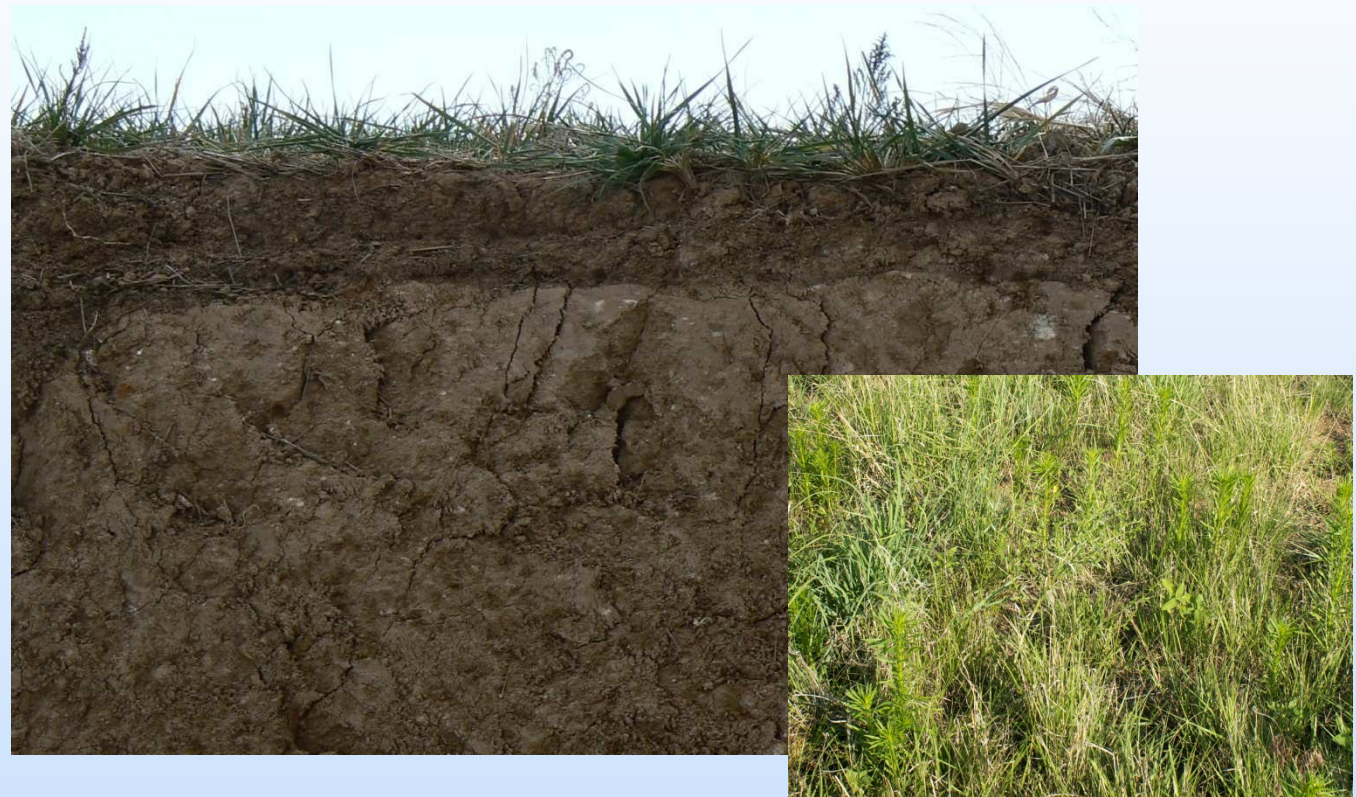
Cross section of the Shell RCRA-Equivalent Cover. Progress of vegetation after one growing season. (EPA field oversight photograph)

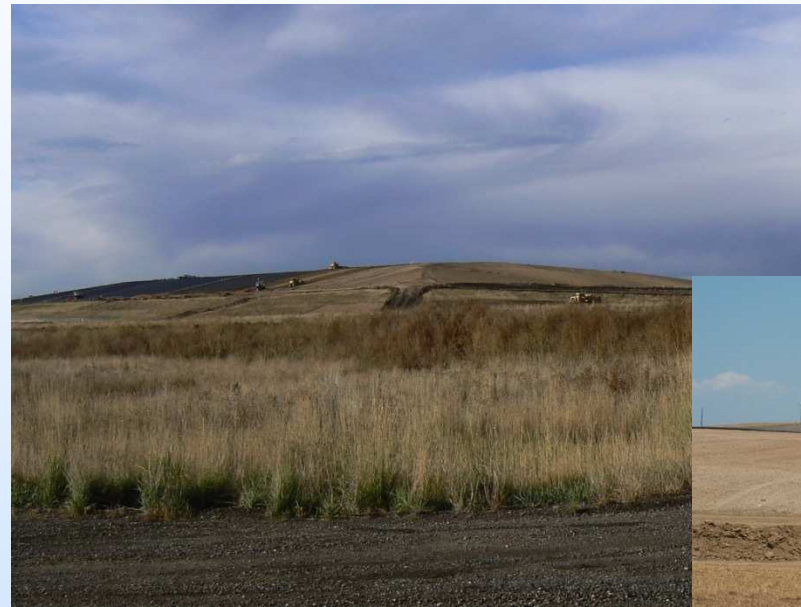
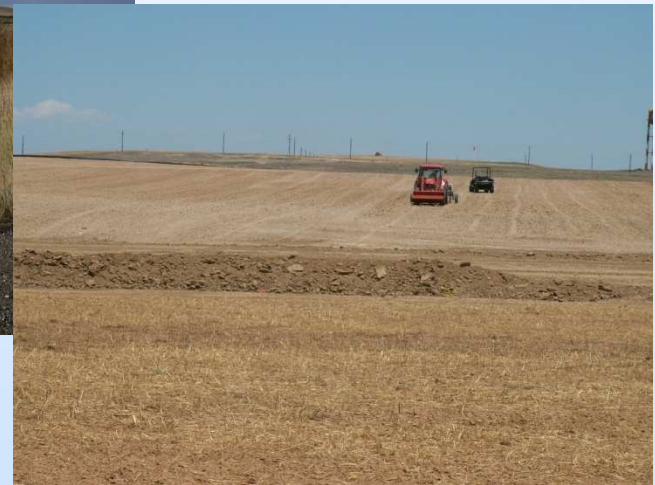
Cover construction on the Hazardous Waste Landfill with 20% to 33% side slopes (top); 3% side slopes on the RCRA-Equivalent cover – undergoing revegetation (right) (EPA field oversight photographs)

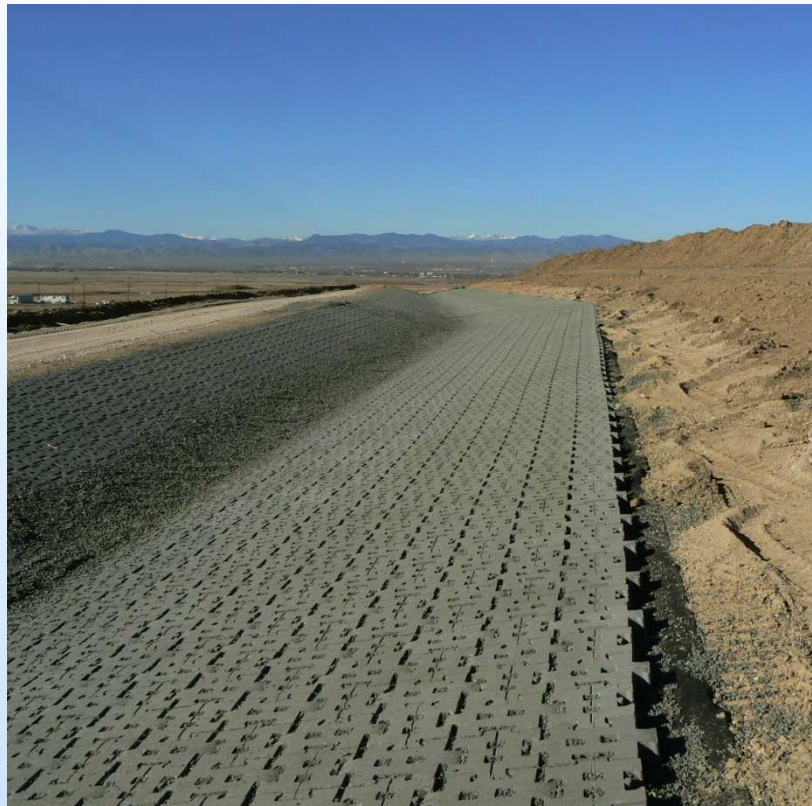
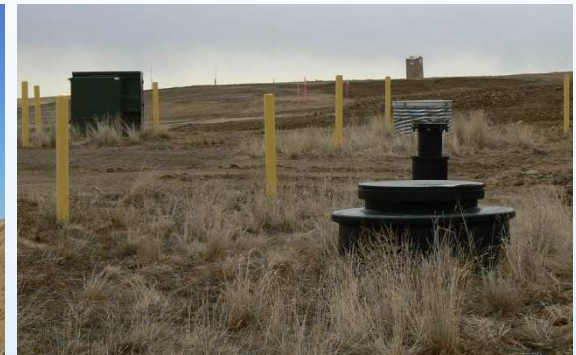
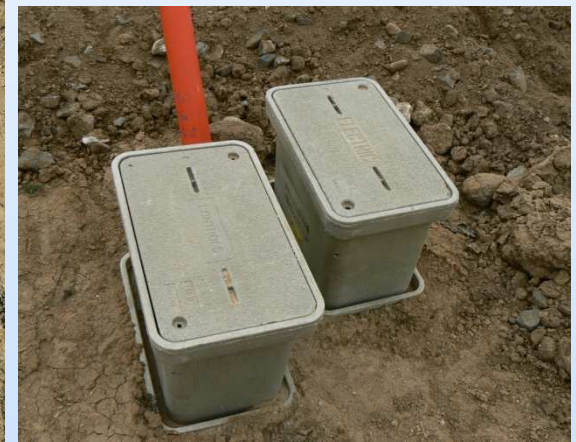
Clockwise from left: articulated concrete blocks drainage channel, power supply and manhole vents, and instrumentation on the Hazardous Waste Landfill cover. (EPA field oversight photographs)

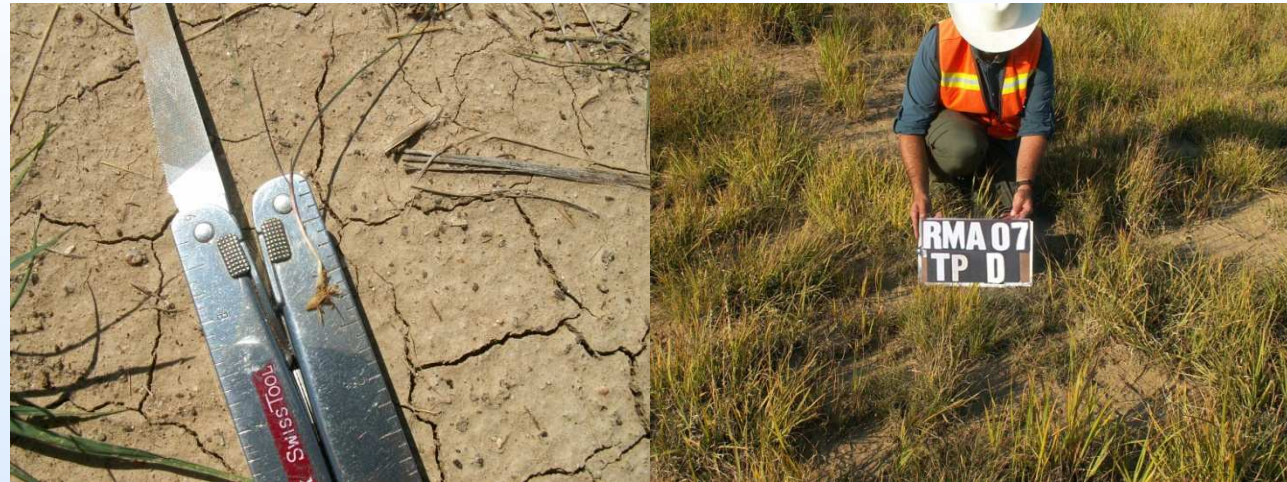
Grass seedling just after germination (top), in progress (top right), well developed vegetation 10 years after seeding (right).
