REMTECH 2009

Drumheller Institution: Kitchen & Health Centre Crawlspace Remediation

October 15, 2009

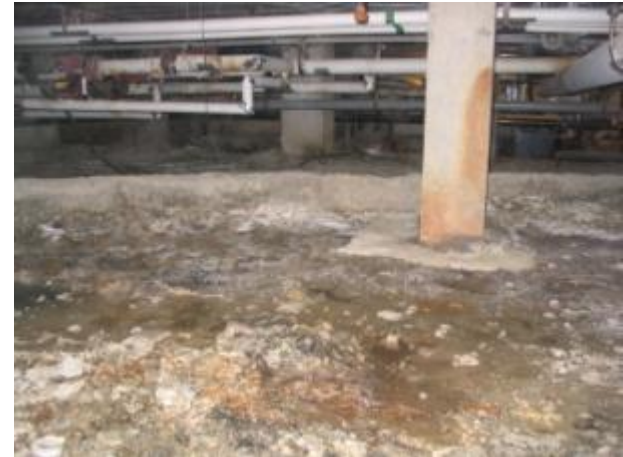
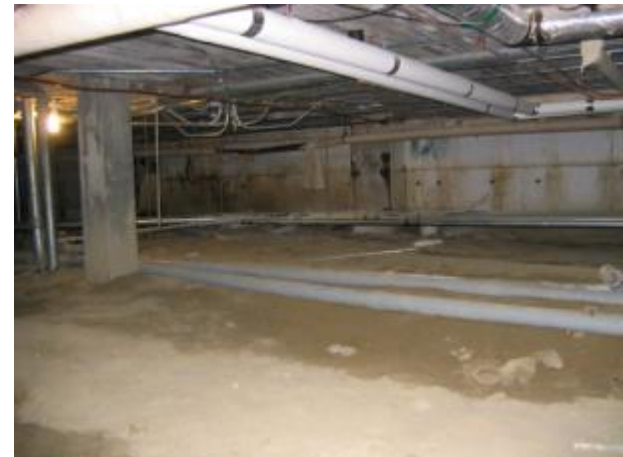
- Buildings construction
 - Exterior grade beam on footings
 - Floor: structural slab with piles on spread footings
 - Earth floor in crawlspace with approximately 1 to 1.5 metres of head room
 - Utility and heating piping hung from the underside of floor slab

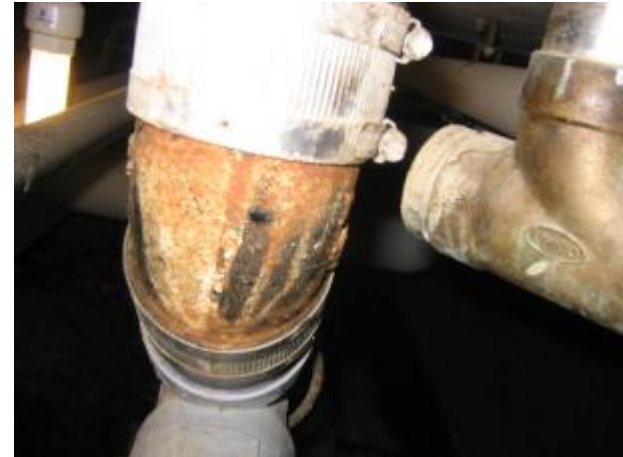
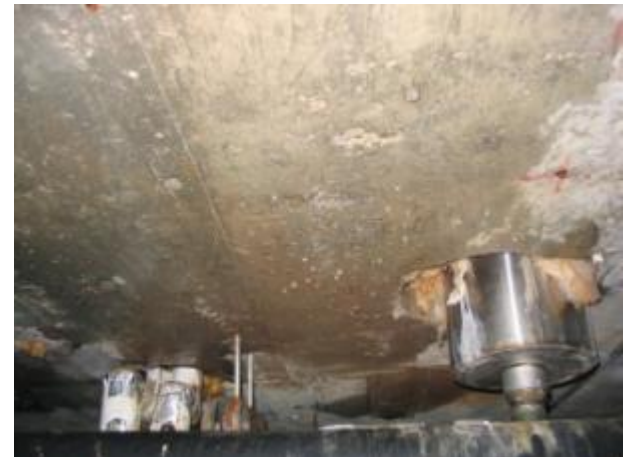
- Joints in utility piping develop leaks
- Leaking at locations where pipes pass thorough floor slab
- Heating pipes develop leaks
- Leaking pipes causes considerable areas of ponding dirty contaminated water

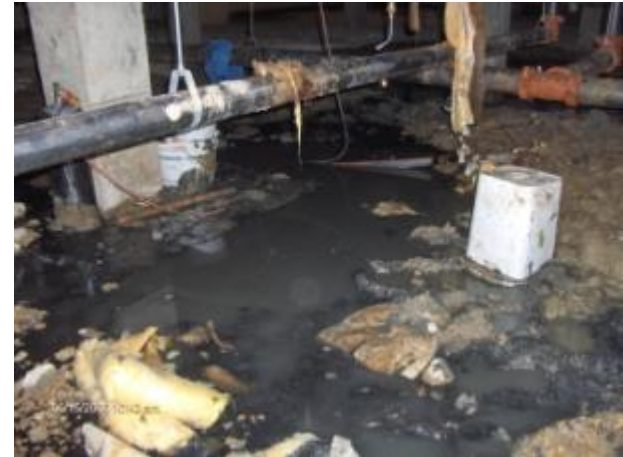
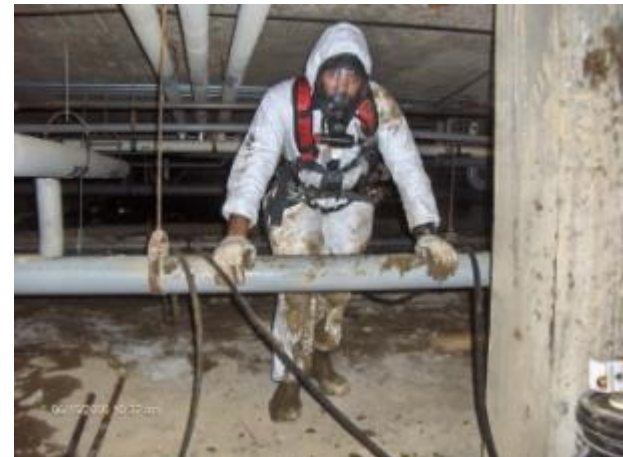
- Ponding water raised concerns with air quality in the crawl space
- Limited head room created maintenance issues
- Due to air quality issues the crawl space was considered a Class A confined space by PWGSC
 - Air packs required
 - Safety harnesses required

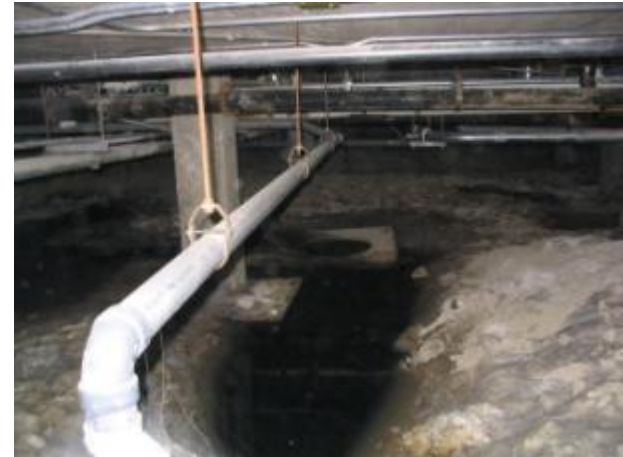
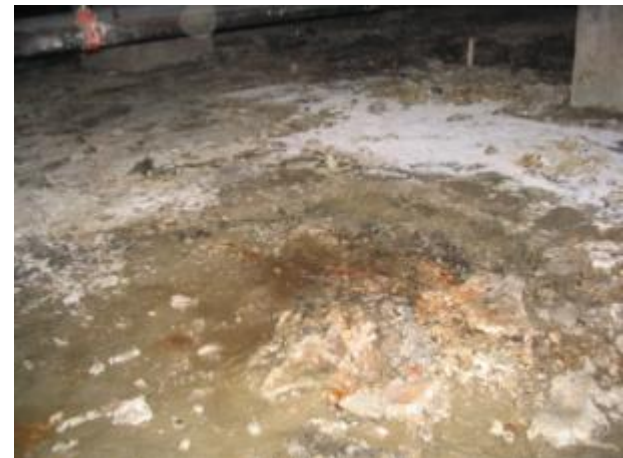
- Due to air quality concerns PWGSC had an environmental assessment report completed in 2004
- The environmental assessment found:
 - Soils samples indicated the presence of total coliform bacteria and *E.coli*,
 - The presence of small areas of *Penicillium/Aspergillus* Mould

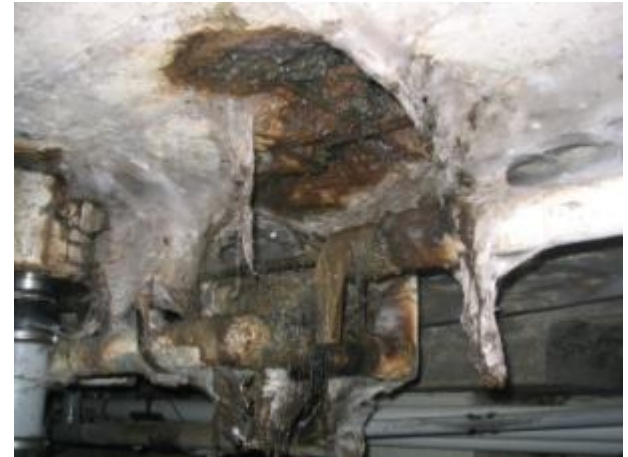
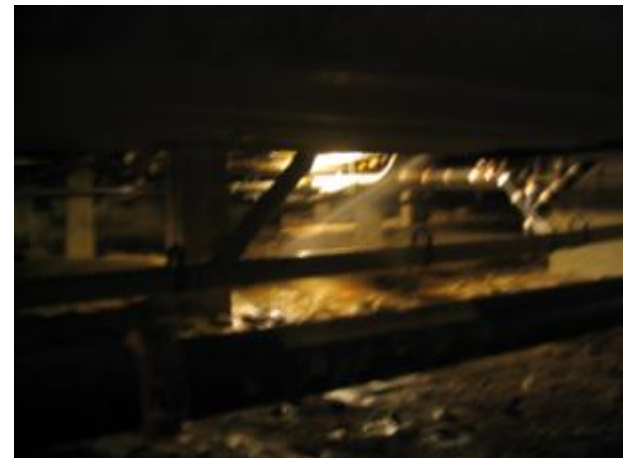
- Propose and design remediation/modifications/improvements to both crawlspaces beneath the kitchen and healthcare to remove the risk of exposure to contractors and employees to bacteria, noxious gases, mould and other hazards from sewage contamination and historical water intrusion;
- Design is to provide a long term solution for sewage back-ups in the crawlspace (can expect that inmate actions will result in the problem recurring);
- Design to include leakage repairs;
- Design must also limit or prevent any of the air in the crawlspace from accessing the occupied spaces.

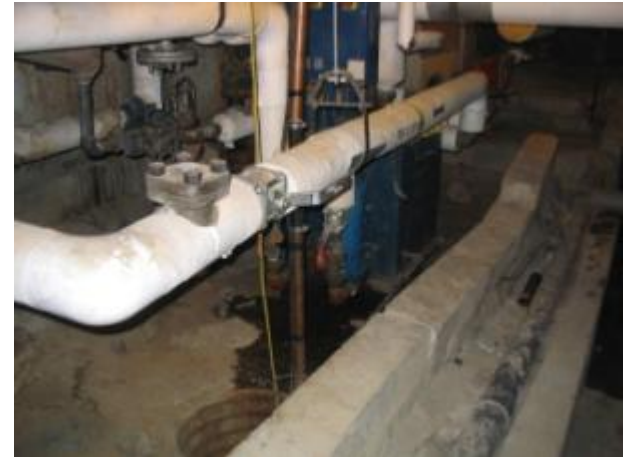
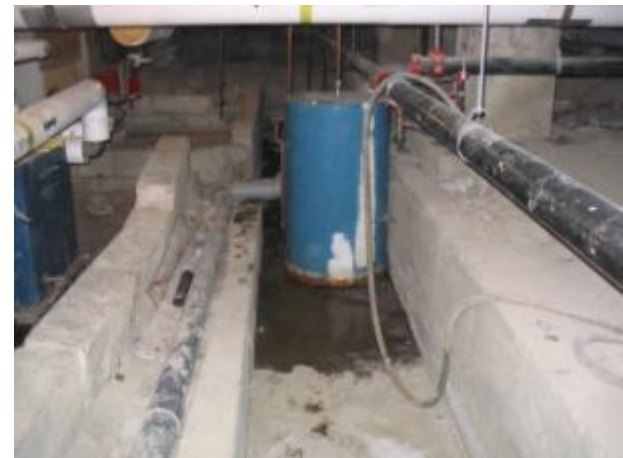
- Wanted a design that would allow ease of maintenance to repair future leaks. Ideally maintenance personnel wanted to be able to stand up in crawlspace, (dig a basement);
- Any geosynthetic liner had to support maintenance and be easy to repair;
- Remediation must seal off contaminated soil and prevent ponding of water;
- Prevent movement of air into occupied space above

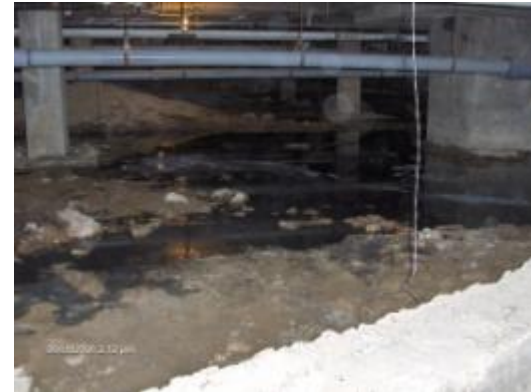
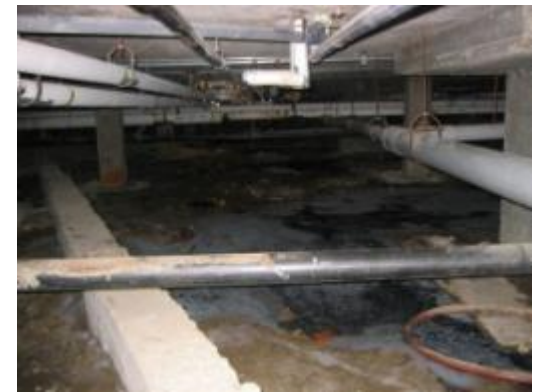
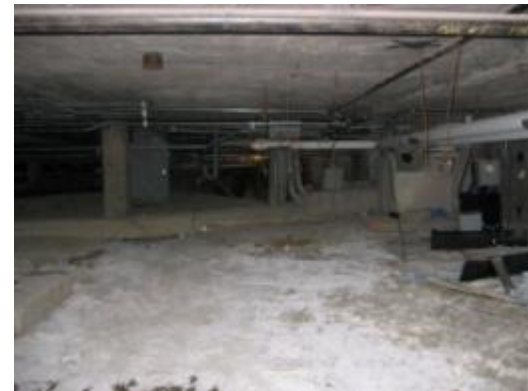
- Large areas of ponding water
- Considerable amount of debris strewn across the earth floor of crawlspaces;
- Electrical cables incased in concrete on top of crawlspace floor

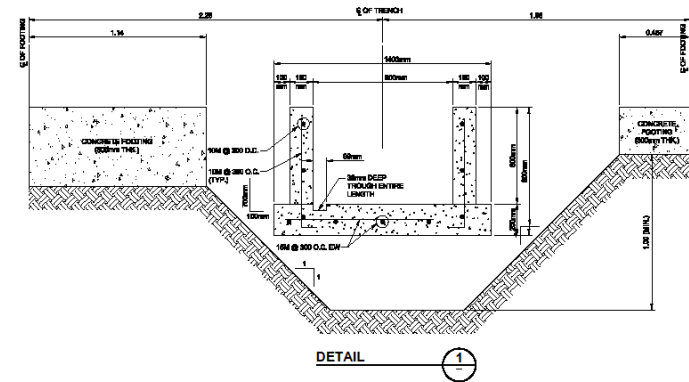
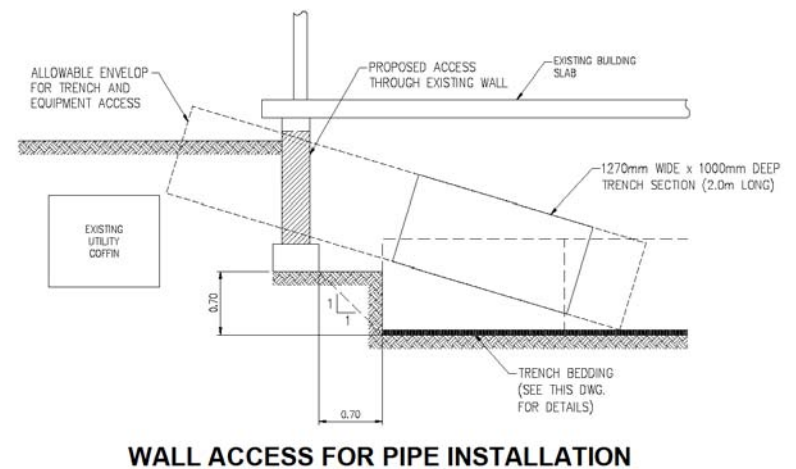
- Building supported by columns on spread footings – two different sizes; design had to prevent compromising the building foundation
- Limited access – one existing exterior and one interior
- Access into the space limited due to foundation design

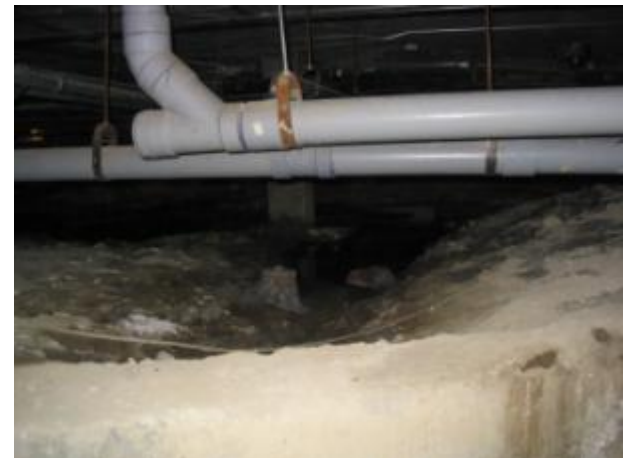
- Surface of crawl space re-graded to allow drainage to the trenches
- Provide ventilation system to maintain a negative pressure in the crawlspace

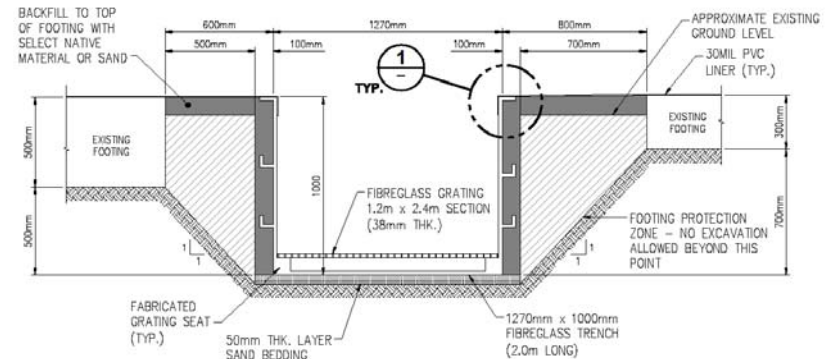
TRENCH DETAIL

- Ability to pre-construct in short lengths to allow easy entrance into the crawlspace
- Lightweight
- Provided grate system to provide non slip surface and separation from drainage water

Trench system chosen was fiberglass

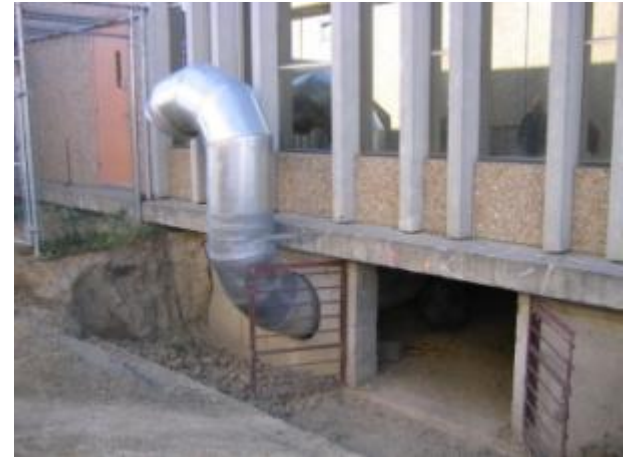
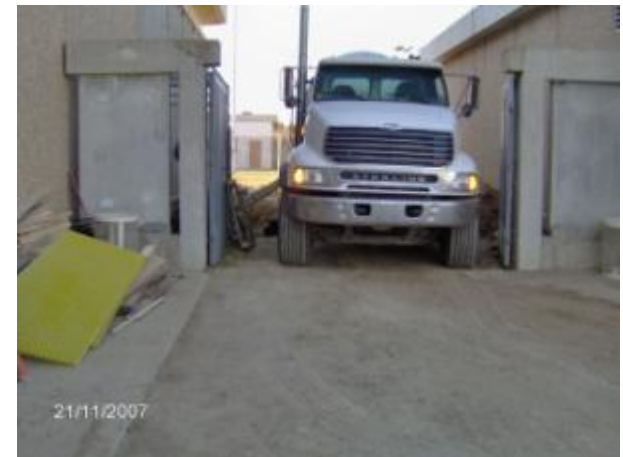
Tight construction Conditions

- All materials had to go in and out through one access point

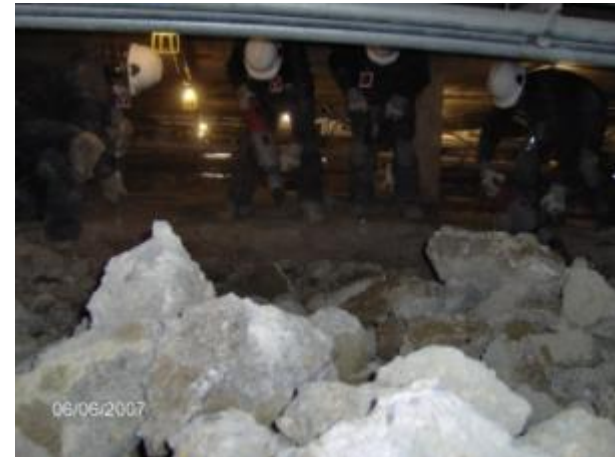
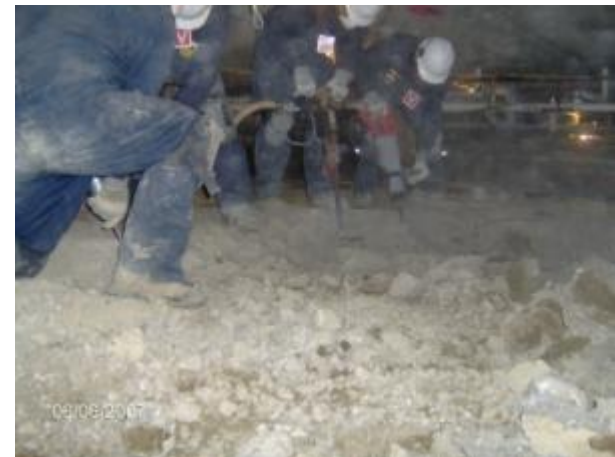
- Large area of concrete dumped during construction of the building had to be removed to facilitate grading

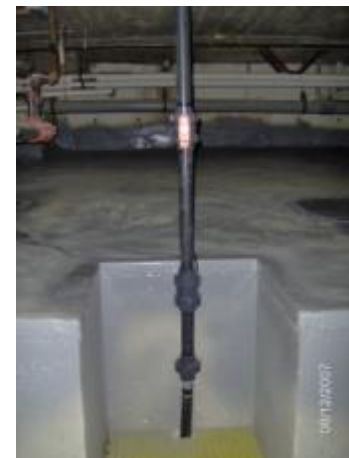
- Completed trench with drainage sump
- Completed trench with grating

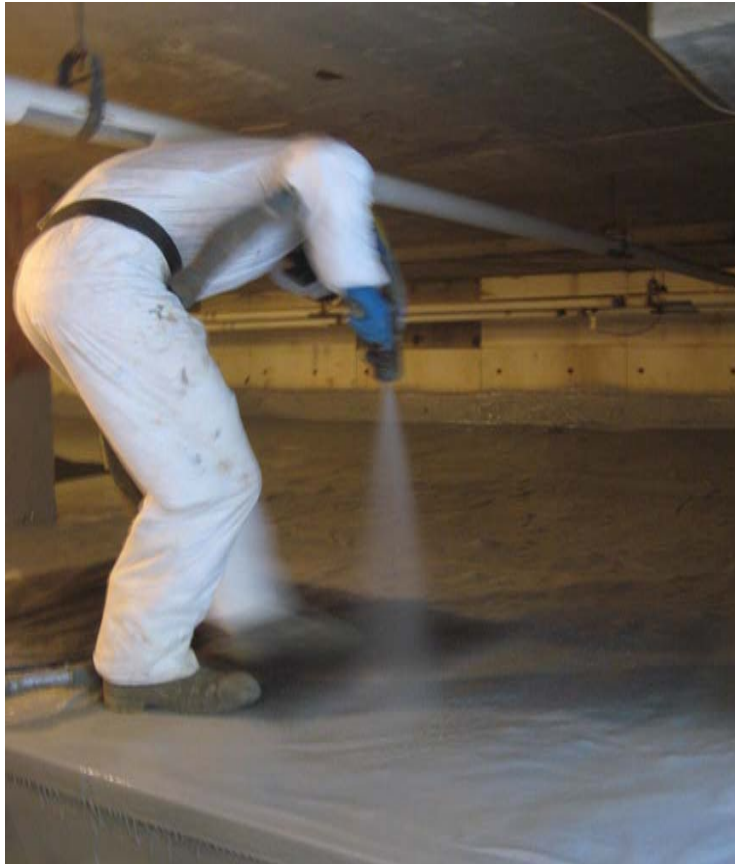
- Premtec sprayed at a 30 mil thickness over filter fabric
