Remediation Technologies Symposium 2009

Biotreatment of Oily Sludges

Presented by: Jeff Dirks

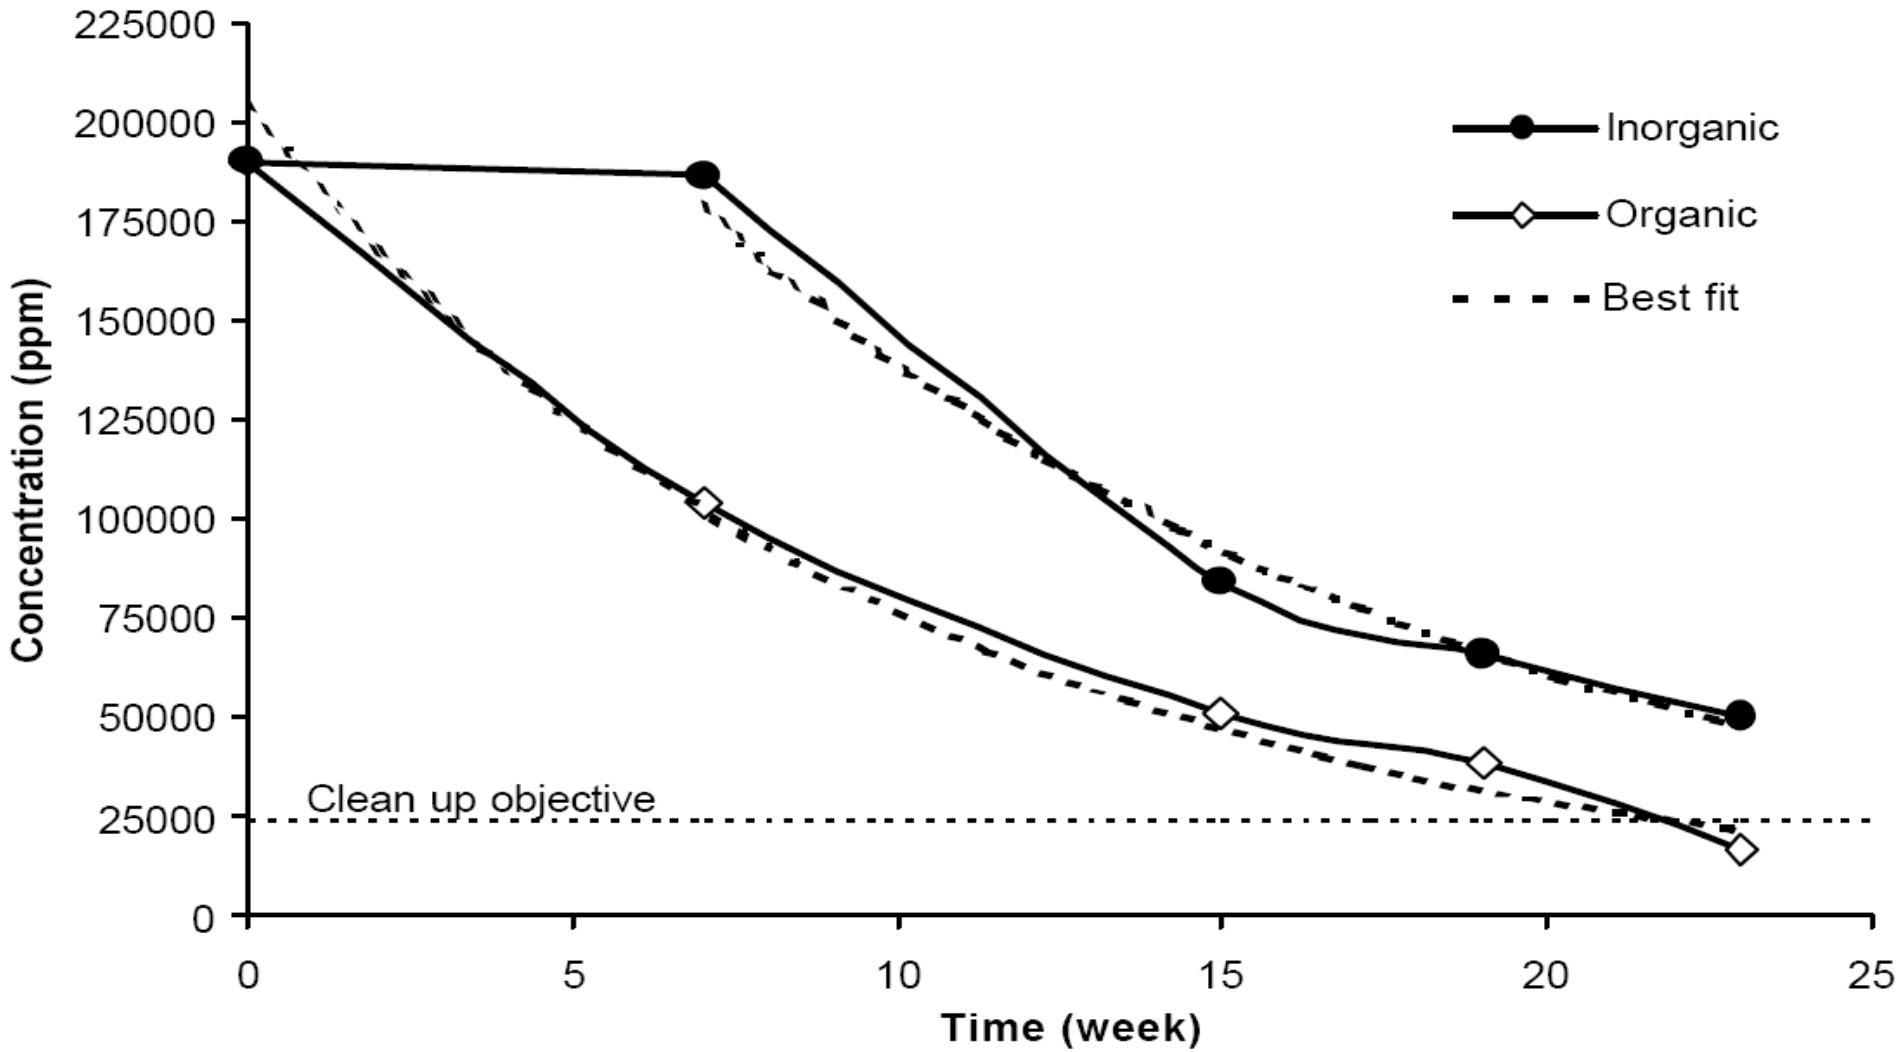
Treatability Study Results

Biodegradation Kinetics (treatability study)

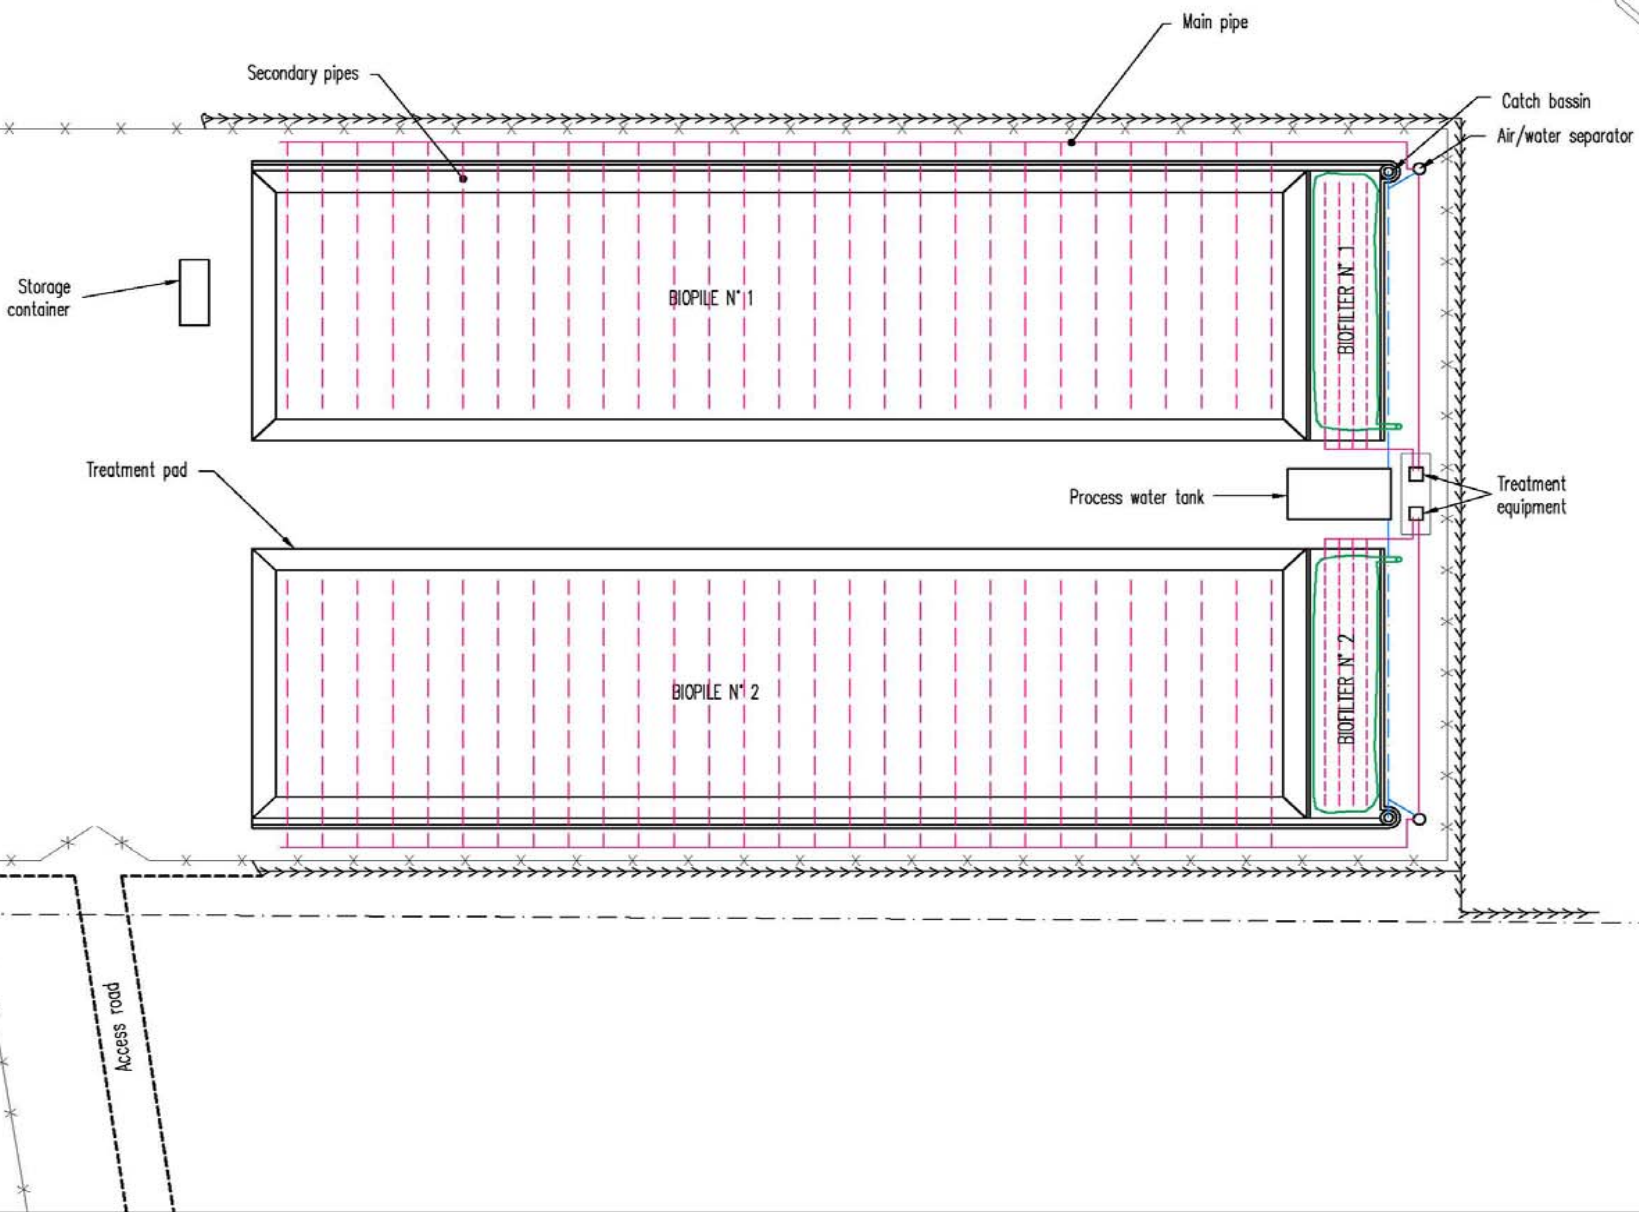
BIOPILE - Schematic View

Secondary pipes

Main pipe

Catch basin
Air/water separator

Storage container

BIOPILE N°1

BIOFILTER N°1

Treatment pad

Process water tank

Treatment equipment

BIOPILE N°2

BIOFILTER N°2

Access road

- Construction of two treatment pads (capacity of 5,000 m³ each)
- Soil amendment with bulking agent and nutrients
- Soil transport
- Periodic soil tilling
- Monitoring of equipment and soil condition
- Disposal at an authorized landfill

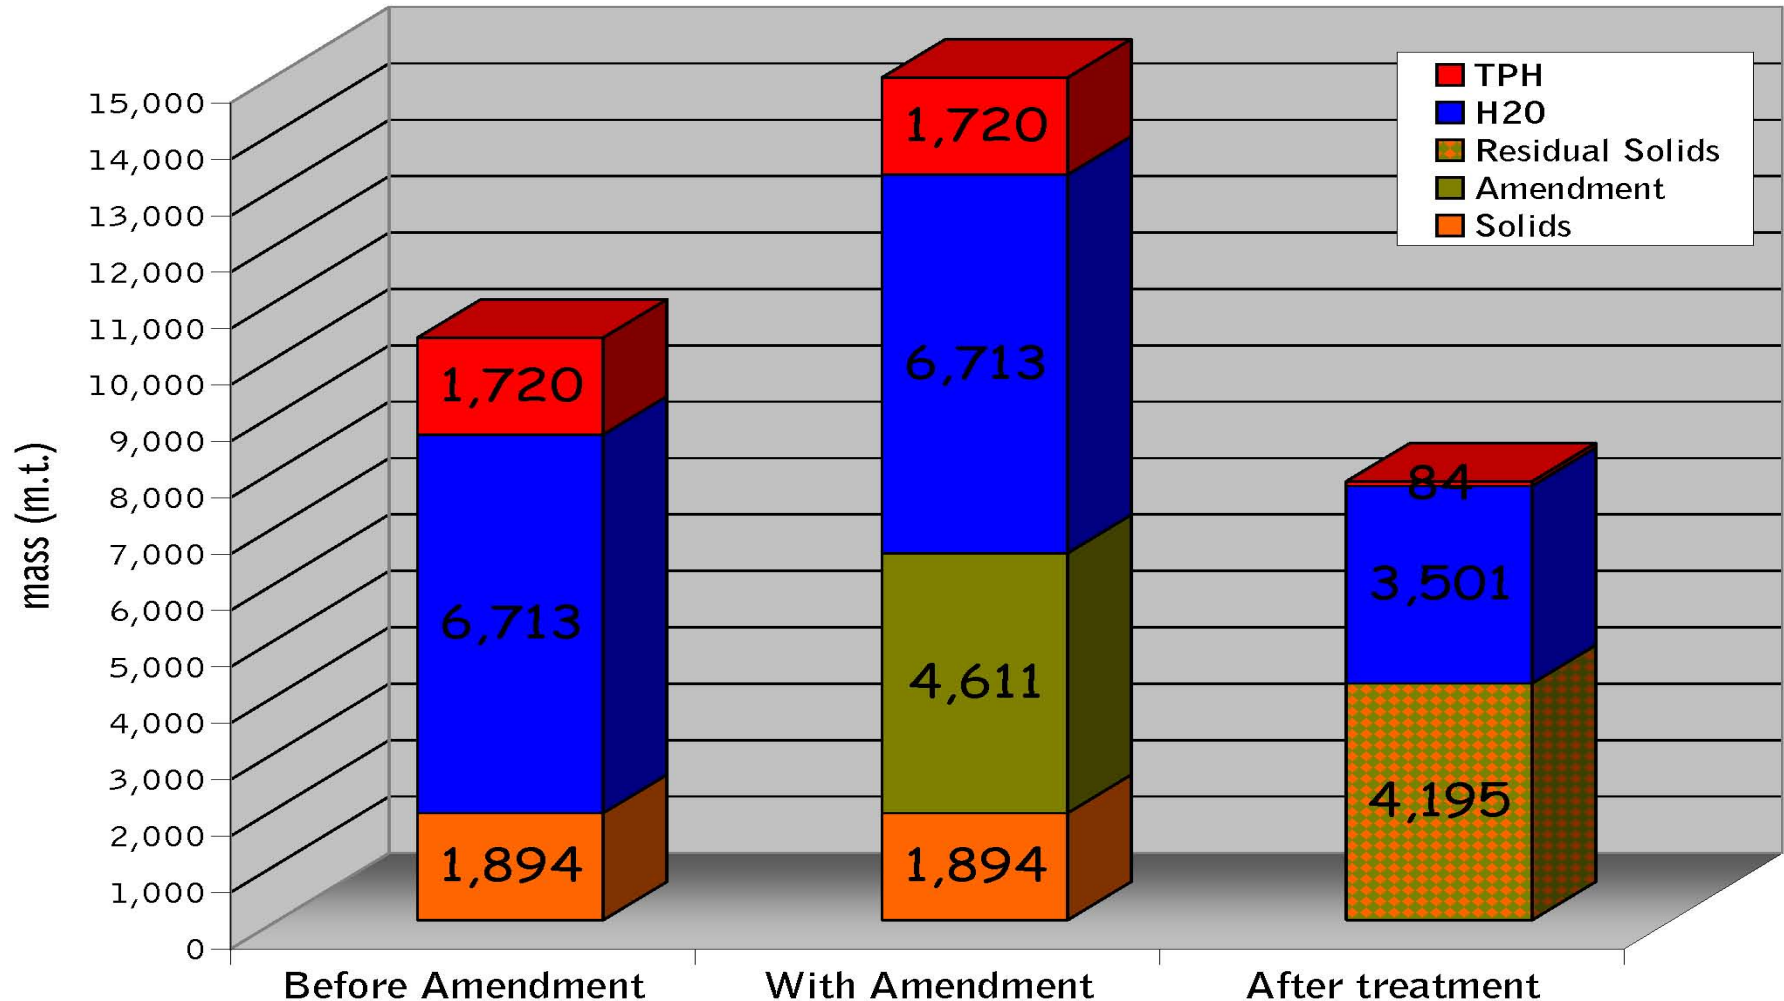
Mass Balance

(Sludge Mass Breakdown in m.t. before and after treatment)
