Quantum Murray LP

Kitkatla Remediation Program

- Diesel generating station 1969 – 1990;
- Initial remediation conducted in 1996 (500m³);
- Elevated WT (approx. 1mbg);
- Oily sheen in ditches down gradient;
- Site assessment concluded large plume;
- Risk to human health and the environment;
- Initiated remediation entire plume 15,000m³.

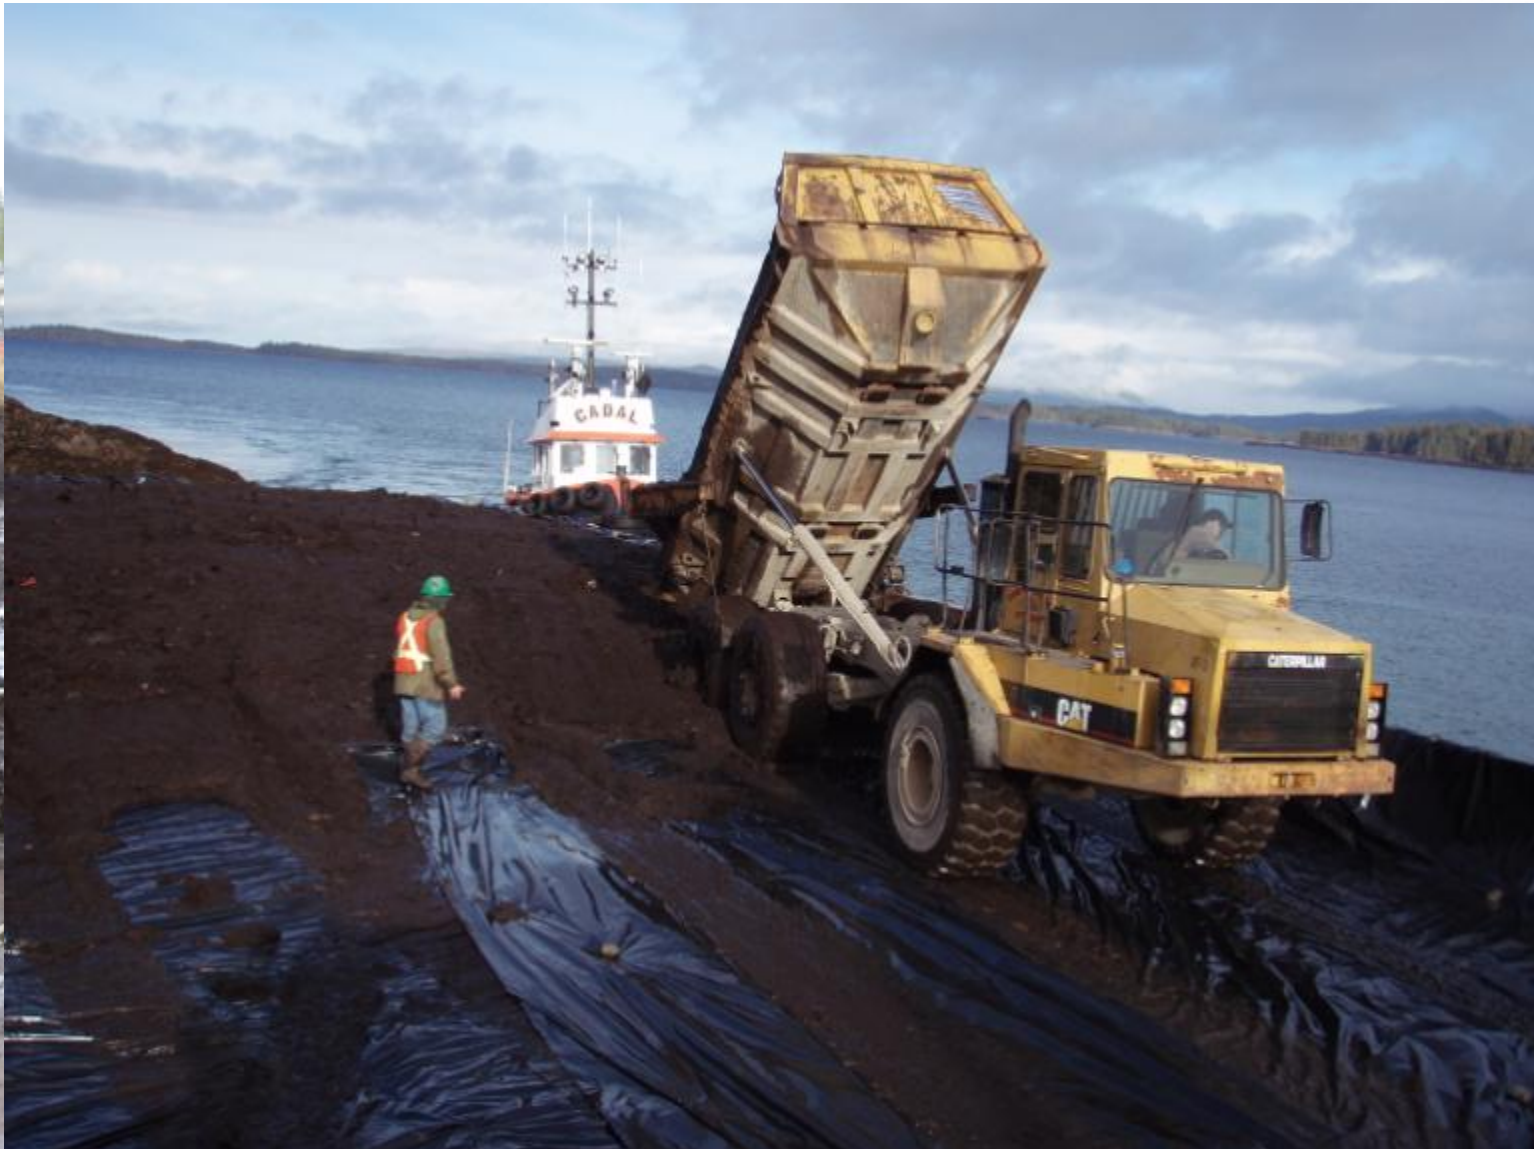
Remediation Program

- Soil and surface/groundwater;
- 11,500m³ of HC impacted soil;
- Surface and groundwater treatment;
- Excavation depth to bedrock (approx. 6.5mbg);
- 3m buffer surrounding church;
- Barging in and out;
- Adequate drainage channels;

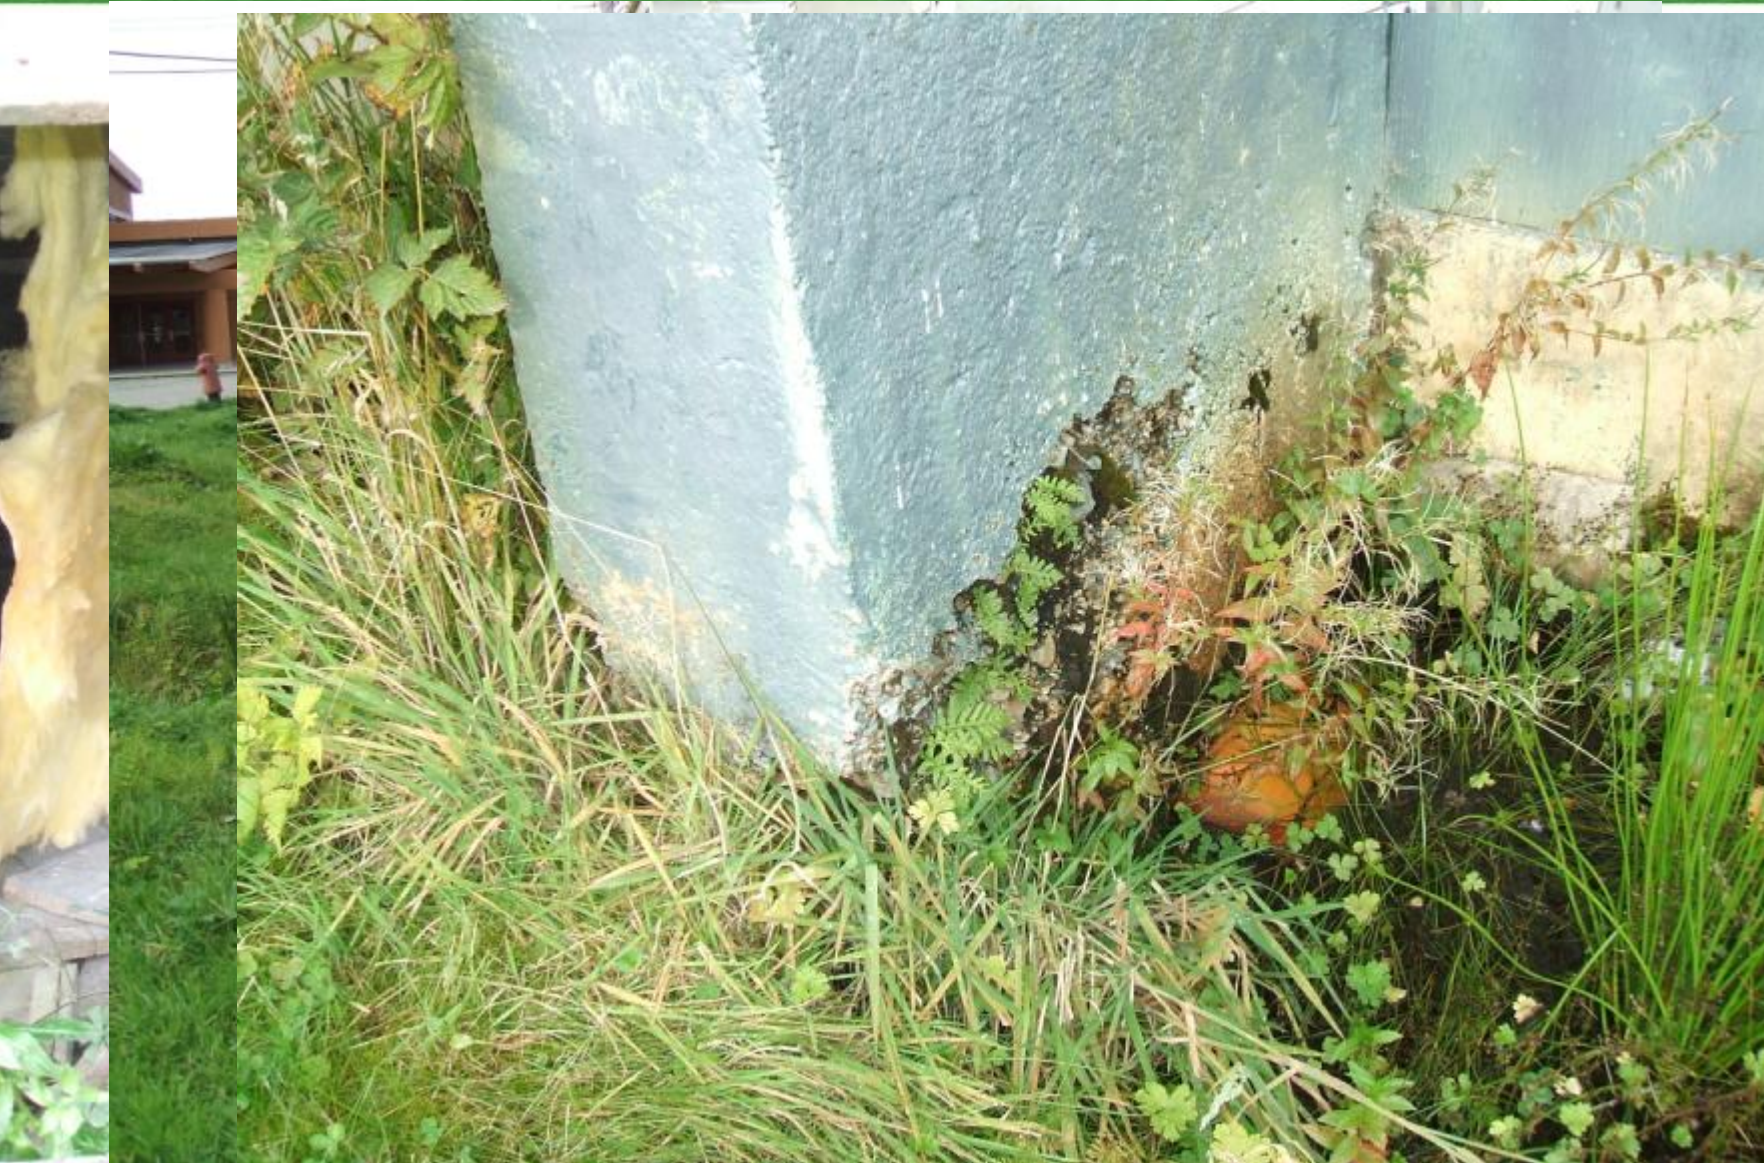
Investigation Outcomes

- No more odour/oily water, etc.;
- 3,500m³ of HC impacted soil surrounding church;
- Geotechnically unstable to excavate (unknown stability);
- Additional site investigations;
- Physical information for ongoing remediation;

- Option 1 – Excavate and support existing structure;

- Option 2 – Move church to new location;
