# **Case Study: Successful Remediation of Operating Service Station and Third-Party Properties at a National Park Townsite**

**Rob Micklethwaite and Elwyn Lyons**

**O'Connor Associates Environmental Inc.**

**October 15, 2009**

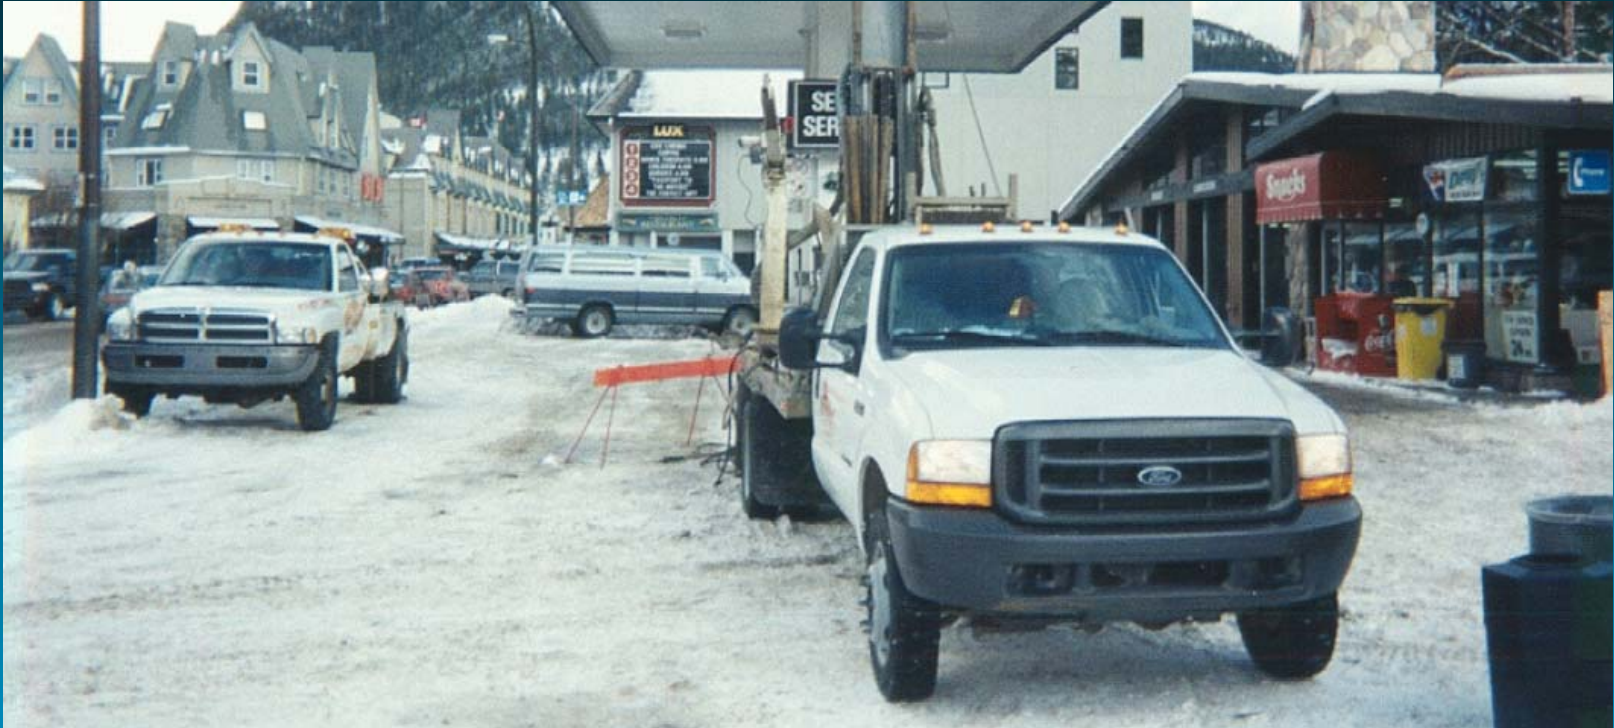
Looking east from near the west property line

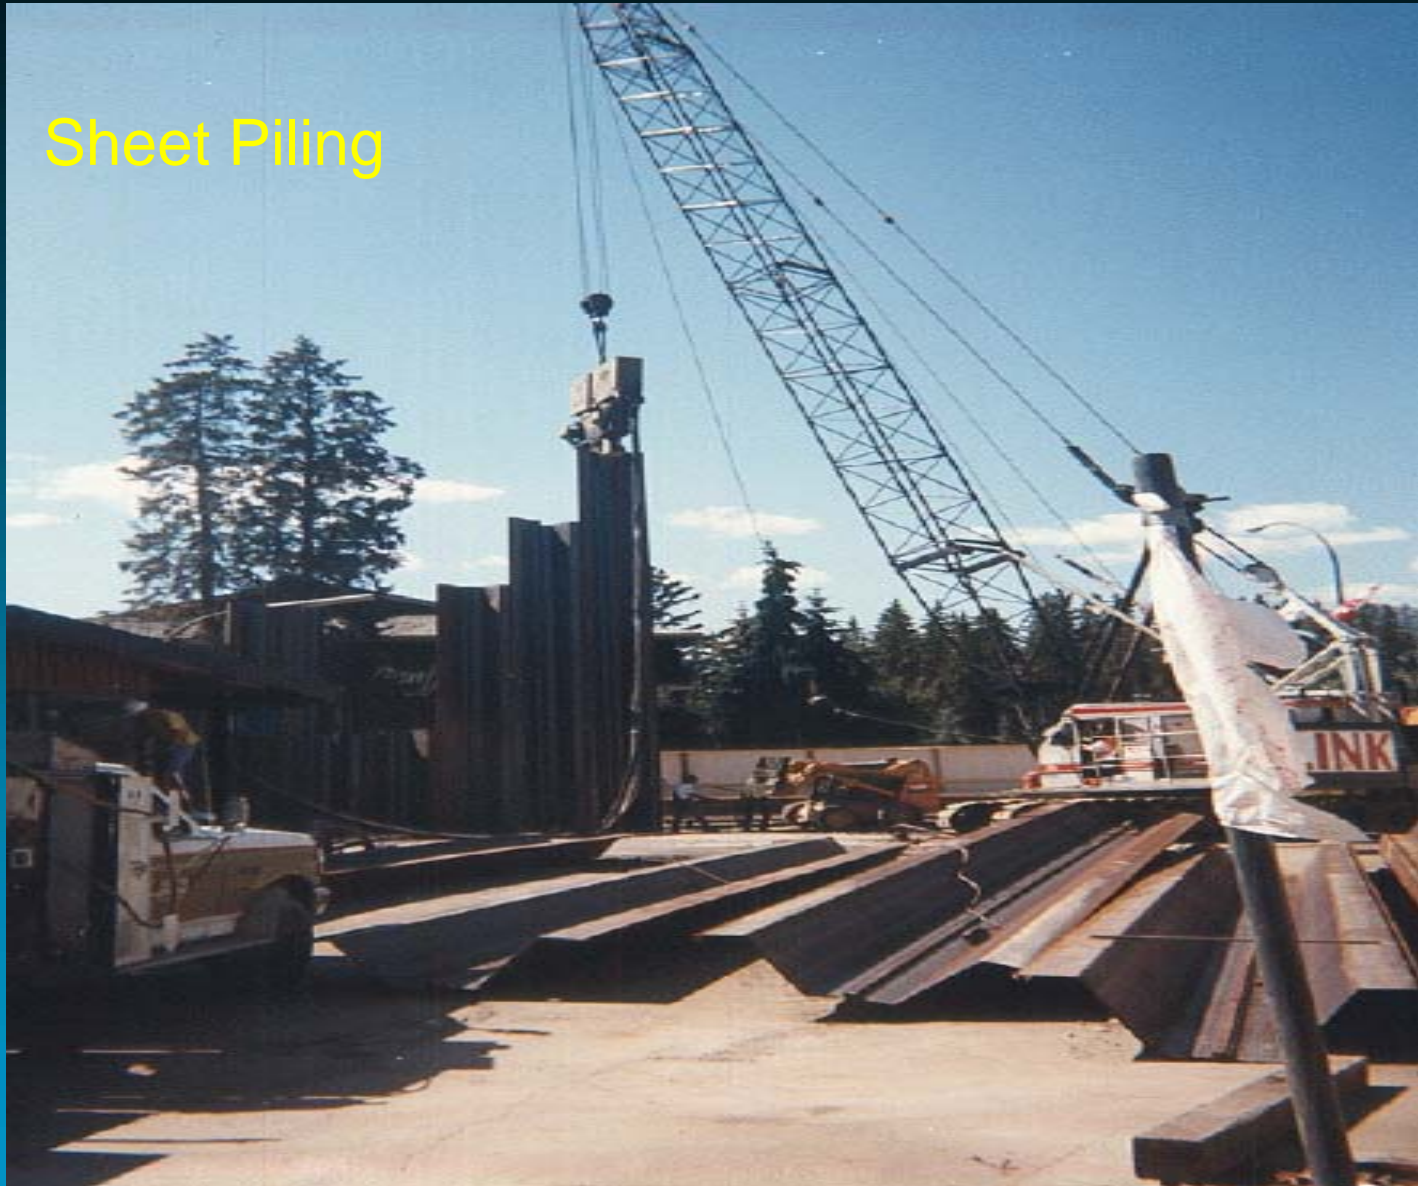
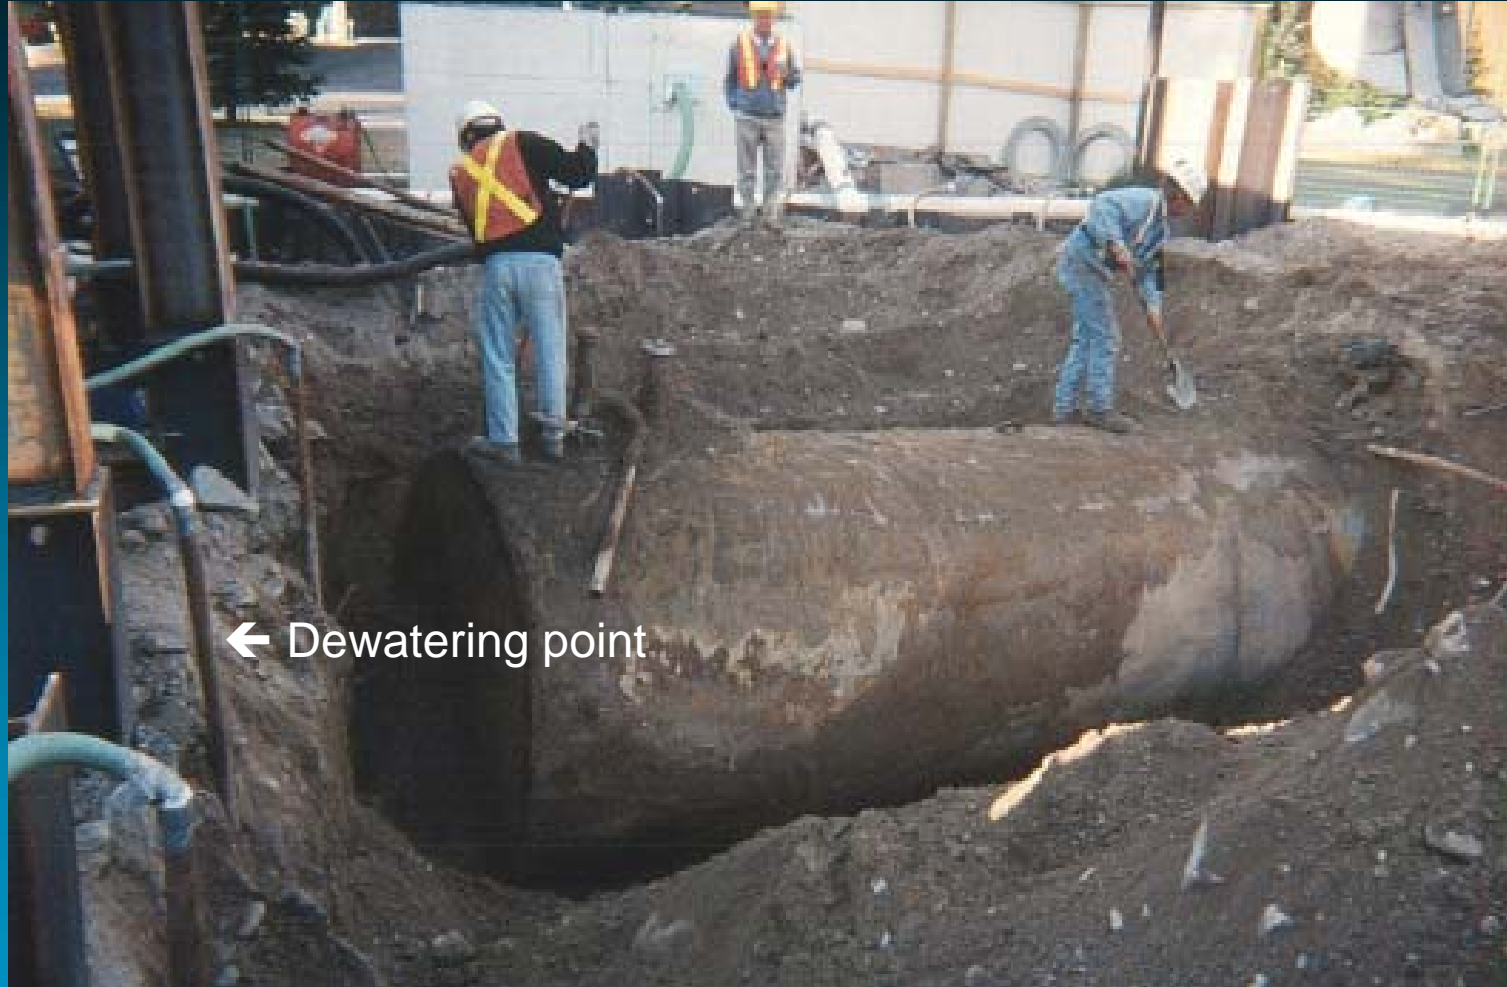
# Sheet Piling

← Dewatering point

Dewatering of the tank nest

- **used a mobile laboratory to establish “clean” base so Parks Canada could approve installation of new tanks**
- **deepest point of excavation was 4.8 m bgs, consistent with expectations**
- **1600 m<sup>3</sup> of petroleum hydrocarbon impacted soil removed outside the park boundary**

- **1700 m<sup>3</sup> of groundwater was treated using GAC and discharged to sanitary sewer**
- **Maximum flow rate of 180 L/min and average of 74 L/min (<<600 L/min), consistent with Groundwater Modelling predictions**

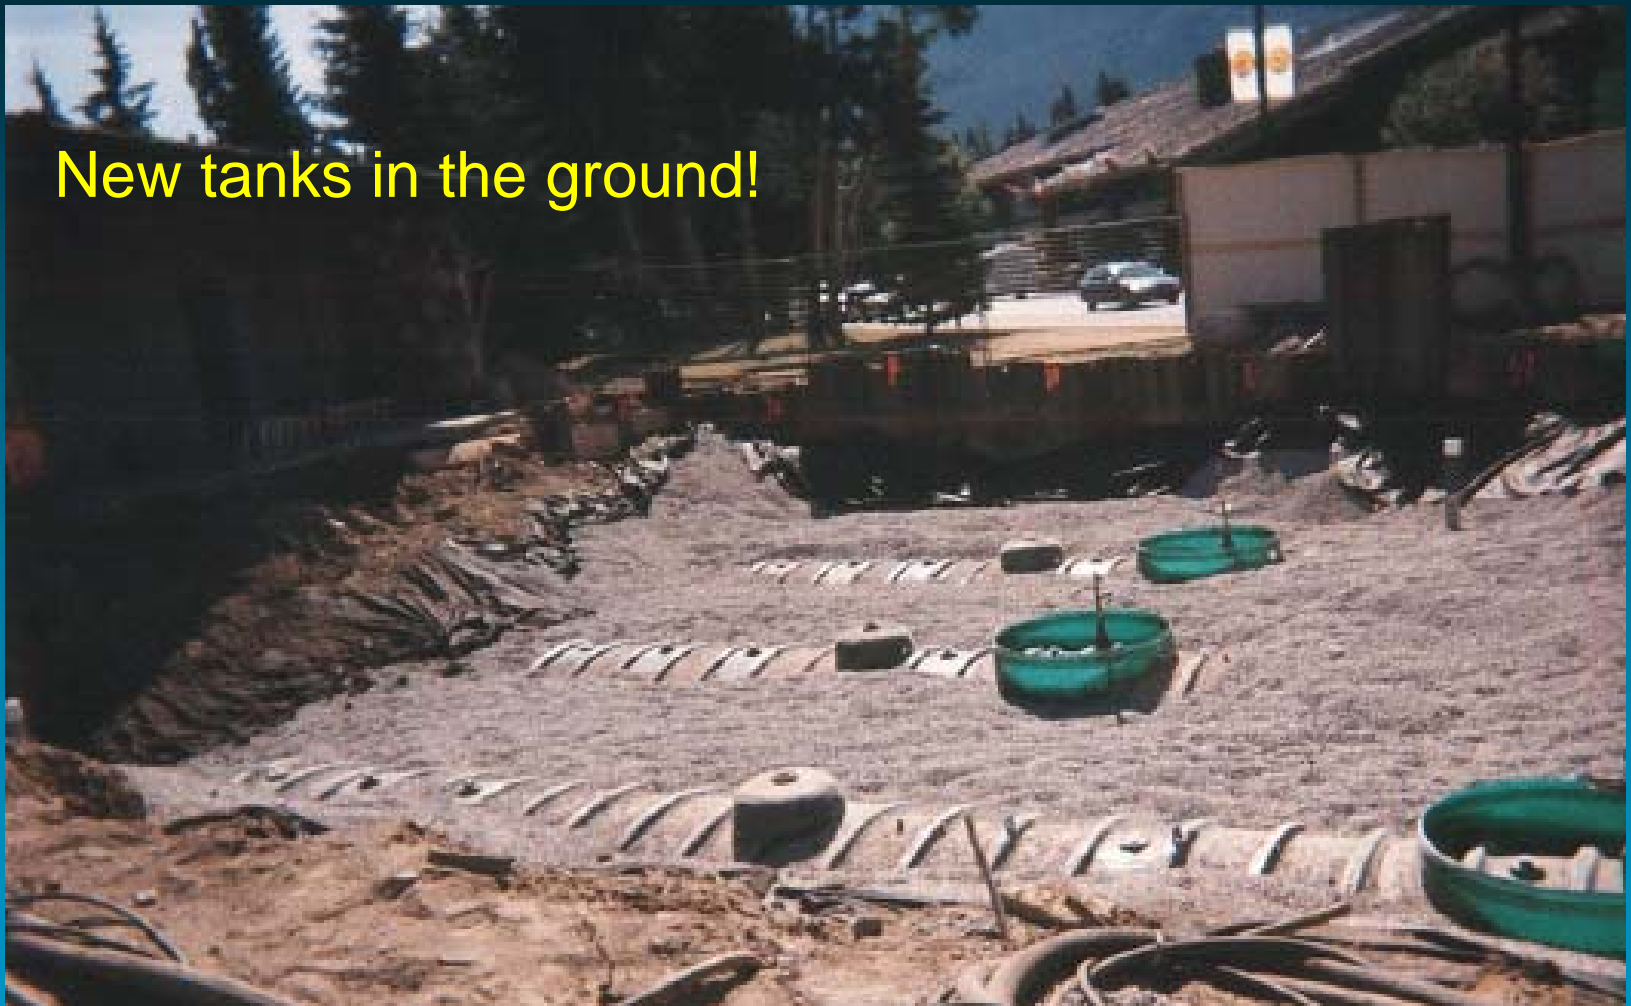
New tanks in the ground!

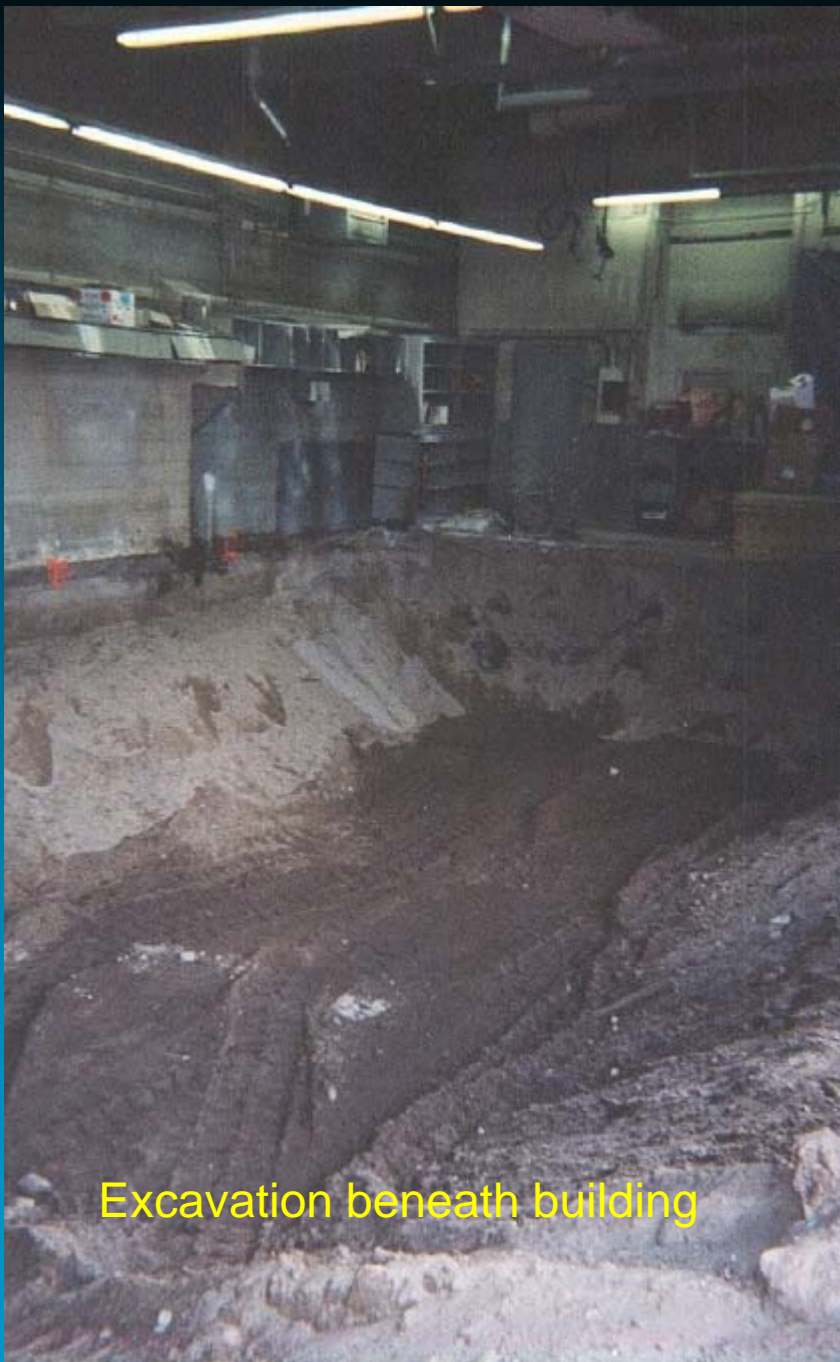
Excavation beneath building

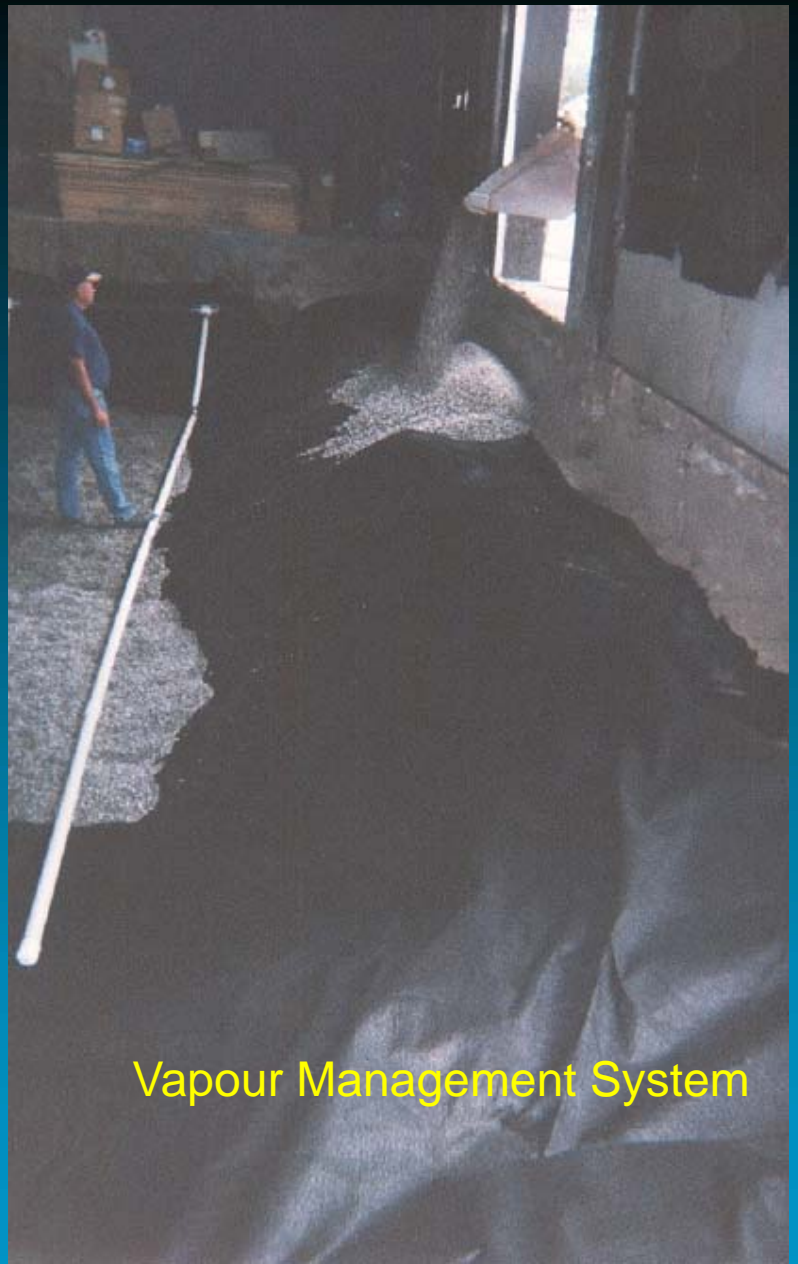
Vapour Management System

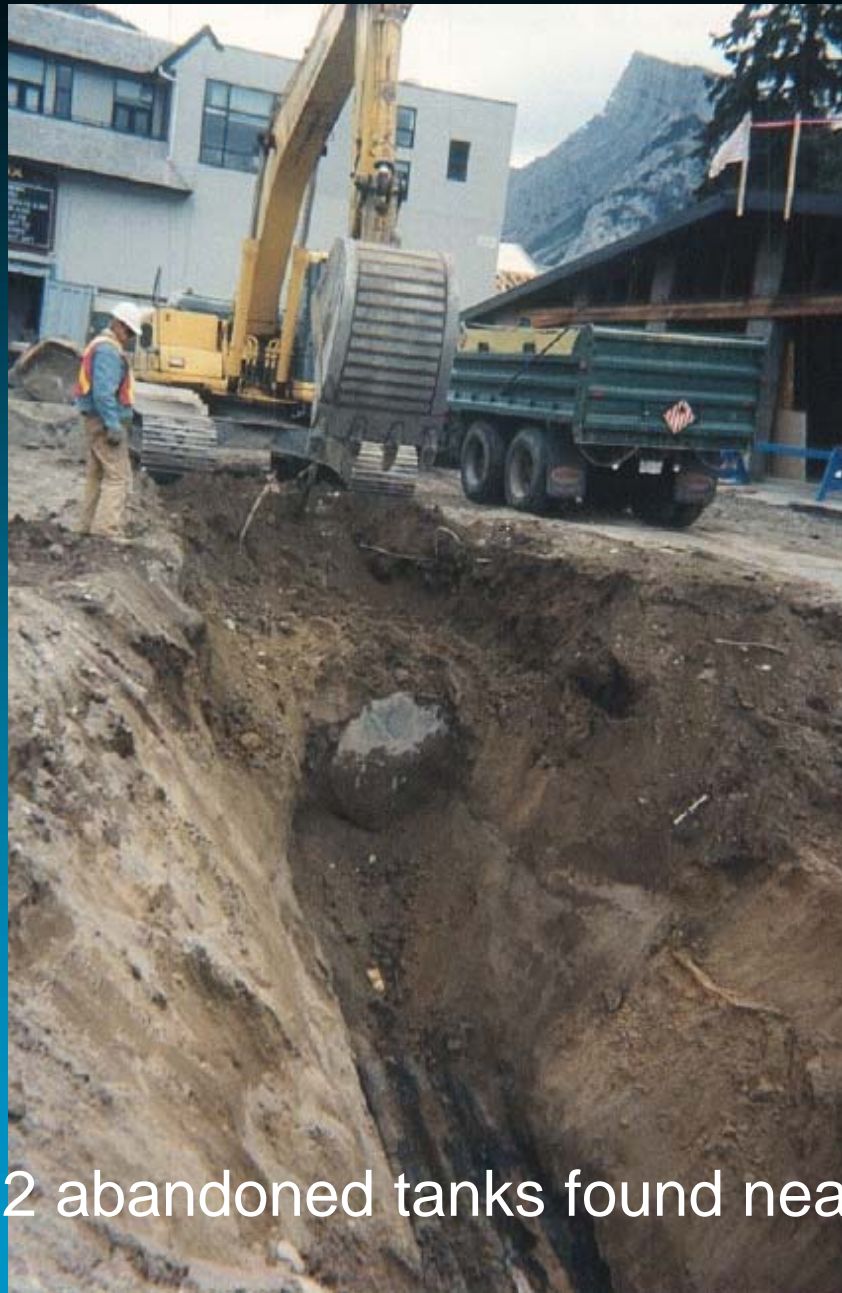
1 of 2 abandoned tanks found near pump island

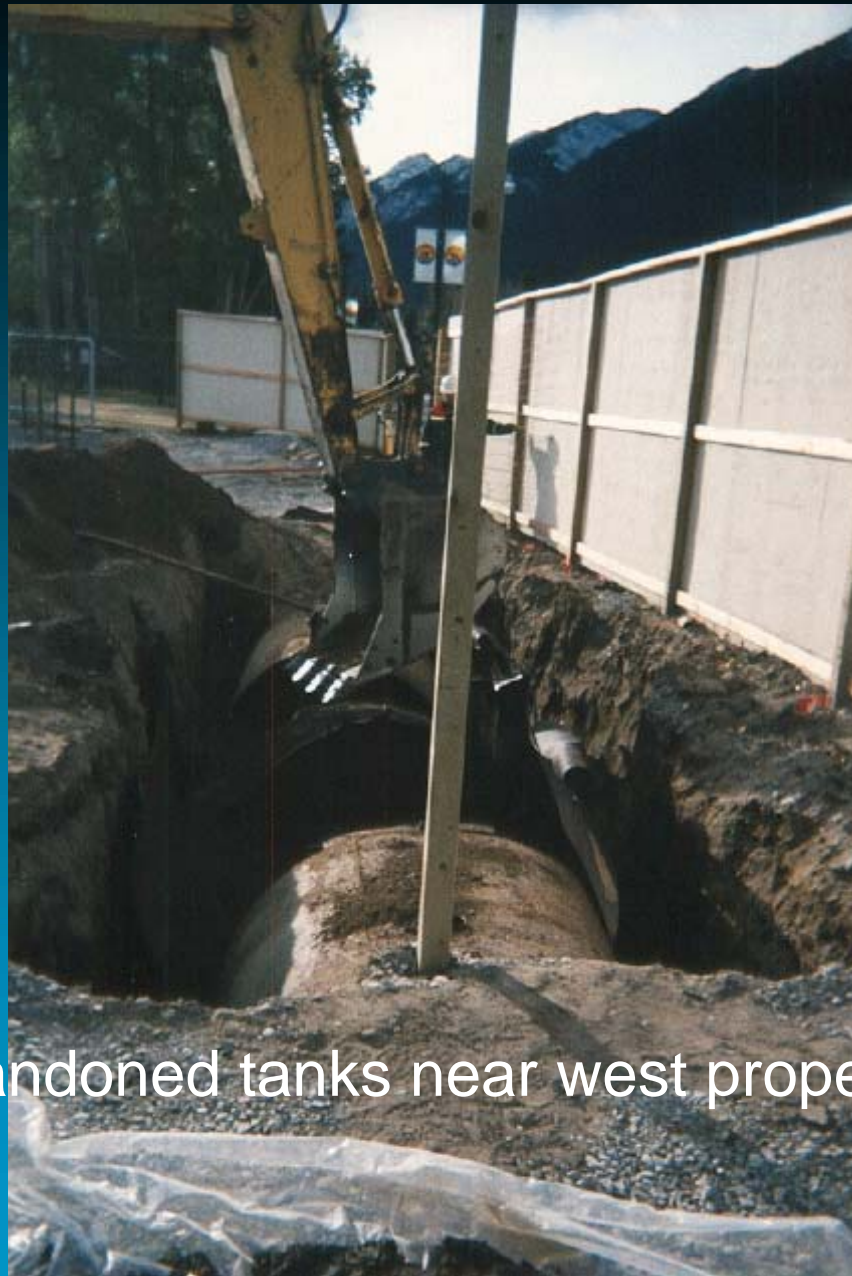
2 abandoned tanks near west property line

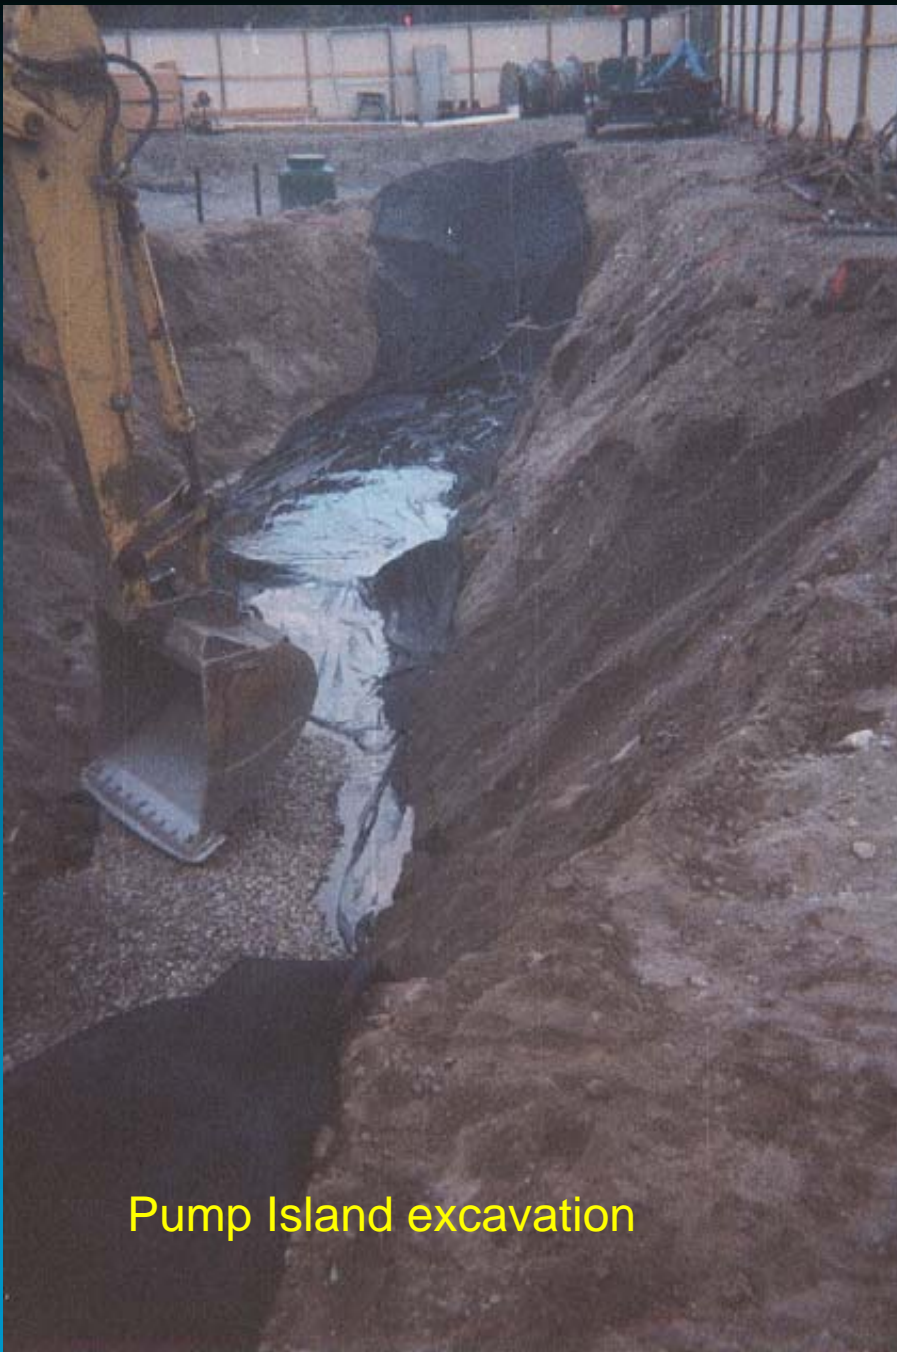
Pump Island excavation

- outside the shoring, confirmed excavation below the water table for soil remediation not possible
- backfilling required filter cloth followed by wash rock and pitrun gravel

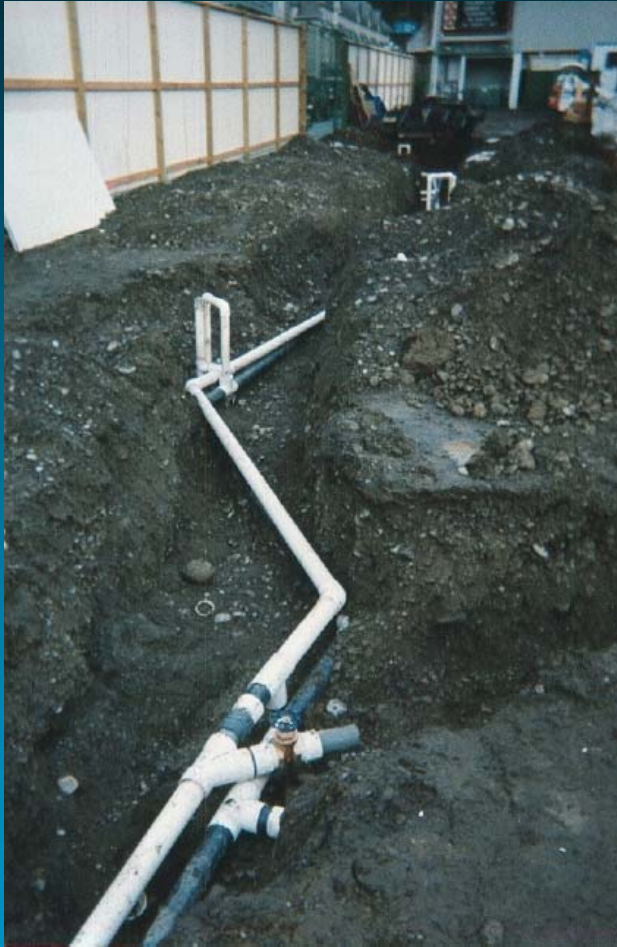
Piping north of new pump islands

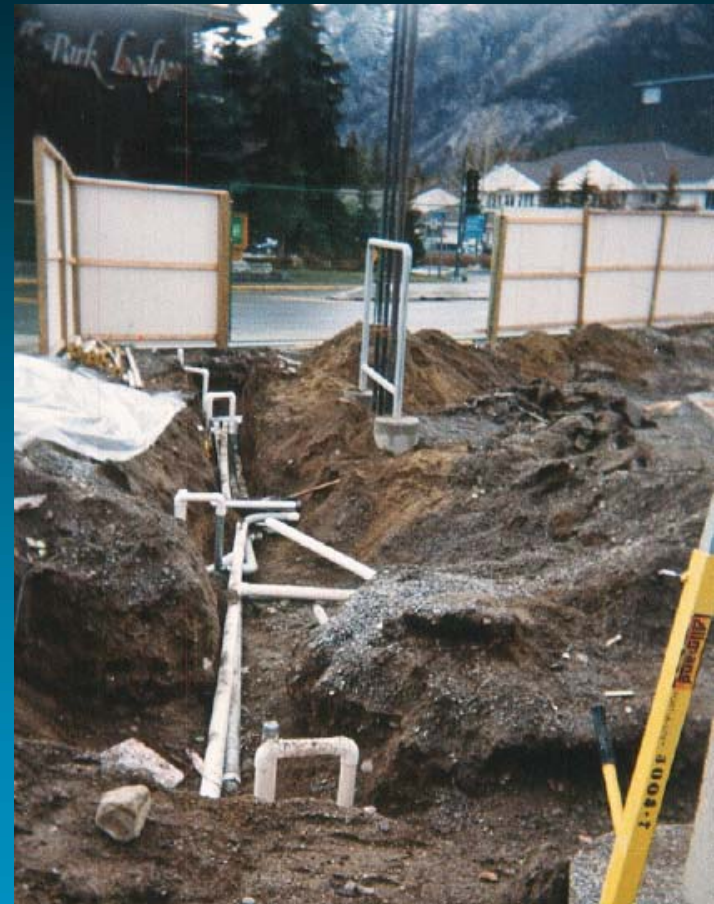
Piping near south property line and west of building
