# Case Study: A Multi-Phase Remediation Strategy for the City of Brandon's 1<sup>st</sup> & Rosser Site

Scott Chapman, M.Sc., P.Eng.

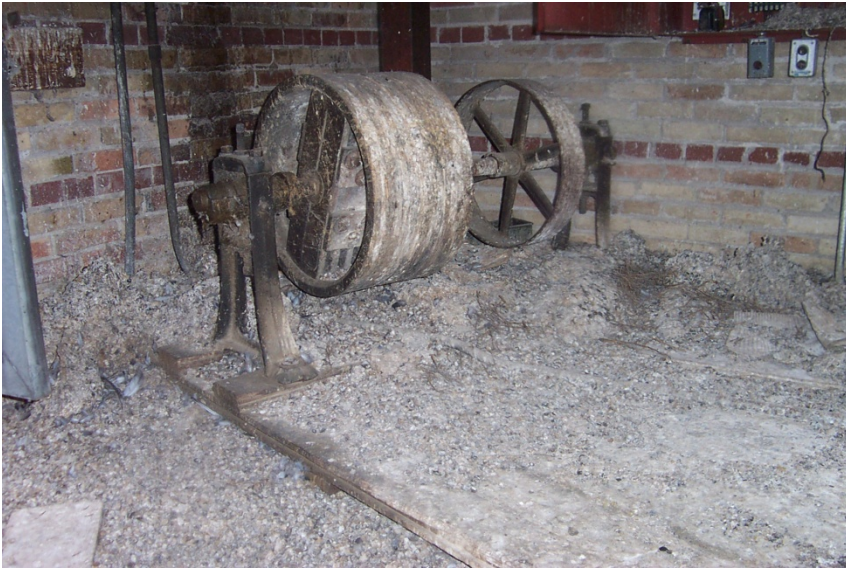
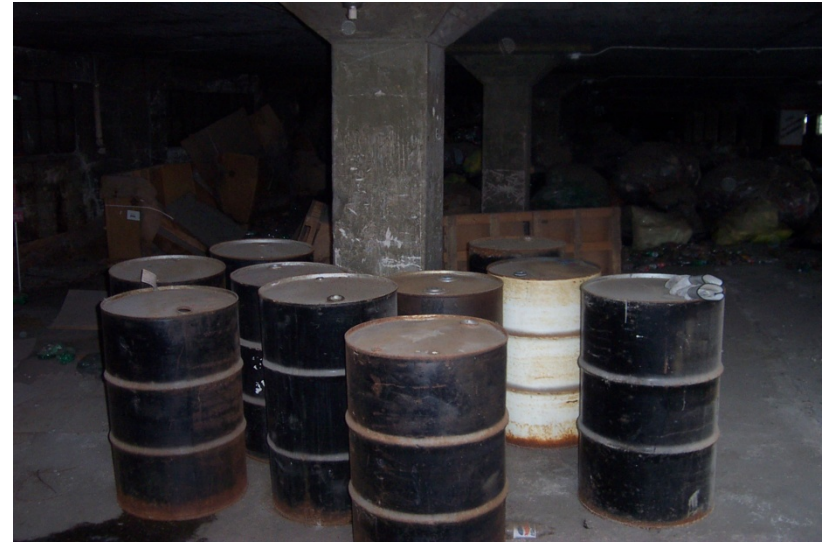
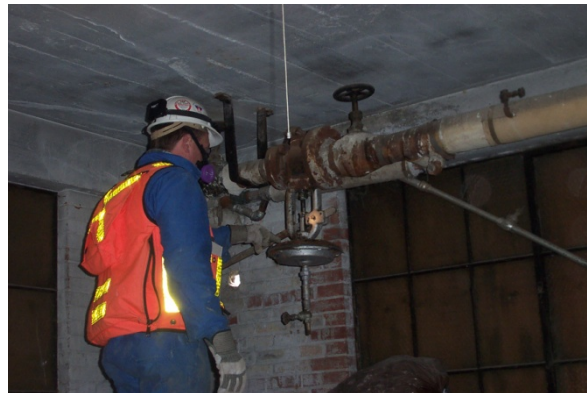
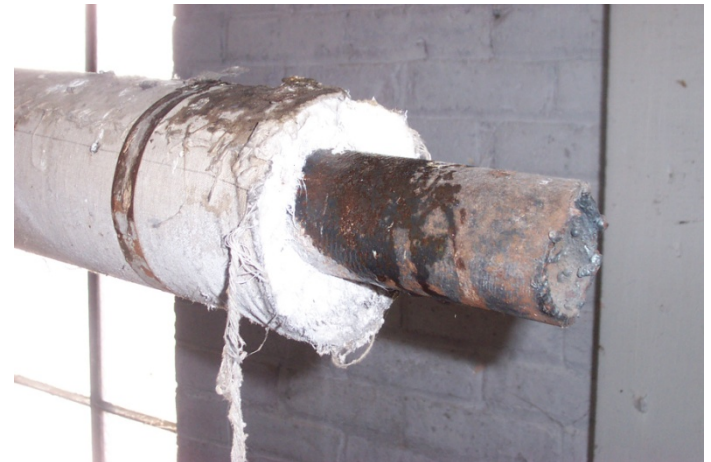
# Phase I ESA (2004)

- **Hazardous Material Assessment**
  - Bird droppings (hantavirus)
  - Asbestos
  - Lead paint
  - Drums

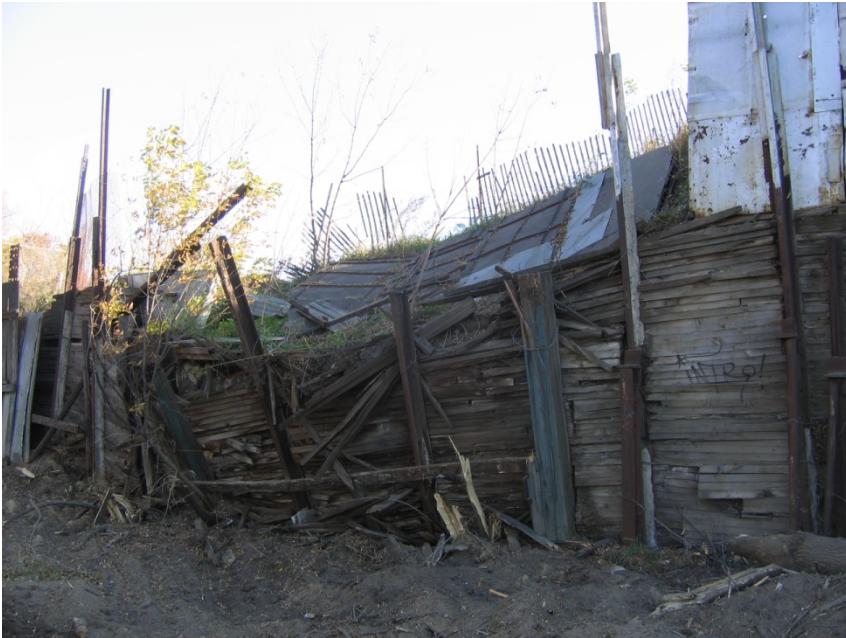
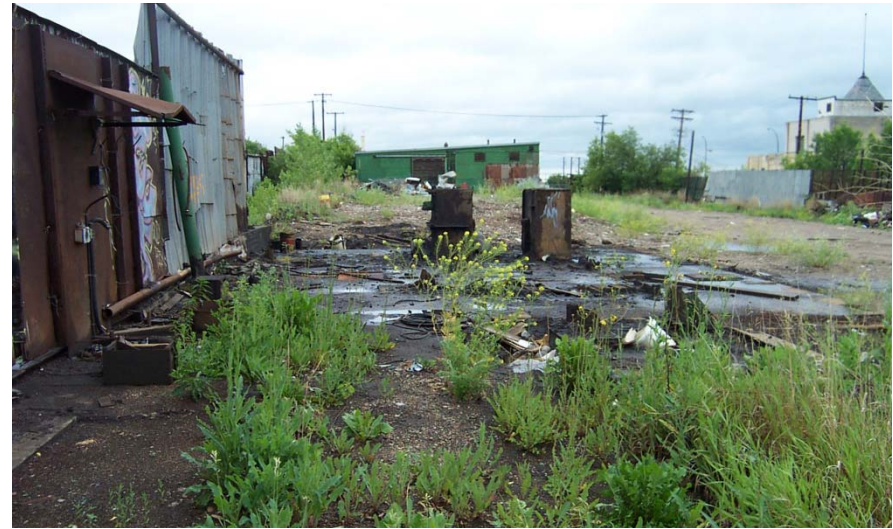
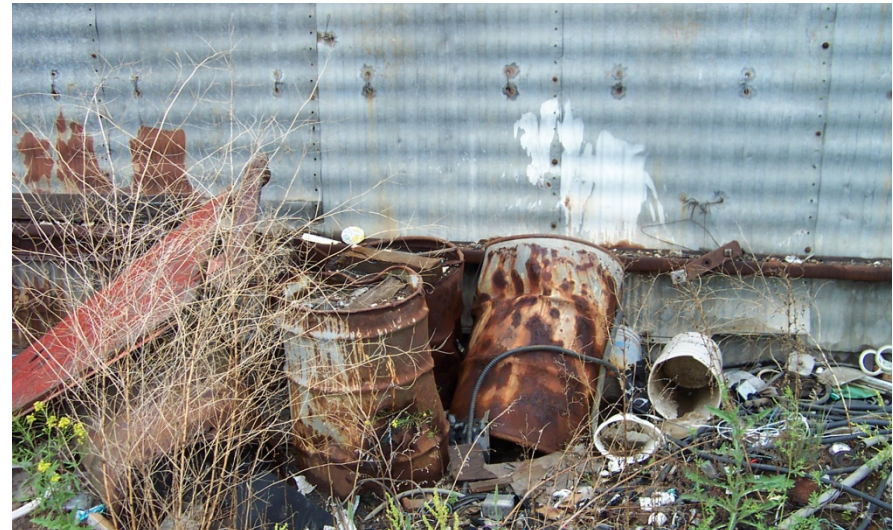
# Phase I ESA

- **Safety Issues**
  - Collapsing Fencing
  - Site Debris
- **Potential impacts to Soil and Groundwater (PHC, Metals, PAH)**

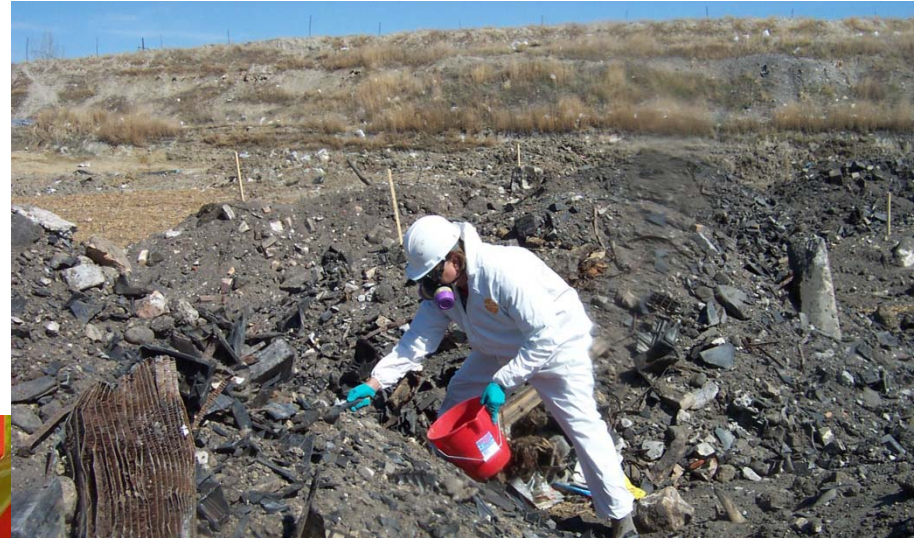
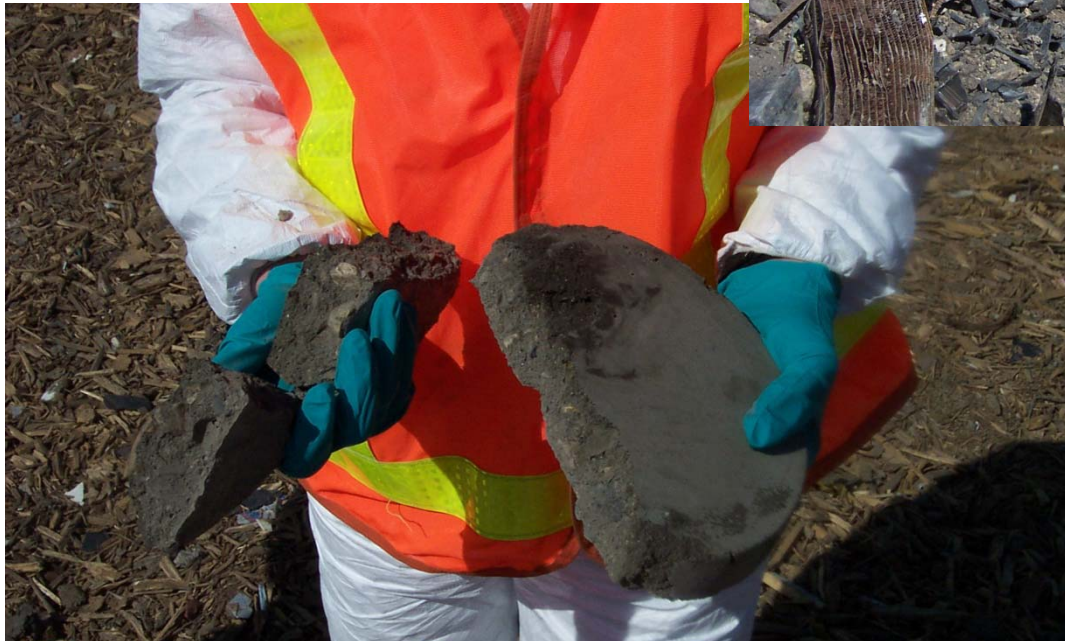
# Battery Casing Cache – Cement Stabilization

- Bench-Scale Testing
  - 10% Portland Cement
  - 15% Portland Cement
  - 20% Portland Cement

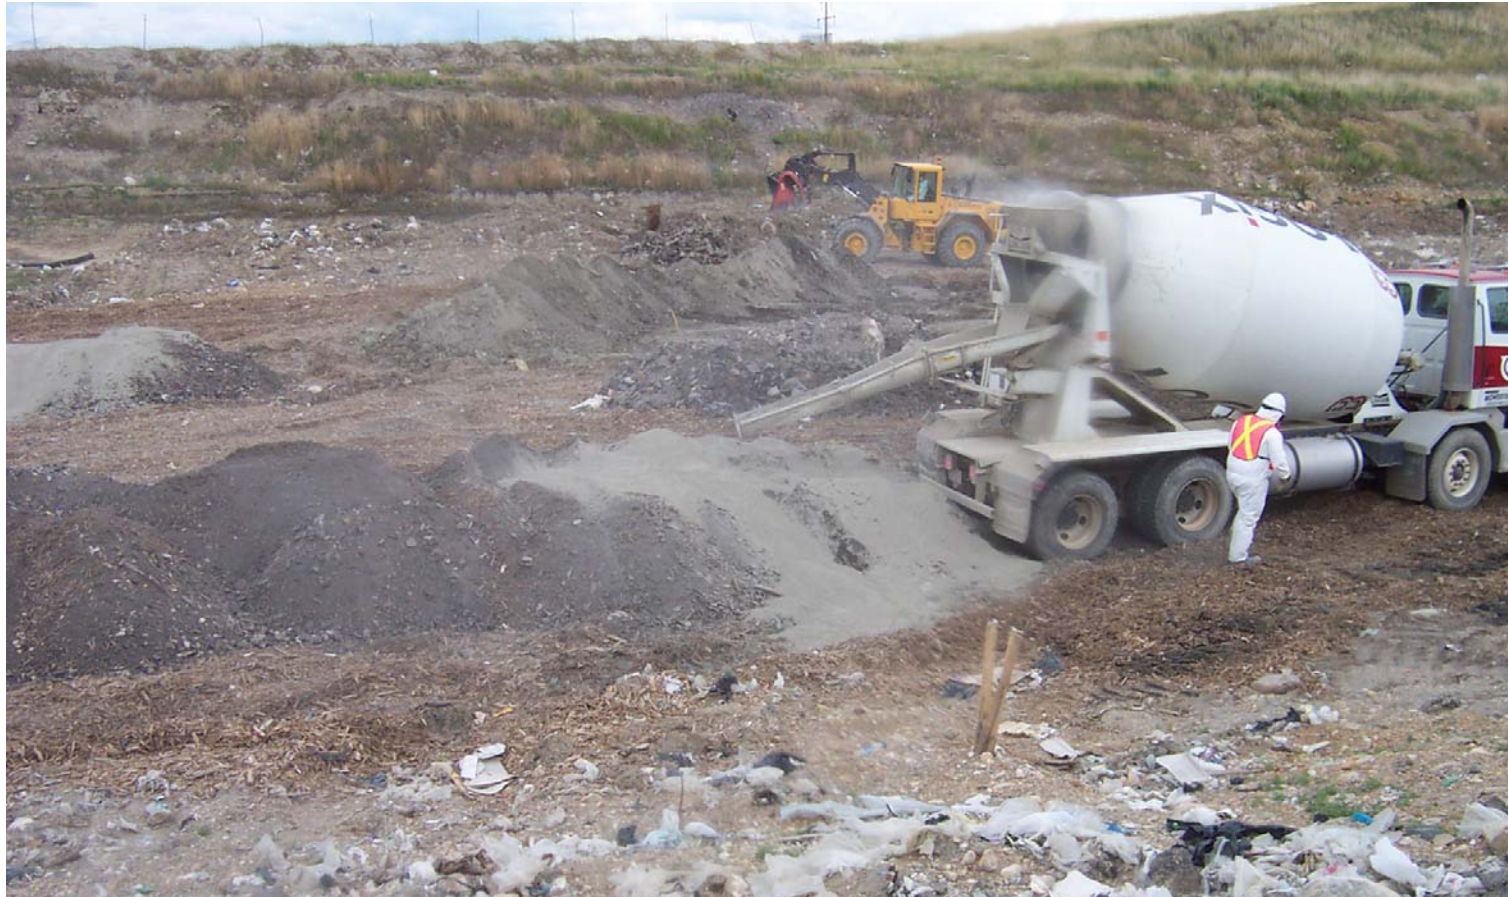
# Battery Casing Cache – 2005

- Pilot-Scale Testing
  - 600 tonnes

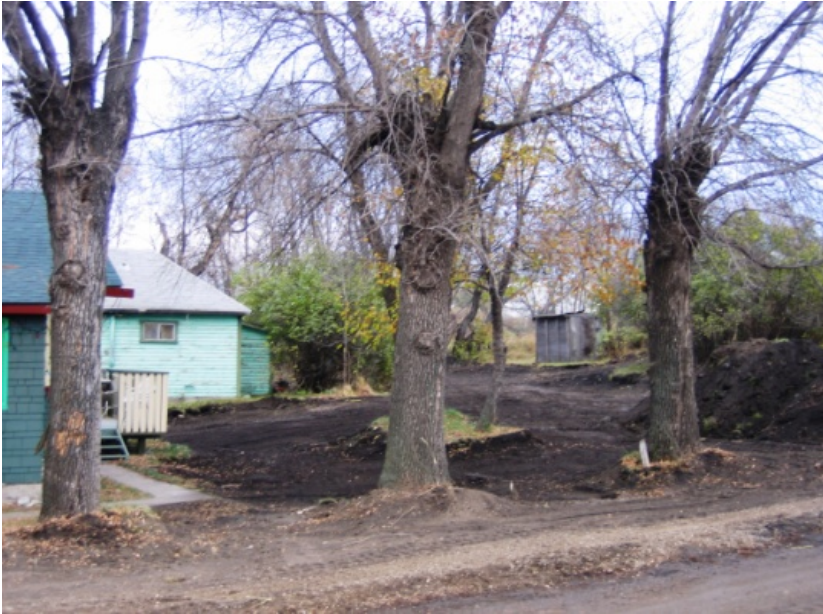
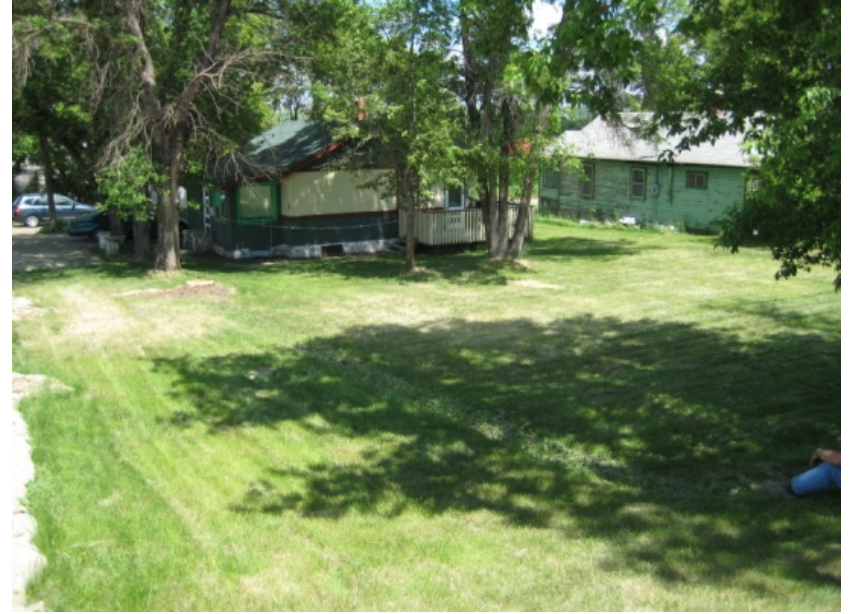
# Residential Remediation

- **Excavation of Surface Soil**
  - 30 cm depth based on site-specific soil quality guideline
  - soil contact/ingestion
