Canada Creosote Site Environmental Update Investigation Tom Jacklin, M. Eng., P. Eng.

October, 2010

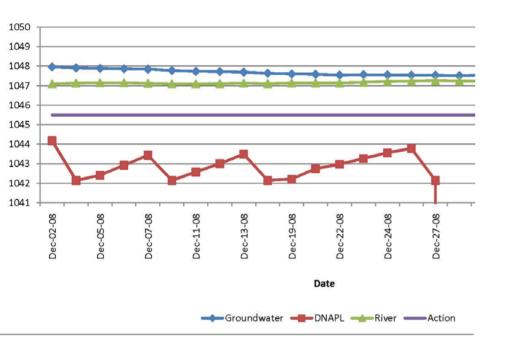
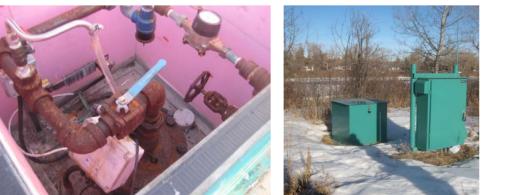
Dirty Well #4 - December 2008

A series of remedial actions were undertaken at the Site between 1990 and 1995.

Containment was selected as the management strategy.

A total of 640 m of low permeability barriers were installed through the alluvium into bedrock (slurry wall and secant pile wall).

Four (4) contaminated groundwater extraction wells south of barriers and seven (7) up-gradient clean groundwater extraction wells were installed.
