The Use of Nitrate as a Supplied Electron Acceptor to Sequentially Transition to Sulfate Reducing Conditions for Petroleum Hydrocarbon Degradation

Chris Mathies, P.Eng. – Stantec Consulting Ltd.

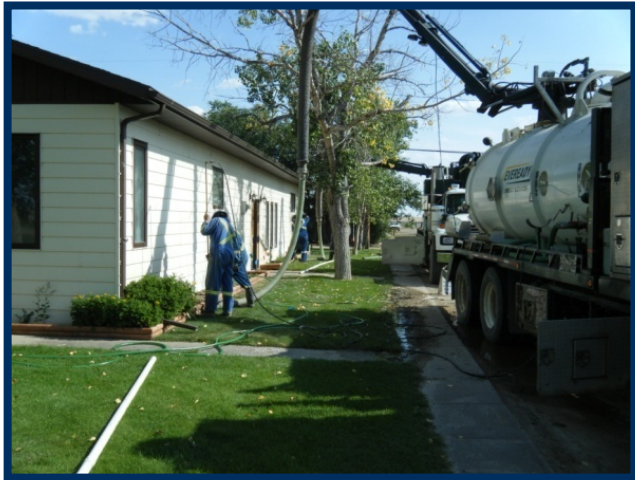
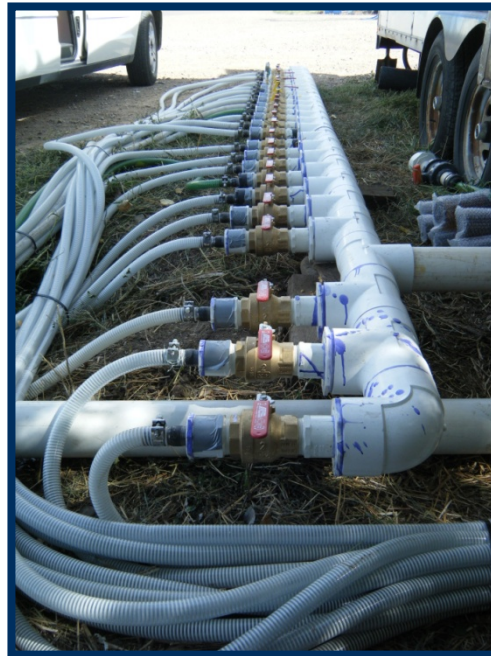
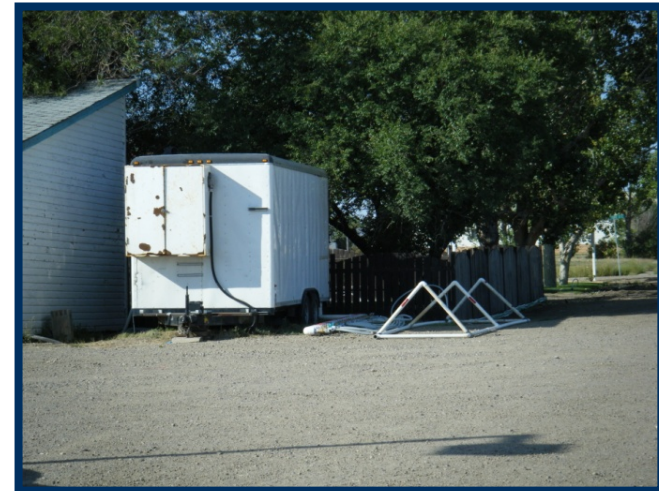
Implementation

- The MPVE system operated for approximately 45 days and recovered approximately 10,000 L of hydrocarbons, which was primarily in the vapour phase.
- Recovery rates declined from approximately 65 L/hr to 3 L/hr, at which time the physical recovery methods were discontinued.

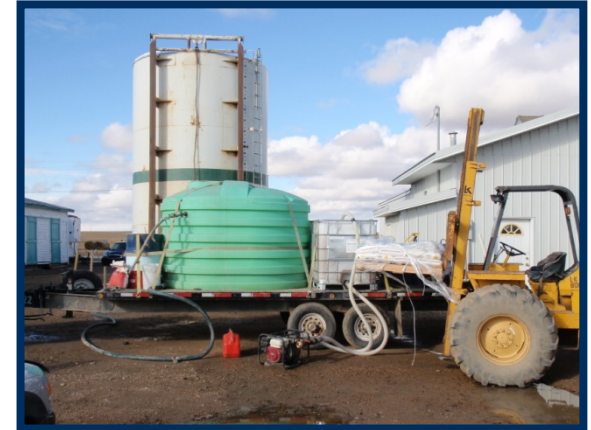
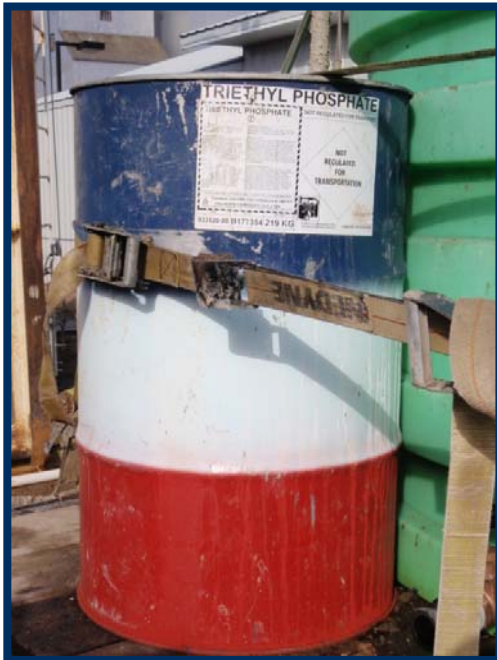
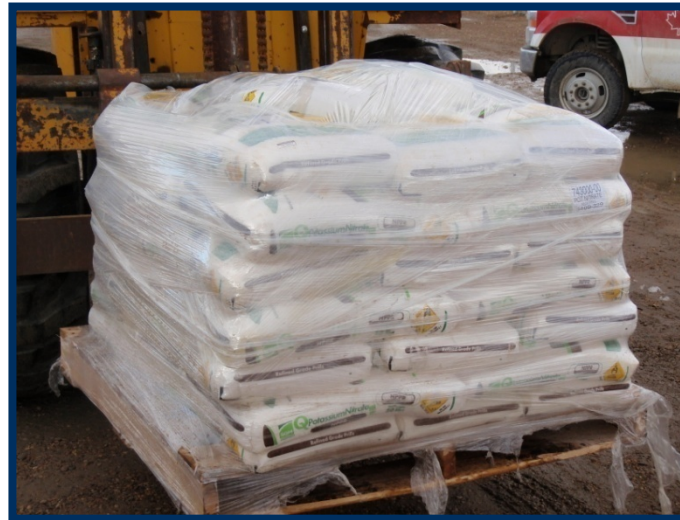
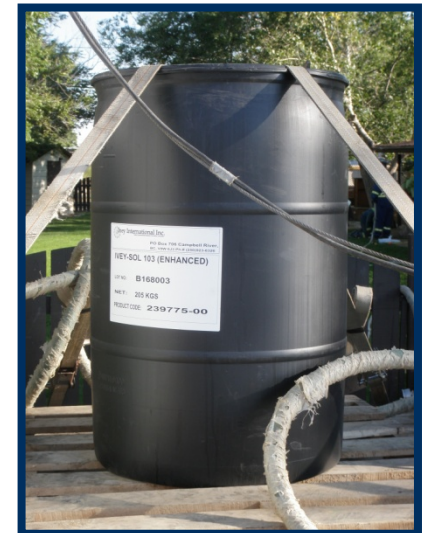
Implementation

The following amendments were injected once the physical recovery methods were discontinued:

1. 1,150 kg of Potassium Nitrate (KNO_3)
2. 205 kg of Triethyl Phosphate ($(\text{C}_2\text{H}_5)_3\text{PO}_4$)
3. 1,000 L of Surfactant Solution.

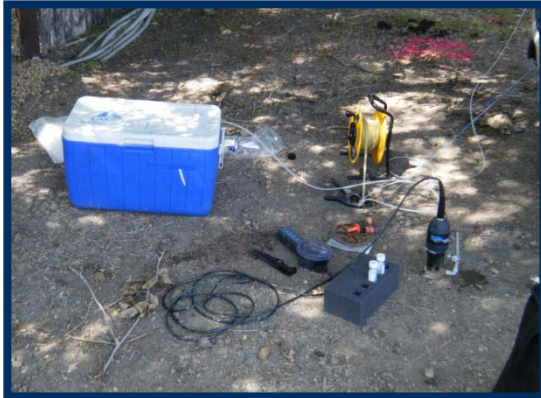
Results and Interpretation

Additional soil and groundwater investigations were conducted in late July 2010 to evaluate the remediation progress.

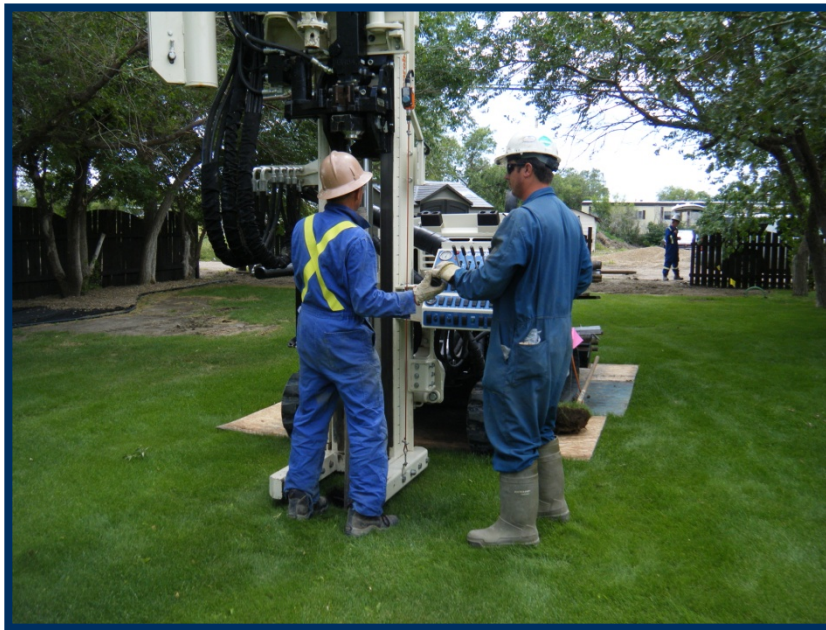
- Borehole S10-01 was drilled approximately 1 m away from S09-04.
- Soil samples were collected from the direct push core which exhibited the most significant impacts.
- Significant removal efficiencies were identified.

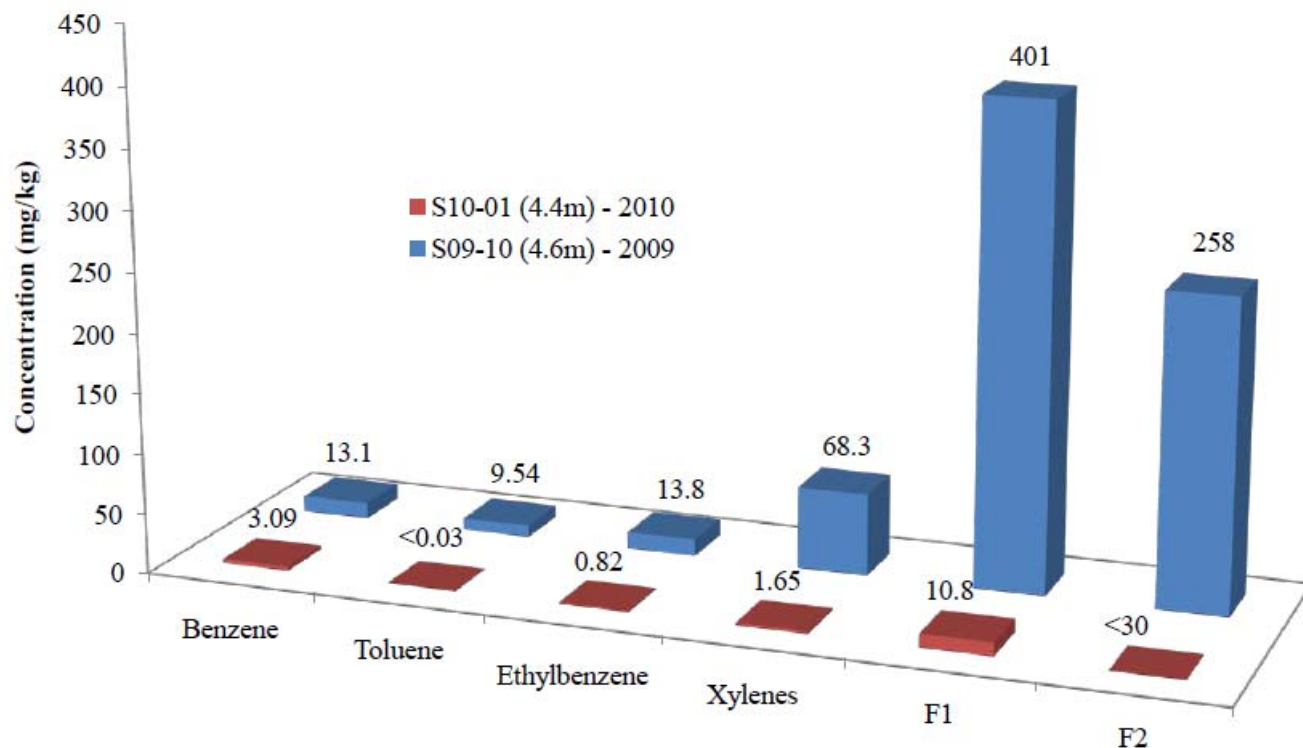
- Borehole S10-02 was drilled approximately 1 m away from S09-10.
- Results were similar to S09-04, with significant removal efficiencies identified.

Removal Efficiencies

B – 76%
T – 99%
E – 94%
X – 98%
F1 – 97%
F2 – >88%

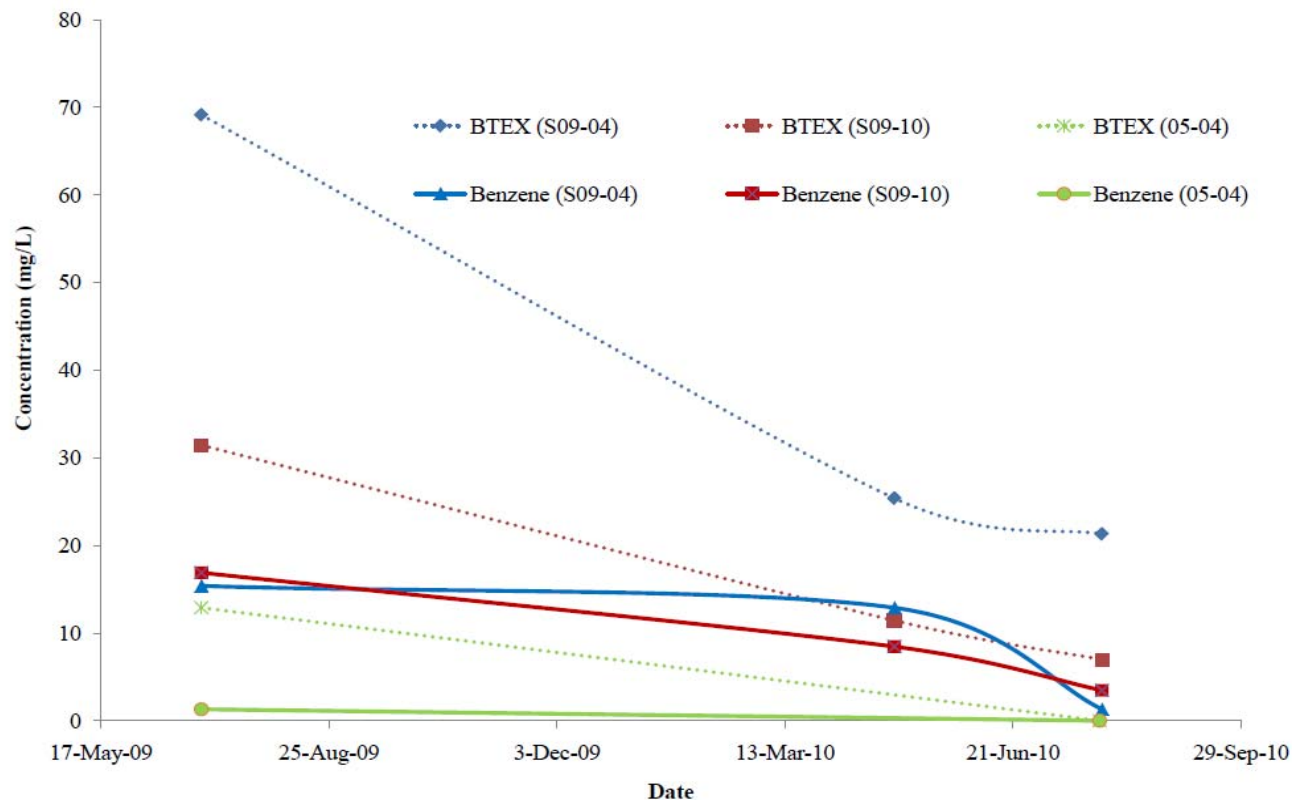
- Groundwater samples were collected from three monitoring wells.
- A groundwater samples was also collected from a monitoring well installed in the basement of the residential house, which confirmed BTEX concentrations were low. Benzene was detected at 0.07 mg/L.

Removal Efficiencies

BTEX – 69% to 99%

Benzene – 80% to 99%

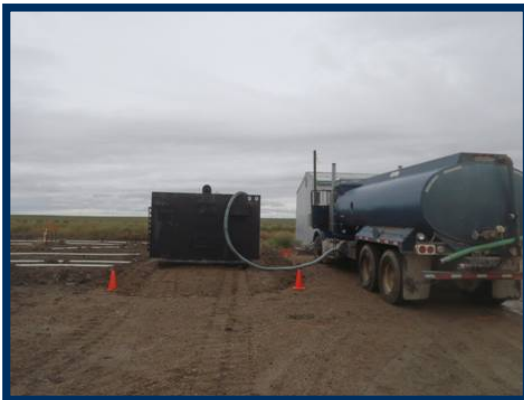
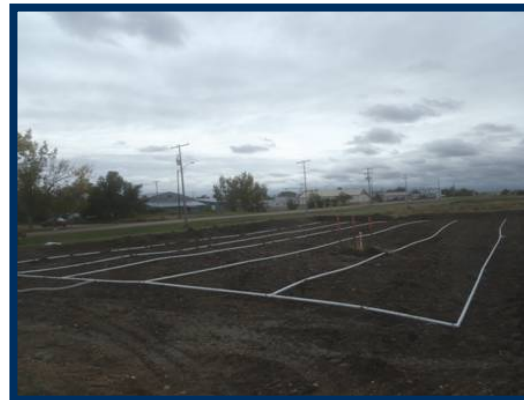
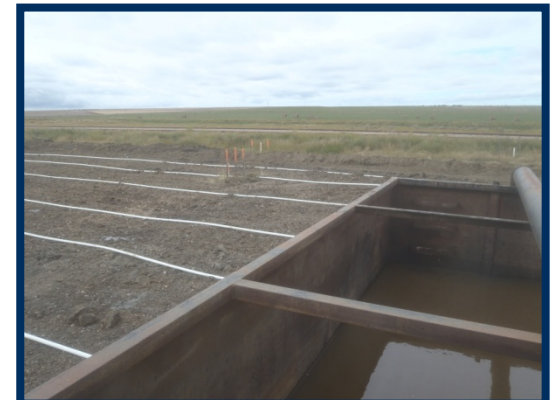
The remediation program has been expanded to build off the recent successes and optimize other aspects.

- A MPVE system is currently operating on the Service Station property to reduce the hydrocarbon mass.
- Recovered water is treated throughout the MPVE system (approximately 500 L to 1,000 L per hour) and is transferred to the Bulk Fuel Facility and surface applied across a cultivated plot area.
- The irrigated water is supplemented with phosphorus (triethyl phosphate and phosphoric acid) to provide the required macronutrient.
- Potassium nitrate is being surface applied to act as a supplied electron acceptor, in addition to the naturally existing sulfate which will be used as a terminal electron acceptor.
- The irrigated water and existing groundwater contains elevated sulfate to be used as a terminal electron acceptor.
