# DND YARROWS SHIPYARD REMEDIATION

## CHALLENGES IN BARRIER WALL CONSTRUCTION AND SITE REMEDIATION ON ESQUIMALT HARBOUR

CFB Esquimalt  
Victoria, British Columbia

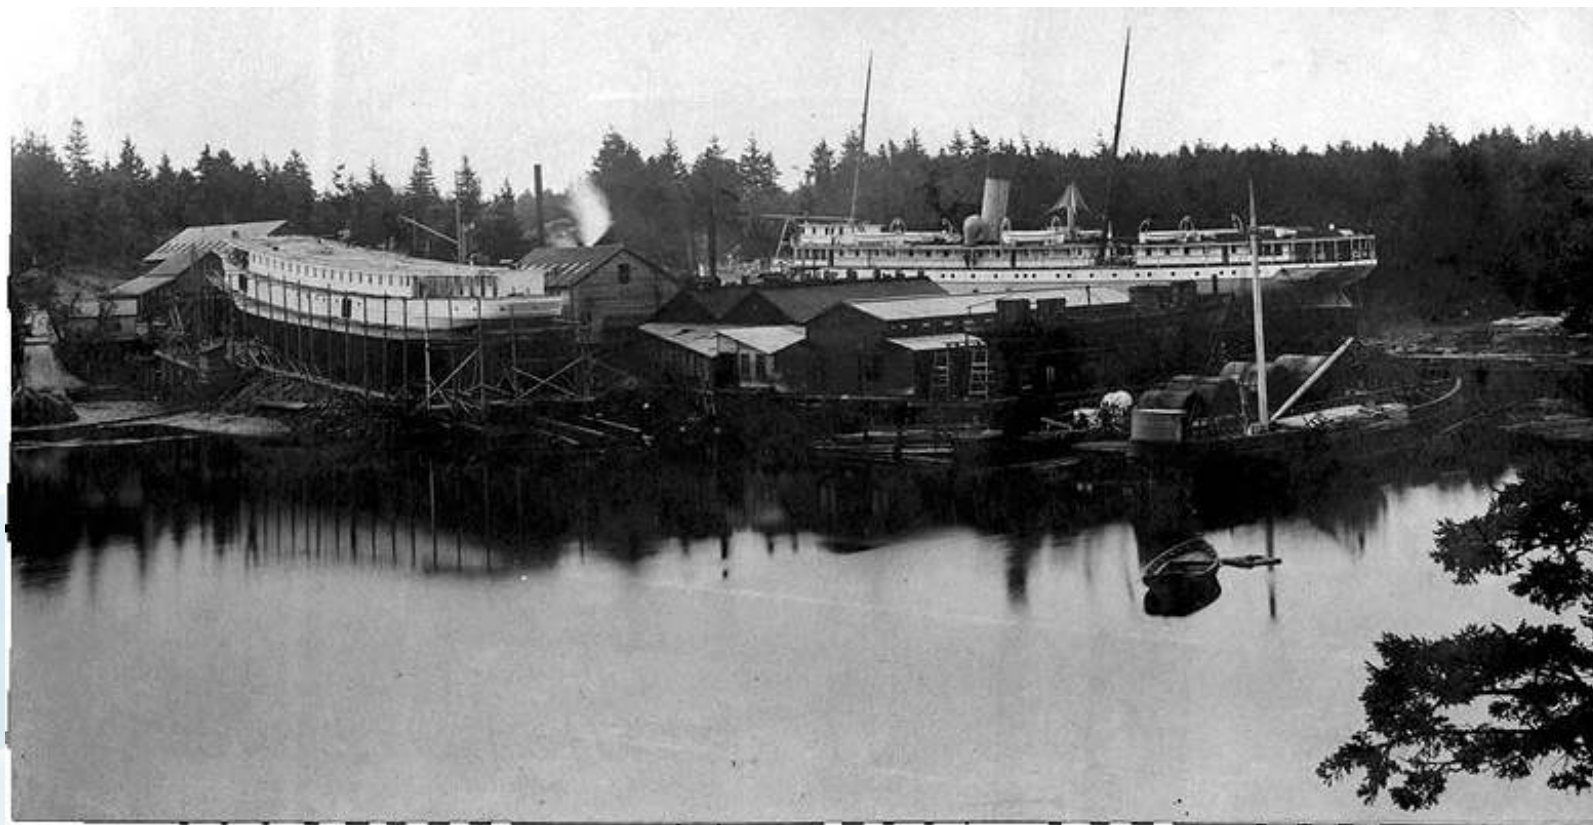
Yarrows Shipyard- Circa 1921

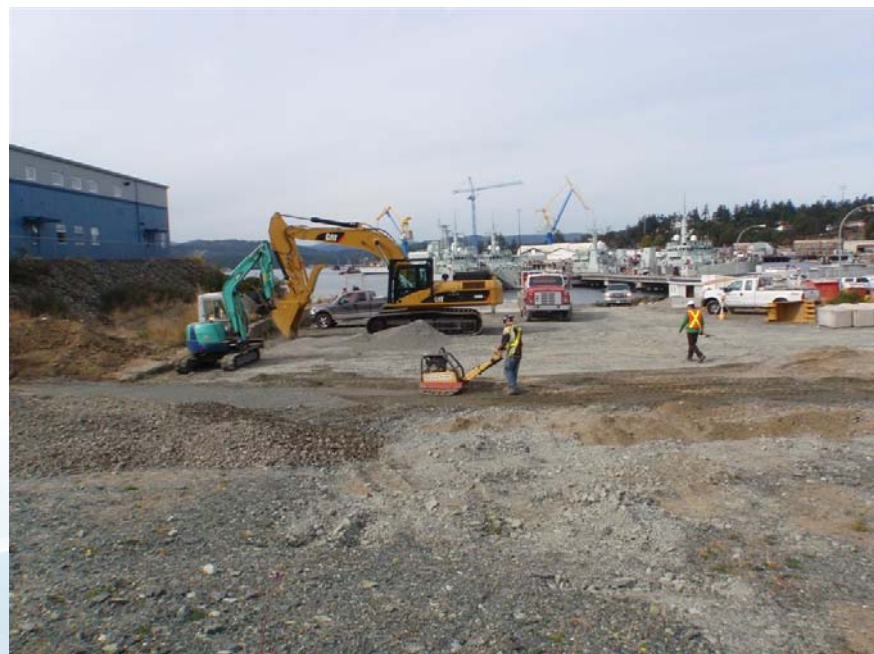
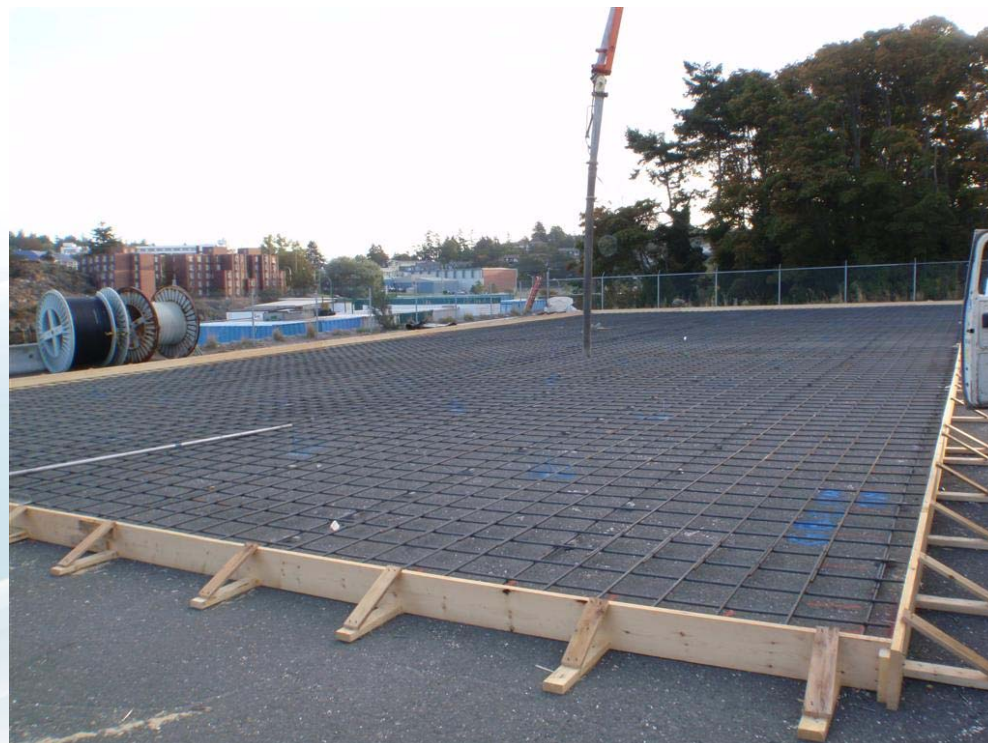
# LAYDOWN AREAS - YARROWS

- Construction of three laydown areas for site material.
- Construction of a barrier wall around the perimeter of the site
- Remediation of contaminated fill below the historic 1924 shoreline.
- Site restoration.

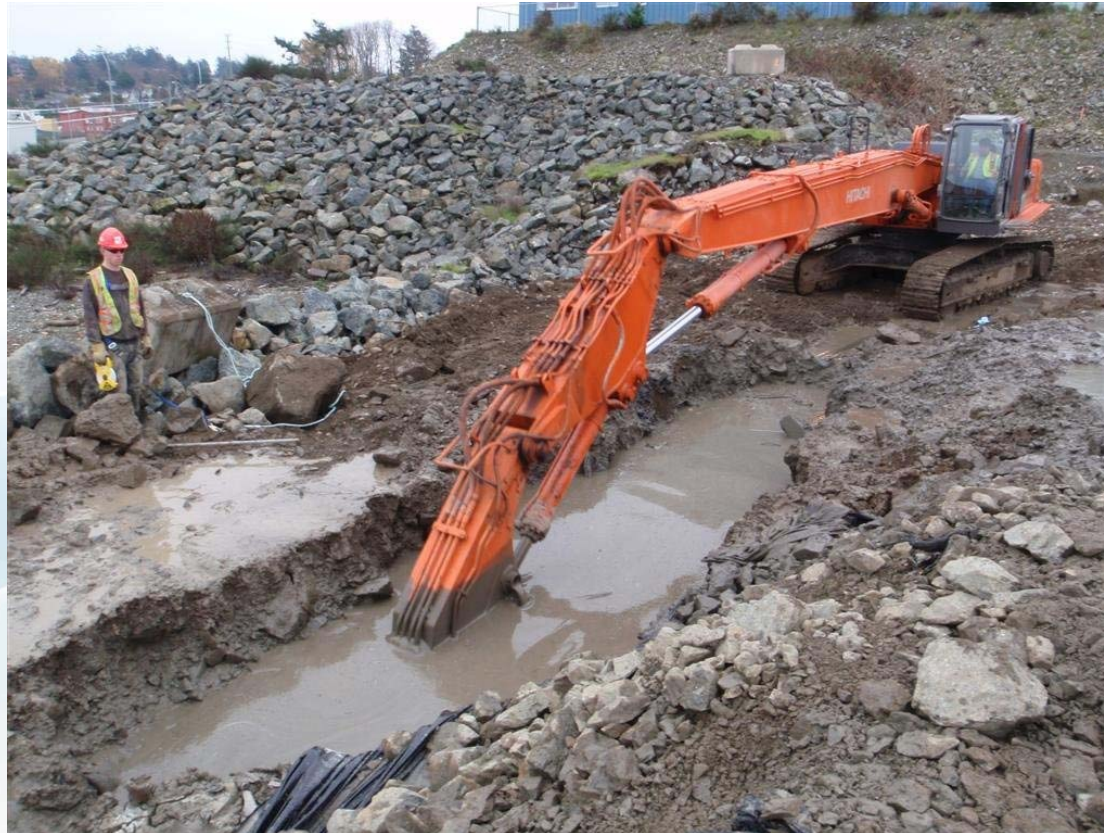
# BENTONITE SLURRY WALL CONSTRUCTION

- The barrier wall was constructed using two different methodologies:
  1. Bentonite Slurry Wall was used in areas where bedrock was closer to the ground surface.
  2. Secant Pile Wall was used in deeper excavation sections.
- Prior to wall construction the top 3 m of fill and concrete was removed to minimize the constructed wall depth.

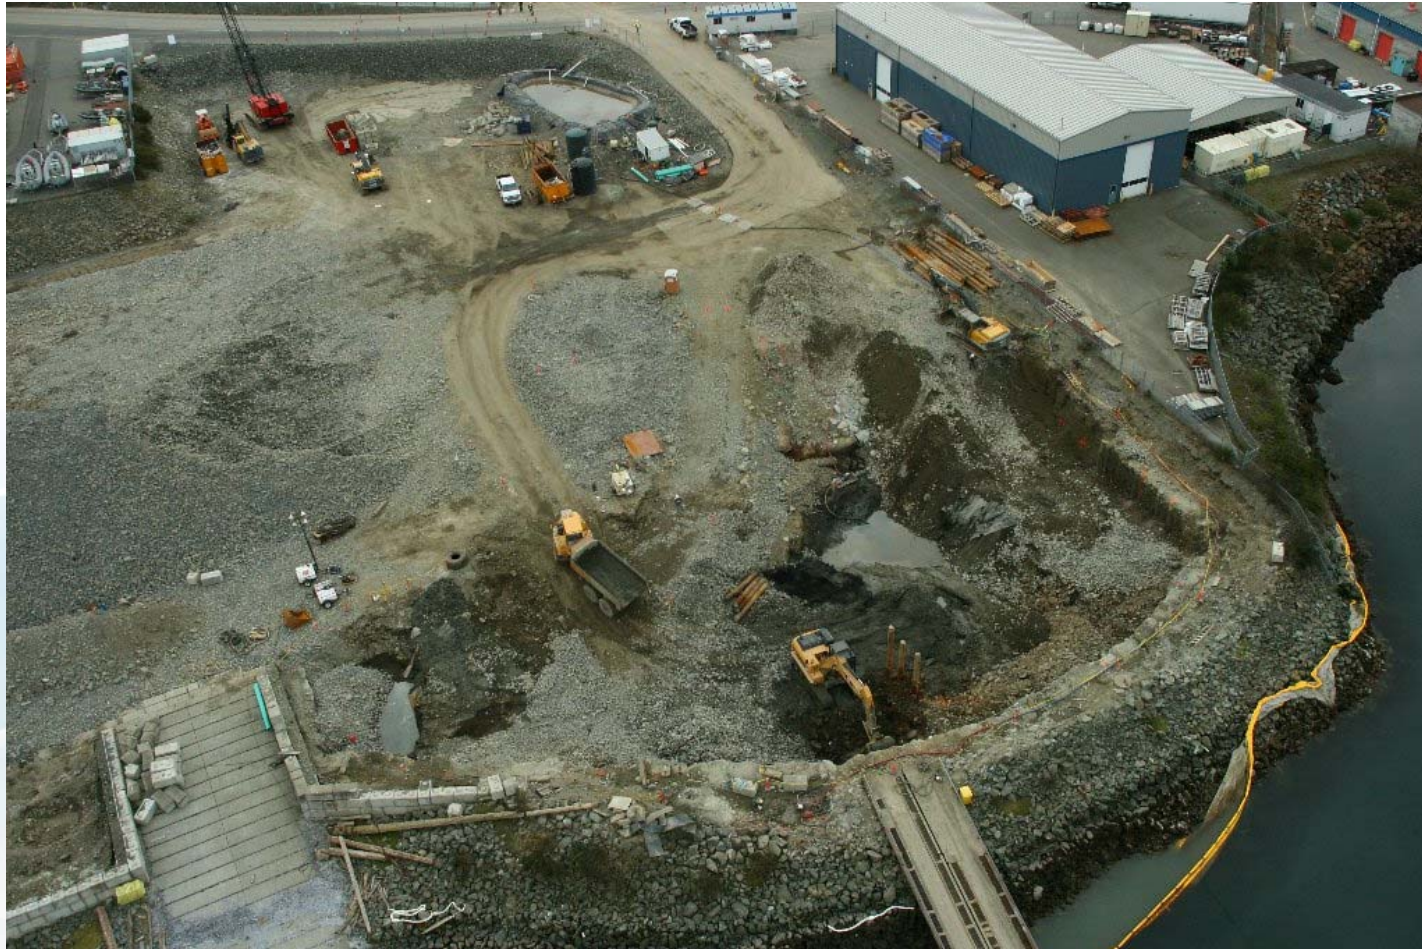
# SITE REMEDIATION

- Approximately 90,000 tonnes of material was removed from the site.
- Impacted fill consisted of soil mixed with metal debris, slag, Bunker C, creosoted piles and a minor amount of asbestos.
- Approximately 60,000 tonnes of material was disposed of at permitted facilities.
- Approximately 3,000 tonnes of Hazardous Waste metals and hydrocarbons were removed from the site.
- 27,000 tonnes of coarse rock was screened from contaminated fill to reduce the disposal cost. The coarse rock was re-used on site to reduce backfill cost.

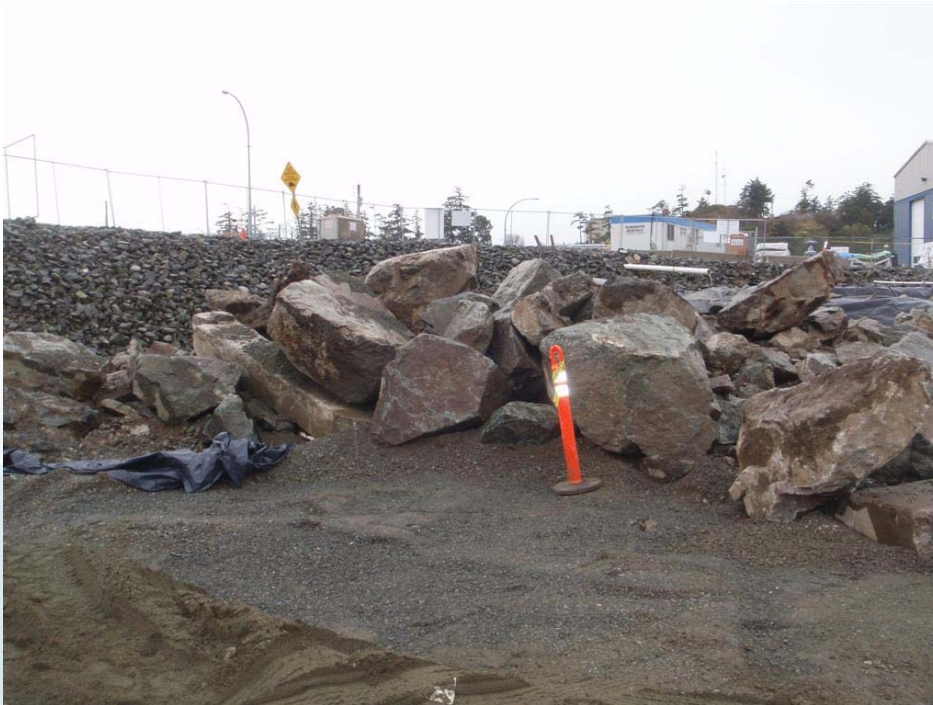
# SUBSURFACE VARIABILITY

- Thick zones of large rock (1.5 m to 2.5 m) was interpreted as bedrock in historic investigations.

- A stratigraphic model was developed based on the results from seven historic investigations.
- Coarse rock and/or rip rap was identified in zones along the perimeter of the excavation.

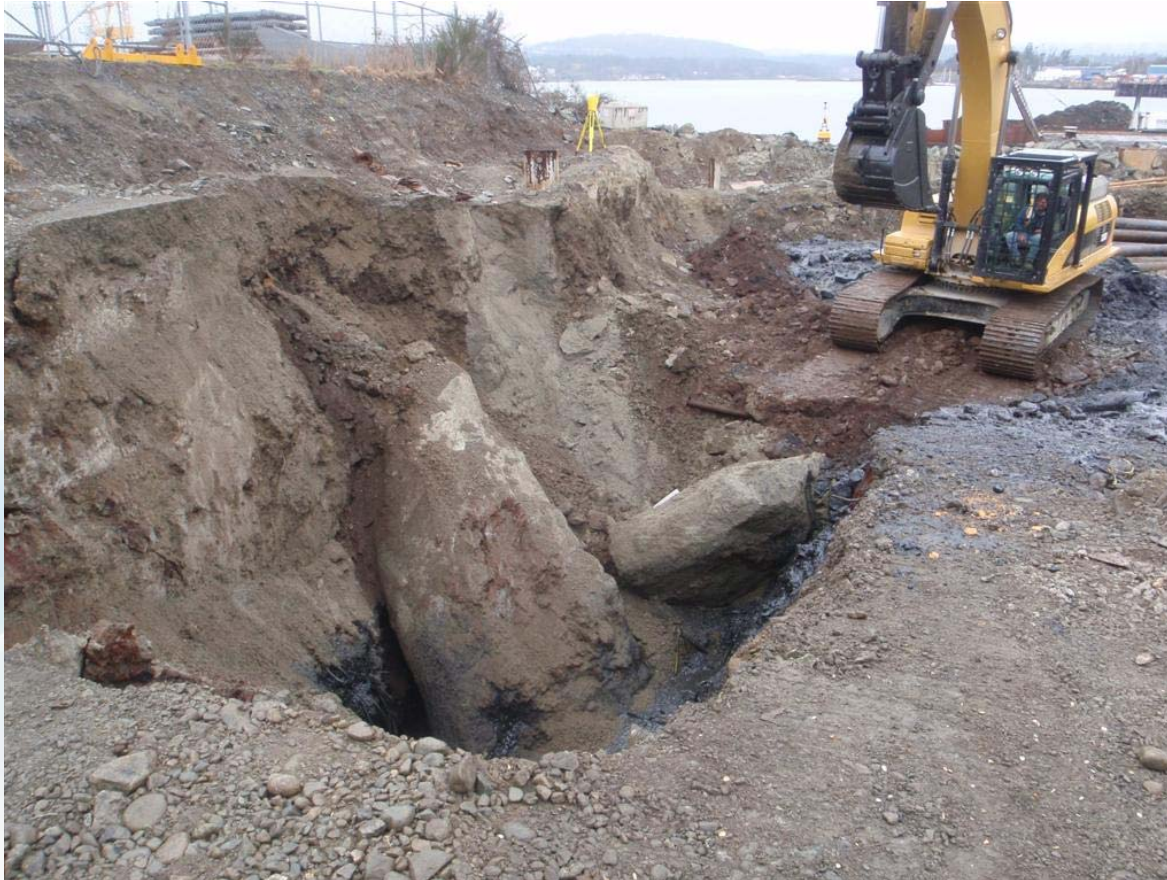
# STRATIGRAPHIC CHANGE – WALL FAILURE

- Barrier wall construction methodology was altered
- Redesign of wall sections to reflect deeper excavation requirements in some areas
- Slower drilling for pile installation
- Wall failure and repair

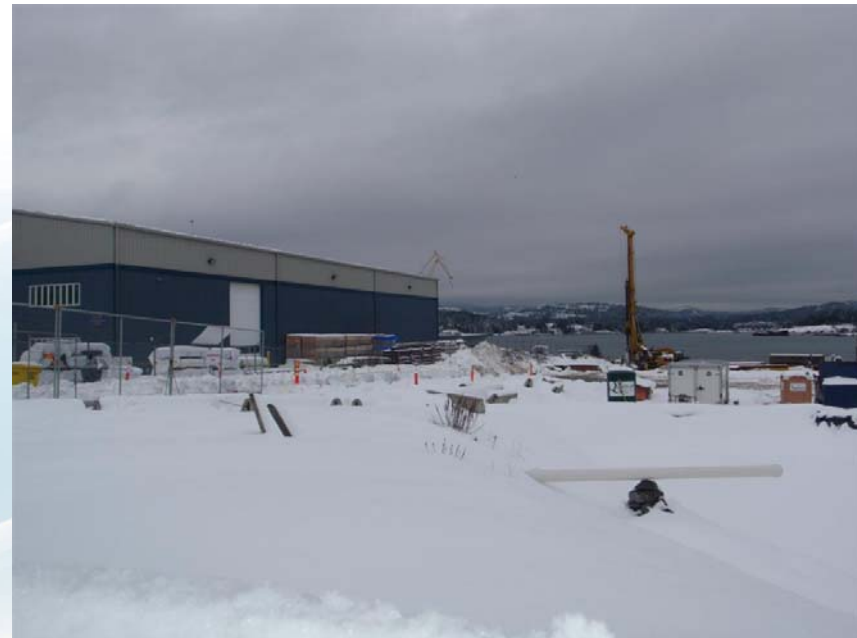
# WEATHER EFFECTS

- A large storm event occurred during the project that was atypical of Victoria weather.
- There was three weeks of record snowfall and high winds that halted construction.
