Overview and Lessons Learned – RCMP Detachment Remediation Project Carcross, Yukon Territory

John R. Taylor – Hemmera Jennifer Mayberry – RCMP Office of Environment & Sustainable Development Remediation Technologies Symposium 2010 Banff, AB

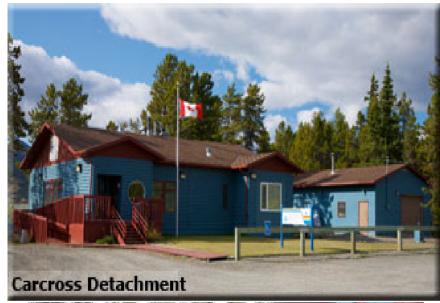
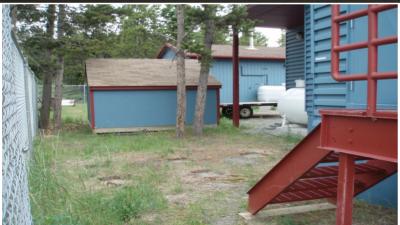
The Site

- 1 Corporal, 2 Constables, 1 PSE
- ~4,000 L of heating oil released in 2002 (earlier leaks suspected) from ASTs and associated piping
- Soil & groundwater contamination on RCMP & neighbouring YTG property
- 1600m³ impacted soil
- 900m² impacted groundwater plume (estimated)
- 200m² LNAPL (estimated)
- Highest concentrations of soil impact beneath DET building

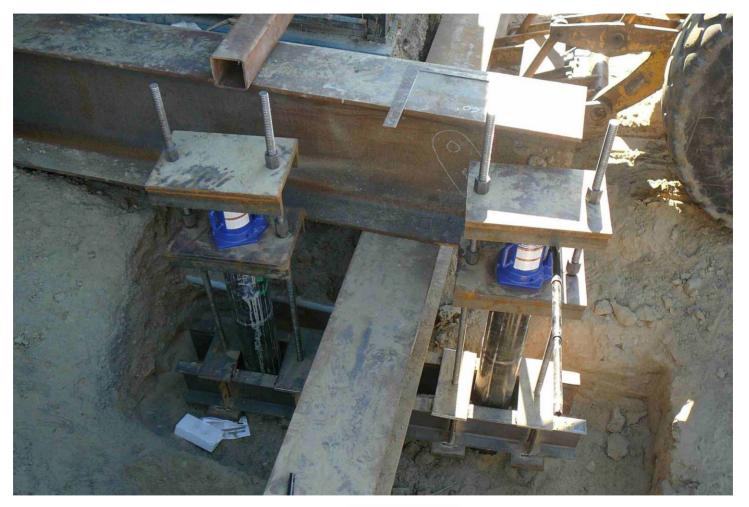
Building Support

- Analysis recommended PHC source removal followed by risk assessment to address any remaining impacts
- Building Management options analysis included temporary support, permanent support, and building relocation
- Selected temporary support of building while contaminated soil excavated from beneath
- Detachment to remain operational through remedial activities

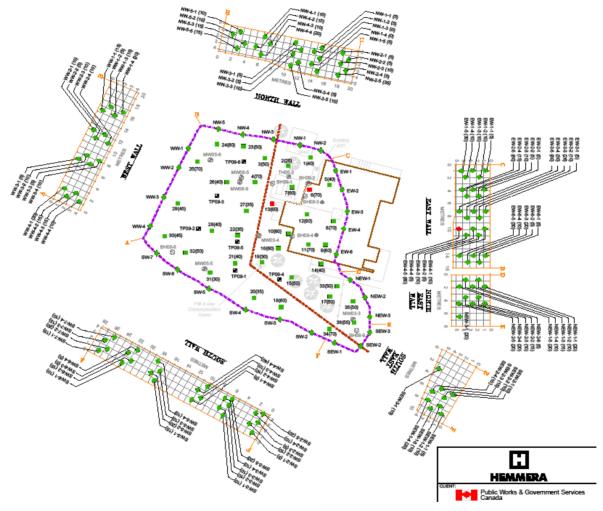
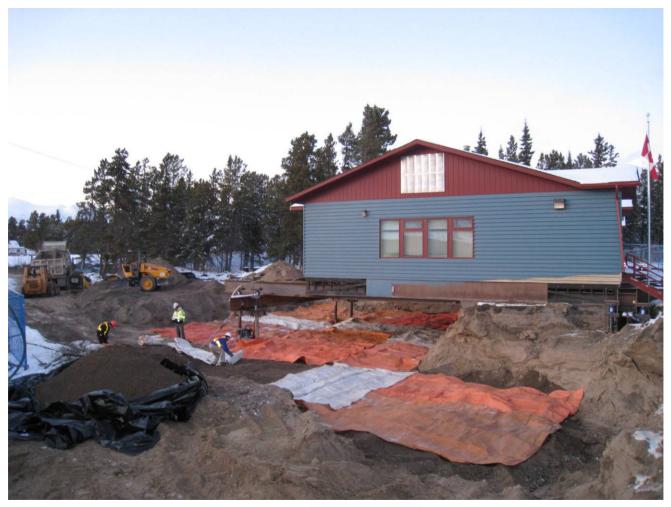
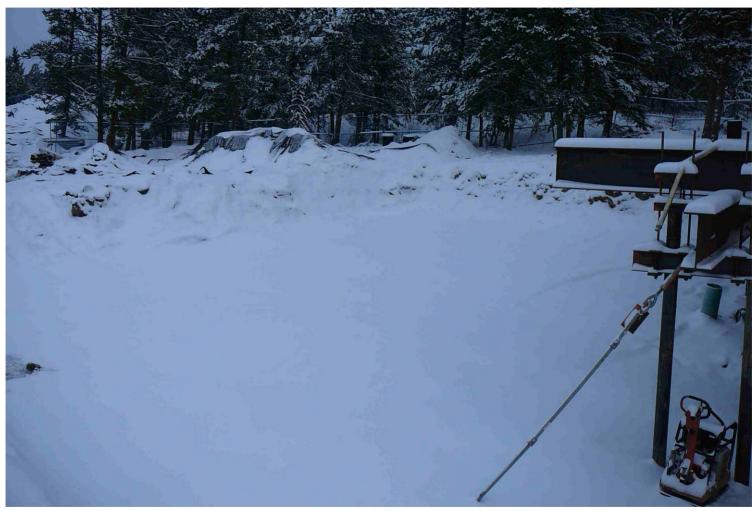
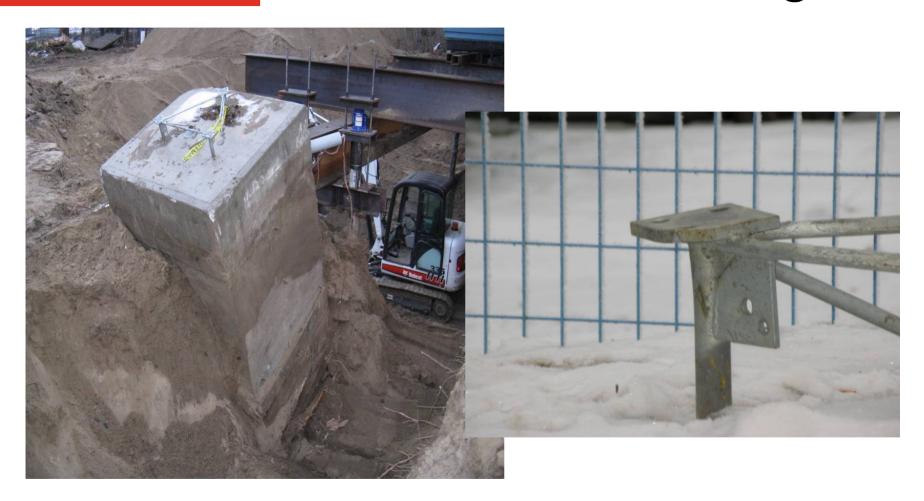
Results - Soil

- Remediate petroleum hydrocarbon concentrations in soil to <DL
- Determine post-remediation groundwater quality
- Update site RAP & RMP based on results (Remedial Action and Risk Management Plan)
