Aquifer Protection: Risk Management and Engineered Controls as an Alternative to Remediation

(Canmore Multiplex Site)

Julie Burghardt, M.Sc.(Eng.), P.Eng.

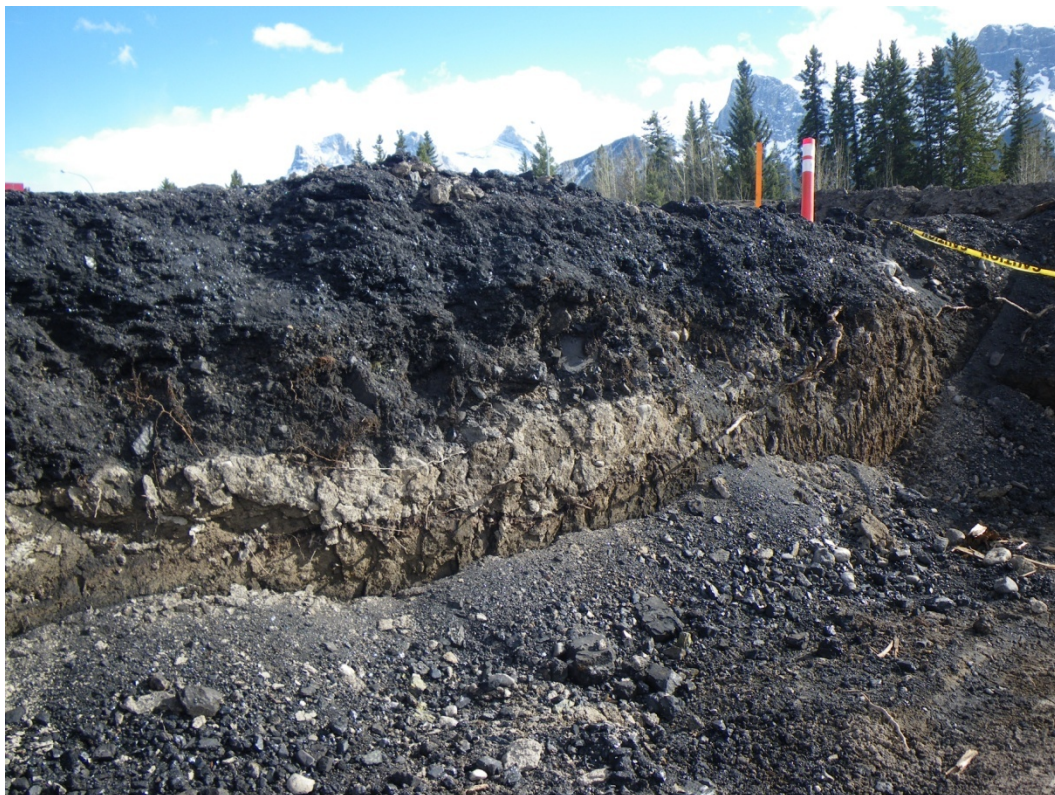
Investigation Findings - Site Geology

- 2 -3 m of alluvial sediments and fill cover the Site
 - Fill consists of coal, clinker and ash material
- Alluvial sediments and fill underlain by high yield non-glacial fluvial sand and gravel
 - Up to 55 meters thick in some areas
- GW depth ~1.5 – 3 m bgs
- Estimated K of 4×10^{-3} m/s
- Estimated GW velocity of 2-3 m/day

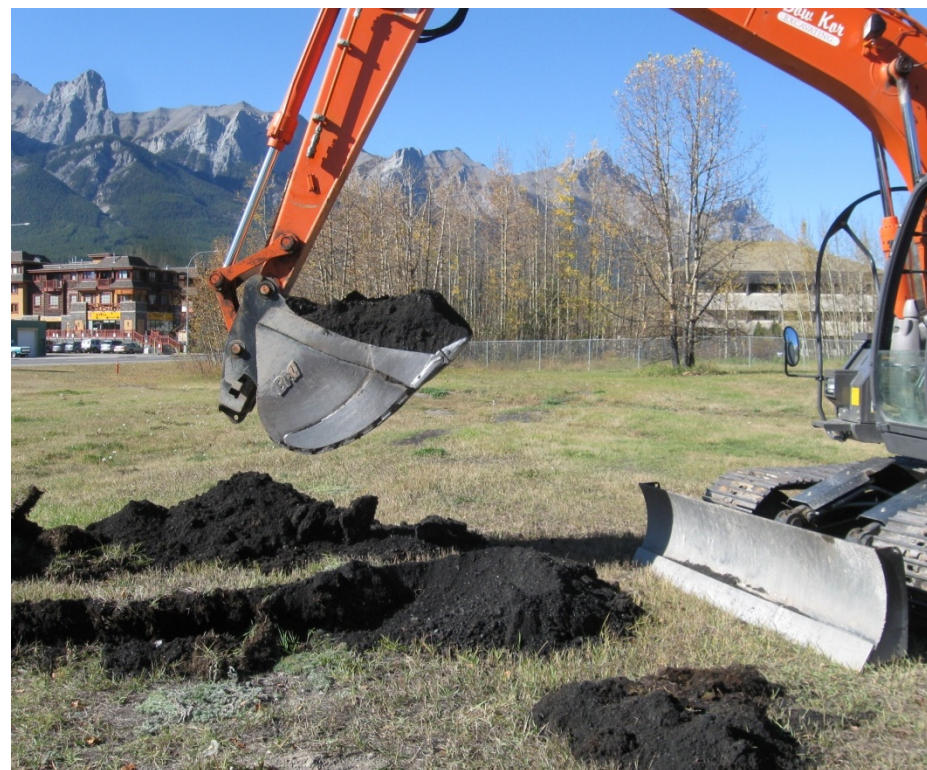
**Most significant issue identified in
Phase I ESA was on-Site fill**

- Boron above AB Tier 1 Guideline at two locations – not widespread
- PAHs above AB Tier 1 Guidelines in all samples submitted from fill
- Phenols (non-speciated) above AB Tier 1 Guidelines in fill
- No PAHs or phenols detected in groundwater in 2010
- No hydrocarbons detected in groundwater in 1992 or 2010

**General lack of correlation between
soil and groundwater results**

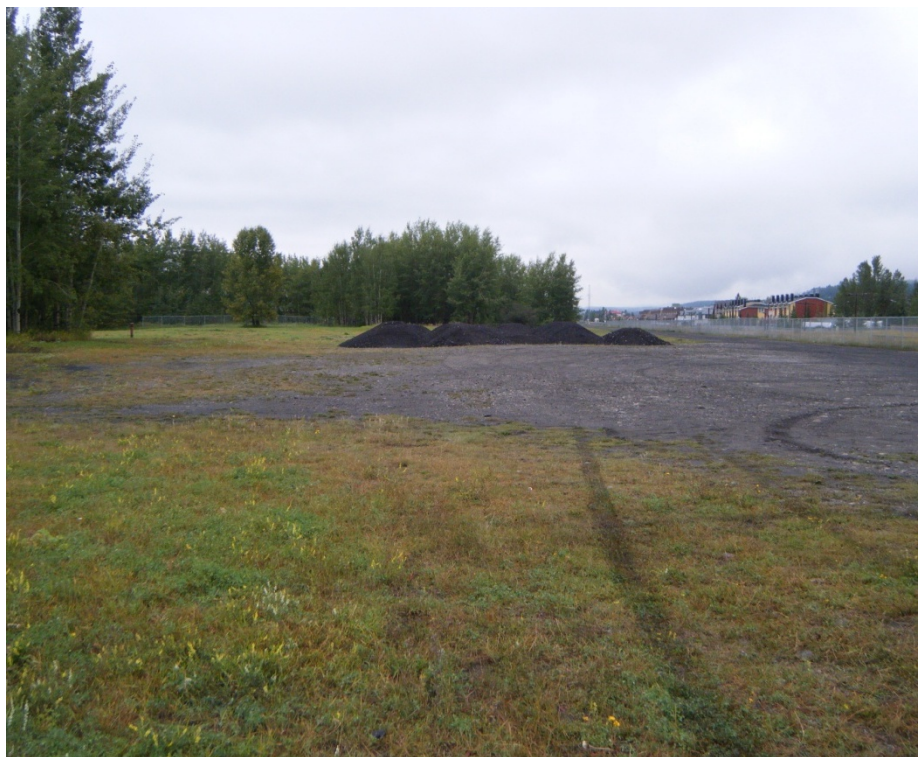
Investigation Findings – Contaminant Characteristics (continued)

- COCs are PAHs and phenols in fill
- AB Tier 1 Guidelines based on FWAL (DUA for IACR)
- If FWAL pathway eliminated, only PAH soil exceedance is B(a)P Equivalent
- **Conclusion:**
PAHs and phenols in fill were not a concern to receptors as they were not present in groundwater pathway

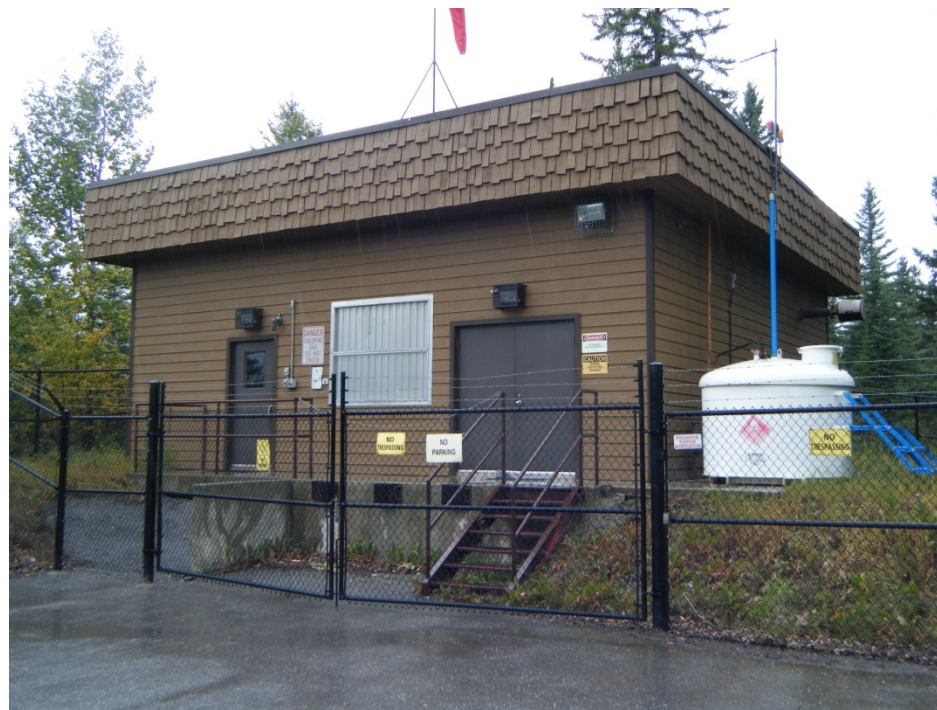
Pump House #1

- Most significant receptor
- Shallow well screened from ~ 14 to 19 m bgs
- Deeper well screened from ~40 to 45 m bgs
- Capture zone extends through south portion of the Multiplex Site
- No interaction between the deep and shallow wells when simultaneously pumped
- Minimal vertical movement within the aquifer
- Pumping had no impact on Policeman's Creek
- Hydrogeological study suggested risk of contamination to shallow well would only occur if source of contamination was present deeper than 7 m bgs

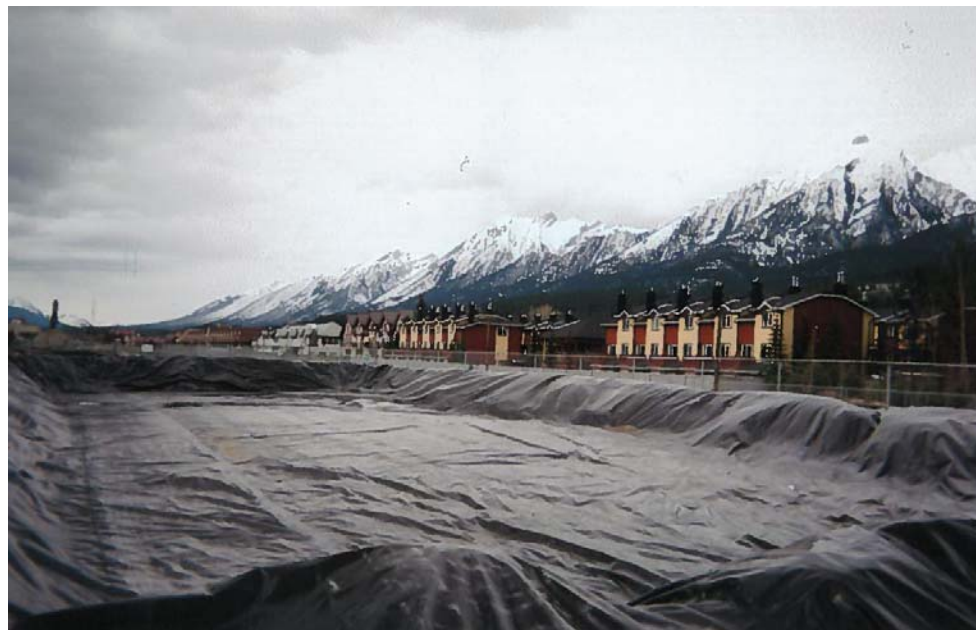
Soil Management Plan

- Where possible, fill not to be disturbed
- Excavated fill kept separated from un-impacted soil
- Fill to be stored in lined and bermed containment cell
- Fill to only be reused under building footprint
 - kept away from building edges
 - Place at least 1 m above seasonally high water table

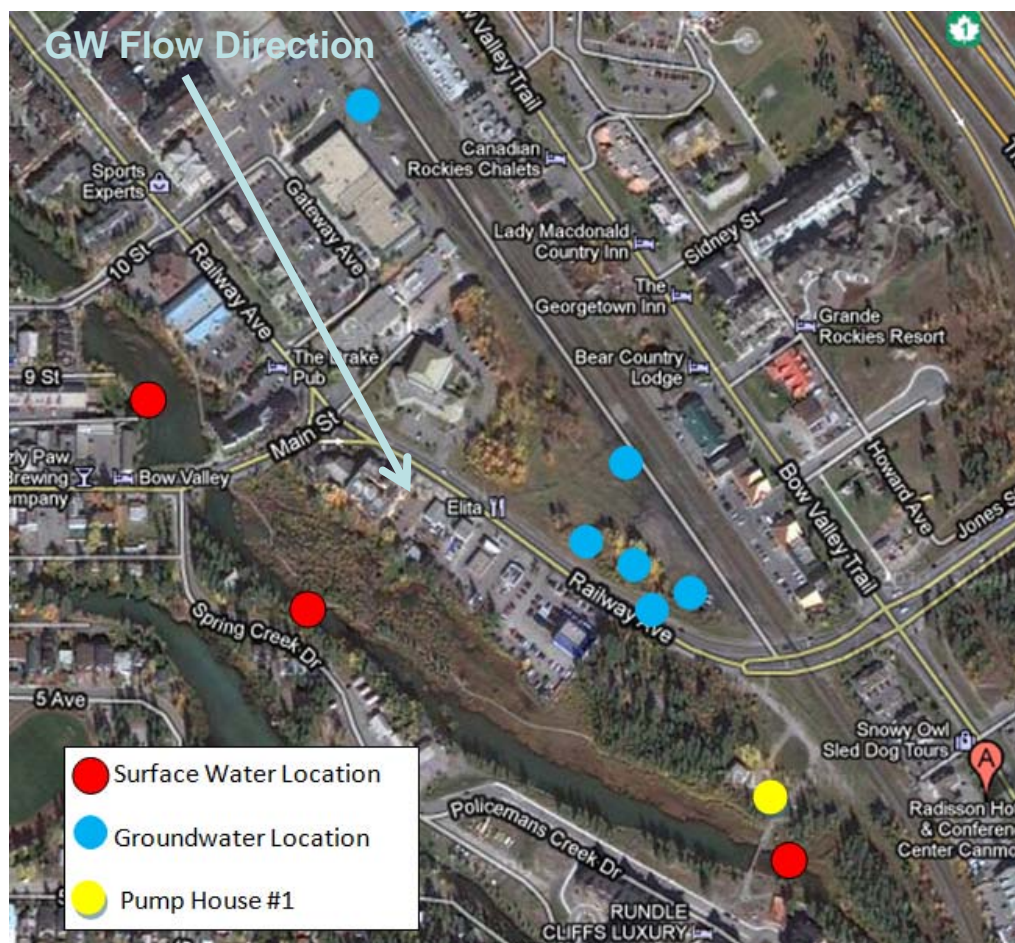
PAHs in Pump House #1

- PAHs including chrysene, phenanthrene and benzo(a)anthracene detected above Tier 1 in Pump House #1 shallow well
- No detections in deep well
- Pump House #1 not analyzed for PAHs before
- Comprehensive sampling program initiated including surface water sampling and upgradient groundwater sampling

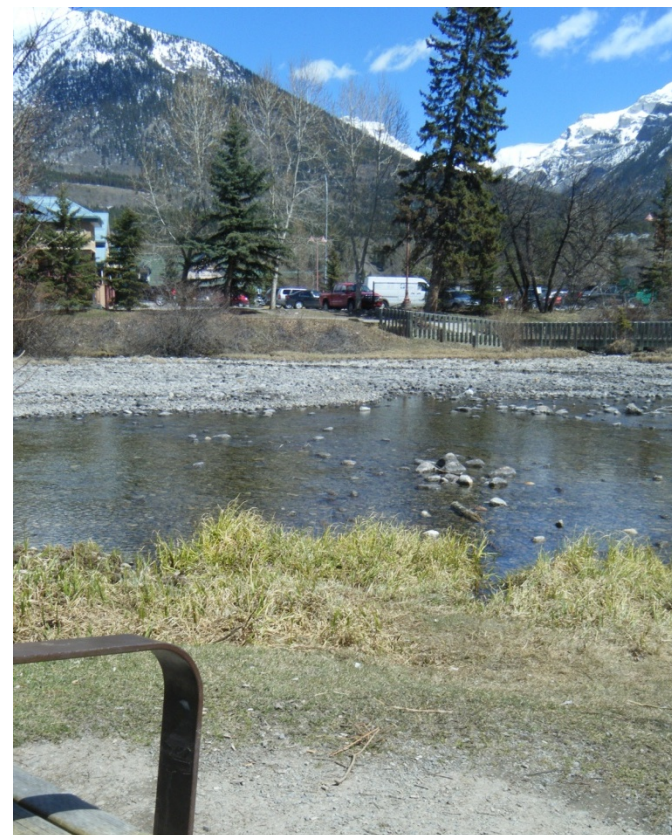
Results of Sampling Program

- Highest concentrations of PAHs in groundwater measured up-gradient at adjacent construction site
- PAH detections in surface water at all three sampling points
- Varying detections in most on-Site monitoring wells including up-gradient well
 - All non-detect since mid-May
 - Pump House #1 shallow well - last PAHs detected in early July
