# On-Site Remediation Approach for a Former Petrochemical Plant

Former Chatterton Petrochemical Plant  
7927 Huston Road, Delta, BC

Jason Christensen  
October 20, 2011 11am

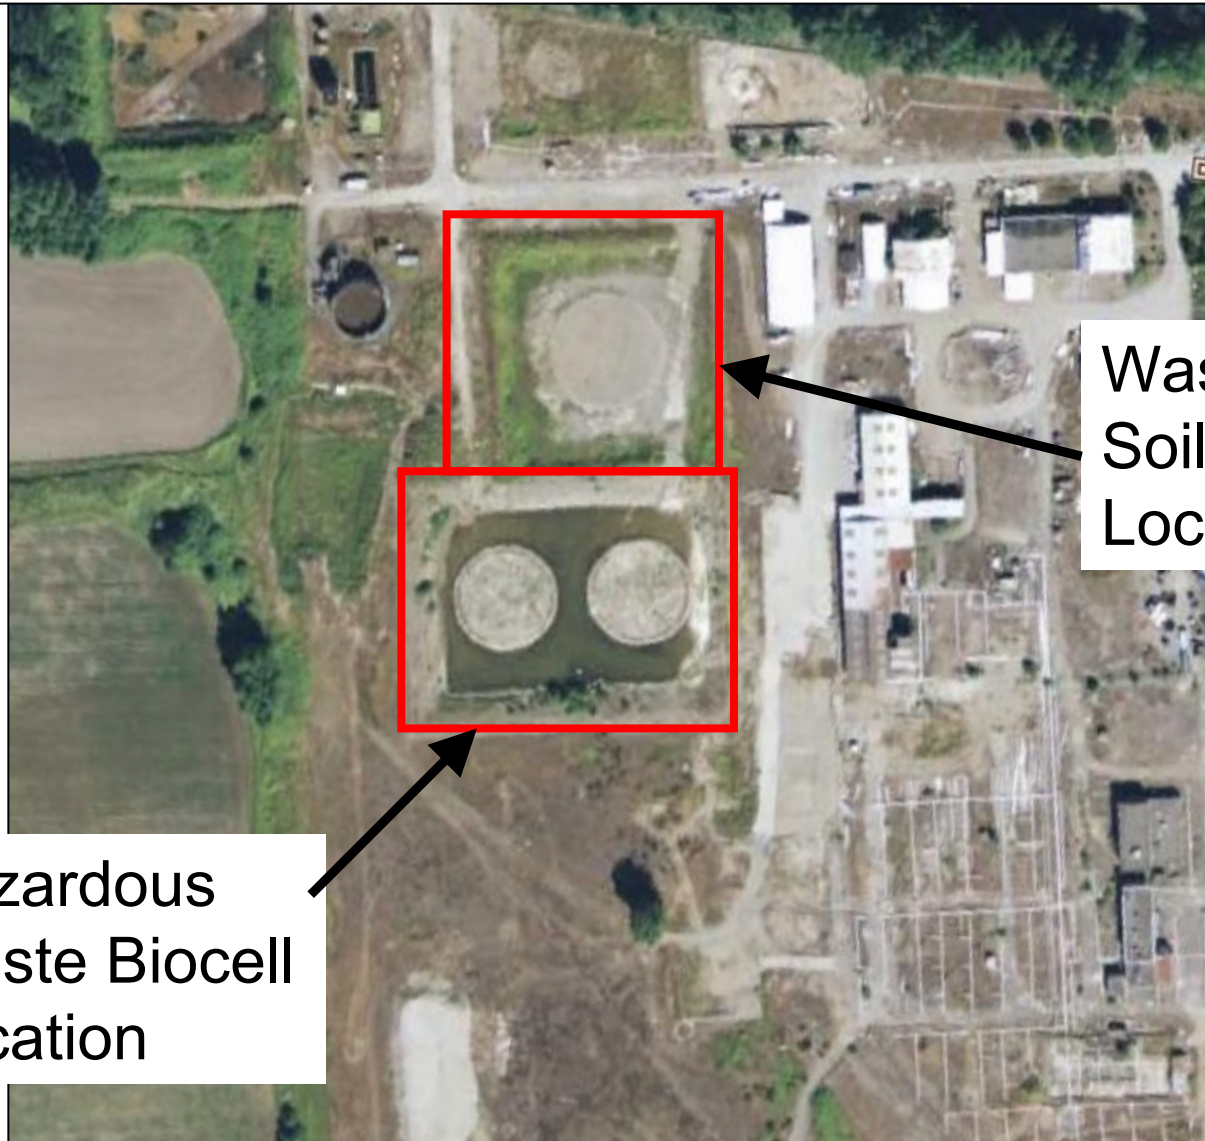
# Biocell Construction

Waste Quality  
Soil Biocell  
Location

Hazardous  
Waste Biocell  
Location

- Treating Hazardous Waste and Waste Quality soil on-site
- Using double liner and monitoring system for hazardous waste containment
- Constructed within former tank nest containment compounds

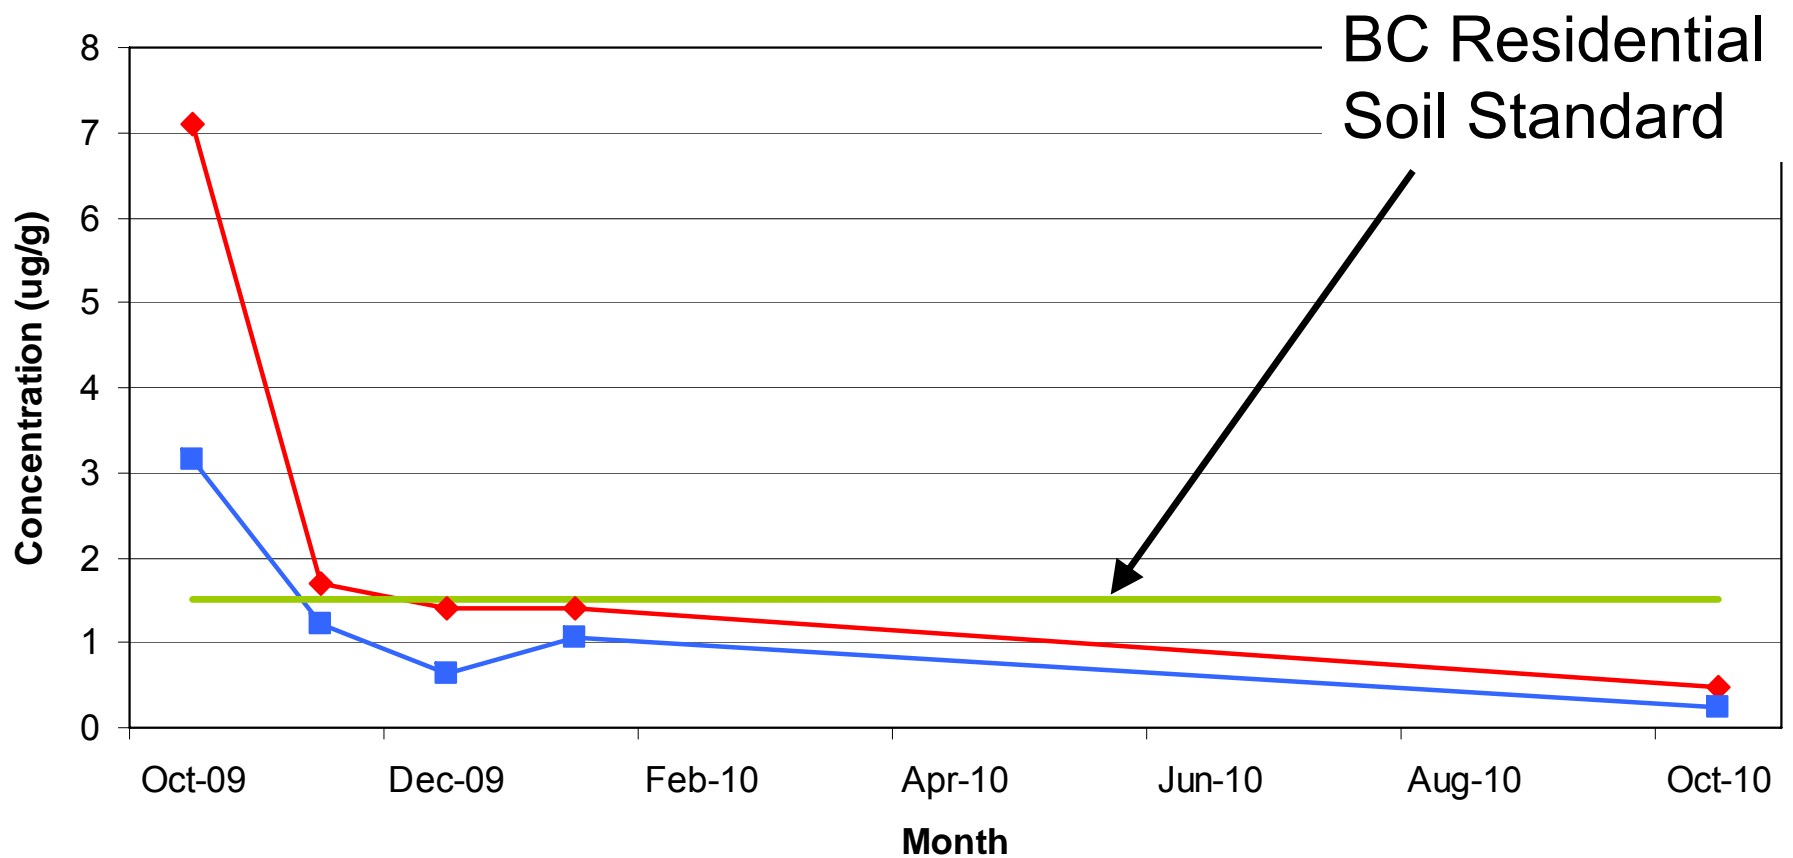
# Biocell Concentrations

◆ Highest Concentration ■ Average Concentration — CSR RL Standard — CSR CL Standard

- Soil concentrations within both the Hazardous Waste and Waste cells were reduced to less than Residential Quality
- Groundwater concentrations within process area were reduced to concentrations acceptable for risk assessment
- Off-Site chemical injection appears to have reduced concentrations adequately for risk assessment

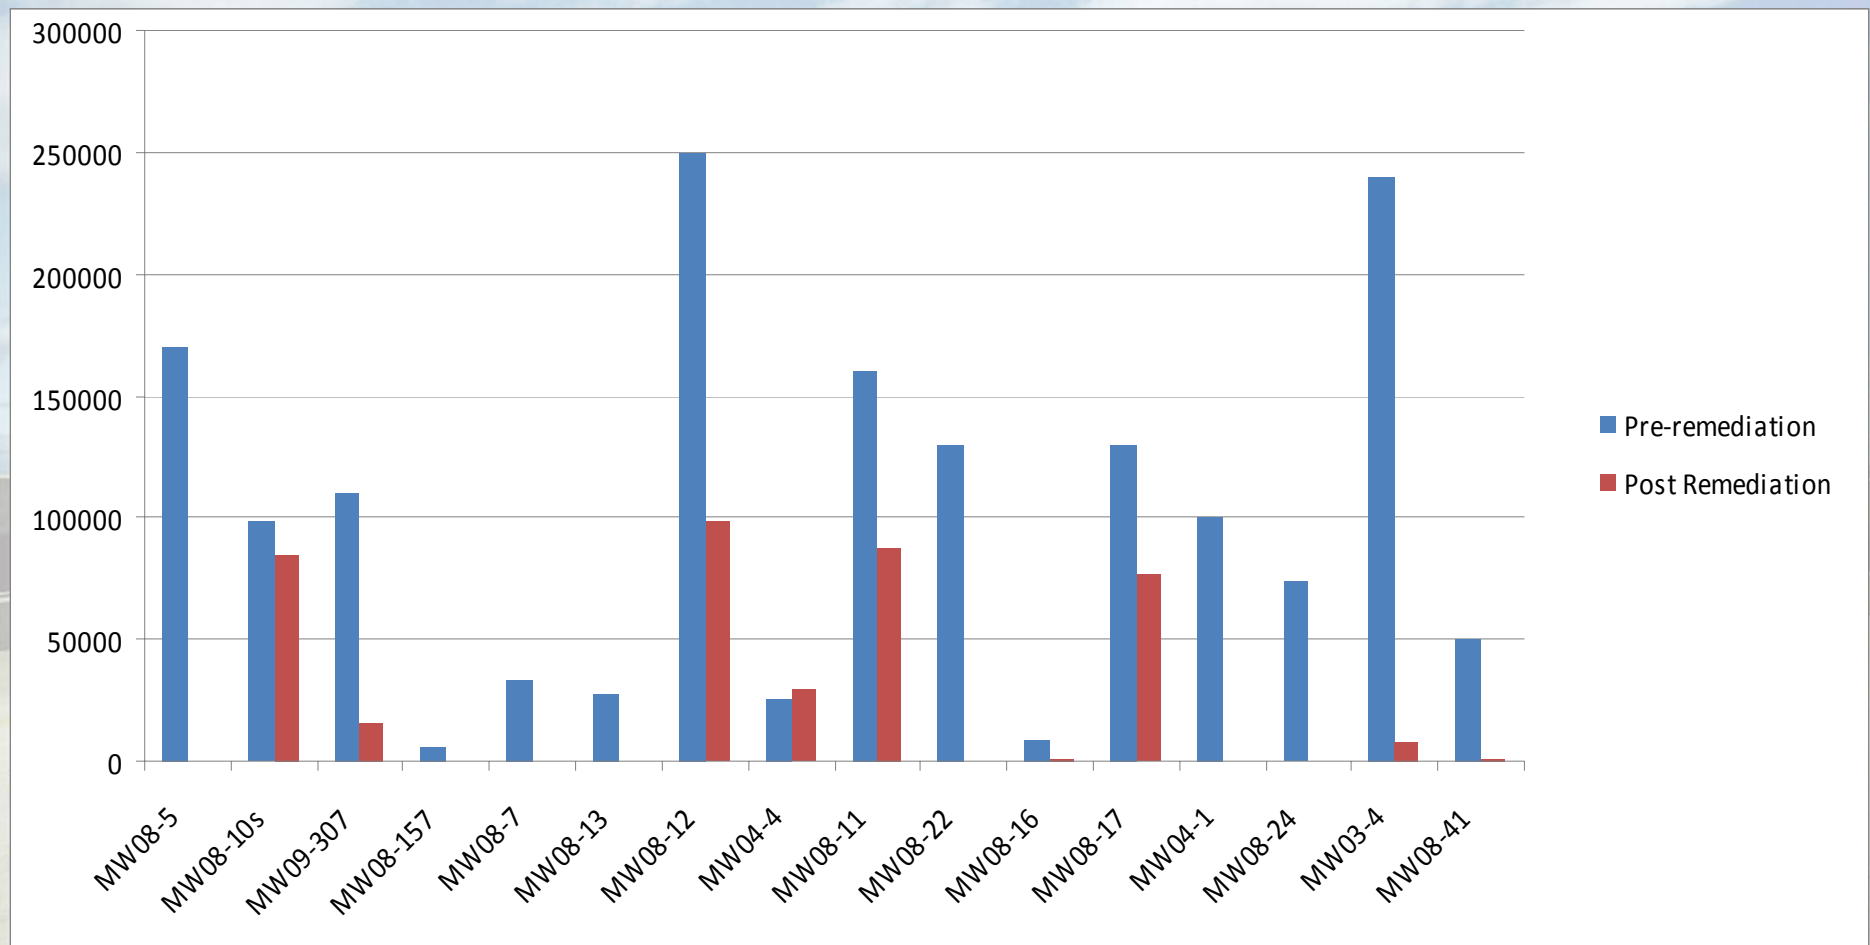
# Confirmatory Groundwater Samples

## VPH Results Pre- and Post-Remediation
