Old Town Clyde River – Site Assessment and Human Health & Ecological Risk Assessment

Date: October 21st, 2011

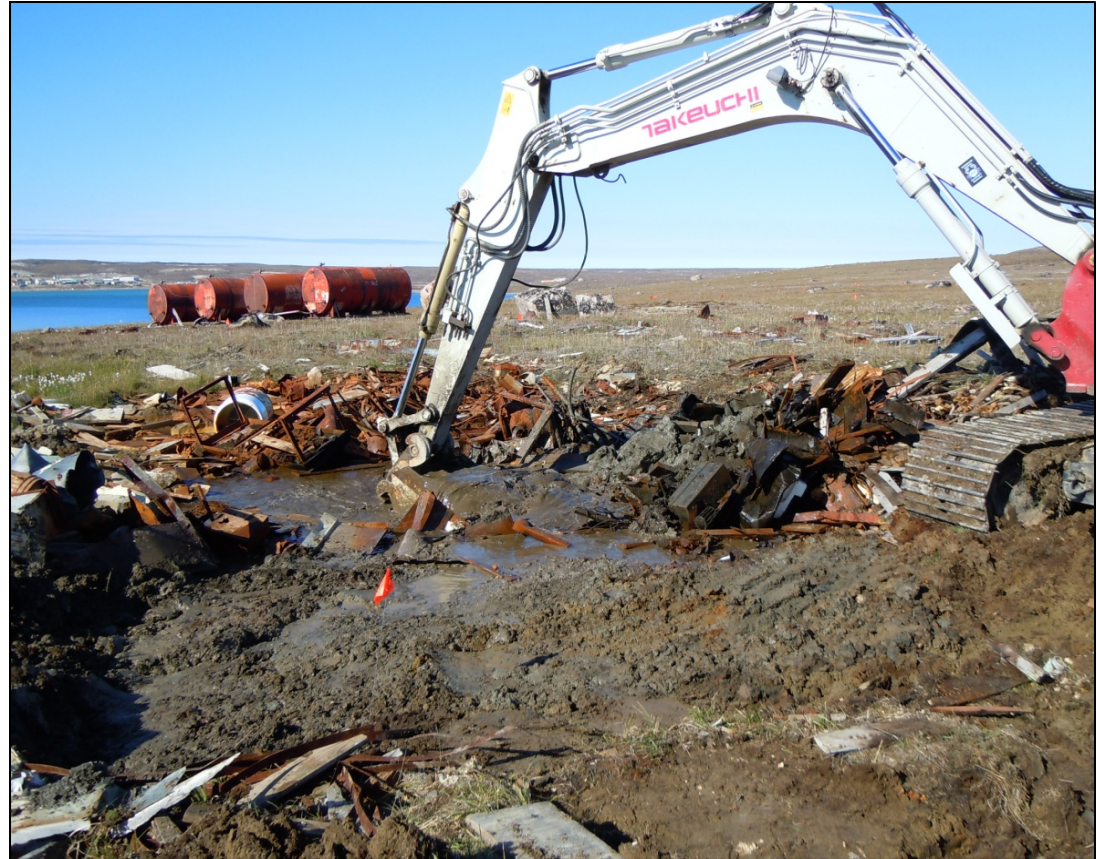
- Impacted Soils
 - Hydrocarbon impacted soils
 - Metals impacted soils
 - Aluminum powder waste

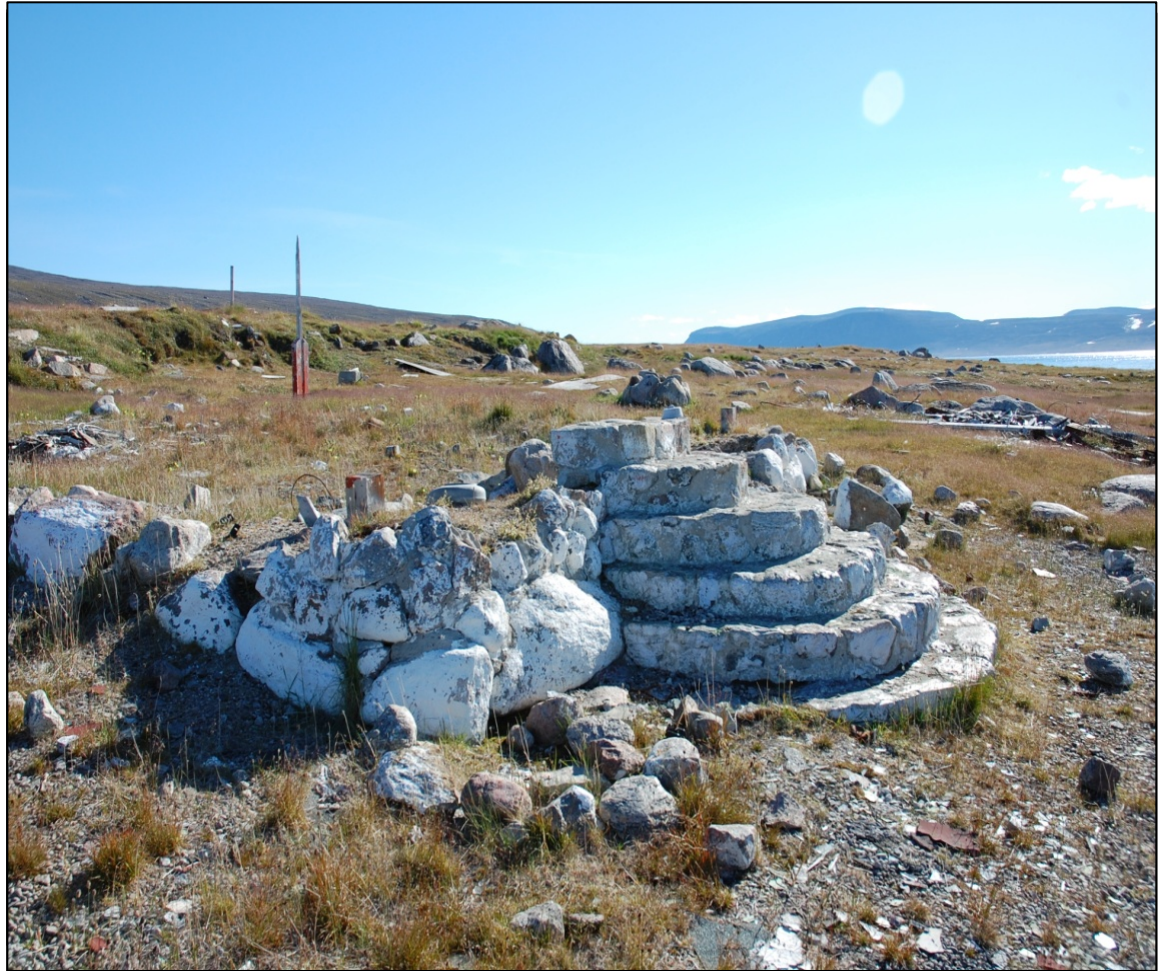
- Impacted groundwater
- Scattered surface and buried debris
- Hazardous waste
- Fuel tanks
- PHC product waste
- Remains of the concrete structures
- Locals exposed to hazards and risks that remain on the site
